Road Safety Audit Stage 1

Darland Farm

Proposed Access and Traffic Calming

Date: 22nd July 2016

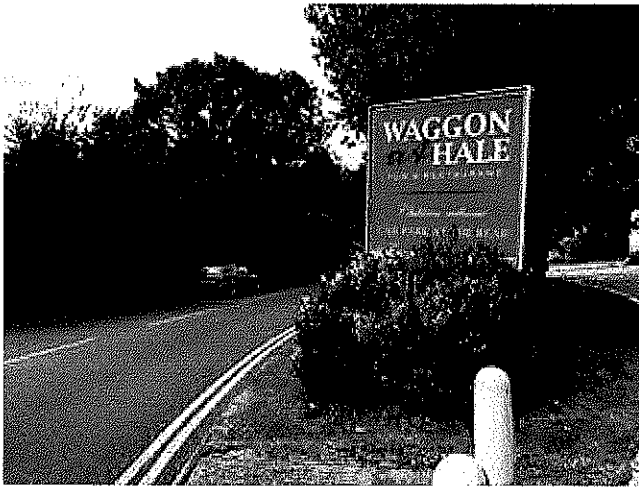
Summary: Lack of visibility may lead to pedestrian accidents.

Visibility to the northwest, at the proposed crossing on Capstone Road is restricted by signage and vegetation, see figure 1 below. Restricted visibility could lead to pedestrian accidents.

Figure 1: Restricted visibility could compromise road safety.

That suitable intervisibility should be provided or that the crossing should be relocated.

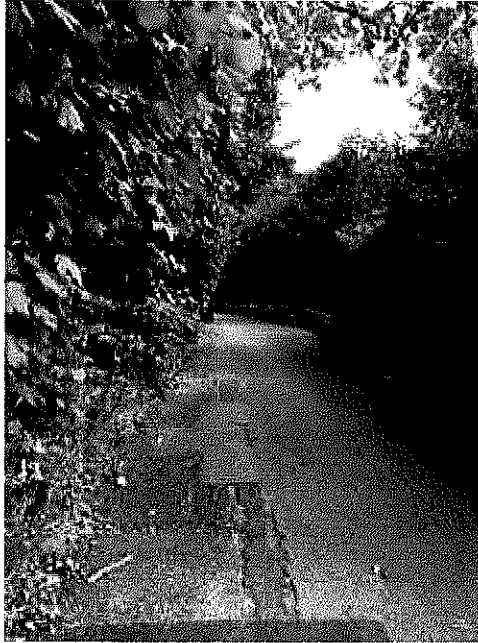
Summary: Insufficient width may lead to user conflicts.

The spur road is to be calmed through horizontal deflection, where pedestrians are expected to walk on this lightly trafficked rural road. However, excessive vegetation is overhanging the carriageway, see figure 2 overleaf, where the width is restricted. Lack of carriageway width may be detrimental to pedestrian safety.

Figure 2: Overgrown vegetation could compromise pedestrian safety.

That the vegetation should be cut back to provide greater width and that a regular maintenance programme should be employed.

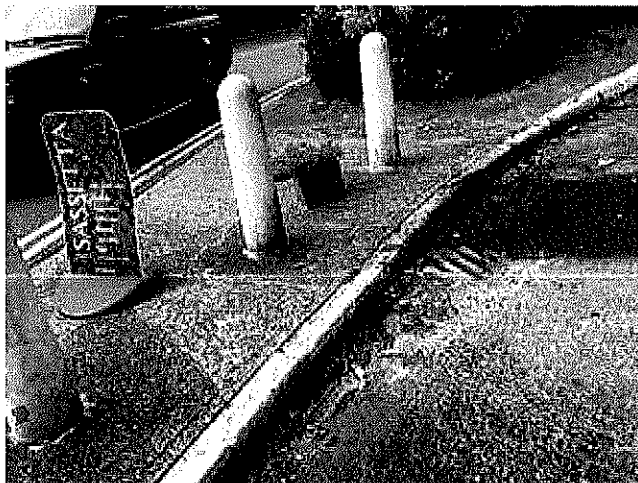
Summary: Gully location could compromise pedestrian safety.

At the proposed crossing on Capstone Road, there is a blocked gully sited in the spur road on the western side of the carriageway, see figure 3 below. A blocked gully could lead to ponding and possible pedestrian accidents, particularly in icy conditions. Further, the gully could be on the pedestrian desire line, which may lead to pedestrian trips, particularly for the visually and mobility impaired.

Figure 3: Blocked gully could compromise pedestrian safety.

That the gully should be unblocked and relocated away from the pedestrian desire line.
