Gladman Developments Limited

**Dover Road, Deal**

**Arboricultural Assessment**

February 2017

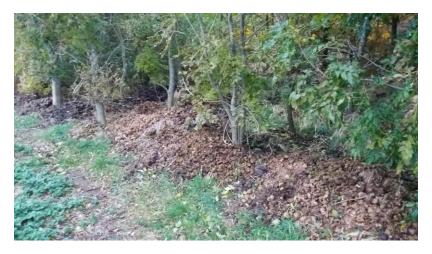
3.3 G1 consisted of mixed native species planted to form a small wooded area to the east. Young and semi mature examples of ash *Fraxinus excelsior*, beech *Fagus sylvatica*, English oak *Quercus robur*, sessile oak *Quercus petraea*, holm oak *Quercus ilex*, hawthorn *Crataegus monogyna*, and alder *Alnus glutinosa* were found to be generally fair in condition. Close planting intervals had resulted in low interlocking and dense crowns which also contained dense undergrowth such as bramble and thorn thickets. A large quantity of horse manure was present along the southern edge of G1 where the occupants of the horse paddock to the south had been tipping manure amongst the trees. Due to the potential for G1 to become a key landscape feature in the future this group of trees was considered to be retention category B.

Photograph 1: Horse manure piled around tree stems within G1

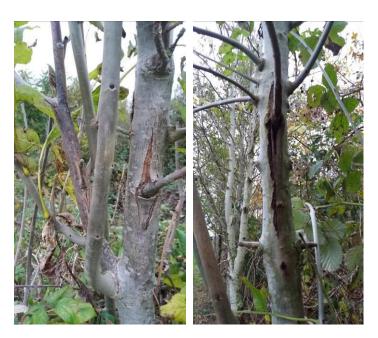
3.4 The presence of Chalara dieback of ash *Hymenoscyphus fraxineus* was observed throughout G1. This fungus causes leaf loss, crown dieback and bark lesions and is usually fatal within young tree stock. The presence of this disease would need to be confirmed through DNA testing so the appropriate management can be implemented. Despite this, overall the group was still regarded as being moderate in quality due to the possibility of managing the ash stock.

Photographs 2 & 3: Symptoms of Ash Dieback

4.8 Due to the presence of Chalara and age of trees infected it is also recommended that G1 is managed appropriately to reduce the potential for the spread of the disease within the naturally grown trees surrounding area. The removal and burning of the infected ash specimens would be recommended, the removal of the infected trees will also aid in the thinning of G1 to allow the remaining tree cover to mature into quality specimens as part of the future management in accordance with industry best practice.

- Due to the presence of Chalara present within G1, it is recommended that infected trees are managed appropriately in accordance with industry best practice.

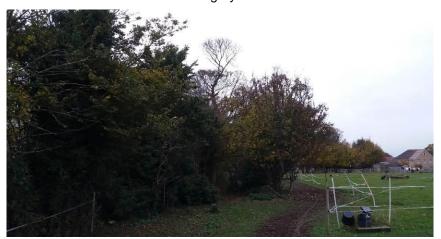
3.5 Tree cover along the western boundary comprised of low quality specimens either sporadically positioned along the existing stone wall or larger individuals situated within the paddock compartments. Species comprised of sycamore *Acer pseudoplatanus*, hawthorn, elder *Sambucus nigra* and English elm *Ulmus procera*. T1, T2, T3 and T8 had all developed in close proximity to the stone wall resulting in crossing and rubbing branches, bark wounds and basal suckers. G2 consisted of outgrown forms positioned either side of the stone wall with dense undergrowth forming a linear group adjacent to Dover Road. Dead trees were noted with dense ivy and poached ground to the east.

3.6 T4 and T5, both mature sycamores, were recorded separately due to their greater proportions in comparison to the surrounding tree cover of G2. Both of these trees housed branch stubs, broken branches, basal suckers, branch socket cavities and dead wood. Bark wounds were commonly observed due to regular browsing by resident horses and poached ground was also present. T5 had developed a significant secondary leader which extended past the main crown due to the die back of lower branches. All of this tree cover was considered to be low in quality due to the defects present and therefore recorded as category C.

Photograph 4: Low quality tree cover to the west
