# **Asbestos Survey for**

**GREEN EARTH MANAGEMENT CO LTD**

**FORMER HANSON OFFICE BUILDING**

Project Number: DNH-050

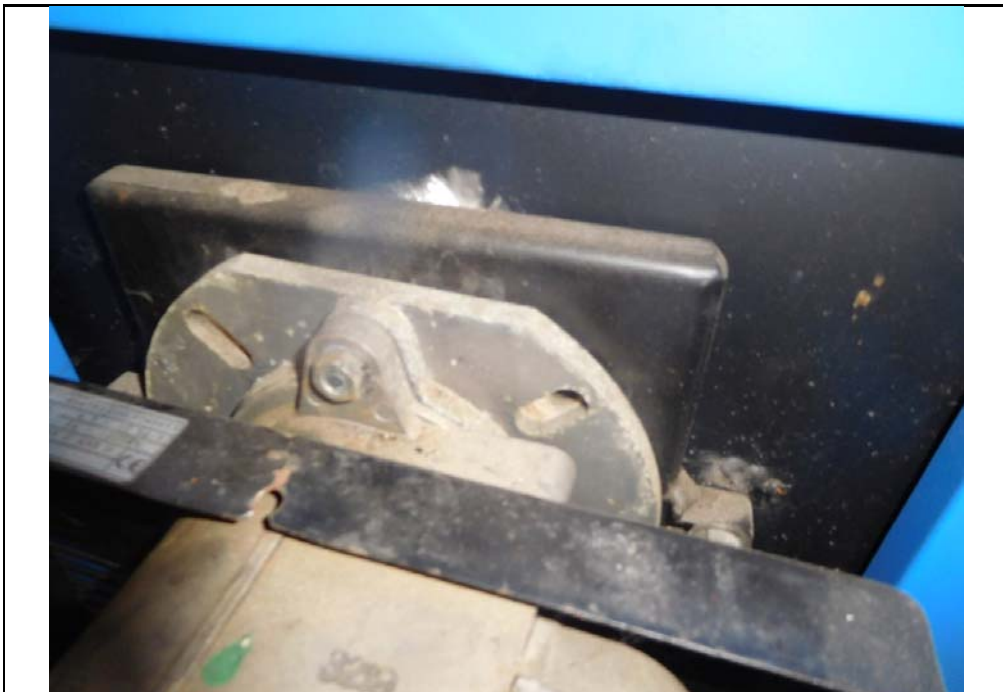
Location ID:	37513	Survey Type:	R D
Location Ref:	HO-001	Product Type:	NADIS
Product:	Rope Gasket to Boiler	Damage:	NADIS
Area:	Hanson Office Building	Treatment:	NADIS
Floor:	Ground Floor	Asbestos Type:	NADIS
Room:	Boiler Cupboard	Identification:	Identified
Surveyor Name:	L Harridge	Quantity:	
Drawing Ref:	1	Accessibility:	
Asbestos ?	No		
Date:	21 March 2017		
Next Inspection:	Not Applicable		
Analysis:			
Action:	No Action Required

Material Risk Score: 0  
Material Risk Band: NADIS  
Priority Risk Score: N/A

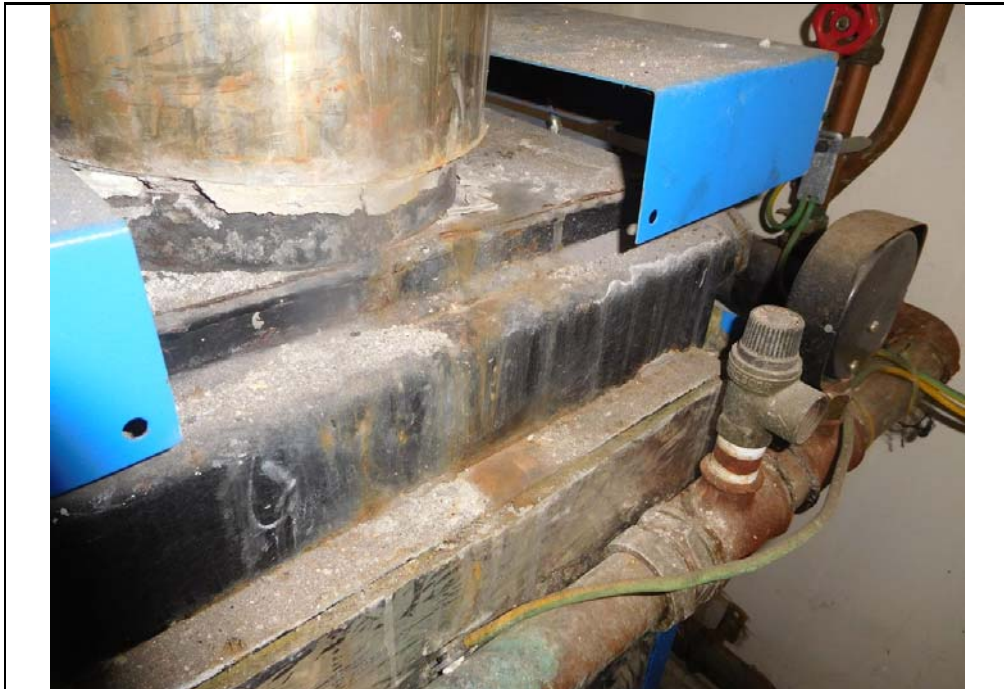
Location ID:	37514	Survey Type:	R D
Location Ref:	HO-002	Product Type:	NADIS
Product:	Putty to Flu Pipe	Damage:	NADIS
Area:	Hanson Office Building	Treatment:	NADIS
Floor:	Ground Floor	Asbestos Type:	NADIS
Room:	Boiler Cupboard	Identification:	Identified
Surveyor Name:	L Harridge	Quantity:	
Drawing Ref:	1	Accessibility:	
Asbestos ?	No		
Date:	21 March 2017		
Next Inspection:	Not Applicable		
Analysis:			
Action:	No Action Required

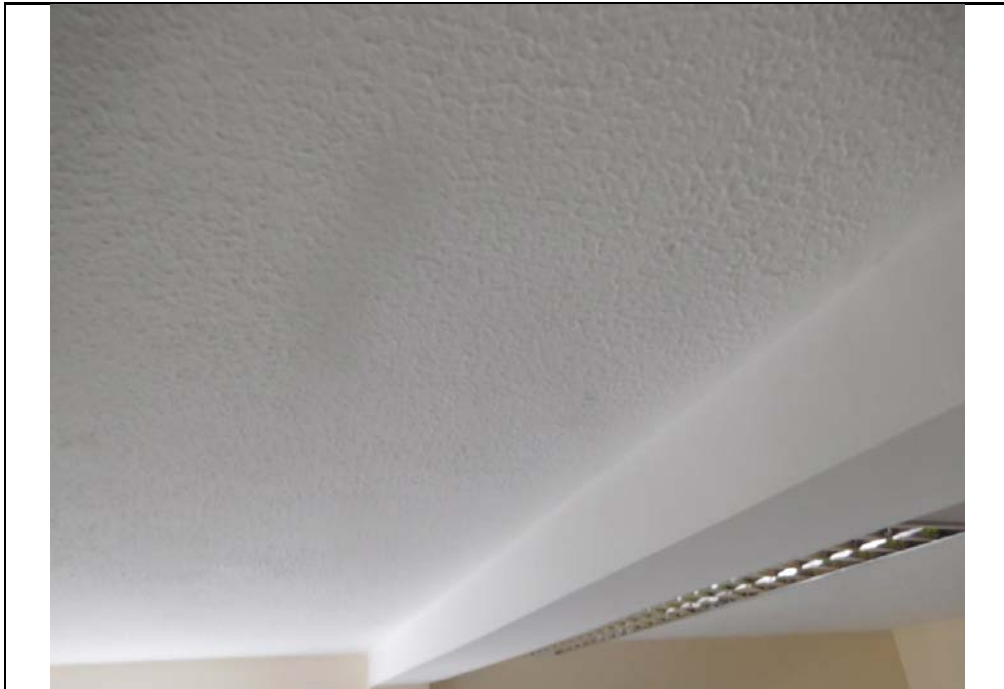
Location ID:	37515	Survey Type:	R D
Location Ref:	HO-003	Product Type:	NADIS
Product:	Text Coat to Ceiling	Damage:	NADIS
Area:	Hanson Office Building	Treatment:	NADIS
Floor:	Ground Floor	Asbestos Type:	NADIS
Room:	Toilet	Identification:	Identified
Surveyor Name:	L Harridge	Quantity:	
Drawing Ref:	1	Accessibility:	
Asbestos ?	No		
Date:	21 March 2017		
Next Inspection:	Not Applicable		
Analysis:			
Action:	No Action Required

Material Risk Score:	0
Material Risk Band:	NADIS
Priority Risk Score:	N/A

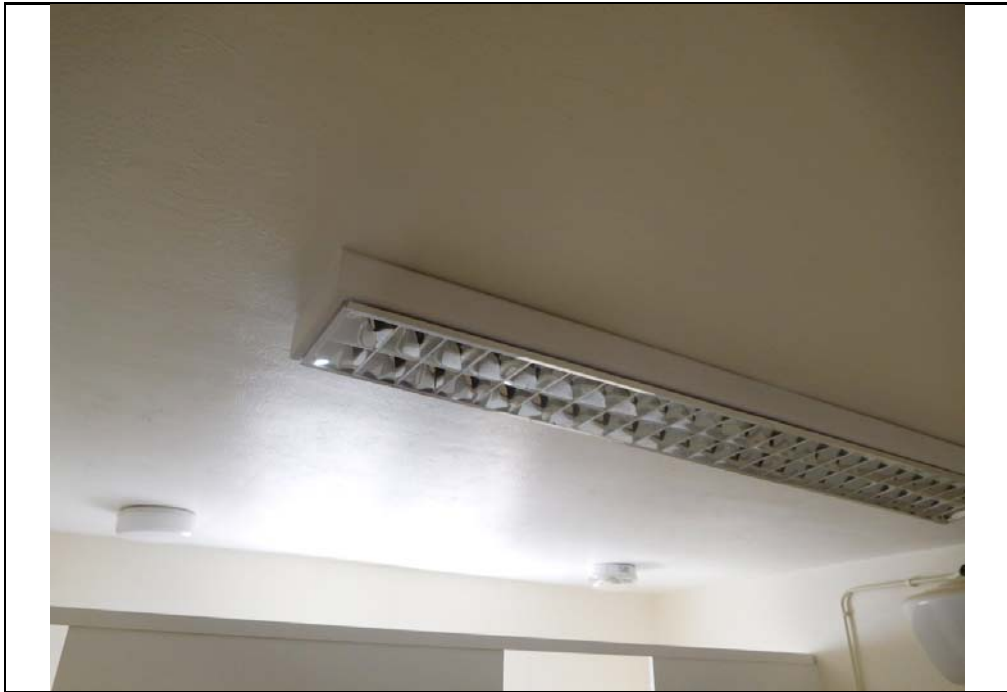
Location ID:	37516	Survey Type:	R D
Location Ref:	HO-004	Product Type:	NADIS
Product:	Text Coat to Ceiling	Damage:	NADIS
Area:	Hanson Office Building	Treatment:	NADIS
Floor:	Ground Floor	Asbestos Type:	NADIS
Room:	Toilets	Identification:	Identified
Surveyor Name:	L Harridge	Quantity:	
Drawing Ref:	1	Accessibility:	
Asbestos ?	No		
Date:	21 March 2017		
Next Inspection:	Not Applicable		
Analysis:			
Action:	No Action Required

Material Risk Score: 0  
Material Risk Band: NADIS  
Priority Risk Score: N/A

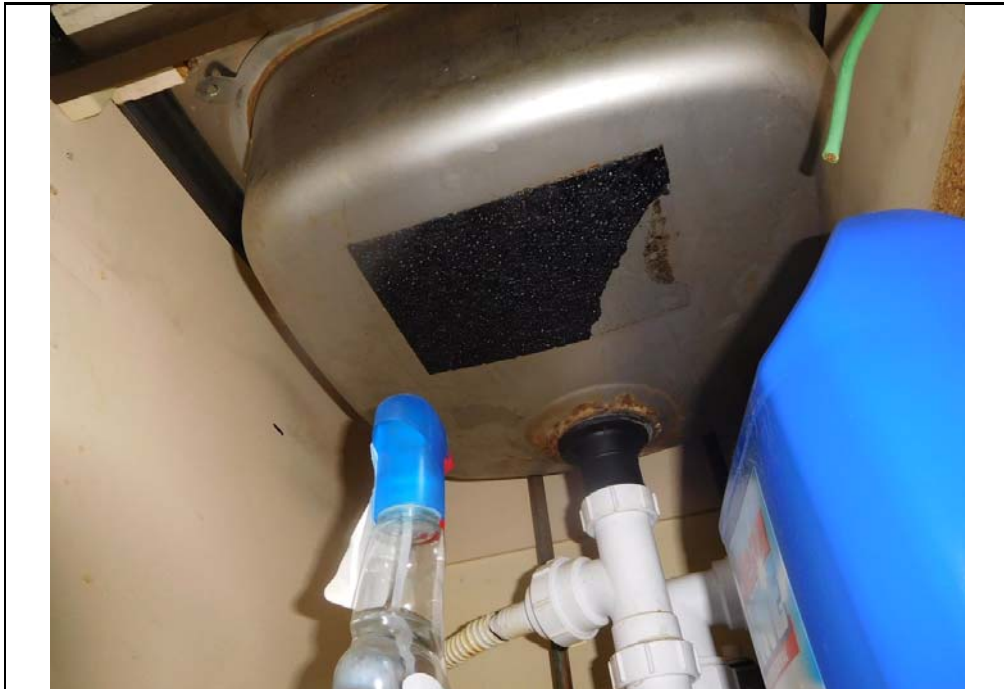
Location ID:	37517	Survey Type:	R D
Location Ref:	HO-005	Product Type:	Asbestos Reinforced Composites
Product:	Sink Pad	Damage:	Low damage
Area:	Hanson Office Building	Treatment:	Composite asbestos materials
Floor:	Ground Floor	Asbestos Type:	Chrysotile
Room:	Kitchen	Identification:	Identified
Surveyor Name:	L Harridge	Quantity:	X 2 Number to each sink
Drawing Ref:	1	Accessibility:	Easy Accessibility
Asbestos ?	Yes		
Date:	21 March 2017		
Next Inspection:	21 March 2018		
Analysis:	Trace		
		Material Risk Score:	3
		Material Risk Band:	Very Low Risk
		Priority Risk Score:	N/A

- 2 The non licensed asbestos materials that were located during this survey were the sink pads to the underside of the stainless steel sinks in the kitchens and also the old vinyl floor tiles in the stair cupboard. These products which were all proven to contain chrysotile asbestos fibres must be removed by suitably trained operatives under controlled conditions prior to the demolition works commencing.

Action: Requires Removal Under Controlled Conditions

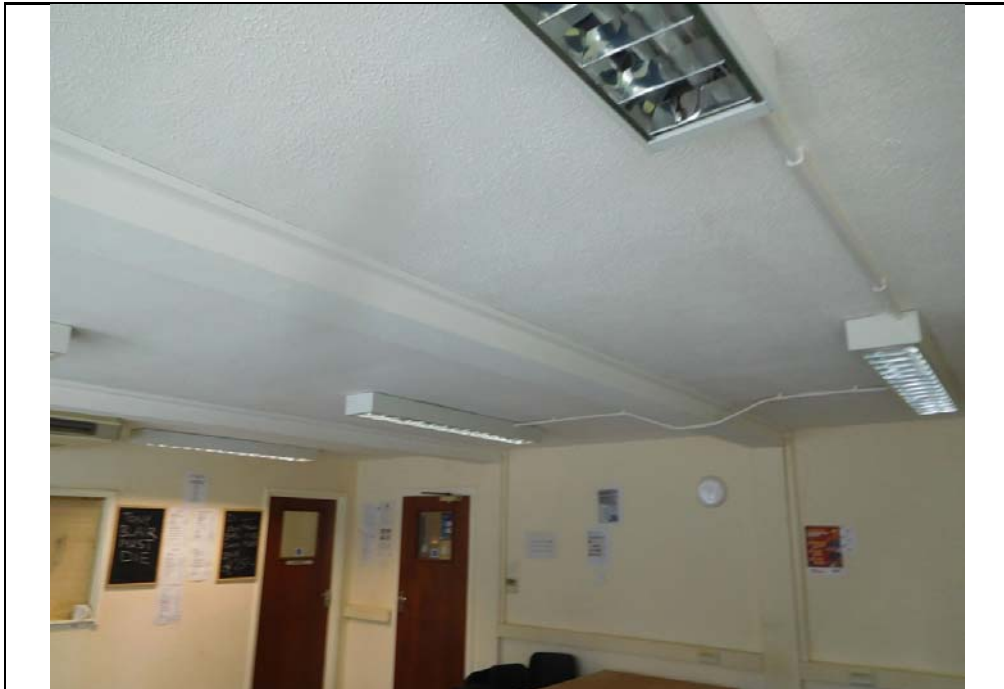
Location ID:	37518	Survey Type:	R D
Location Ref:	HO-006	Product Type:	NADIS
Product:	Text Coat to Ceiling	Damage:	NADIS
Area:	Hanson Office Building	Treatment:	NADIS
Floor:	Ground Floor	Asbestos Type:	NADIS
Room:	Canteen	Identification:	Identified
Surveyor Name:	L Harridge	Quantity:	
Drawing Ref:	1	Accessibility:	
Asbestos ?	No	Material Risk Score:	0
Date:	21 March 2017	Material Risk Band:	NADIS
Next Inspection:	Not Applicable	Priority Risk Score:	N/A
Analysis:			
Action:	No Action Required

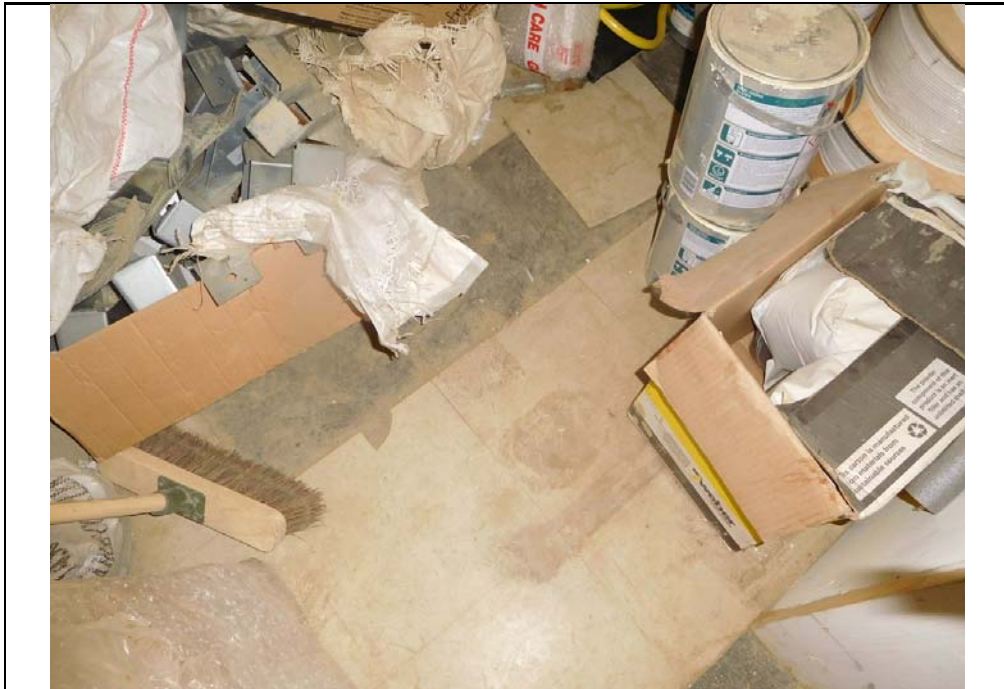
Location ID:	37519	Survey Type:	R D
Location Ref:	HO-007	Product Type:	Vinyl floor tiles
Product:	Floor Tiles	Damage:	Low damage
Area:	Hanson Office Building	Treatment:	Vinyl tiles
Floor:	Ground Floor	Asbestos Type:	Chrysotile
Room:	Stair Cupboard	Identification:	Identified
Surveyor Name:	L Harridge	Quantity:	Approx 2 Sq m
Drawing Ref:	1	Accessibility:	Easy Accessibility
Asbestos ?	Yes		
Date:	21 March 2017		
Next Inspection:	21 March 2018		
Analysis:	Trace		
		Material Risk Score:	3
		Material Risk Band:	Very Low Risk
		Priority Risk Score:	N/A

Action: Requires Removal Under Controlled Conditions

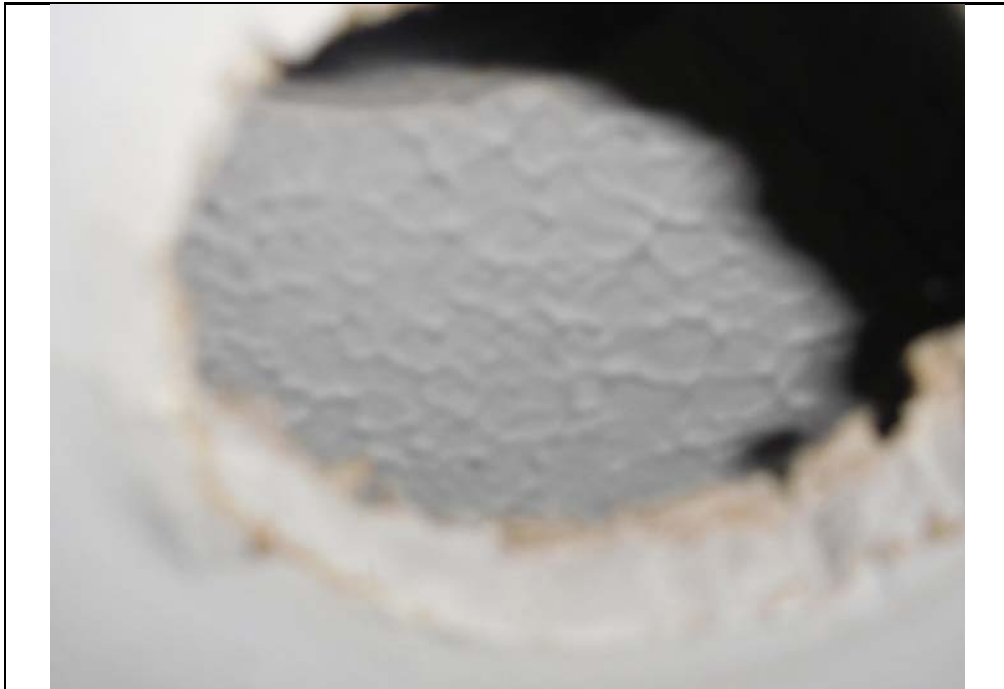
Location ID:	37520	Survey Type:	R D
Location Ref:	HO-007P	Product Type:	NADIS
Product:	Text Coat to Ceiling	Damage:	NADIS
Area:	Hanson Office Building	Treatment:	NADIS
Floor:	Ground Floor	Asbestos Type:	NADIS
Room:	Reception Office	Identification:	Strongly Presumed as previous sample
Surveyor Name:	L Harridge	Quantity:	
Drawing Ref:	1	Accessibility:	
Asbestos ?	No		
Date:	21 March 2017		
Next Inspection:	Not Applicable		
Analysis:			
Action:	No Action Required

Material Risk Score:	0
Material Risk Band:	NADIS
Priority Risk Score:	N/A

All textured coating samples were negative, whilst there is significant quantity of textured coating (throughout building all ceilings), enough samples were taken for quantity present therefore, the strong presumption is made as previous negative samples.

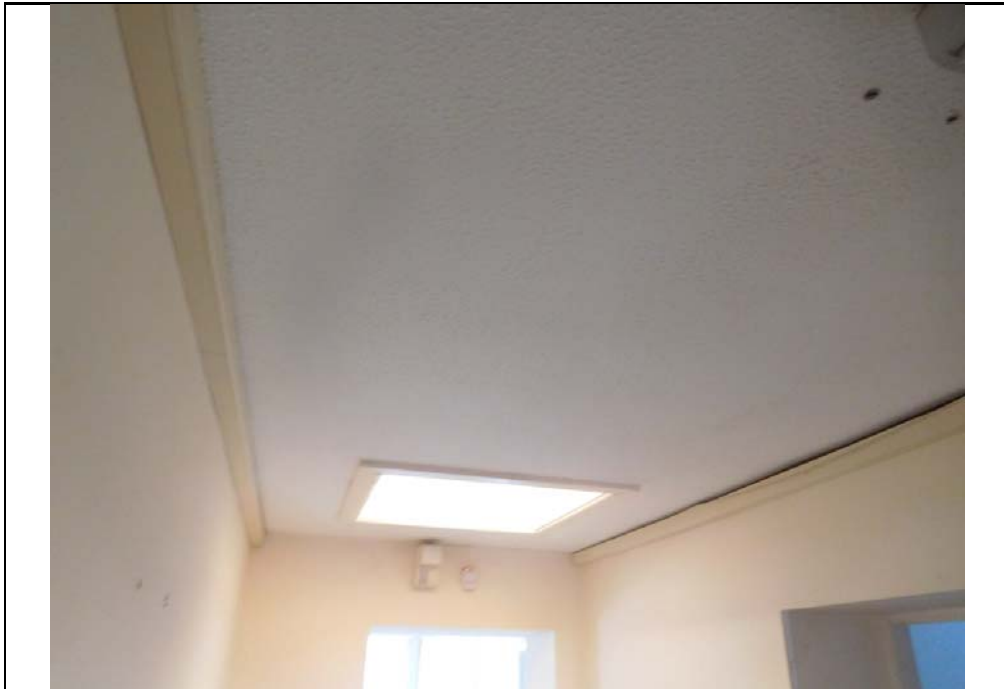
Location ID:	37522	Survey Type:	R D
Location Ref:	HO-009	Product Type:	NADIS
Product:	Text Coat to Ceiling	Damage:	NADIS
Area:	Hanson Office Building	Treatment:	NADIS
Floor:	First Floor	Asbestos Type:	NADIS
Room:	Corridor	Identification:	Identified
Surveyor Name:	L Harridge	Quantity:	
Drawing Ref:	2	Accessibility:	
Asbestos ?	No		
Date:	21 March 2017		
Next Inspection:	Not Applicable		
Analysis:			
Action:	No Action Required

Material Risk Score:	0
Material Risk Band:	NADIS
Priority Risk Score:	N/A

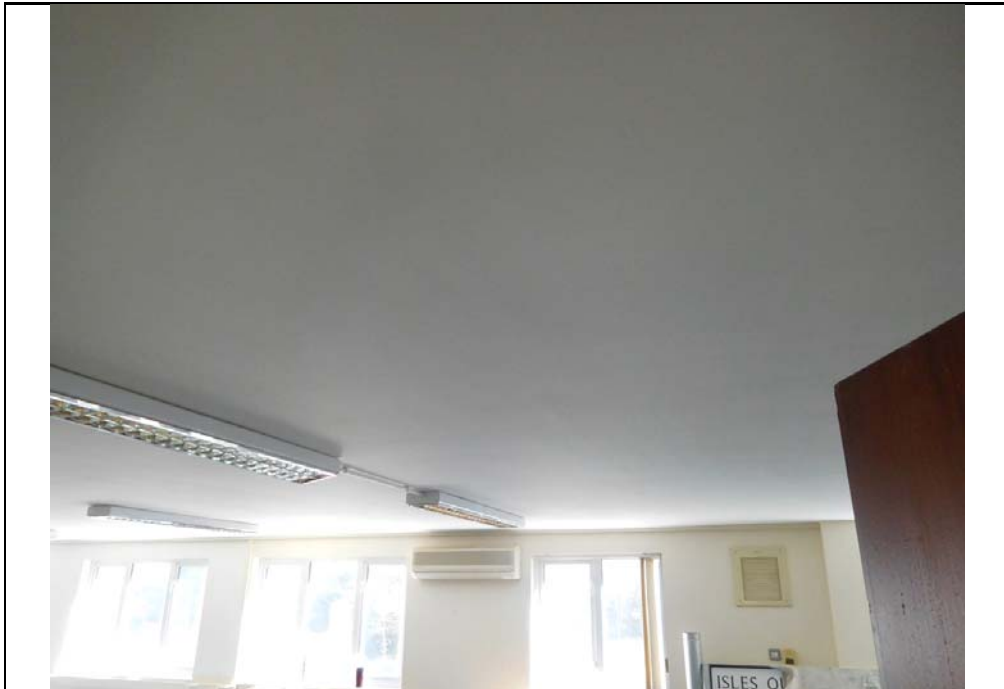
Location ID:	37523	Survey Type:	R D
Location Ref:	HO-010	Product Type:	NADIS
Product:	Text Coat to Ceiling	Damage:	NADIS
Area:	Hanson Office Building	Treatment:	NADIS
Floor:	First Floor	Asbestos Type:	NADIS
Room:	Meeting Room	Identification:	Identified
Surveyor Name:	L Harridge	Quantity:	
Drawing Ref:	2	Accessibility:	
Asbestos ?	No		
Date:	21 March 2017		
Next Inspection:	Not Applicable		
Analysis:			
Action:	No Action Required

Material Risk Score: 0  
Material Risk Band: NADIS  
Priority Risk Score: N/A

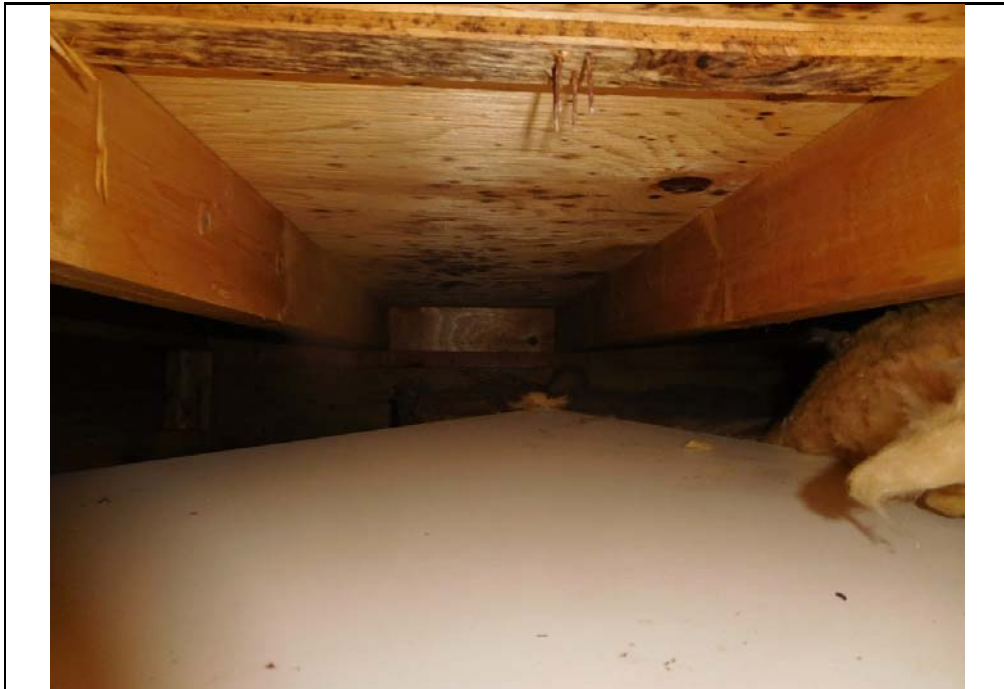
Location ID:	37524	Survey Type:	R D
Location Ref:	HO-011	Product Type:	Not Applicable
Product:	No Asbestos Located	Damage:	Not Applicable
Area:	Hanson Office Building	Treatment:	Not Applicable
Floor:	First Floor	Asbestos Type:	Not Applicable
Room:	Ceiling Void	Identification:	
Surveyor Name:	L Harridge	Quantity:	
Drawing Ref:	2	Accessibility:	
Asbestos ?	No		
Date:	21 March 2017		
Next Inspection:	Not Applicable		
Analysis:			
Action:	No Action Required

No asbestos located therefore, no samples taken.

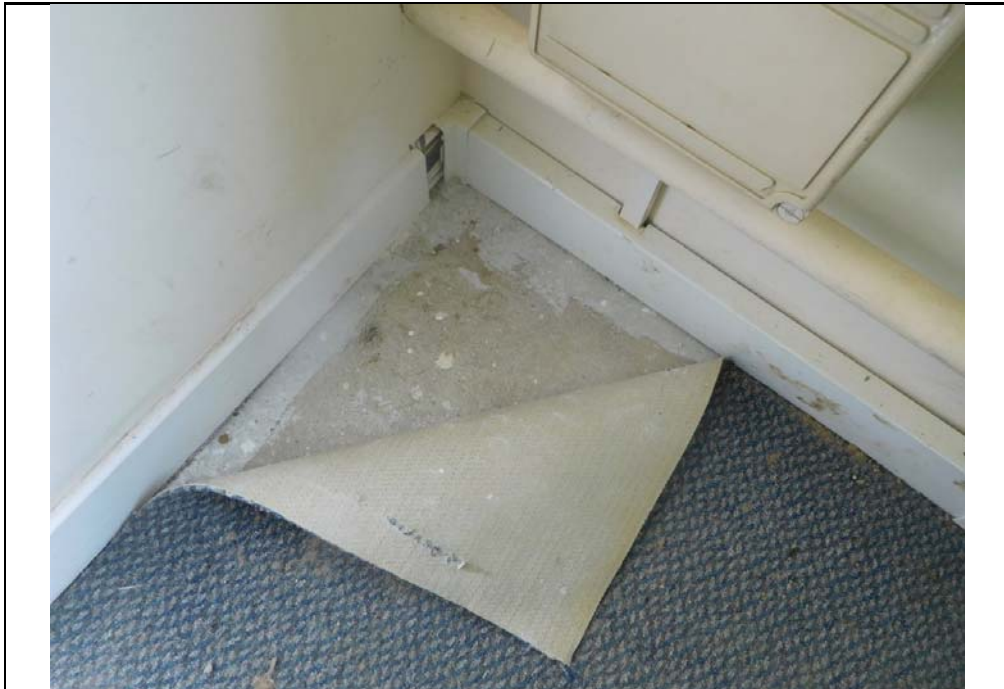
Location ID:	37525	Survey Type:	R D
Location Ref:	HO-012	Product Type:	Not Applicable
Product:	Beneath Carpet	Damage:	Not Applicable
Area:	Hanson Office Building	Treatment:	Not Applicable
Floor:	First Floor	Asbestos Type:	Not Applicable
Room:	Office	Identification:	
Surveyor Name:	L Harridge	Quantity:	
Drawing Ref:	2	Accessibility:	
Asbestos ?	No		
Date:	21 March 2017		
Next Inspection:	Not Applicable		
Analysis:			
Action:	No Action Required

No asbestos located, therefore no sampling carried out.

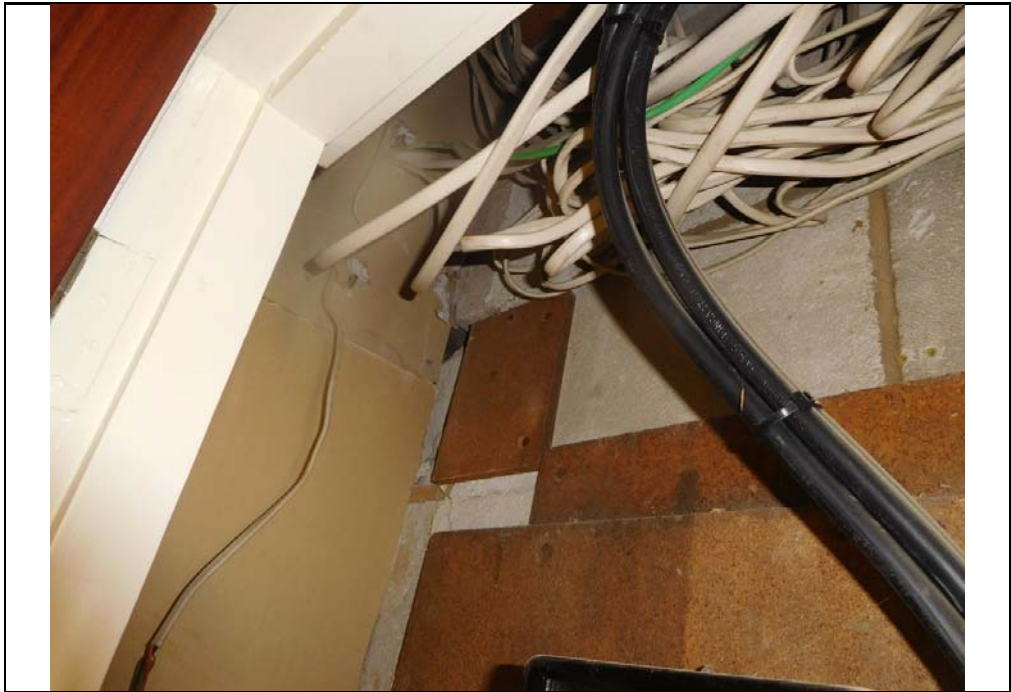
Location ID:	37526	Survey Type:	R D
Location Ref:	HO-013	Product Type:	Not Applicable
Product:	No Asbestos Located	Damage:	Not Applicable
Area:	Hanson Office Building	Treatment:	Not Applicable
Floor:	Ground Floor	Asbestos Type:	Not Applicable
Room:	Electrical Cupboard	Identification:	Identified
Surveyor Name:	L Harridge	Quantity:	
Drawing Ref:	1	Accessibility:	
Asbestos ?	No		
Date:	21 March 2017		
Next Inspection:	Not Applicable		
Analysis:			
Action:	No Action Required

Material Comments: No asbestos located, therefore no sampling carried out.

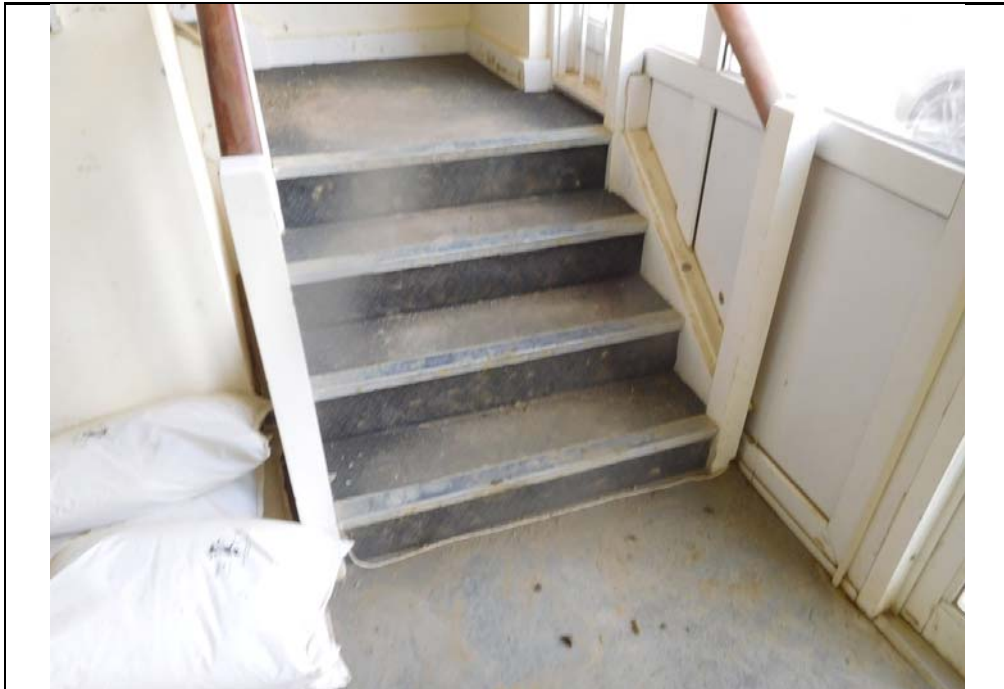
Location ID:	37527	Survey Type:	R D
Location Ref:	HO-014	Product Type:	Not Applicable
Product:	Stair Tread	Damage:	Not Applicable
Area:	Hanson Office Building	Treatment:	Not Applicable
Floor:	Ground / First	Asbestos Type:	Not Applicable
Room:	Staircase	Identification:	
Surveyor Name:	L Harridge	Quantity:	
Drawing Ref:	1	Accessibility:	
Asbestos ?	No		
Date:	21 March 2017		
Next Inspection:	Not Applicable		
Analysis:			
Action:	No Action Required

These treads were too new to contain asbestos fibres.

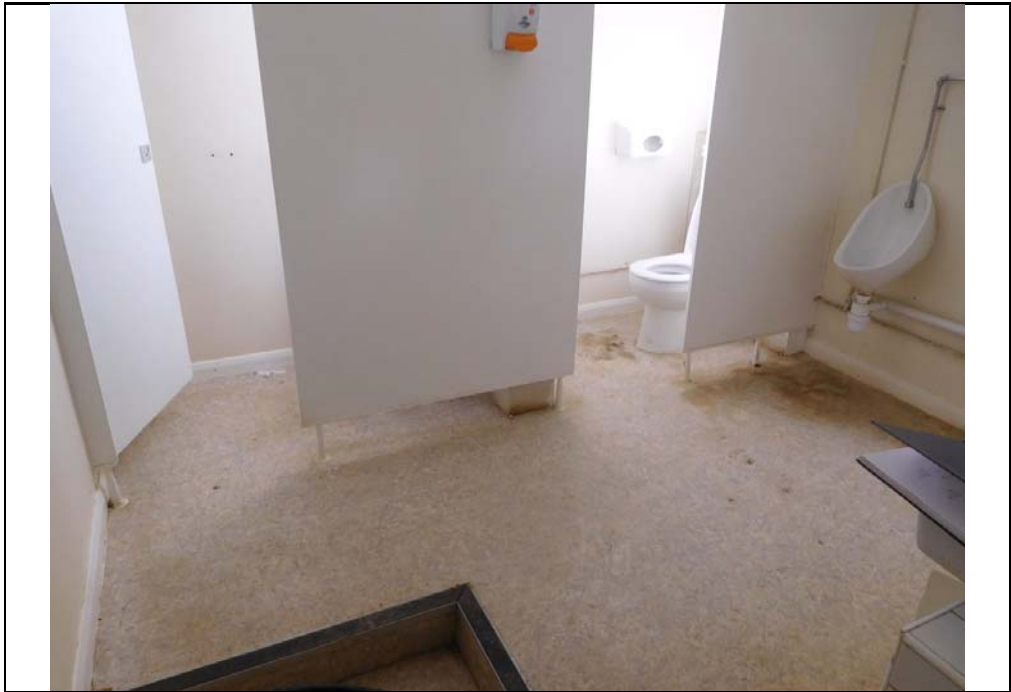
Location ID:	37528	Survey Type:	R D
Location Ref:	HO-015	Product Type:	Not Applicable
Product:	Floor Covering	Damage:	Not Applicable
Area:	Hanson Office Building	Treatment:	Not Applicable
Floor:	Ground Floor	Asbestos Type:	Not Applicable
Room:	Toilets	Identification:	
Surveyor Name:	L Harridge	Quantity:	
Drawing Ref:	1	Accessibility:	
Asbestos ?	No		
Date:	21 March 2017		
Next Inspection:	Not Applicable		
Analysis:			
Action:	No Action Required

Material Comments: No asbestos located, therefore no sampling carried out.
