Arboricultural Report

BS5837 Tree Survey

**Pinnock Yard
The Pinnock
Pluckley
Kent
TN27 0SS**

12th September 2019

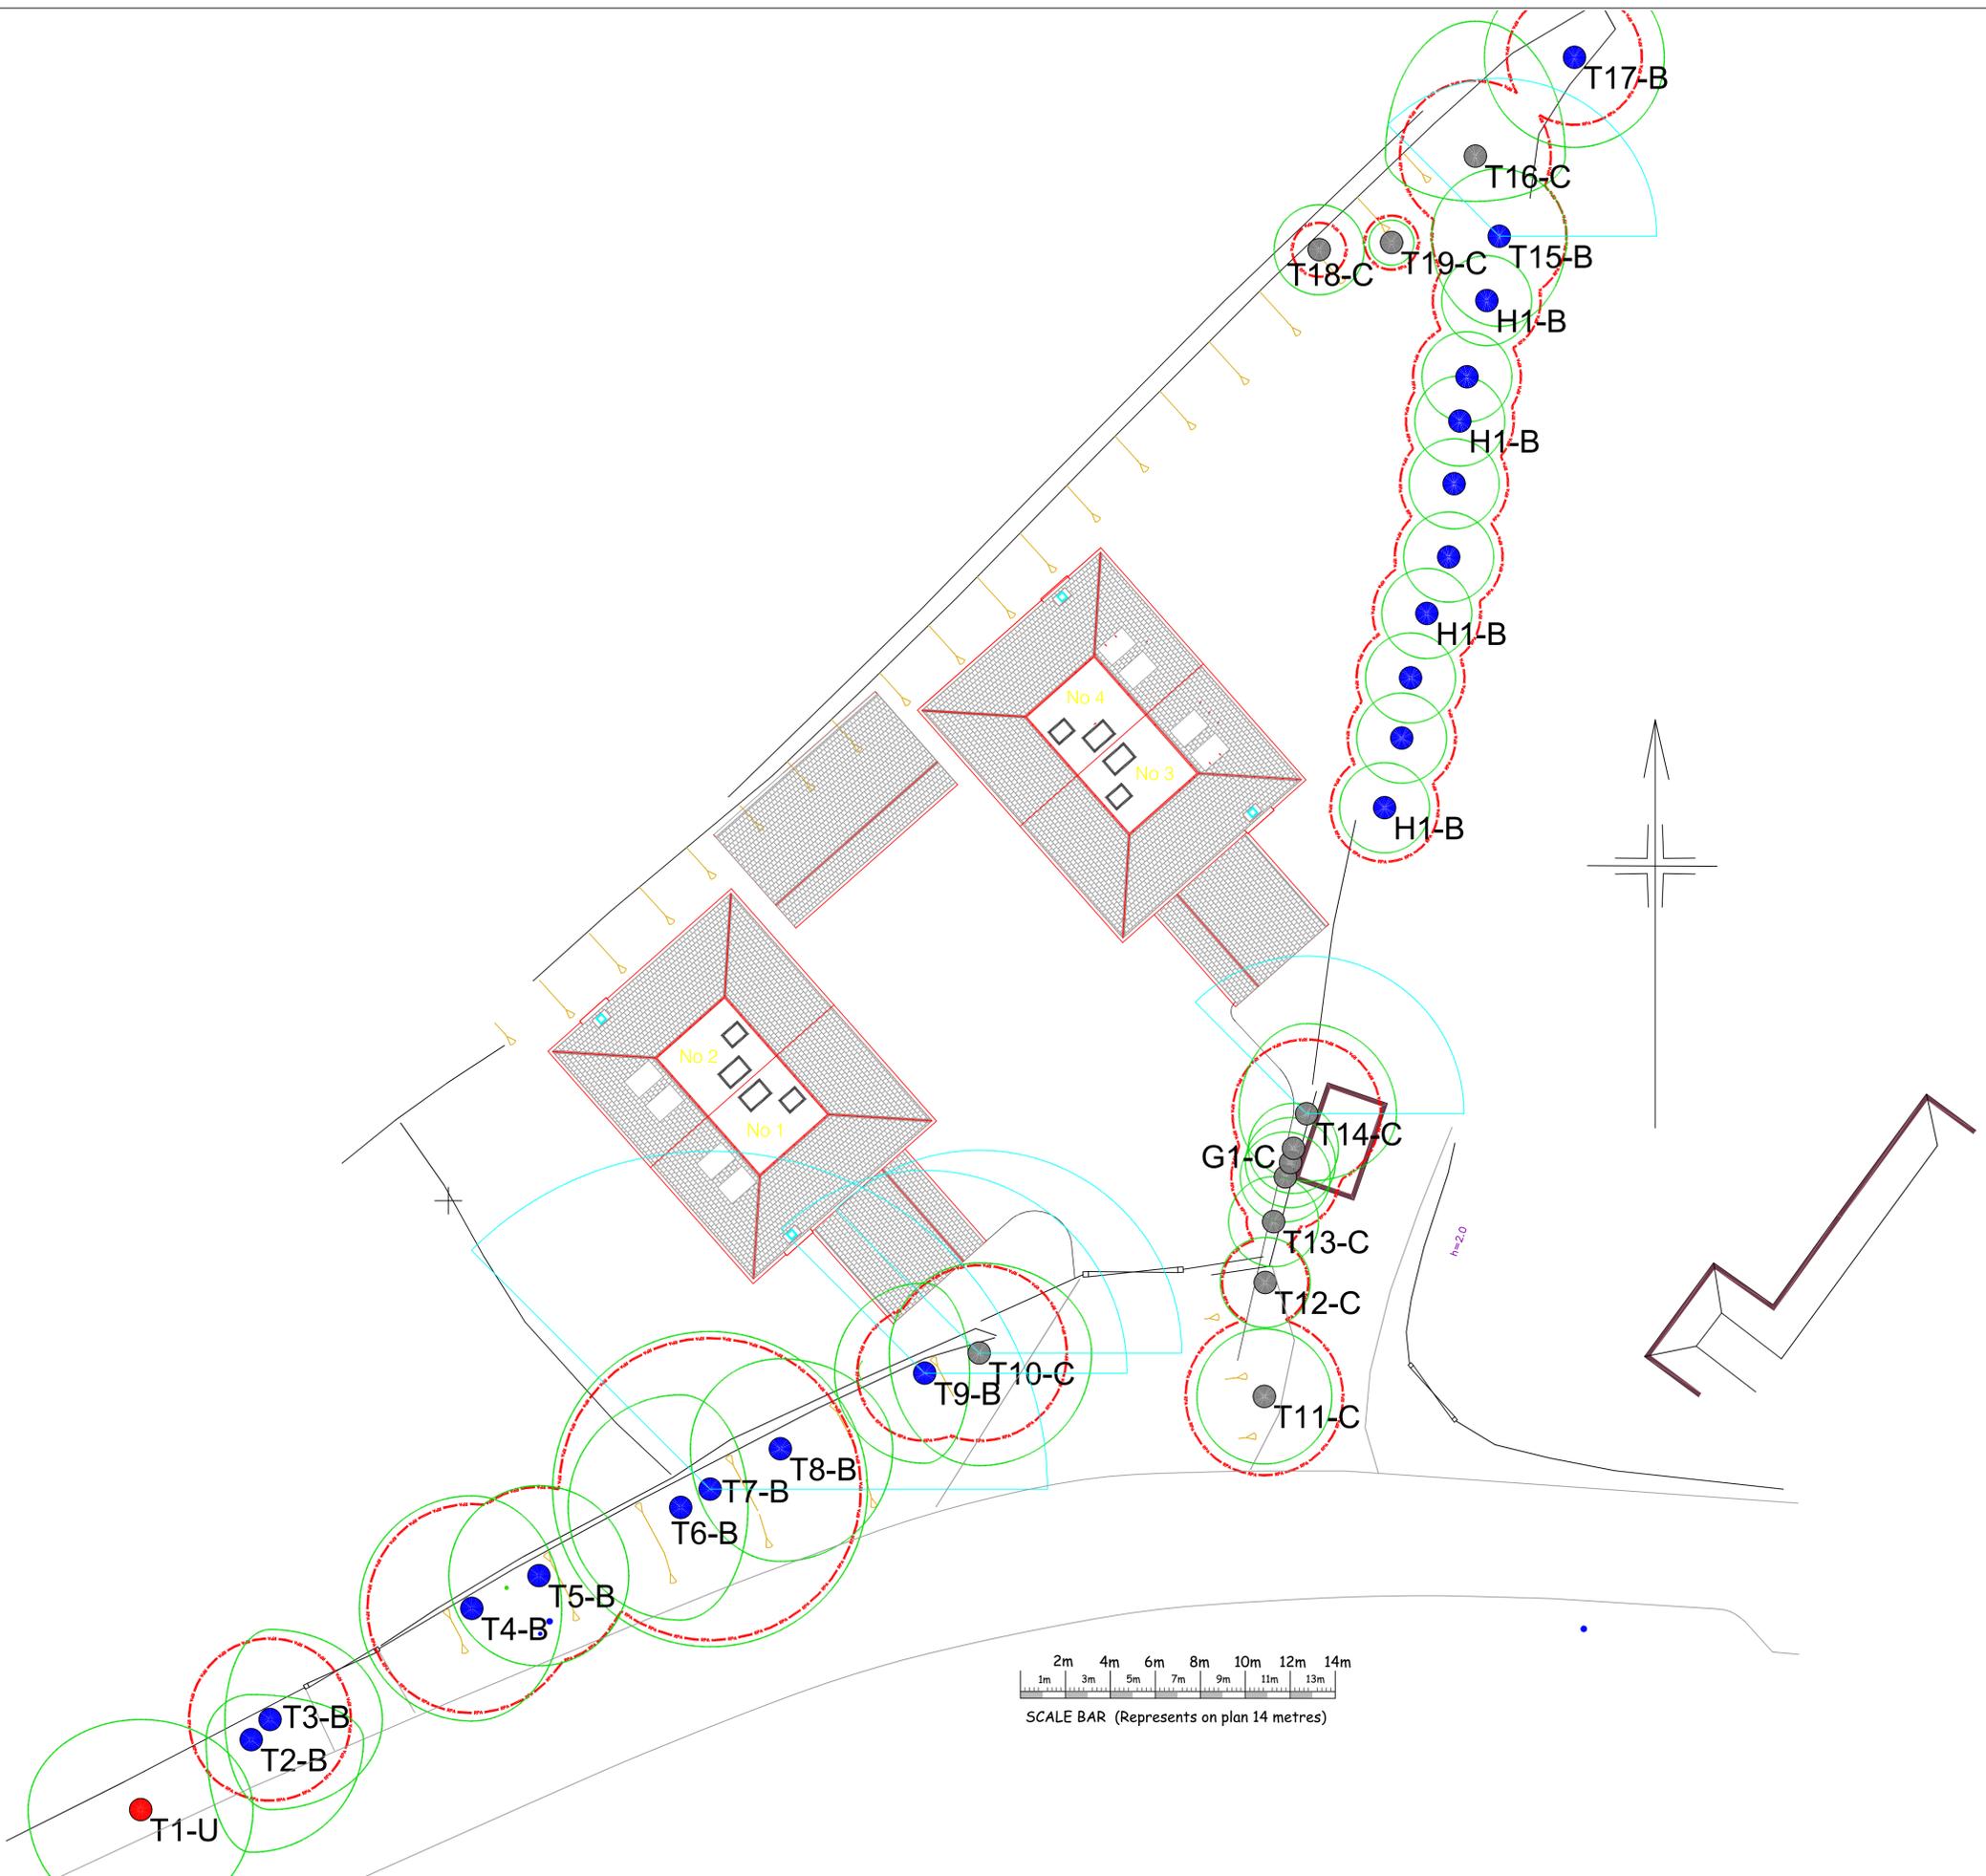
TREE SURVEY & CONSTRAINTS PLAN

I would recommend the removal of the Leylandii (T12 & G1), Ash (T13) and Oak (T14) due to their proximity to the proposed development and to allow for space and re-landscaping. As **Category C** trees they should not therefore be considered as a constraint to the development

The poor physiological and structural condition of the Ash (T1) is such that its removal is recommended on purely arboricultural grounds regardless of whether the development is permitted or not. For the purposes of the survey, these trees have been recorded as **Category U** (BS5837: 2012, Table 1) being in a condition where they cannot be retained as living trees for longer than 10 years. These trees are extremely poor specimens with any remedial works considered unlikely to produce trees with any degree of longevity.
