**Farm Buildings  
East Malling Trust,  
Ditton,  
Aylesford  
ME20 6ED**

**Management Survey  
Asbestos Register Report**

Date of Survey:- 12<sup>TH</sup> January 2021

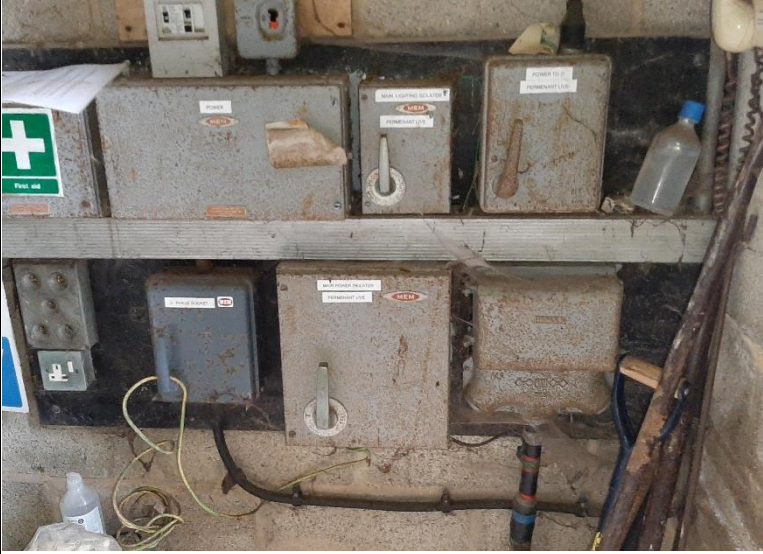
Material Details (Caution)			
Location:	Building 1

Position:	Electrical Switchgear		
Product:	Asbestos Cloth		
Accessibility:	Low		
Quantity:	Unknow		
Status:	Presumed. <b>ASBESTOS CLOTH</b>		
Reported:	12 <sup>TH</sup> January 2021		
Material Risk Score			
<b>Product Type</b>	Asbestos-reinforced composites (plastics, resins, mastics, roofing felt, vinyl flooring, decorative finishes, asbestos cement)	1	
	AIB, millboard, other low density insulation boards, asbestos textiles, gaskets, ropes & Asbestos paper & felt	2	2
	Thermal insulation, sprayed asbestos, loose asbestos, asbestos mattresses & packing	3	
<b>Extent of damage / deterioration:</b>	Good : No visible damage	0	0
	Low damage : A few scratches or surface marks broken edges on boards, tiles etc.	1	
	Medium damage: Significant breakage of materials or areas of visible asbestos fibres	2	
	High damage or de-lamination of materials, sprays & thermal insulation. Visible asbestos debris	3

<b>Surface Treatment</b>	Composite materials (reinforced plastics, resins, vinyl tiles)	0	
	Enclosed sprays & lagging, AIB (with exposed face painted or encapsulated) asbestos cement sheets.	1	1
	Unsealed AIB or encapsulated lagging & sprays	2	
	Unsealed lagging and sprays	3	
<b>Asbestos Type:</b>	Chrysotile	1	1
	Amphibole asbestos excluding Crocidolite	2	
	Crocidolite	3	
<b>Total Material Risk Score</b>			<b>4</b>
<b>Priority Risk Score (HSG227)</b>	<b>Low Risk</b>	2	<b>2</b>
	<b>Medium Risk</b>	4	
	<b>High Risk</b>	6	
<b>Total Risk Score</b>			<b>6</b>
Recommendation: Caution should be taken if removing fuses. Any suspect material should be sampled, analysed and appropriate action taken. Comments:

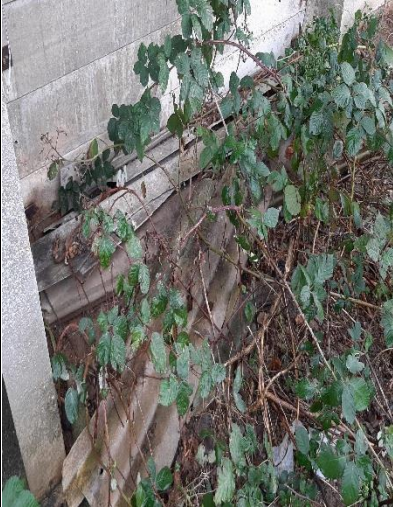
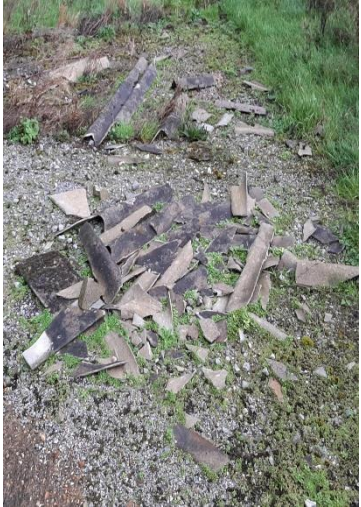
<b>Material Details (Sample No 03)</b>			
Location:	Building 2

Position:	External, Loose on Ground		
Product:	Corrugated Asbestos Cement		
Accessibility:	High		
Quantity:	2 - 4 Sqm Approx		
Status:	Asbestos Present <b>Chrysotile</b>		
Reported:	12 <sup>TH</sup> January 2021		
<b>Material Risk Score</b>			
<b>Product Type</b>	Asbestos-reinforced composites (plastics, resins, mastics, roofing felt, vinyl flooring, decorative finishes, asbestos cement)	1	1
	AIB, millboard, other low density insulation boards, asbestos textiles, gaskets, ropes & Asbestos paper & felt	2	
	Thermal insulation, sprayed asbestos, loose asbestos, asbestos mattresses & packing	3	
<b>Extent of damage / deterioration:</b>	Good : No visible damage	0	
	Low damage : A few scratches or surface marks broken edges on boards, tiles etc.	1	
	Medium damage: Significant breakage of materials or areas of visible asbestos fibres	2	
	High damage or de-lamination of materials, sprays & thermal insulation. Visible asbestos debris	3	3

<b>Surface Treatment</b>	Composite materials (reinforced plastics, resins, vinyl tiles)	0	
	Enclosed sprays & lagging, AIB (with exposed face painted or encapsulated) asbestos cement sheets.	1	1
	Unsealed AIB or encapsulated lagging & sprays	2	
	Unsealed lagging and sprays	3	
<b>Asbestos Type:</b>	Chrysotile	1	1
	Amphibole asbestos excluding Crocidolite	2	
	Crocidolite	3	
<b>Total Material Risk Score</b>			<b>6</b>
<b>Priority Risk Score (HSG227)</b>	<b>Low Risk</b>	2	<b>4</b>
	<b>Medium Risk</b>	4	
	<b>High Risk</b>	6	
<b>Total Risk Score</b>			<b>10</b>
Recommendation: Recommend removal as soon as practicable.			
Comments:

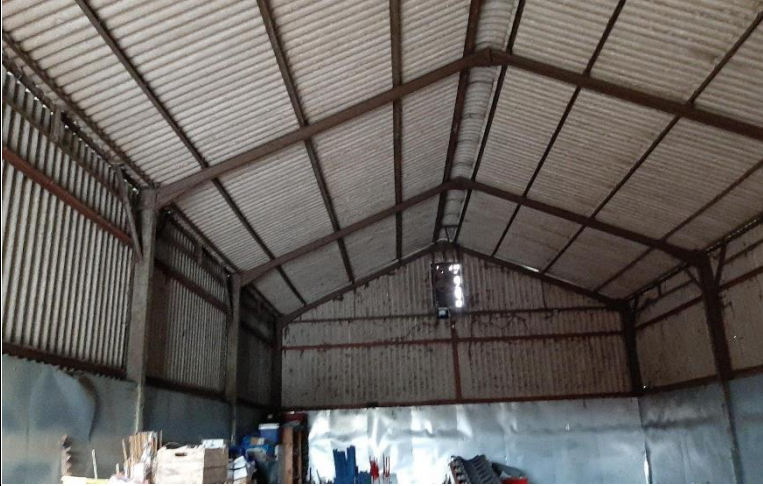
<b>Material Details (Sample No 04)</b>			
Location:	Building 3

Position:	Internal / External Roof, Walls & Gable Ends		
Product:	Asbestos Cement		
Accessibility:	Low		
Quantity:	350 Sqm Approx		
Status:	Asbestos Present <b>Chrysotile</b>		
Reported:	12 <sup>TH</sup> January 2021		
<b>Material Risk Score</b>			
<b>Product Type</b>	Asbestos-reinforced composites (plastics, resins, mastics, roofing felt, vinyl flooring, decorative finishes, asbestos cement)	1	1
	AIB, millboard, other low density insulation boards, asbestos textiles, gaskets, ropes & Asbestos paper & felt	2	
	Thermal insulation, sprayed asbestos, loose asbestos, asbestos mattresses & packing	3	
<b>Extent of damage / deterioration:</b>	Good : No visible damage	0	
	Low damage : A few scratches or surface marks broken edges on boards, tiles etc.	1	1
	Medium damage: Significant breakage of materials or areas of visible asbestos fibres	2

High damage or de-lamination of materials, sprays & thermal insulation. Visible asbestos debris	3	
<b>Surface Treatment</b>	Composite materials (reinforced plastics, resins, vinyl tiles)	0	
	Enclosed sprays & lagging, AIB (with exposed face painted or encapsulated) asbestos cement sheets.	1	1
	Unsealed AIB or encapsulated lagging & sprays	2	
	Unsealed lagging and sprays	3	
<b>Asbestos Type:</b>	Chrysotile	1	1
	Amphibole asbestos excluding Crocidolite	2	
	Crocidolite	3	
<b>Total Material Risk Score</b>			<b>4</b>
<b>Priority Risk Score (HSG227)</b>	<b>Low Risk</b>	2	<b>2</b>
	<b>Medium Risk</b>	4	
	<b>High Risk</b>	6	
<b>Total Risk Score</b>			<b>6</b>
Recommendation: Monitor condition at regular intervals and manage. Recommend annual re-inspections Comments:
