**The Estate Yard,
Camp Hill,
Chiddingstone Causeway
TN11 8LD**

Refurbishment / Demolition Survey
Asbestos Report

Date: 5TH September 2019

Survey undertaken for: The Trustees of Redleaf Trust,

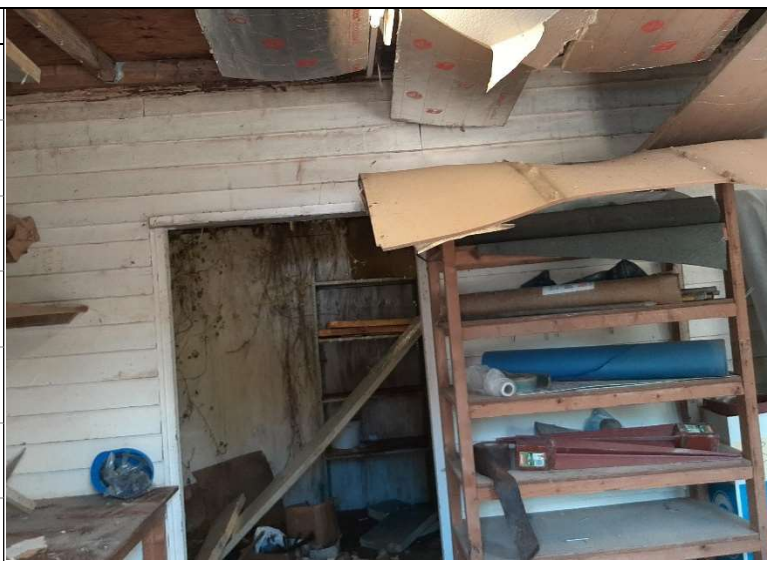
Material Details	
Location:	Outbuilding 1, Stores
Position:	G.01, Typical View
Product:	N / A
Accessibility:	N / A
Quantity:	N / A
Status:	No Asbestos Noted
Reported:	5 TH September 2019
Recommendation: Comments: No Asbestos noted in any of the areas inspected.

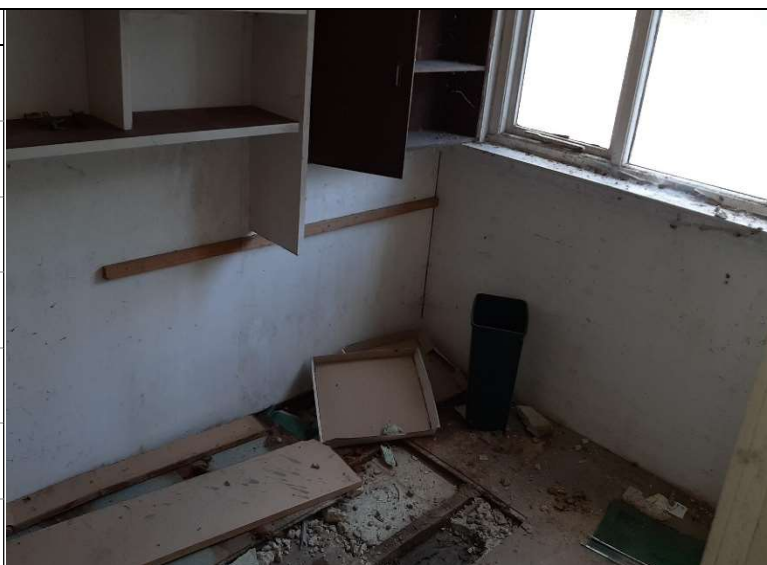
Material Details	
Location:	Outbuilding 1, Stores
Position:	G.02, Typical View
Product:	N / A
Accessibility:	N / A
Quantity:	N / A
Status:	No Asbestos Noted
Reported:	5 TH September 2019
Recommendation: Comments: No Asbestos noted in any of the areas inspected.

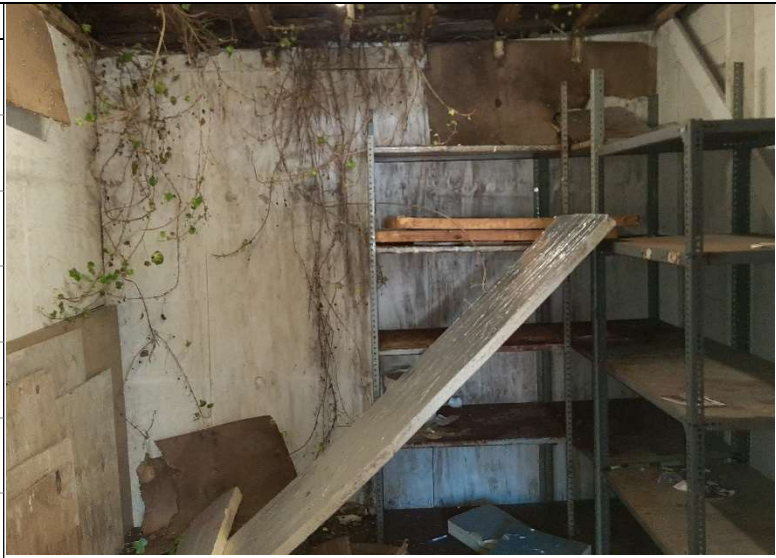
Material Details	
Location:	Outbuilding 1, Stores
Position:	G.03, Typical View
Product:	N / A
Accessibility:	N / A
Quantity:	N / A
Status:	No Asbestos Noted
Reported:	5 TH September 2019
Recommendation: Comments: No Asbestos noted in any of the areas inspected.

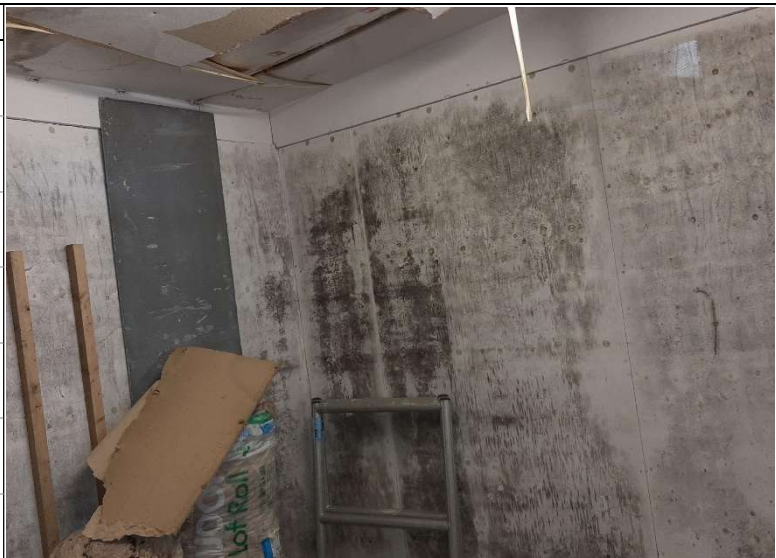
Material Details	
Location:	Outbuilding 1, Stores
Position:	G.04, Typical View
Product:	N / A
Accessibility:	N / A
Quantity:	N / A
Status:	No Asbestos Noted
Reported:	5 TH September 2019
Recommendation: Comments: No Asbestos noted in any of the areas inspected.

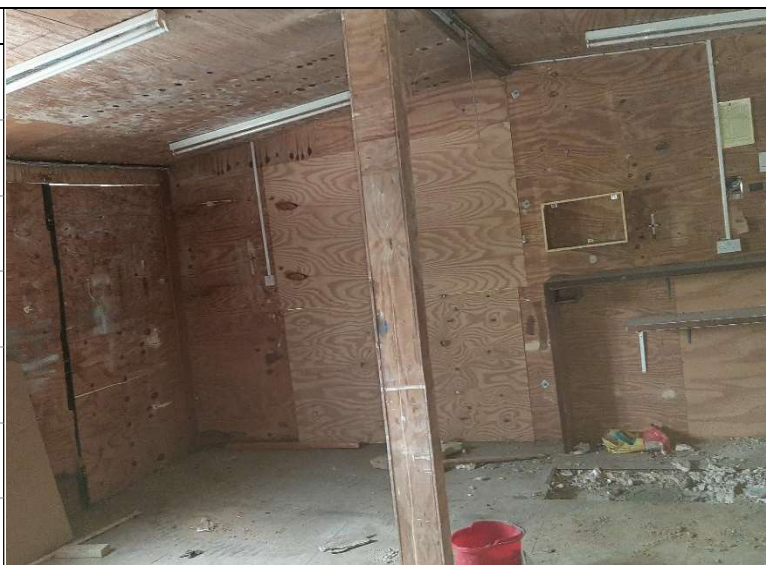
Material Details	
Location:	Outbuilding 1, Stores
Position:	G.05, Typical View
Product:	N / A
Accessibility:	N / A
Quantity:	N / A
Status:	No Asbestos Noted
Reported:	5 TH September 2019
Recommendation: Comments: No Asbestos noted in any of the areas inspected.

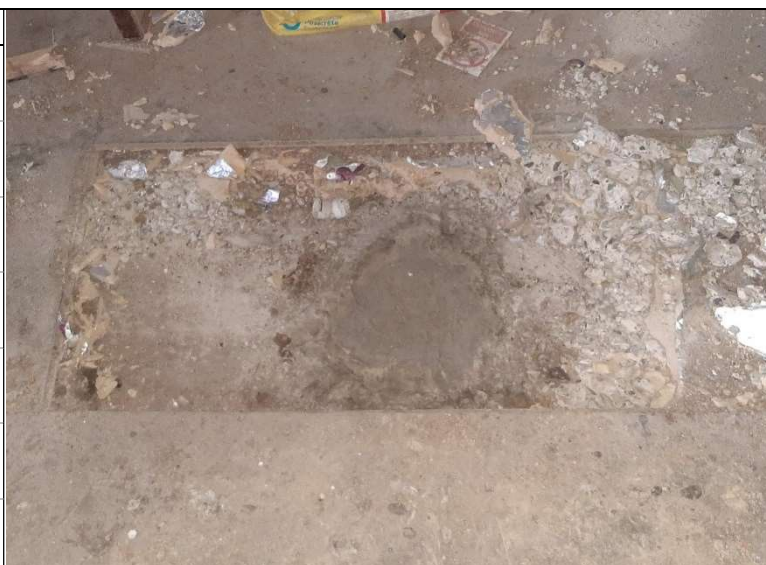
Material Details	
Location:	Outbuilding 1, Stores
Position:	G.05, Under Timber Floor
Product:	Insulation Slab & Concrete
Accessibility:	N / A
Quantity:	N / A
Status:	No Asbestos Noted
Reported:	5 TH September 2019
Recommendation: Comments: No Asbestos noted in any of the areas inspected.

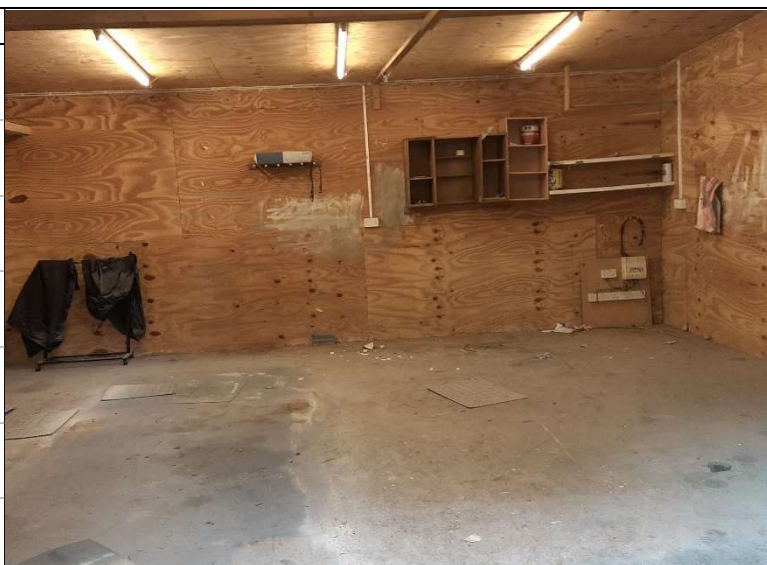
Material Details	
Location:	Outbuilding 1, Stores
Position:	G.06, Typical View
Product:	N / A
Accessibility:	N / A
Quantity:	N / A
Status:	No Asbestos Noted
Reported:	5 TH September 2019
Recommendation: Comments: No Asbestos noted in any of the areas inspected.

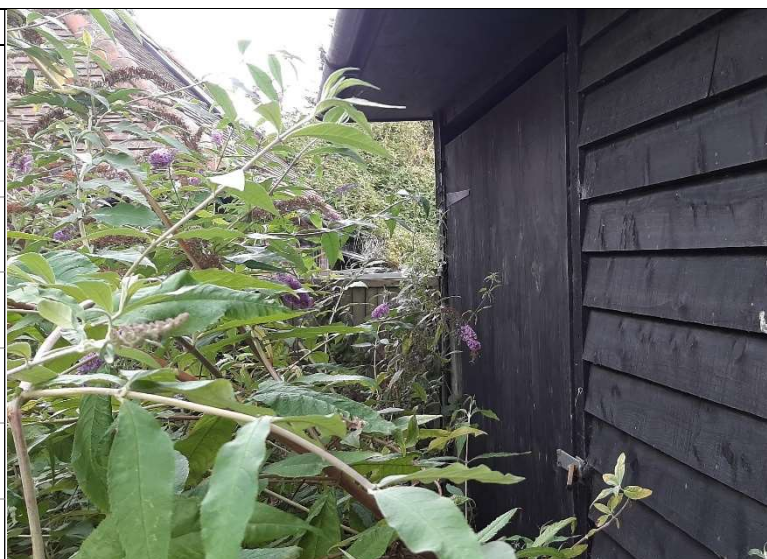
Material Details	
Location:	Outbuilding 1, Stores
Position:	G.07 (Locked)
Product:	N / A
Accessibility:	N / A
Quantity:	N / A
Status:	No Asbestos Noted
Reported:	5 TH September 2019
Recommendation: Comments: No access was made into this area as the door was padlocked shut and no keys were available. Caution should be taken when working in this area. Any suspect material should be sampled, analysed and appropriate action taken.

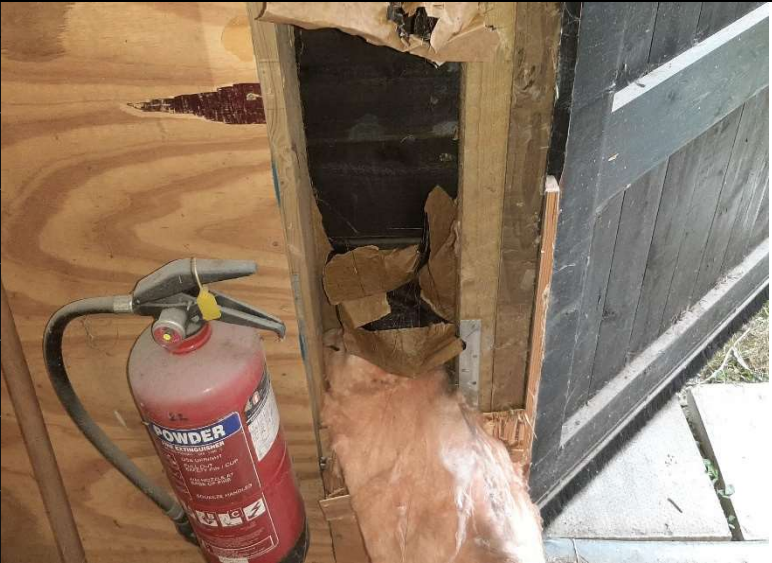
Material Details

Location:	Outbuilding 1, Stores	
Position:	Behind Timber Wall Cladding	
Product:	Insulation - Timber	
Accessibility:	N / A	
Quantity:	N / A	
Status:	No Asbestos Noted	
Reported:	5 TH September 2019	
Recommendation: Comments: No Asbestos noted in any of the areas inspected.

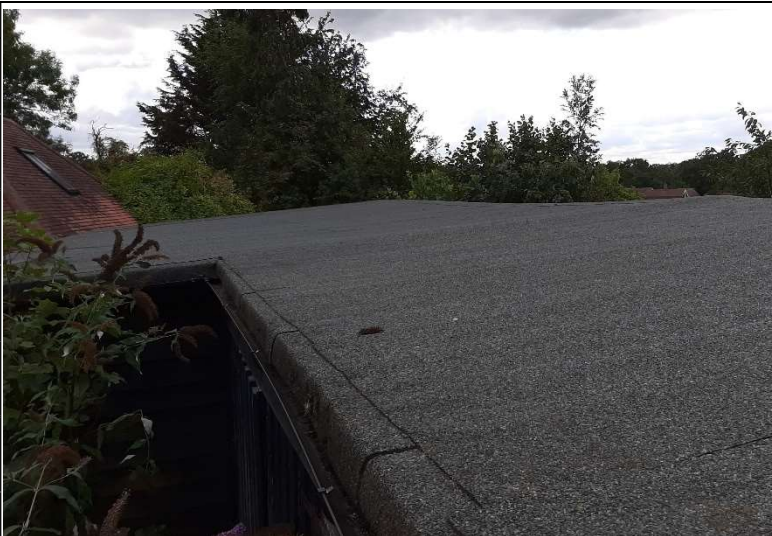
Material Details (Sample No 01)

Location:	Outbuilding 1, Stores	
Position:	External Roof	
Product:	Felt Roof Covering	
Accessibility:	N / A	
Quantity:	N / A	
Status:	N.A.D.I.S	
Reported:	5 TH September 2019	
Recommendation: Comments: No Asbestos detected in sample obtained.

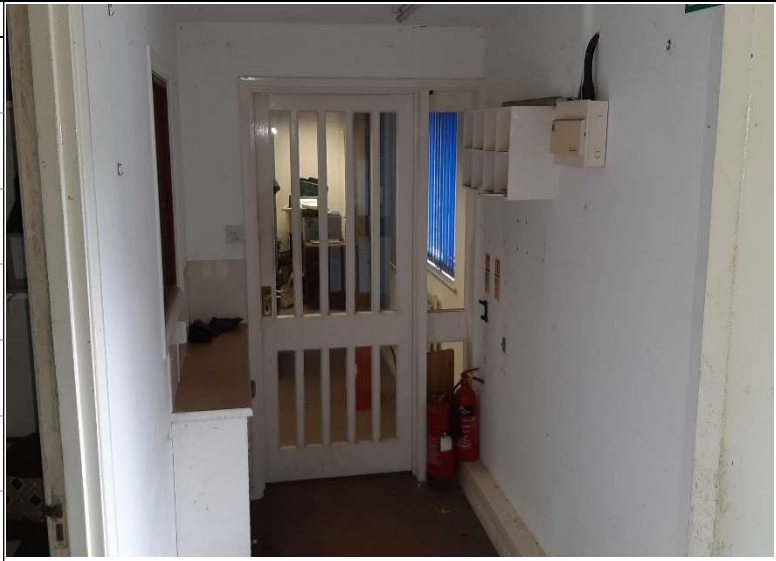
Material Details	
Location:	Outbuilding 2, Offices
Position:	G.01, Typical View
Product:	N / A
Accessibility:	N / A
Quantity:	N / A
Status:	No Asbestos Noted
Reported:	5 TH September 2019
Recommendation: Comments: No Asbestos noted in any of the areas inspected.

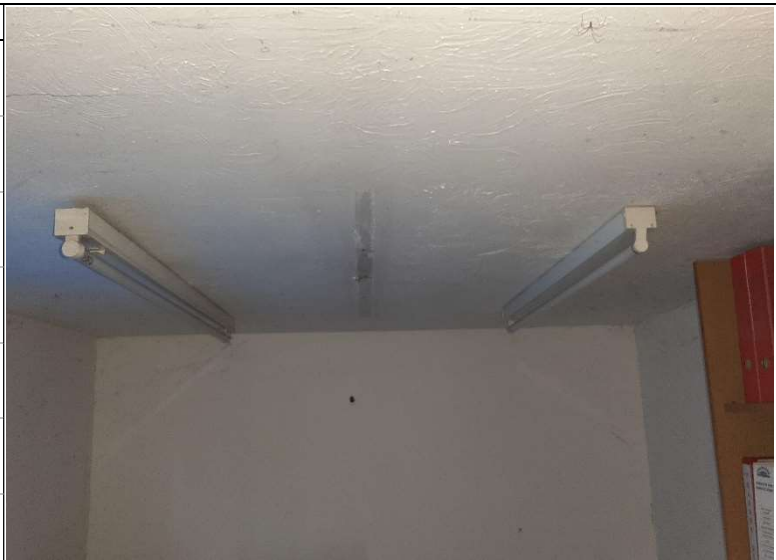
Material Details (Sample No 02)	
Location:	Outbuilding 2, Offices
Position:	G.02, Ceiling
Product:	Textured Ceiling Coating
Accessibility:	N / A
Quantity:	N / A
Status:	N.A.D.I.S.
Reported:	5 TH September 2019
Recommendation: Comments: No Asbestos detected in sample obtained.

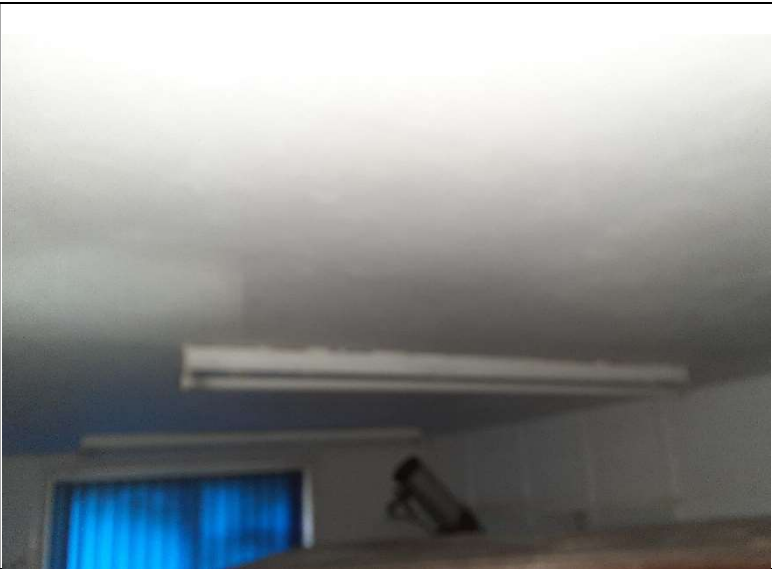
Material Details (Sample No 03)	
Location:	Outbuilding 2, Offices
Position:	G.03, Ceiling
Product:	Textured Ceiling Coating
Accessibility:	N / A
Quantity:	N / A
Status:	N.A.D.I.S.
Reported:	5 TH September 2019
Recommendation: Comments: No Asbestos detected in sample obtained.

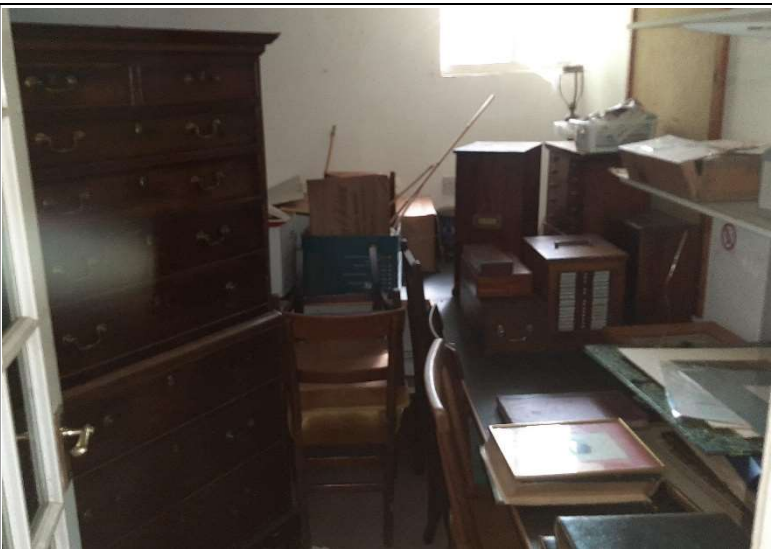
Material Details	
Location:	Outbuilding 2, Offices
Position:	G.03, Typical View
Product:	N / A
Accessibility:	N / A
Quantity:	N / A
Status:	No Asbestos Noted
Reported:	5 TH September 2019
Recommendation: Comments: No Asbestos noted in any of the areas inspected.

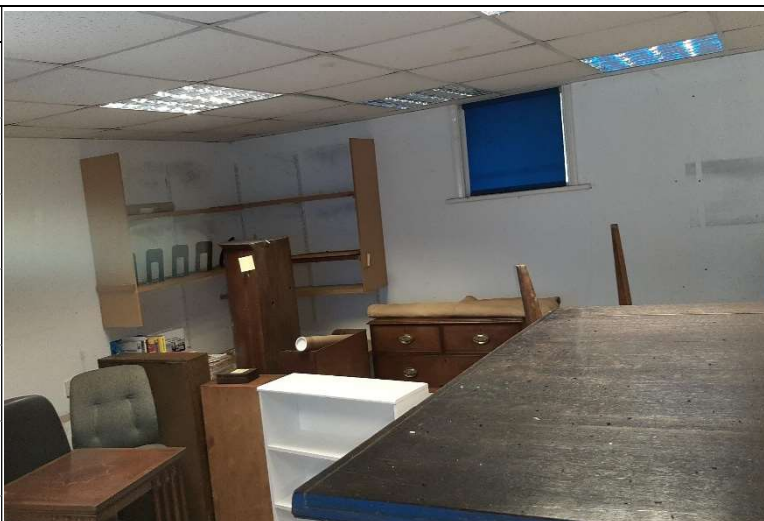
Material Details	
Location:	Outbuilding 2, Offices
Position:	G.04, Typical View
Product:	N / A
Accessibility:	N / A
Quantity:	N / A
Status:	No Asbestos Noted
Reported:	5 TH September 2019
Recommendation: Comments: No Asbestos noted in any of the areas inspected.

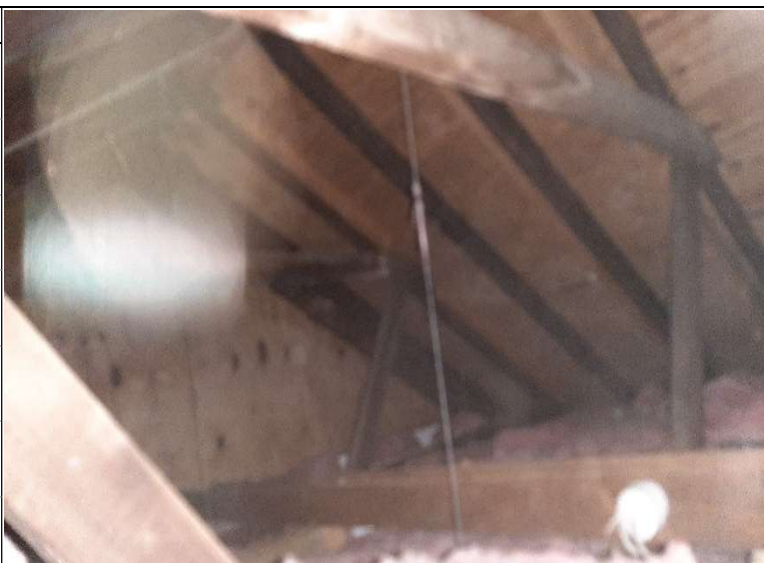
Material Details	
Location:	Outbuilding 2, Offices
Position:	G.04, Ceiling Void Typical View
Product:	N / A
Accessibility:	N / A
Quantity:	N / A
Status:	No Asbestos Noted
Reported:	5 TH September 2019
Recommendation: Comments: No Asbestos noted in any of the areas inspected.

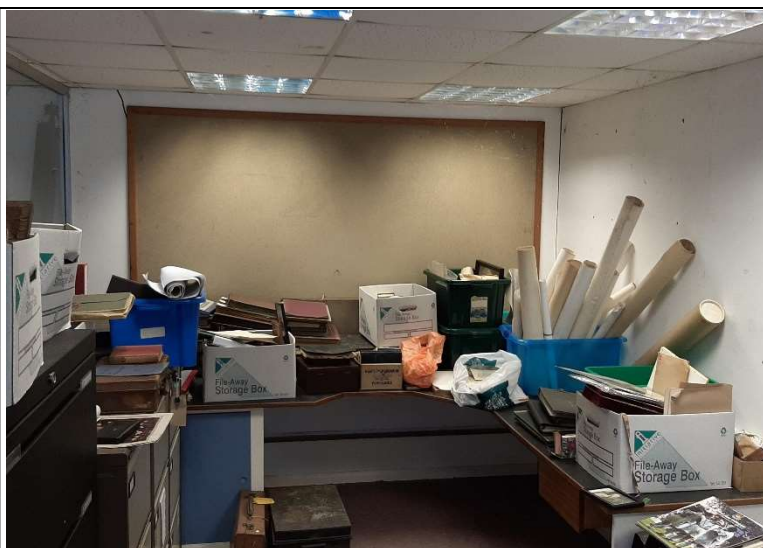
Material Details	
Location:	Outbuilding 2, Offices
Position:	G.05, Typical View
Product:	N / A
Accessibility:	N / A
Quantity:	N / A
Status:	No Asbestos Noted
Reported:	5 TH September 2019
Recommendation: Comments: No Asbestos noted in any of the areas inspected.

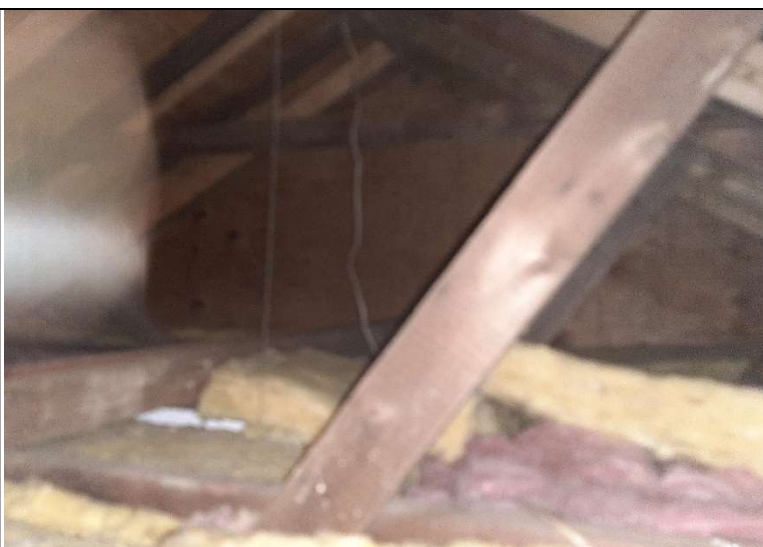
Material Details	
Location:	Outbuilding 2, Offices
Position:	G.05, Ceiling Void Typical View
Product:	N / A
Accessibility:	N / A
Quantity:	N / A
Status:	No Asbestos Noted
Reported:	5 TH September 2019
Recommendation: Comments: No Asbestos noted in any of the areas inspected.

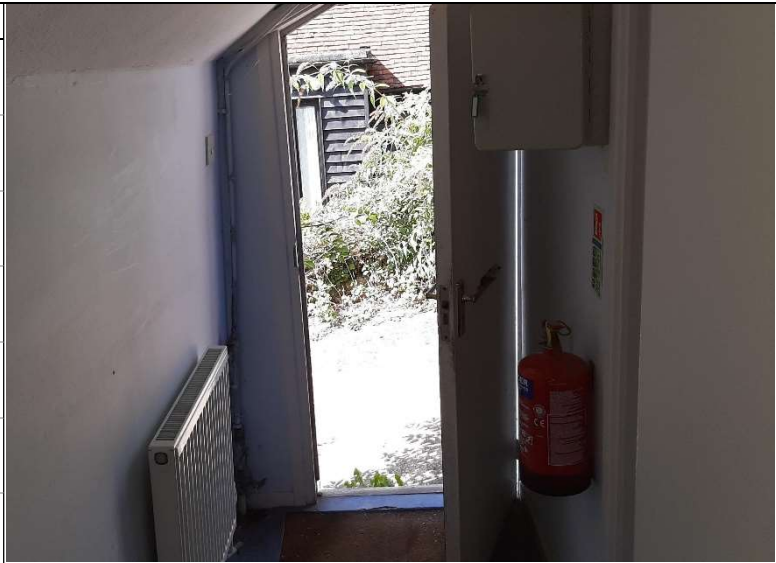
Material Details	
Location:	Barn
Position:	G.01, Typical View
Product:	N / A
Accessibility:	N / A
Quantity:	N / A
Status:	No Asbestos Noted
Reported:	5 TH September 2019
Recommendation: Comments: No Asbestos noted in any of the areas inspected.

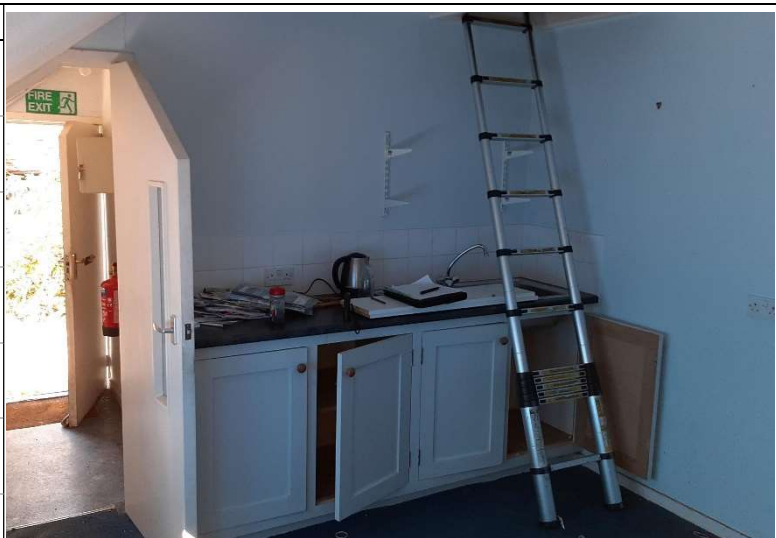
Material Details	
Location:	Barn
Position:	G.03, Typical View
Product:	N / A
Accessibility:	N / A
Quantity:	N / A
Status:	No Asbestos Noted
Reported:	5 TH September 2019
Recommendation: Comments: No Asbestos noted in any of the areas inspected.

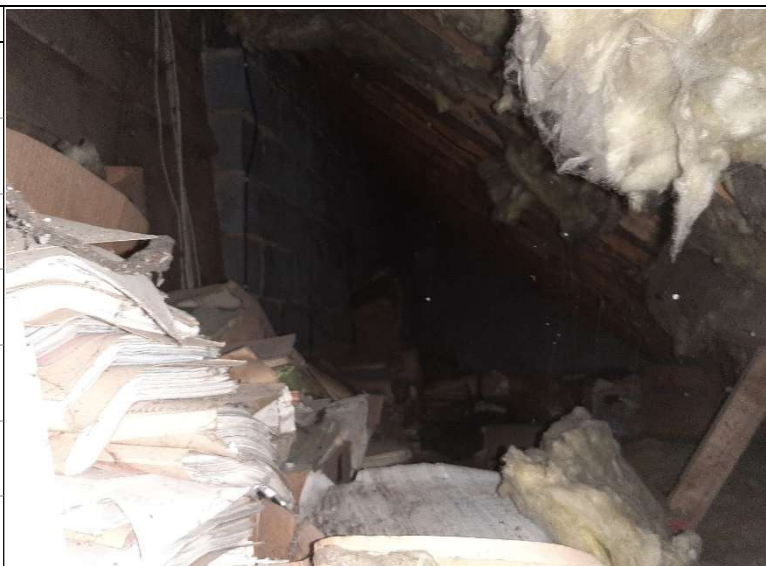
Material Details	
Location:	Barn
Position:	G.03 Roof Space Typical View
Product:	N / A
Accessibility:	N / A
Quantity:	N / A
Status:	No Asbestos Noted
Reported:	5 TH September 2019
Recommendation: Comments: No Asbestos noted in any of the areas inspected.

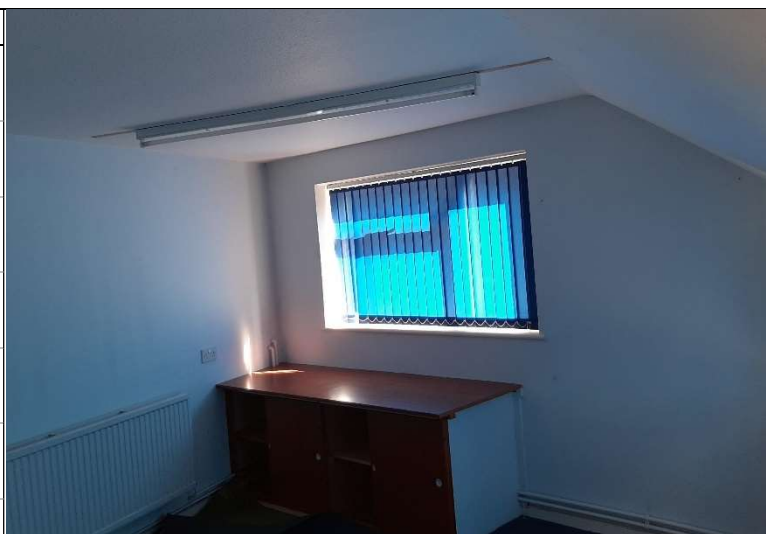
Material Details	
Location:	Barn
Position:	G.04, Typical View
Product:	N / A
Accessibility:	N / A
Quantity:	N / A
Status:	No Asbestos Noted
Reported:	5 TH September 2019
Recommendation: Comments: No Asbestos noted in any of the areas inspected.

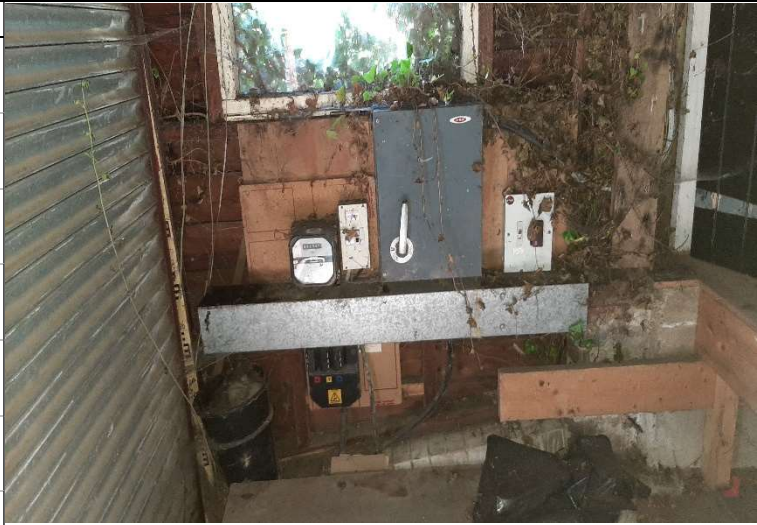
Material Details (Visual)	
Location:	Barn
Position:	G.05, Electrical Switchgear
Product:	Cloth Spark Arrestors
Accessibility:	Low
Quantity:	Unknown
Status:	Presumed Spark Arrestors Asbestos Cloth
Reported:	5 TH September 2019
Recommendation: Removal required if any disturbance is likely. Comments: The above assessment is precautionary only, no access was made into any live apparatus due to the risk of electric shock.

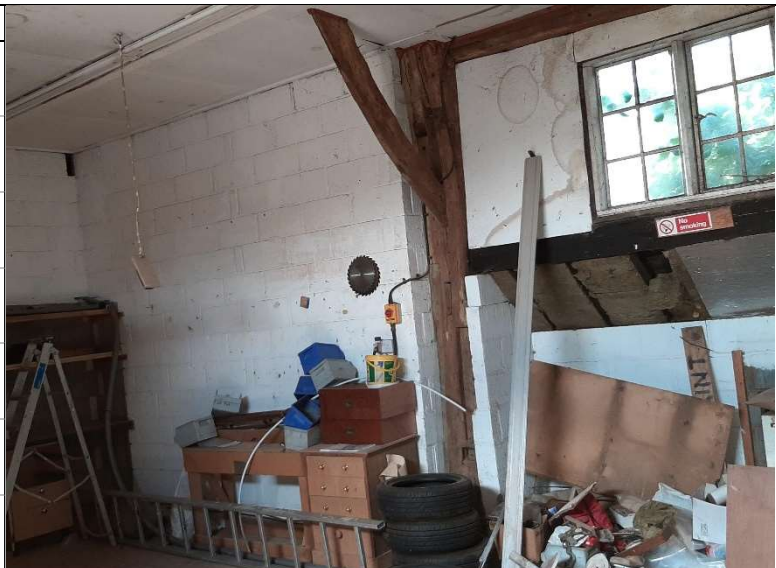
Material Details	
Location:	Barn
Position:	G.08, Typical View
Product:	N / A
Accessibility:	N / A
Quantity:	N / A
Status:	No Asbestos Noted
Reported:	5 TH September 2019
Recommendation: Comments: No Asbestos noted in any of the areas inspected.

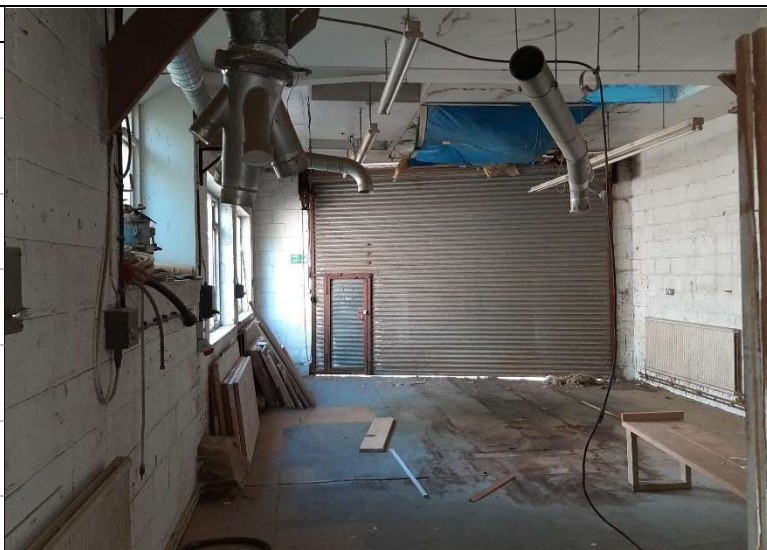
Material Details	
Location:	Barn
Position:	G.09, Typical View
Product:	N / A
Accessibility:	N / A
Quantity:	N / A
Status:	No Asbestos Noted
Reported:	5 TH September 2019
Recommendation: Comments: No Asbestos noted in any of the areas inspected.

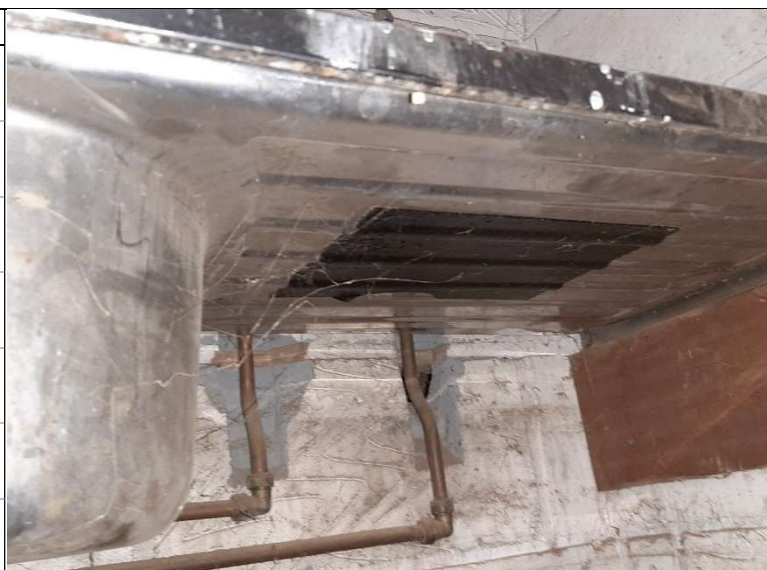
Material Details (Sample No 05)	
Location:	Barn
Position:	G.09, Under Sink
Product:	Bitumen Sink Pad
Accessibility:	Low
Quantity:	1
Status:	Asbestos Present Chrysotile
Reported:	5 TH September 2019
Recommendation: Removal required if any disturbance is likely. Comments:

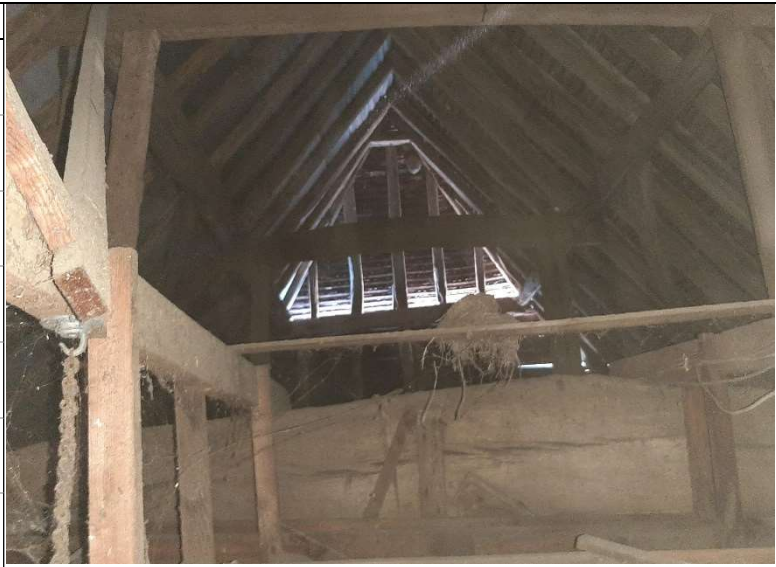
Material Details	
Location:	Barn
Position:	Roof Space Typical View
Product:	N / A
Accessibility:	N / A
Quantity:	N / A
Status:	No Asbestos Noted
Reported:	5 TH September 2019
Recommendation: Comments: No Asbestos noted in any of the areas inspected.

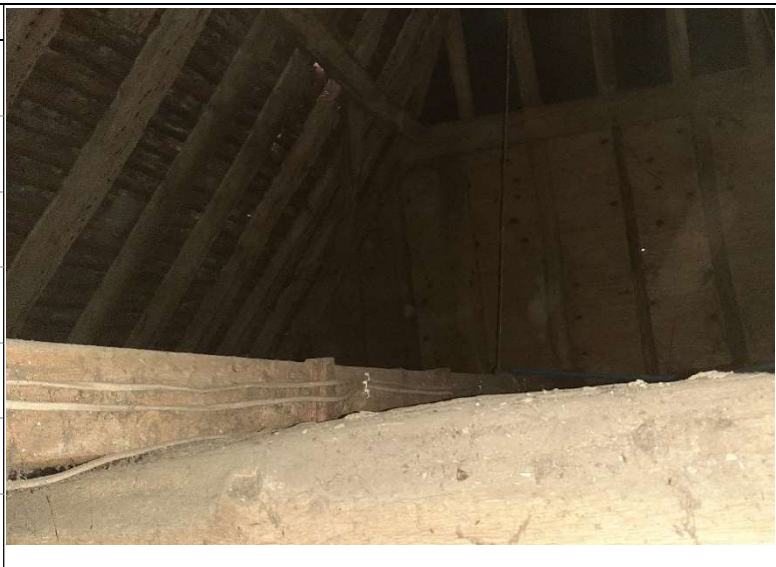
Material Details	
Location:	Barn
Position:	Roof Space Typical View
Product:	N / A
Accessibility:	N / A
Quantity:	N / A
Status:	No Asbestos Noted
Reported:	5 TH September 2019
Recommendation: Comments: No Asbestos noted in any of the areas inspected.

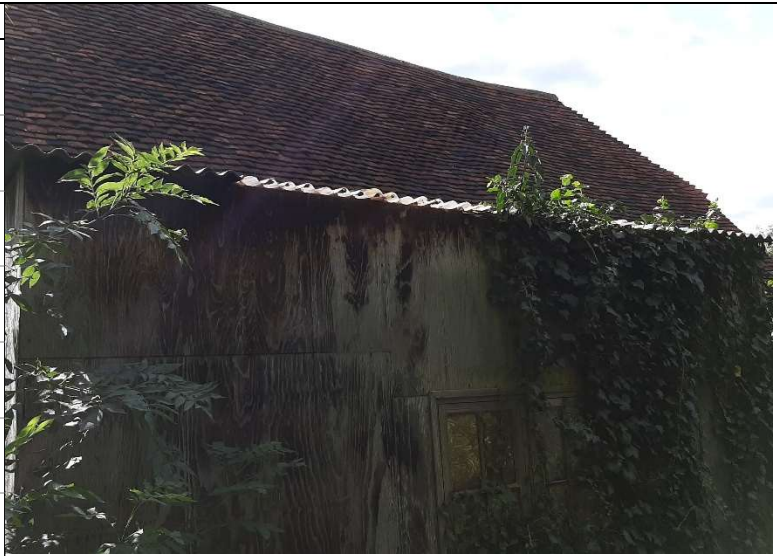
Material Details (Sample No 06)	
Location:	Extract Shed
Position:	Roof
Product:	Corrugated Cement Sheets
Accessibility:	N / A
Quantity:	N / A
Status:	N.A.D.I.S
Reported:	5 TH September 2019
Recommendation: Comments: No Asbestos detected in sample obtained.

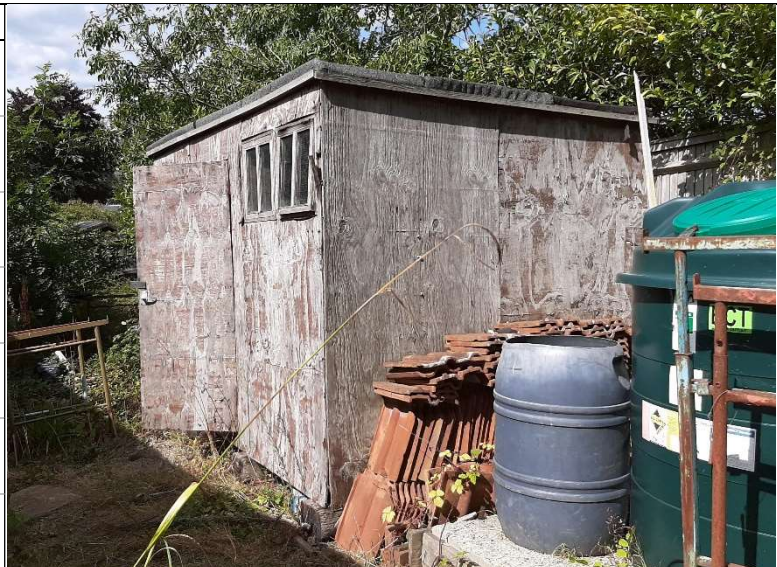
Material Details	
Location:	External Shed
Position:	Typical View
Product:	N / A
Accessibility:	N / A
Quantity:	N / A
Status:	No Asbestos Noted
Reported:	5 TH September 2019
Recommendation: Comments: No Asbestos noted in any of the areas inspected. Non-Asbestos cement boarding to external rear.

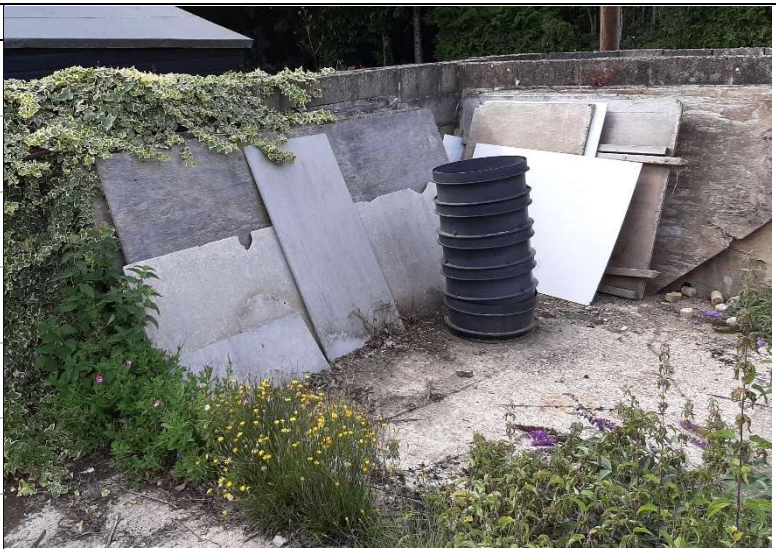
All accessible areas were inspected as far as practicably possible and a sample of loose boarding outside outbuilding 1 was obtained and confirmed as Chrysotile (white) Asbestos cement. No further suspect materials were noted in the areas inspected.

Material Details (Sample No 08)	
Location:	Yard
Position:	Outside Outbuilding 1
Product:	Asbestos Cement Sheets
Accessibility:	High
Quantity:	4 Sqm Approx.
Status:	Asbestos Present Chrysotile
Reported:	5 TH September 2019
Recommendation: Removal required if any disturbance is likely. Comments:
