MANAGEMENT ASBESTOS SURVEY REPORT

Conducted at: Foxbury Farm House & Foxbury Farm Cottage
Stone Street
Sevenoaks
Kent TN15 0LW

Date: 6th September 2018

Survey Reference: AS/05838-MS/MH

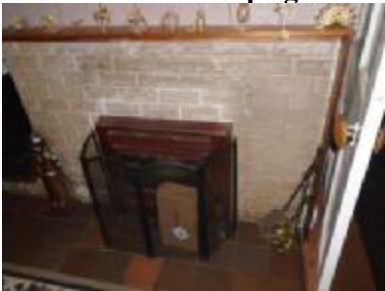
Floor Level	Location / Area Ref	Reason / Comments
Foxbury Farm House- Ground Floor	G03- Dining Room	No access within live fireplace- Strongly presumed to contain asbestos rope gaskets

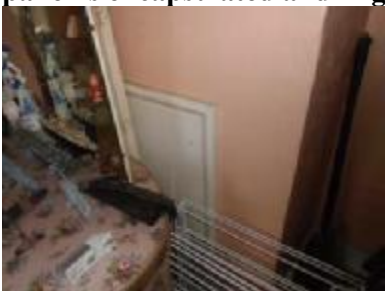
Foxbury Farm House- First Floor	1.07- Bedroom- Fireplace	Strongly presumed asbestos panel- Not sampled as the panel is encapsulated and in good condition

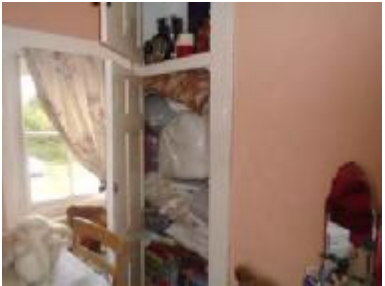
Foxbury Farm House- First Floor	1.08- Cupboard	Limited access due to stored items
