Asbestos Management Survey
Sandbanks
1 Cacklebury Close, Hailsham, Wealden, BN27 3LU

A Management Survey has been carried out at Sandbanks, 1 Cacklebury Close, Hailsham, Wealden, BN27 3LU.

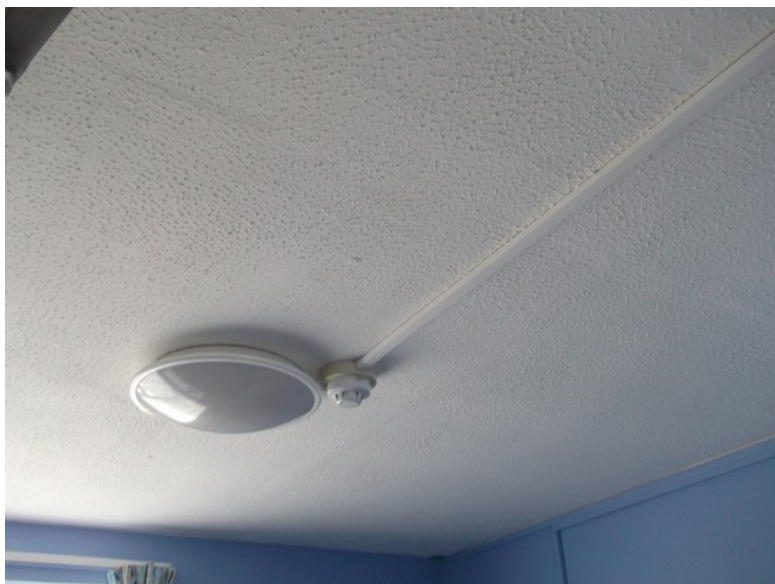
Sample No.	26462-008	Product Type	Textured Coating	1
	Photo 55957-035.jpg	Condition	Good Condition	-
Building	Sandbanks	Surface Treatment	Sealed	-
Floor	Ground	Asbestos Type	Chrysotile	1
Room	003 - Bedroom	Material Risk Assessment		2
Item	Textured Coating	Item Risk Classification	Very Low Risk	
Extent & Location	8sqm - Ceiling	Highest Risk Classification for Room	Very Low Risk

Main Recommendations: **Manage risk using appropriate controls and training.
Inspect materials at least annually for further damage**

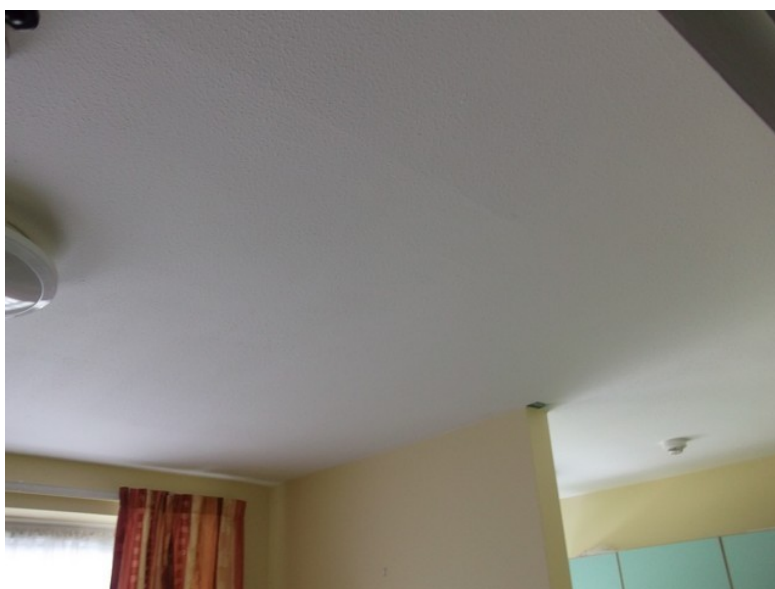
Sample No.	26462-REF 008	Product Type	Textured Coating	1
	Photo 55957-036.jpg	Condition	Good Condition	-
Building	Sandbanks	Surface Treatment	Sealed	-
Floor	Ground	Asbestos Type	Chrysotile	1
Room	004 - Bedroom & Kitchenette	Material Risk Assessment		2
Item	Textured Coating	Item Risk Classification	Very Low Risk	
Extent & Location	12sqm - Ceiling	Highest Risk Classification for Room	Very Low Risk

Main Recommendations: **Manage risk using appropriate controls and training.**
Inspect materials at least annually for further damage

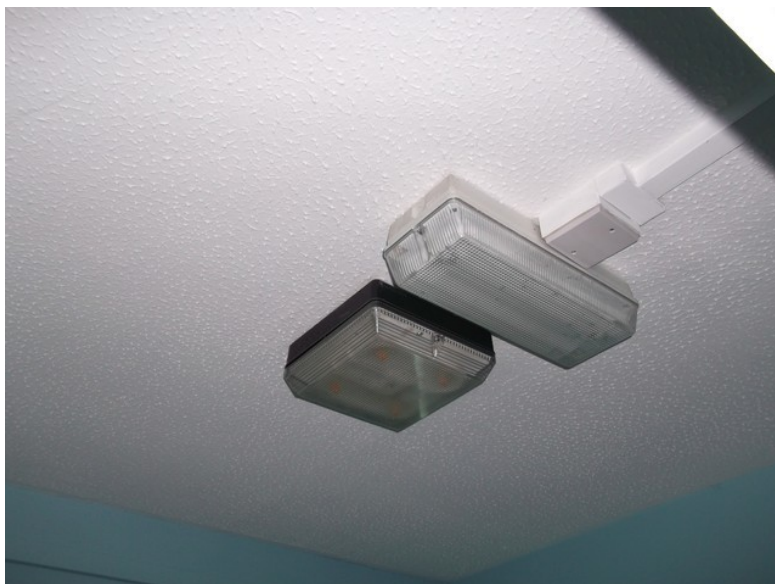
Sample No.	26462-010	Product Type	Textured Coating	1
	Photo 55957-043.jpg	Condition	Good Condition	-
Building	Sandbanks	Surface Treatment	Sealed	-
Floor	Ground	Asbestos Type	Chrysotile	1
Room	006 - Toilet	Material Risk Assessment		2
Item	Textured Coating	Item Risk Classification	Very Low Risk	
Extent & Location	6sqm - Ceiling	Highest Risk Classification for Room	Very Low Risk

Main Recommendations: **Manage risk using appropriate controls and training.**
Inspect materials at least annually for further damage

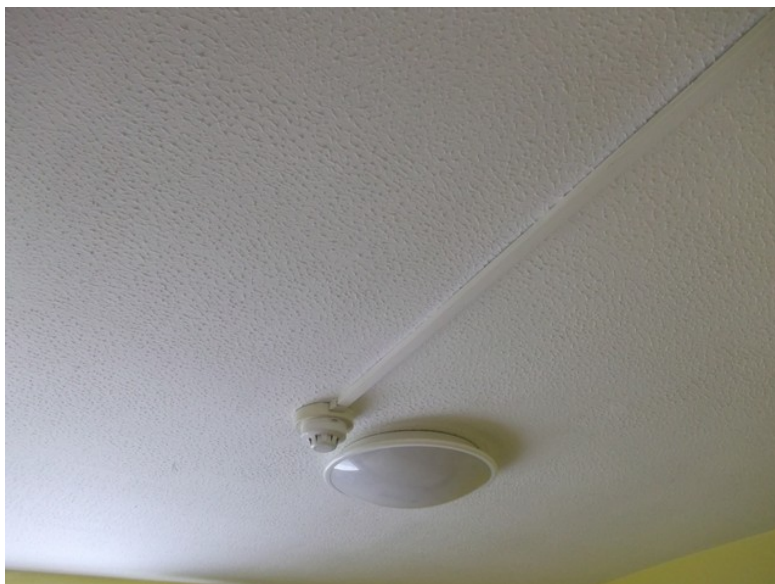
Sample No.	26462-REF 010	Product Type	Textured Coating	1
	Photo 55957-044.jpg	Condition	Good Condition	-
Building	Sandbanks	Surface Treatment	Sealed	-
Floor	Ground	Asbestos Type	Chrysotile	1
Room	007 - Bedroom	Material Risk Assessment		2
Item	Textured Coating	Item Risk Classification	Very Low Risk	
Extent & Location	8sqm - Ceiling	Highest Risk Classification for Room	Very Low Risk

Main Recommendations: **Manage risk using appropriate controls and training.**
Inspect materials at least annually for further damage

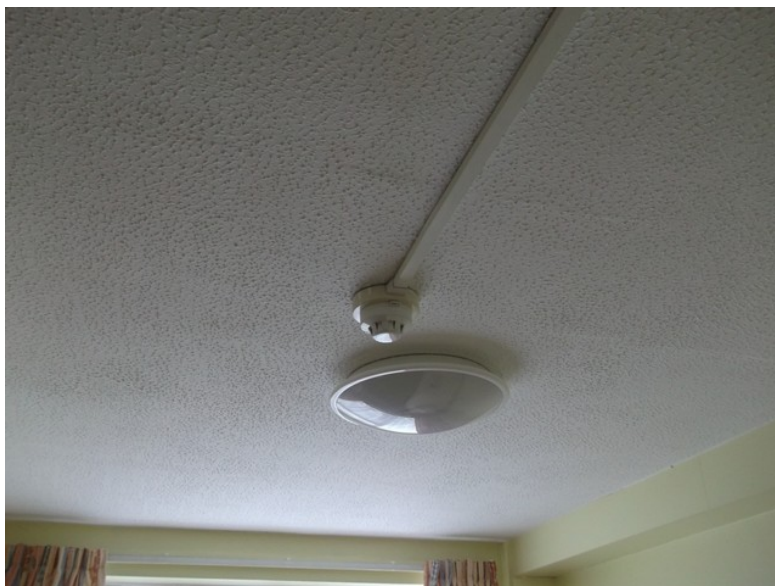
Sample No.	26462-REF 036	Product Type	Textured Coating	1
	Photo 55957-045.jpg	Condition	Good Condition	-
Building	Sandbanks	Surface Treatment	Sealed	-
Floor	Ground	Asbestos Type	Chrysotile	1
Room	008 - Medical Room	Material Risk Assessment		2
Item	Textured Coating	Item Risk Classification	Very Low Risk	
Extent & Location	4sqm - Ceiling	Highest Risk Classification for Room	Very Low Risk

Main Recommendations: **Manage risk using appropriate controls and training.**
Inspect materials at least annually for further damage

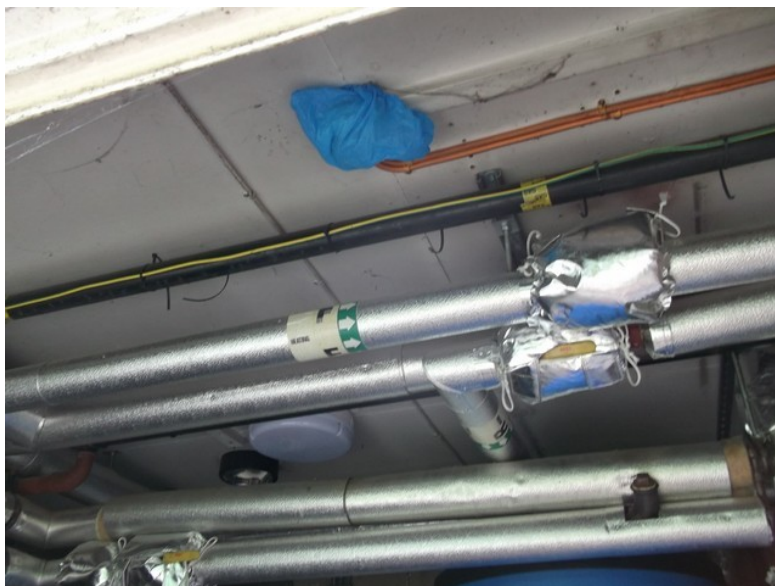
Sample No.	26462-047	Product Type	Insulating Board	2
	Photo 55957-061.jpg	Condition	Minor Damage	1
Building	Sandbanks	Surface Treatment	Sealed	1
Floor	Ground	Asbestos Type	Amosite	2
Room	010 - Boiler Room	Material Risk Assessment		6
Item	Insulating Board Panels	Item Risk Classification	Low Risk	
Extent & Location	12sqm - Ceiling	Highest Risk Classification for Room	Low Risk

Main Recommendations: **Manage risk using appropriate controls and training.**
Inspect materials at least annually for further damage

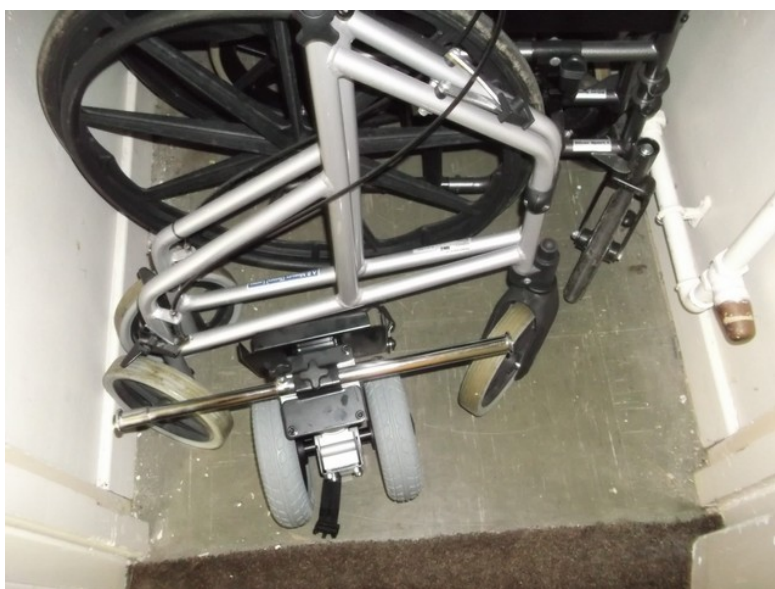
Sample No.	26462-011	Product Type	Asbestos Reinforced Composite	1
	Photo 55957-056.jpg	Condition	Good Condition	-
Building	Sandbanks	Surface Treatment	Sealed	-
Floor	Ground	Asbestos Type	Chrysotile	1
Room	011 - Store	Material Risk Assessment		2
Item	Green Thermoplastic Tiles	Item Risk Classification	Very Low Risk	
Extent & Location	2sqm - Floor	Highest Risk Classification for Room	Very Low Risk

Main Recommendations: **Manage risk using appropriate controls and training.**
Inspect materials at least annually for further damage

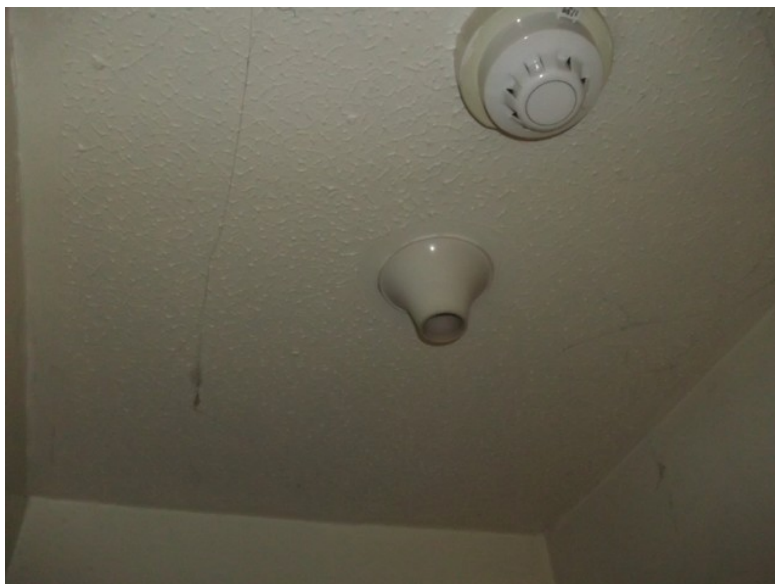
Sample No.	26462-REF 008	Product Type	Textured Coating	1
	Photo 55957-055.jpg	Condition	Good Condition	-
Building	Sandbanks	Surface Treatment	Sealed	-
Floor	Ground	Asbestos Type	Chrysotile	1
Room	011 - Store	Material Risk Assessment		2
Item	Textured Coating	Item Risk Classification	Very Low Risk	
Extent & Location	1sqm - Ceiling	Highest Risk Classification for Room	Very Low Risk

Main Recommendations: **Manage risk using appropriate controls and training.**
Inspect materials at least annually for further damage

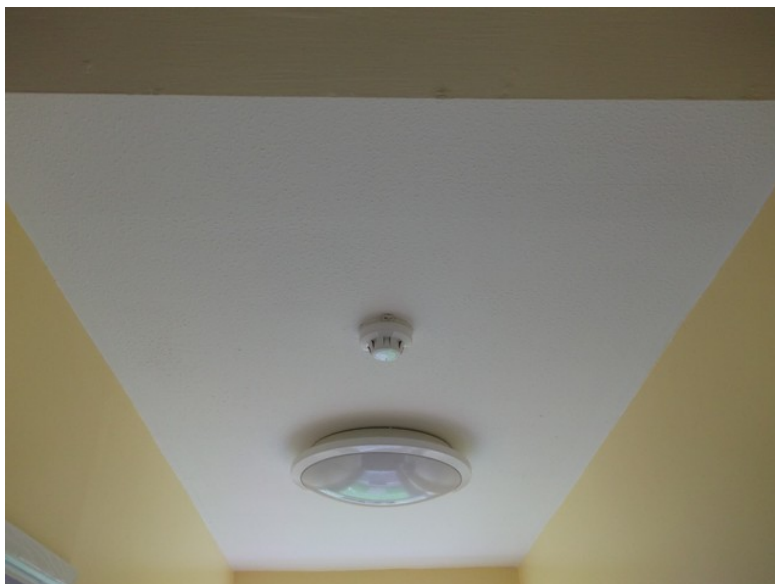
Sample No.	26462-REF 008	Product Type	Textured Coating	1
	Photo 55957-050.jpg	Condition	Good Condition	-
Building	Sandbanks	Surface Treatment	Sealed	-
Floor	Ground	Asbestos Type	Chrysotile	1
Room	013 - Corridor	Material Risk Assessment		2
Item	Textured Coating	Item Risk Classification	Very Low Risk	
Extent & Location	4sqm - Between Rooms 001& 017	Highest Risk Classification for Room	Very Low Risk

Main Recommendations: **Manage risk using appropriate controls and training.**
Inspect materials at least annually for further damage

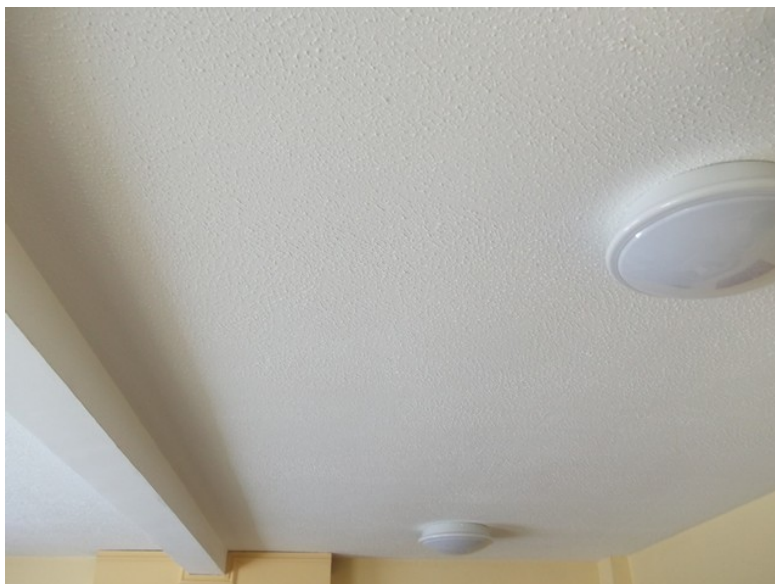
Sample No.	26462-REF 010	Product Type	Textured Coating	1
	Photo 55957-060.jpg	Condition	Good Condition	-
Building	Sandbanks	Surface Treatment	Sealed	-
Floor	Ground	Asbestos Type	Chrysotile	1
Room	016 - Store	Material Risk Assessment		2
Item	Textured Coating	Item Risk Classification	Very Low Risk	
Extent & Location	6sqm - Ceiling	Highest Risk Classification for Room	Very Low Risk

Main Recommendations: **Manage risk using appropriate controls and training.**
Inspect materials at least annually for further damage

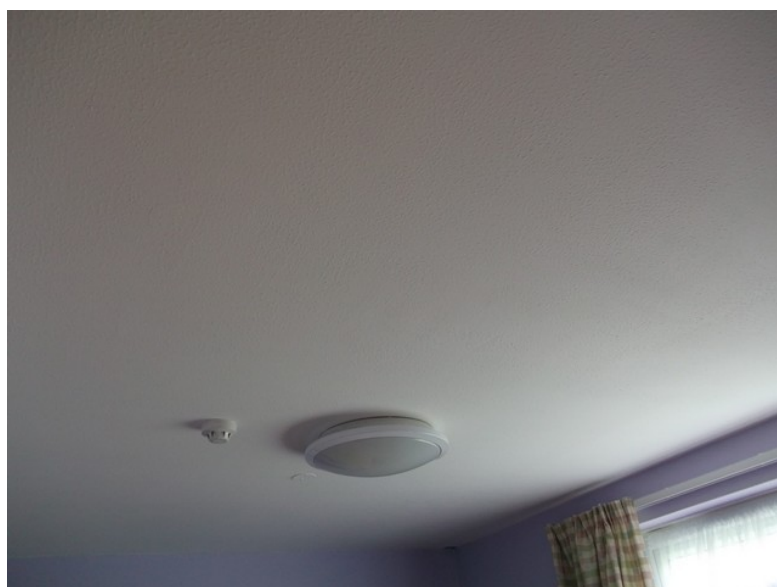
Sample No.	26462-REF 005	Product Type	Textured Coating	1
	Photo 55957-037.jpg	Condition	Good Condition	-
Building	Sandbanks	Surface Treatment	Sealed	-
Floor	Ground	Asbestos Type	Chrysotile	1
Room	017 - Bedroom	Material Risk Assessment		2
Item	Textured Coating	Item Risk Classification	Very Low Risk	
Extent & Location	10sqm - Ceiling	Highest Risk Classification for Room	Very Low Risk

Main Recommendations: **Manage risk using appropriate controls and training.**
Inspect materials at least annually for further damage

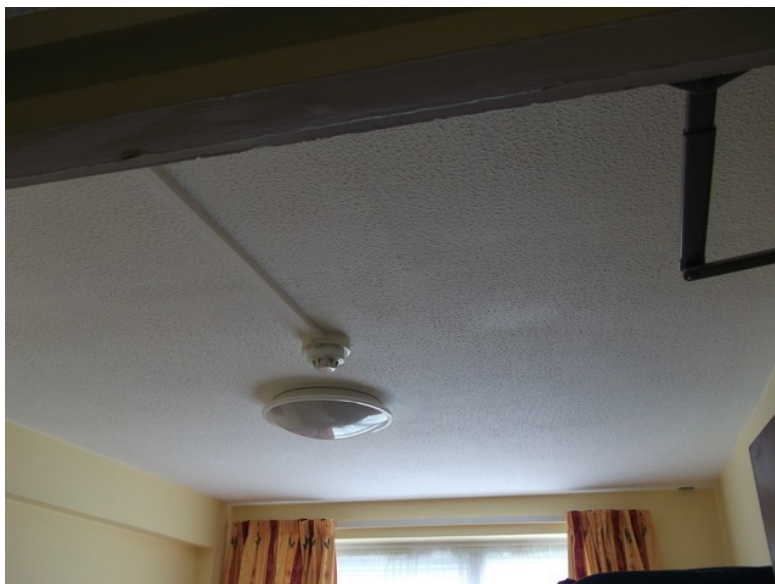
Sample No.	26462-REF 005	Product Type	Textured Coating	1
	Photo 55957-038.jpg	Condition	Good Condition	-
Building	Sandbanks	Surface Treatment	Sealed	-
Floor	Ground	Asbestos Type	Chrysotile	1
Room	018 - Bedroom	Material Risk Assessment		2
Item	Textured Coating	Item Risk Classification	Very Low Risk	
Extent & Location	10sqm - Ceiling	Highest Risk Classification for Room	Very Low Risk

Main Recommendations: **Manage risk using appropriate controls and training.**
Inspect materials at least annually for further damage

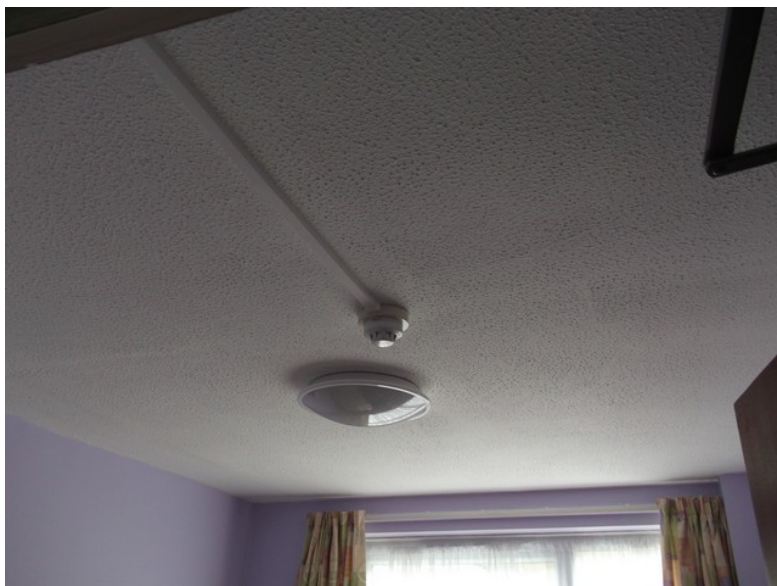
Sample No.	26462-005	Product Type	Textured Coating	1
	Photo 55957-039.jpg	Condition	Good Condition	-
Building	Sandbanks	Surface Treatment	Sealed	-
Floor	Ground	Asbestos Type	Chrysotile	1
Room	019 - Bedroom	Material Risk Assessment		2
Item	Textured Coating	Item Risk Classification	Very Low Risk	
Extent & Location	8sqm - Ceiling	Highest Risk Classification for Room	Very Low Risk

Main Recommendations: **Manage risk using appropriate controls and training.
Inspect materials at least annually for further damage**

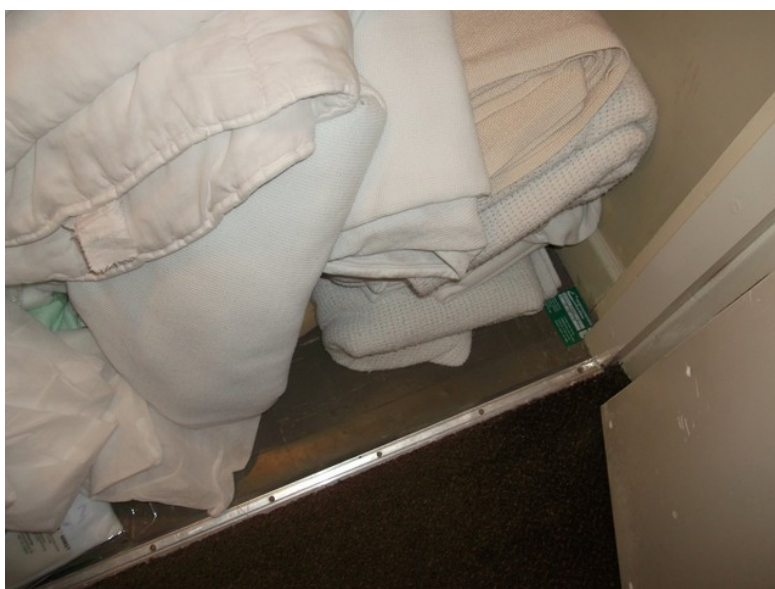
Sample No.	26462-REF 011	Product Type	Asbestos Reinforced Composite	1
	Photo 55957-041.jpg	Condition	Good Condition	-
Building	Sandbanks	Surface Treatment	Sealed	-
Floor	Ground	Asbestos Type	Chrysotile	1
Room	020 - Store	Material Risk Assessment		2
Item	Green Thermoplastic Tiles	Item Risk Classification	Very Low Risk	
Extent & Location	2sqm - Floor	Highest Risk Classification for Room	Very Low Risk

Main Recommendations: **Manage risk using appropriate controls and training.**
Inspect materials at least annually for further damage

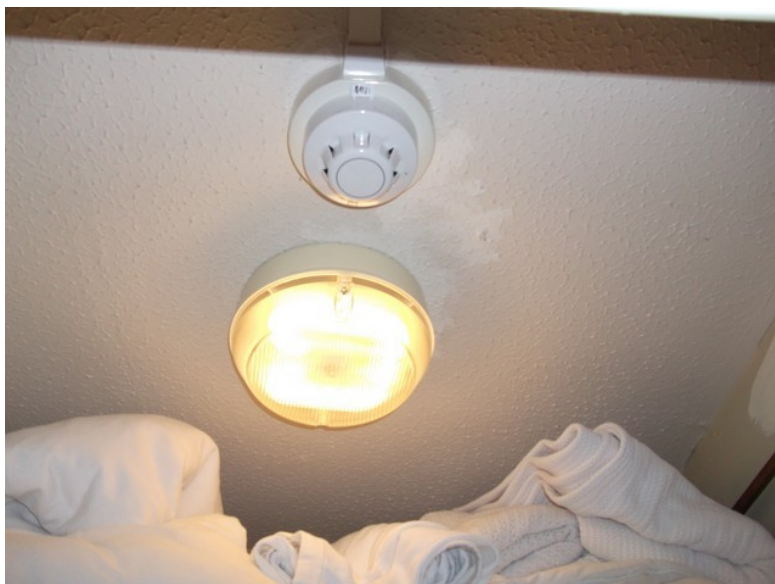
Sample No.	26462-REF 005	Product Type	Textured Coating	1
	Photo 55957-040.jpg	Condition	Good Condition	-
Building	Sandbanks	Surface Treatment	Sealed	-
Floor	Ground	Asbestos Type	Chrysotile	1
Room	020 - Store	Material Risk Assessment		2
Item	Textured Coating	Item Risk Classification	Very Low Risk	
Extent & Location	2sqm - Ceiling	Highest Risk Classification for Room	Very Low Risk

Main Recommendations: **Manage risk using appropriate controls and training.**
Inspect materials at least annually for further damage

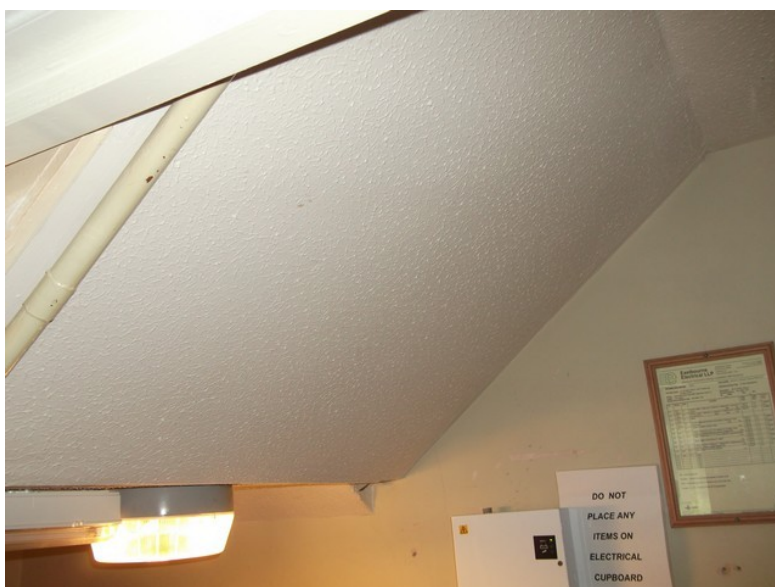
Sample No.	26462-REF 010	Product Type	Textured Coating	1
	Photo 55957-042.jpg	Condition	Good Condition	-
Building	Sandbanks	Surface Treatment	Sealed	-
Floor	Ground	Asbestos Type	Chrysotile	1
Room	021 - Store Under Stairs	Material Risk Assessment		2
Item	Textured Coating	Item Risk Classification	Very Low Risk	
Extent & Location	4sqm - Ceiling	Highest Risk Classification for Room	Very Low Risk

Main Recommendations: **Manage risk using appropriate controls and training.**
Inspect materials at least annually for further damage

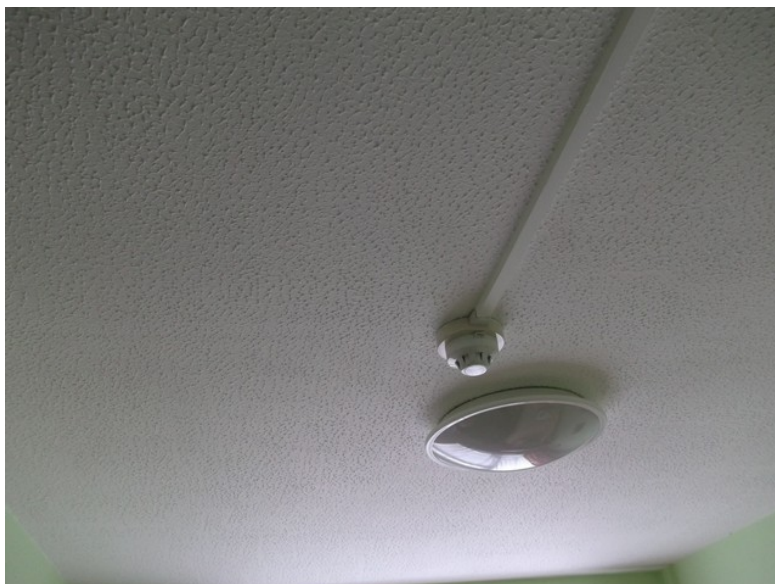
Sample No.	26462-004	Product Type	Textured Coating	1
	Photo 55957-046.jpg	Condition	Good Condition	-
Building	Sandbanks	Surface Treatment	Sealed	-
Floor	Ground	Asbestos Type	Chrysotile	1
Room	022 - Bedroom	Material Risk Assessment		2
Item	Textured Coating	Item Risk Classification	Very Low Risk	
Extent & Location	10sqm - Ceiling	Highest Risk Classification for Room	Very Low Risk

Main Recommendations: **Manage risk using appropriate controls and training.**
Inspect materials at least annually for further damage

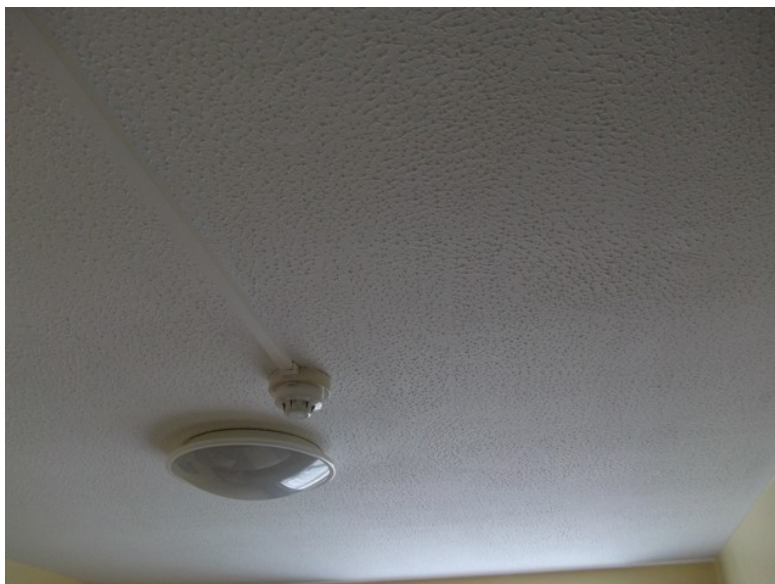
Sample No.	26462-003	Product Type	Textured Coating	1
	Photo 55957-047.jpg	Condition	Good Condition	-
Building	Sandbanks	Surface Treatment	Sealed	-
Floor	Ground	Asbestos Type	Chrysotile	1
Room	023 - Bedroom	Material Risk Assessment		2
Item	Textured Coating	Item Risk Classification	Very Low Risk	
Extent & Location	8sqm - Ceiling	Highest Risk Classification for Room	Very Low Risk

Main Recommendations: **Manage risk using appropriate controls and training.**
Inspect materials at least annually for further damage

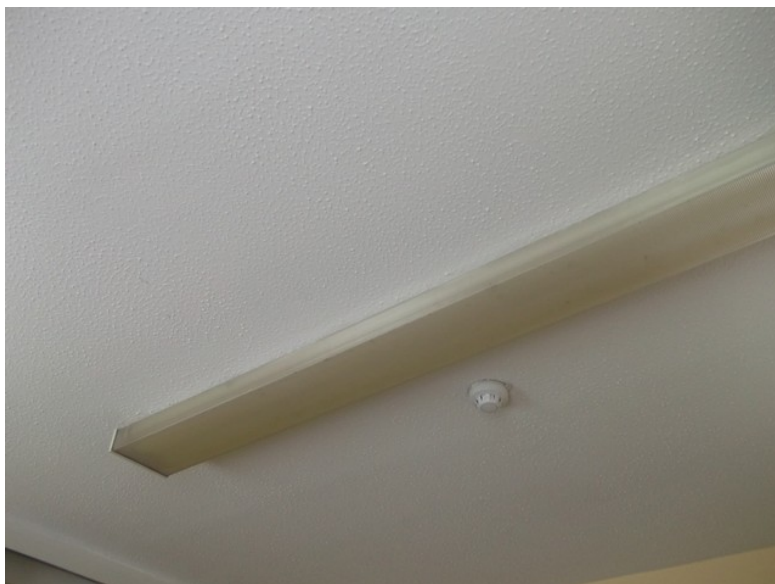
Sample No.	26462-002	Product Type	Textured Coating	1
	Photo 55957-048.jpg	Condition	Good Condition	-
Building	Sandbanks	Surface Treatment	Sealed	-
Floor	Ground	Asbestos Type	Chrysotile	1
Room	024 - Bedroom	Material Risk Assessment		2
Item	Textured Coating	Item Risk Classification	Very Low Risk	
Extent & Location	8sqm - Ceiling	Highest Risk Classification for Room	Very Low Risk

Main Recommendations: **Manage risk using appropriate controls and training.**
Inspect materials at least annually for further damage

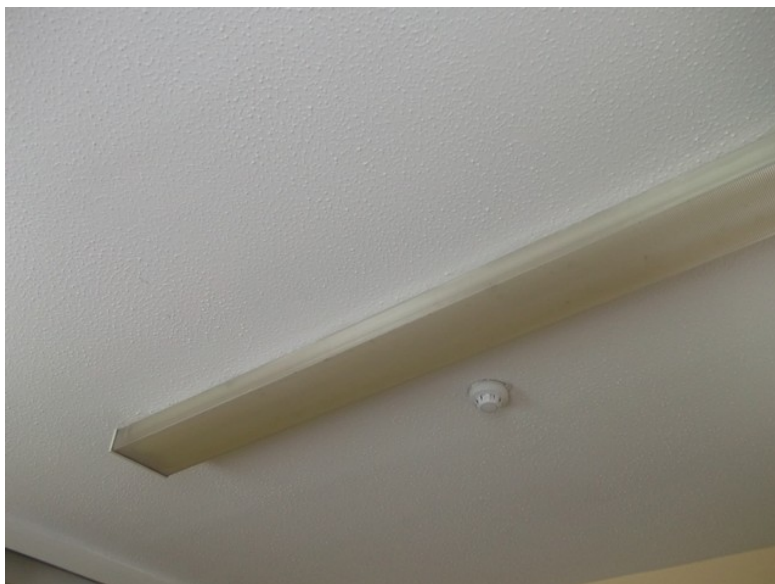
Sample No.	26462-001	Product Type	Textured Coating	1
	Photo 55957-048.jpg	Condition	Good Condition	-
Building	Sandbanks	Surface Treatment	Sealed	-
Floor	Ground	Asbestos Type	Chrysotile	1
Room	024 - Bedroom	Material Risk Assessment		2
Item	Textured Coating	Item Risk Classification	Very Low Risk	
Extent & Location	8sqm - Ceiling	Highest Risk Classification for Room	Very Low Risk

Main Recommendations: **Manage risk using appropriate controls and training.**
Inspect materials at least annually for further damage

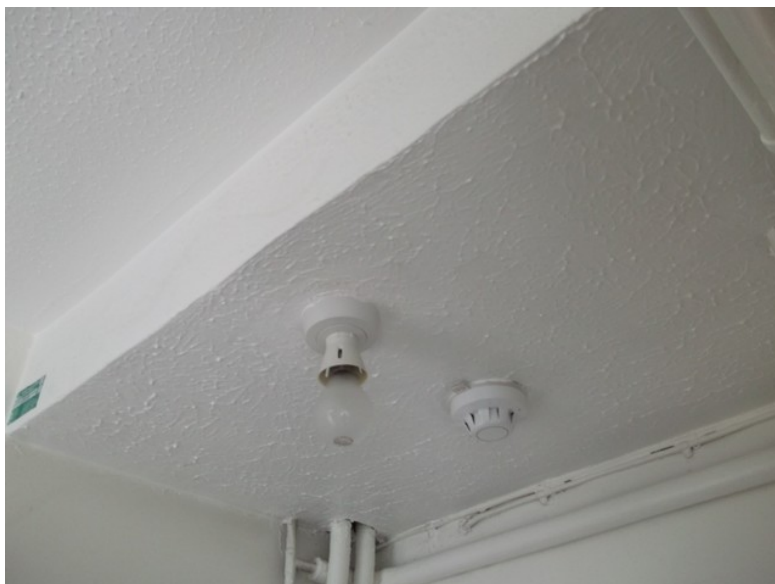
Sample No.	26462-REF 036	Product Type	Textured Coating	1
	Photo 55957-057.jpg	Condition	Minor Damage	1
Building	Sandbanks	Surface Treatment	Sealed	-
Floor	Ground	Asbestos Type	Chrysotile	1
Room	031 - Kitchen Toilet	Material Risk Assessment		3
Item	Textured Coating	Item Risk Classification	Very Low Risk	
Extent & Location	4sqm - Ceiling	Highest Risk Classification for Room	Very Low Risk

Main Recommendations: **Manage risk using appropriate controls and training.**
Inspect materials at least annually for further damage

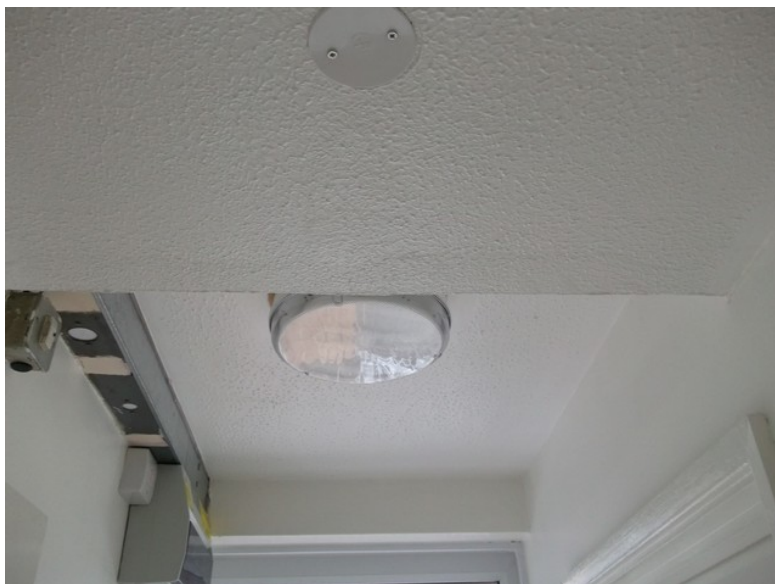
Sample No.	26462-REF 036	Product Type	Textured Coating	1
	Photo 55957-058.jpg	Condition	Minor Damage	1
Building	Sandbanks	Surface Treatment	Sealed	-
Floor	Ground	Asbestos Type	Chrysotile	1
Room	034 - Kitchen	Material Risk Assessment		3
Item	Textured Coating	Item Risk Classification	Very Low Risk	
Extent & Location	2sqm - Ceiling Above Doorway To External	Highest Risk Classification for Room	Very Low Risk

Main Recommendations: **Manage risk using appropriate controls and training.**
Inspect materials at least annually for further damage

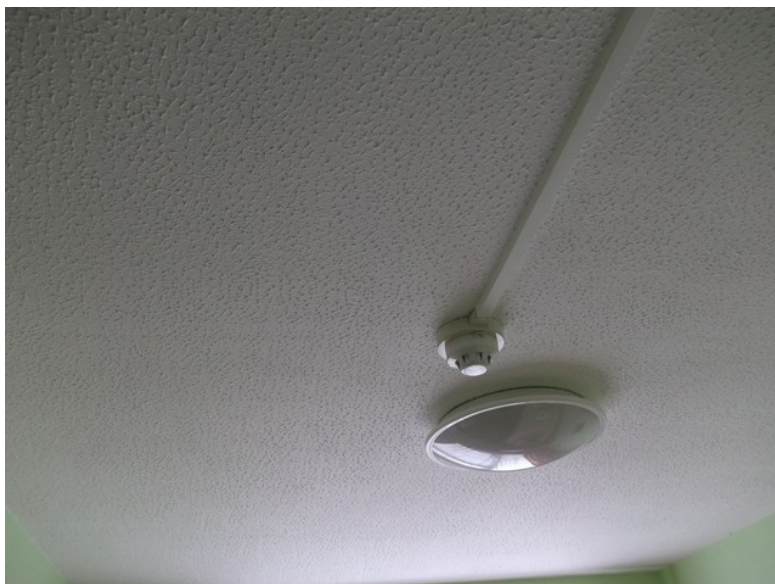
Sample No.	26462-REF 036	Product Type	Textured Coating	1
	Photo 55957-051.jpg	Condition	Good Condition	-
Building	Sandbanks	Surface Treatment	Sealed	-
Floor	Ground	Asbestos Type	Chrysotile	1
Room	035 - Small Lounge	Material Risk Assessment		2
Item	Textured Coating	Item Risk Classification	Very Low Risk	
Extent & Location	10sqm - Ceiling	Highest Risk Classification for Room	Very Low Risk

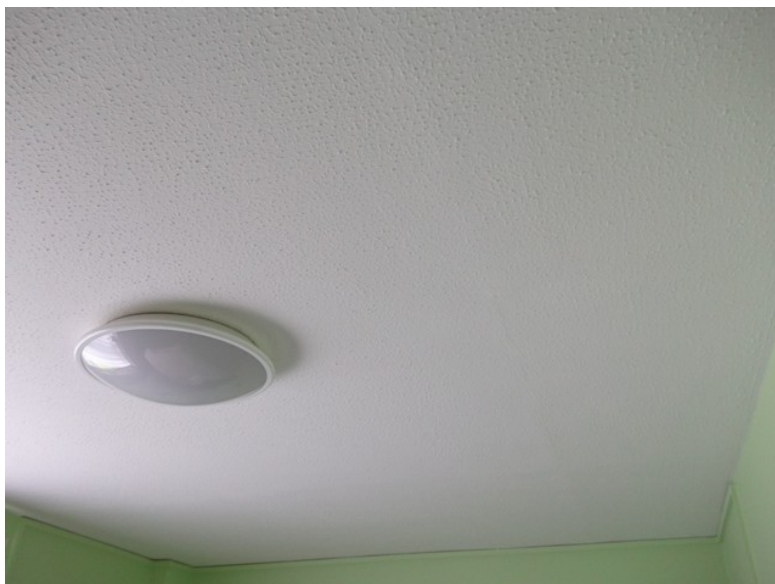
Sample No.	26462-020	Product Type	Textured Coating	1
	Photo 55957-015.jpg	Condition	Good Condition	-
Building	Sandbanks	Surface Treatment	Sealed	-
Floor	Ground	Asbestos Type	Chrysotile	1
Room	037 - Bedroom	Material Risk Assessment		2
Item	Textured Coating	Item Risk Classification	Very Low Risk	
Extent & Location	11sqm - Ceiling	Highest Risk Classification for Room	Very Low Risk

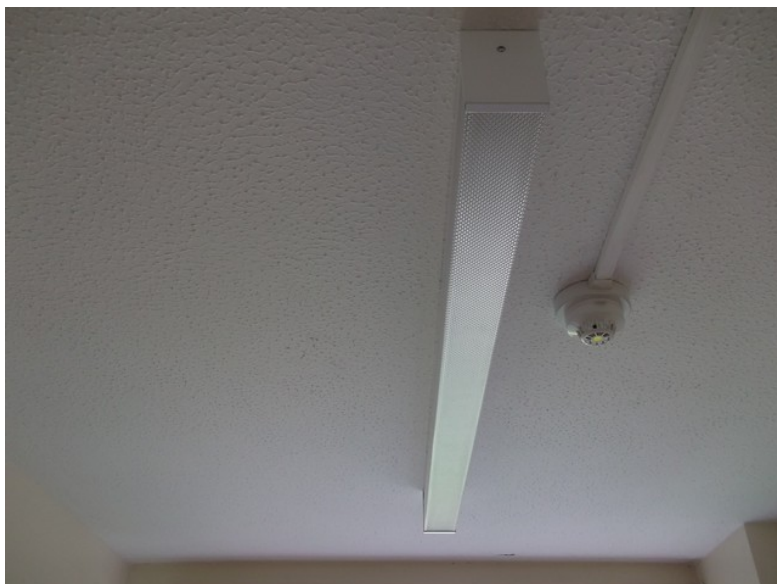
Sample No.	26462-REF 020	Product Type	Textured Coating	1
	Photo 55957-016.jpg	Condition	Good Condition	-
Building	Sandbanks	Surface Treatment	Sealed	-
Floor	Ground	Asbestos Type	Chrysotile	1
Room	038 - Staff Kitchen	Material Risk Assessment		2
Item	Textured Coating	Item Risk Classification	Very Low Risk	
Extent & Location	8sqm - Ceiling	Highest Risk Classification for Room	Very Low Risk

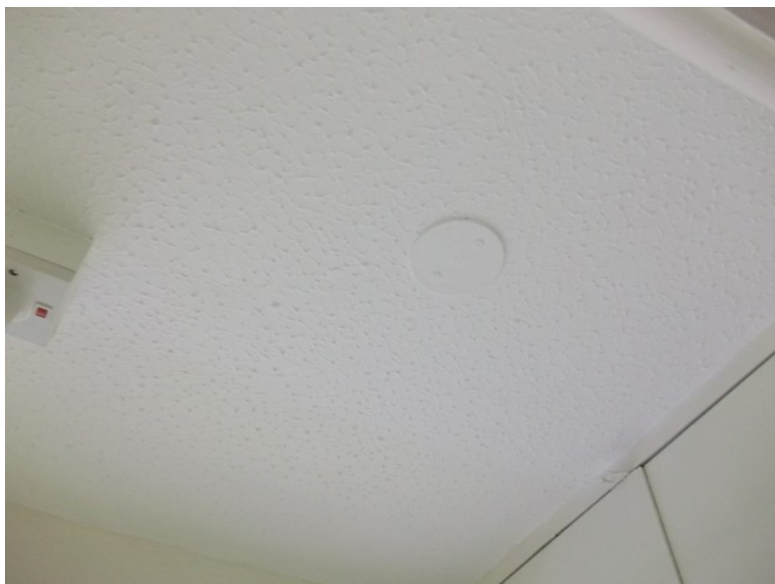
Sample No.	26462-REF 020	Product Type	Textured Coating	1
	Photo 55957-017.jpg	Condition	Good Condition	-
Building	Sandbanks	Surface Treatment	Sealed	-
Floor	Ground	Asbestos Type	Chrysotile	1
Room	039 - Toilet	Material Risk Assessment		2
Item	Textured Coating	Item Risk Classification	Very Low Risk	
Extent & Location	2sqm - Ceiling To Entrance	Highest Risk Classification for Room	Very Low Risk

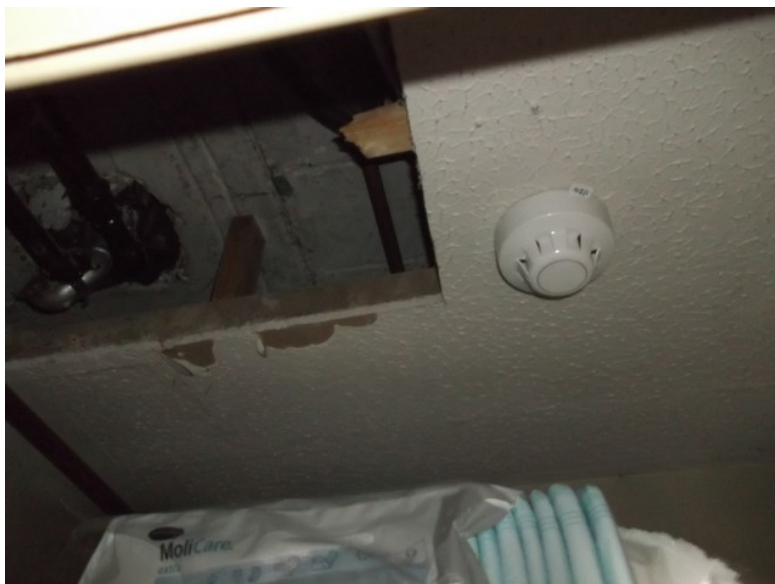
Sample No.	26462-REF 020	Product Type	Textured Coating	1
	Photo 55957-018.jpg	Condition	Significant Damage	2
Building	Sandbanks	Surface Treatment	Sealed	-
Floor	Ground	Asbestos Type	Chrysotile	1
Room	040 - Hoist Store	Material Risk Assessment		4
Item	Textured Coating	Item Risk Classification	Very Low Risk	
Extent & Location	2sqm - Ceiling	Highest Risk Classification for Room	Very Low Risk

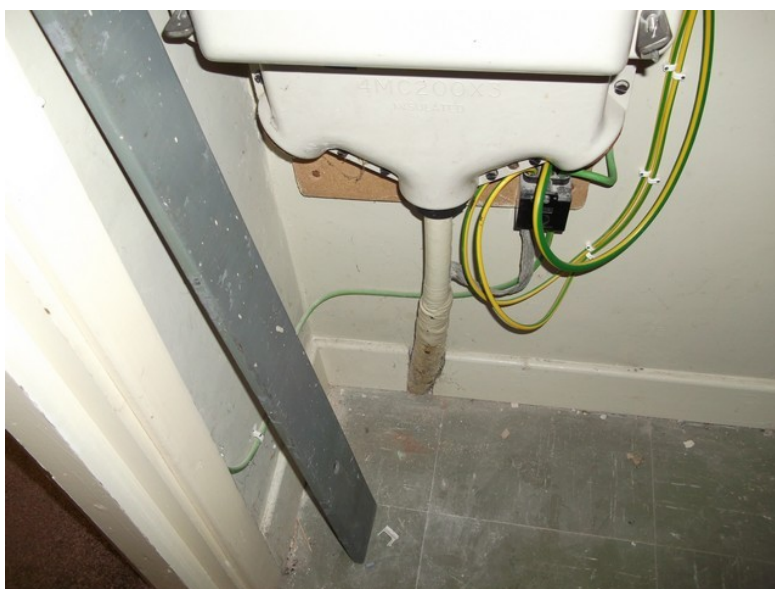
Sample No.	55957-VISUAL	Product Type	Asbestos Reinforced Composite	1
	Photo 55957-054.jpg	Condition	Good Condition	-
Building	Sandbanks	Surface Treatment	Sealed	-
Floor	Ground	Asbestos Type	Chrysotile	1
Room	043 - Meters Store	Material Risk Assessment		2
Item	Bitumen Wrap	Item Risk Classification	Very Low Risk	
Extent & Location	x1 - Intake Cable	Highest Risk Classification for Room	Very Low Risk

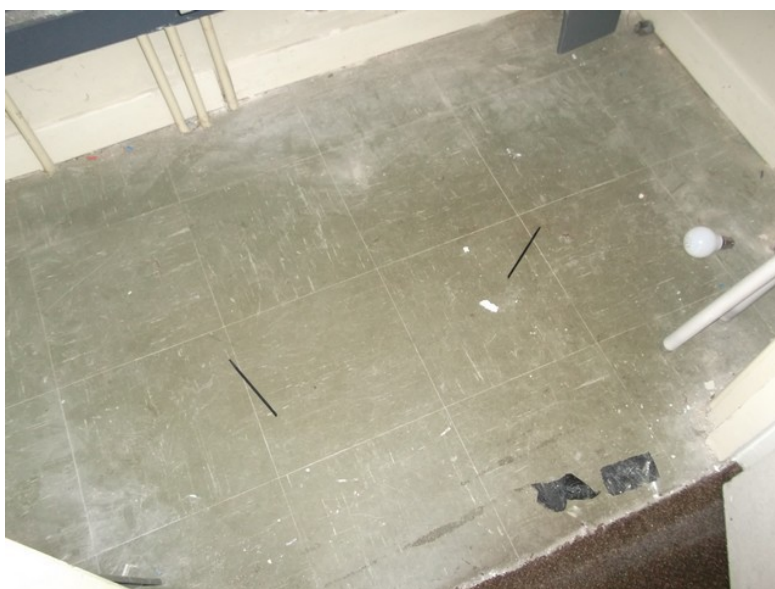
Sample No.	26462-REF 011	Product Type	Asbestos Reinforced Composite	1
	Photo 55957-052.jpg	Condition	Good Condition	-
Building	Sandbanks	Surface Treatment	Sealed	-
Floor	Ground	Asbestos Type	Chrysotile	1
Room	043 - Meters Store	Material Risk Assessment		2
Item	Green Thermoplastic Tiles	Item Risk Classification	Very Low Risk	
Extent & Location	2sqm - Floor	Highest Risk Classification for Room	Very Low Risk

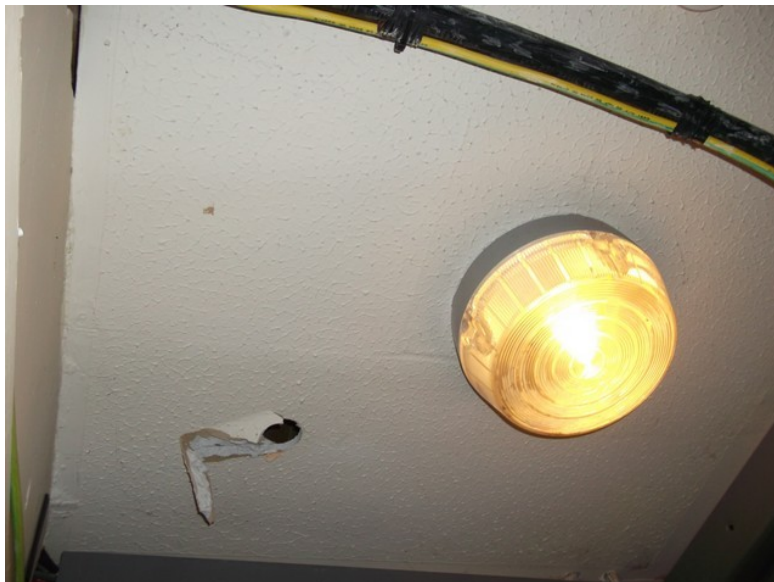
Sample No.	26462-REF 034	Product Type	Textured Coating	1
	Photo 55957-053.jpg	Condition	Good Condition	-
Building	Sandbanks	Surface Treatment	Sealed	-
Floor	Ground	Asbestos Type	Chrysotile	1
Room	043 - Meters Store	Material Risk Assessment		2
Item	Textured Coating	Item Risk Classification	Very Low Risk	
Extent & Location	2sqm - Ceiling	Highest Risk Classification for Room	Very Low Risk

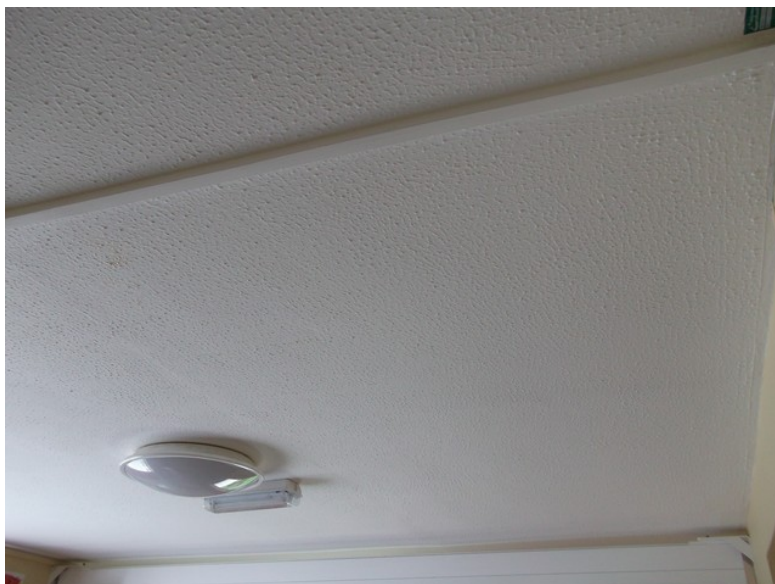
Sample No.	26462-019	Product Type	Textured Coating	1
	Photo 55957-019.jpg	Condition	Good Condition	-
Building	Sandbanks	Surface Treatment	Sealed	-
Floor	Ground	Asbestos Type	Chrysotile	1
Room	047 - Bedroom	Material Risk Assessment		2
Item	Textured Coating	Item Risk Classification	Very Low Risk	
Extent & Location	14sqm - Ceiling	Highest Risk Classification for Room	Very Low Risk

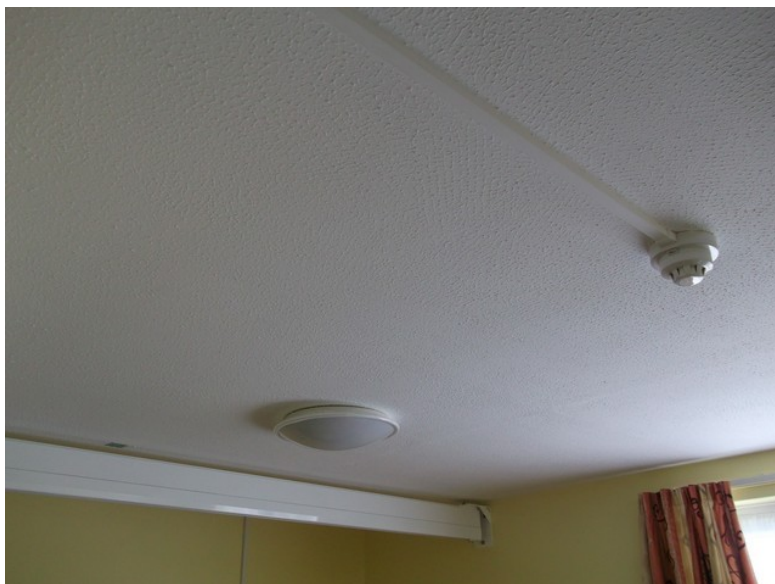
Sample No.	26462-021	Product Type	Textured Coating	1
	Photo 55957-020.jpg	Condition	Good Condition	-
Building	Sandbanks	Surface Treatment	Sealed	-
Floor	Ground	Asbestos Type	Chrysotile	1
Room	049 - Bedroom	Material Risk Assessment		2
Item	Textured Coating	Item Risk Classification	Very Low Risk	
Extent & Location	14sqm - Ceiling	Highest Risk Classification for Room	Very Low Risk

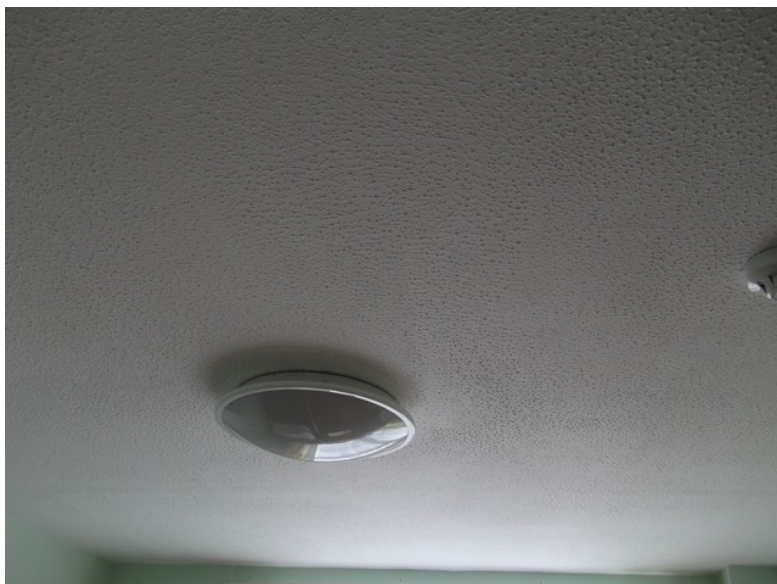
Sample No.	26462-017	Product Type	Textured Coating	1
	Photo 55957-059.jpg	Condition	Good Condition	-
Building	Sandbanks	Surface Treatment	Sealed	-
Floor	Ground	Asbestos Type	Chrysotile	1
Room	054 - Main Lounge	Material Risk Assessment		2
Item	Textured Coating	Item Risk Classification	Very Low Risk	
Extent & Location	24sqm - Ceiling	Highest Risk Classification for Room	Very Low Risk

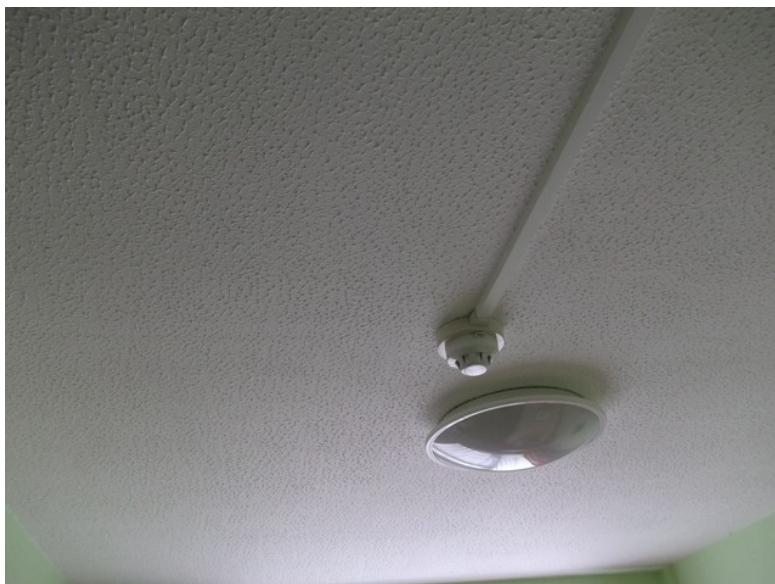
Sample No.	26462-REF 021	Product Type	Textured Coating	1
	Photo 55957-021.jpg	Condition	Good Condition	-
Building	Sandbanks	Surface Treatment	Sealed	-
Floor	First	Asbestos Type	Chrysotile	1
Room	055 - Bathroom	Material Risk Assessment		2
Item	Textured Coating	Item Risk Classification	Very Low Risk	
Extent & Location	10sqm - Ceiling	Highest Risk Classification for Room	Very Low Risk

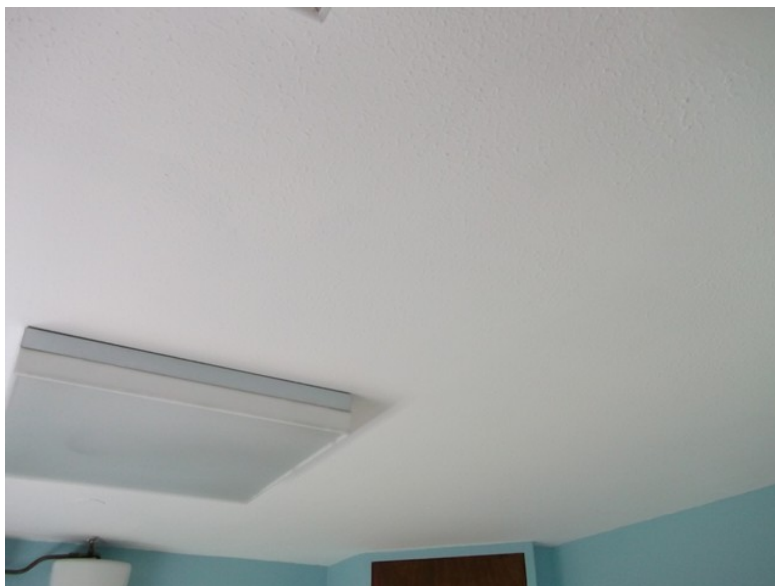
Sample No.	26462-REF 021	Product Type	Textured Coating	1
	Photo 55957-022.jpg	Condition	Good Condition	-
Building	Sandbanks	Surface Treatment	Sealed	-
Floor	First	Asbestos Type	Chrysotile	1
Room	056 - T.V. Lounge	Material Risk Assessment		2
Item	Textured Coating	Item Risk Classification	Very Low Risk	
Extent & Location	20sqm - Ceiling	Highest Risk Classification for Room	Very Low Risk

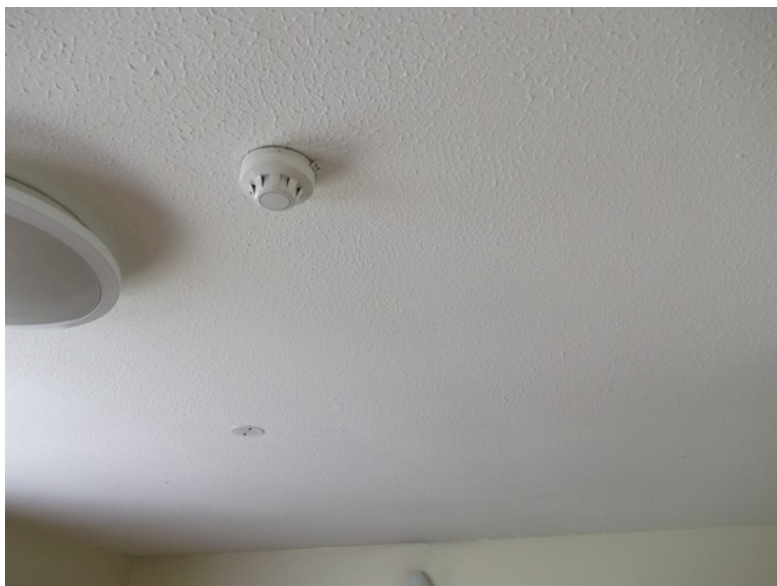
Sample No.	26462-REF 026	Product Type	Textured Coating	1
	Photo 55957-023.jpg	Condition	Good Condition	-
Building	Sandbanks	Surface Treatment	Sealed	-
Floor	First	Asbestos Type	Chrysotile	1
Room	057 - Bedroom	Material Risk Assessment		2
Item	Textured Coating	Item Risk Classification	Very Low Risk	
Extent & Location	16sqm - Ceiling	Highest Risk Classification for Room	Very Low Risk

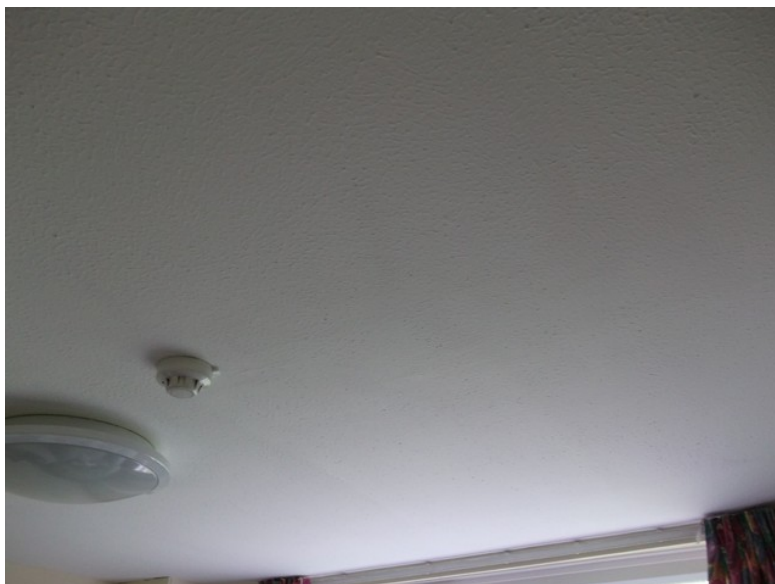
Sample No.	26462-REF 026	Product Type	Textured Coating	1
	Photo 55957-024.jpg	Condition	Good Condition	-
Building	Sandbanks	Surface Treatment	Sealed	-
Floor	First	Asbestos Type	Chrysotile	1
Room	058 - Bedroom	Material Risk Assessment		2
Item	Textured Coating	Item Risk Classification	Very Low Risk	
Extent & Location	12sqm - Ceiling	Highest Risk Classification for Room	Very Low Risk

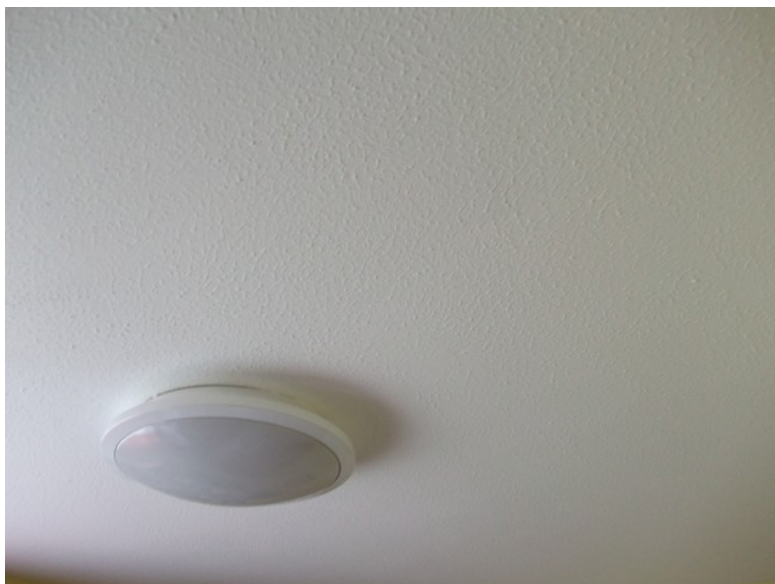
Sample No.	26462-REF 026	Product Type	Textured Coating	1
	Photo 55957-025.jpg	Condition	Good Condition	-
Building	Sandbanks	Surface Treatment	Sealed	-
Floor	First	Asbestos Type	Chrysotile	1
Room	059 - Bedroom	Material Risk Assessment		2
Item	Textured Coating	Item Risk Classification	Very Low Risk	
Extent & Location	14sqm - Ceiling	Highest Risk Classification for Room	Very Low Risk

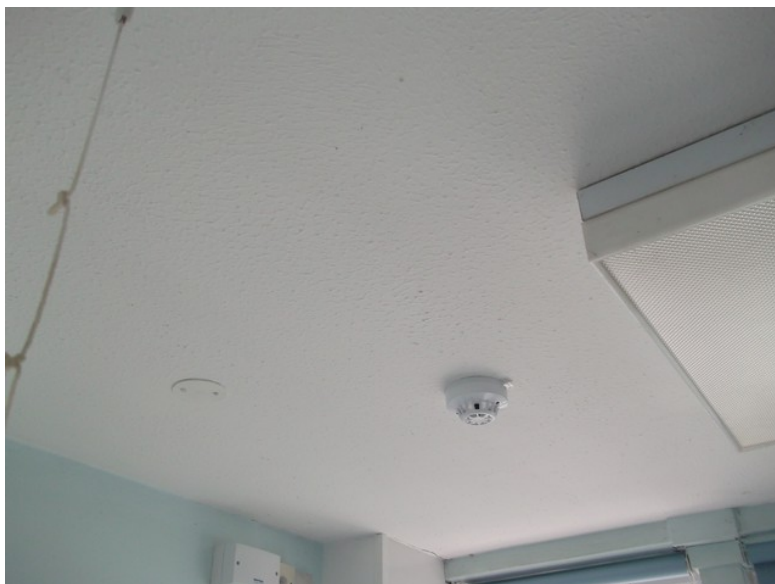
Sample No.	26462-REF 026	Product Type	Textured Coating	1
	Photo 55957-026.jpg	Condition	Good Condition	-
Building	Sandbanks	Surface Treatment	Sealed	-
Floor	First	Asbestos Type	Chrysotile	1
Room	060 - Toilet	Material Risk Assessment		2
Item	Textured Coating	Item Risk Classification	Very Low Risk	
Extent & Location	6sqm - Ceiling	Highest Risk Classification for Room	Very Low Risk
