Asbestos Management Survey
Sandbanks
1 Cacklebury Close, Hailsham, Wealden, BN27 3LU

A Management Survey has been carried out at Sandbanks, 1 Cacklebury Close, Hailsham, Wealden, BN27 3LU.

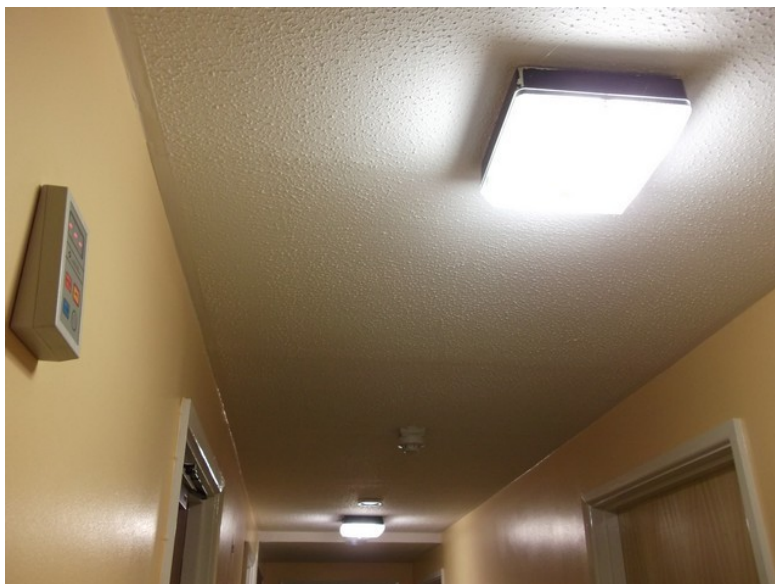
Sample No.	26462-REF 026	Product Type	Textured Coating	1
	Photo 55957-027.jpg	Condition	Good Condition	-
Building	Sandbanks	Surface Treatment	Sealed	-
Floor	First	Asbestos Type	Chrysotile	1
Room	061 - Corridor	Material Risk Assessment		2
Item	Textured Coating	Item Risk Classification	Very Low Risk	
Extent & Location	22sqm - Ceiling	Highest Risk Classification for Room	Very Low Risk

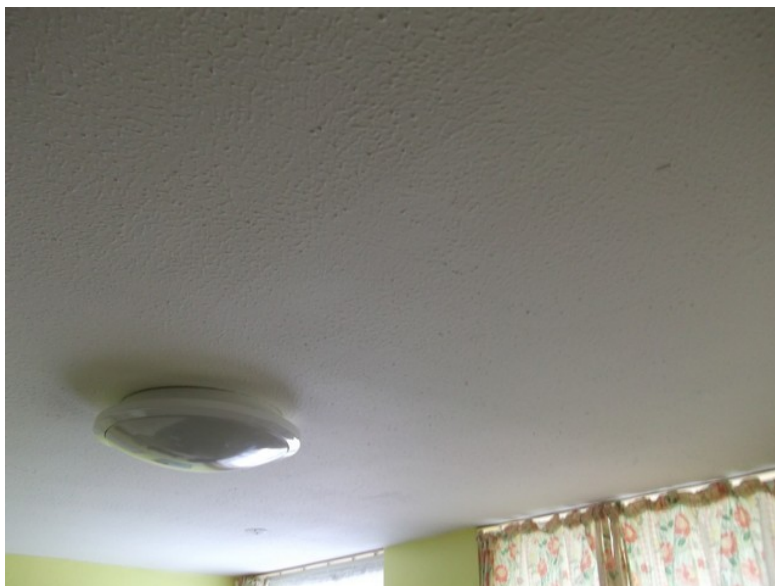
Sample No.	55957-REF 026	Product Type	Textured Coating	1
	Photo 55957-033.jpg	Condition	Good Condition	-
Building	Sandbanks	Surface Treatment	Sealed	-
Floor	First	Asbestos Type	Chrysotile	1
Room	062 - Bedroom	Material Risk Assessment		2
Item	Textured Coating	Item Risk Classification	Very Low Risk	
Extent & Location	12sqm - Ceiling	Highest Risk Classification for Room	Very Low Risk

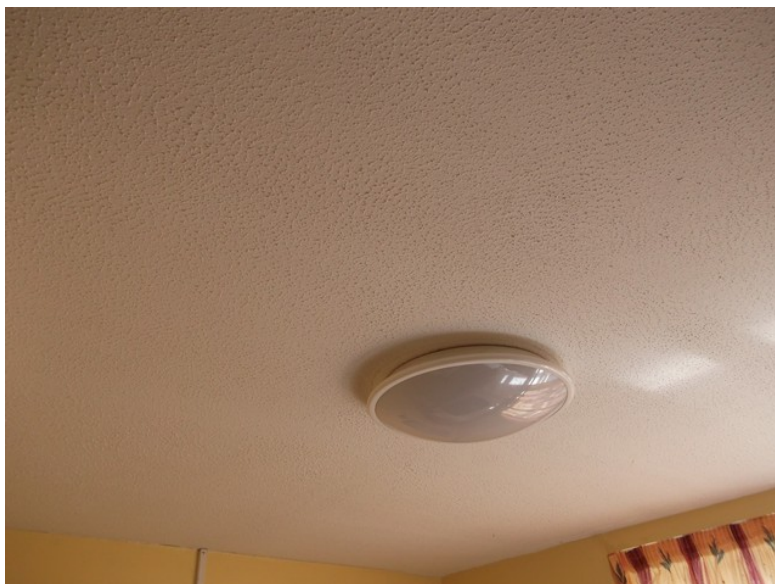
Sample No.	26462-025	Product Type	Textured Coating	1
	Photo 55957-028.jpg	Condition	Good Condition	-
Building	Sandbanks	Surface Treatment	Sealed	-
Floor	First	Asbestos Type	Chrysotile	1
Room	063 - Bedroom	Material Risk Assessment		2
Item	Textured Coating	Item Risk Classification	Very Low Risk	
Extent & Location	10sqm - Ceiling	Highest Risk Classification for Room	Very Low Risk

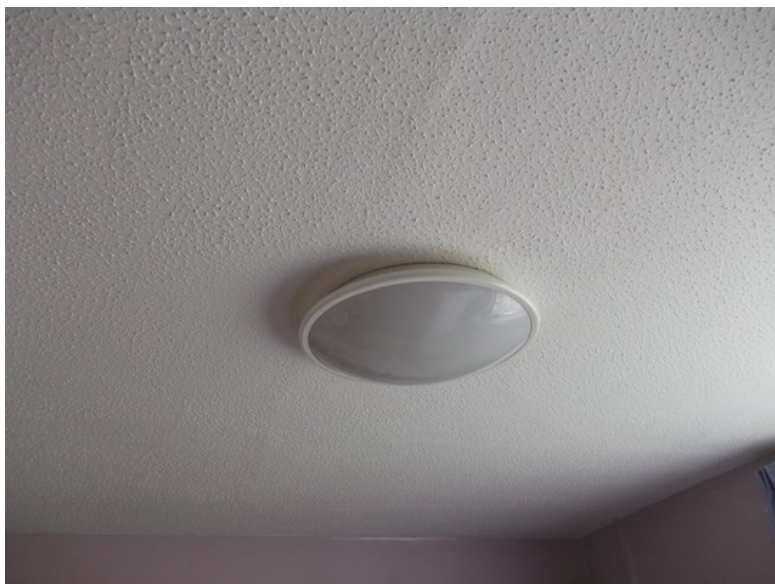
Sample No.	26462-026	Product Type	Textured Coating	1
	Photo 55957-029.jpg	Condition	Good Condition	-
Building	Sandbanks	Surface Treatment	Sealed	-
Floor	First	Asbestos Type	Chrysotile	1
Room	064 - Bedroom	Material Risk Assessment		2
Item	Textured Coating	Item Risk Classification	Very Low Risk	
Extent & Location	10sqm - Ceiling	Highest Risk Classification for Room	Very Low Risk

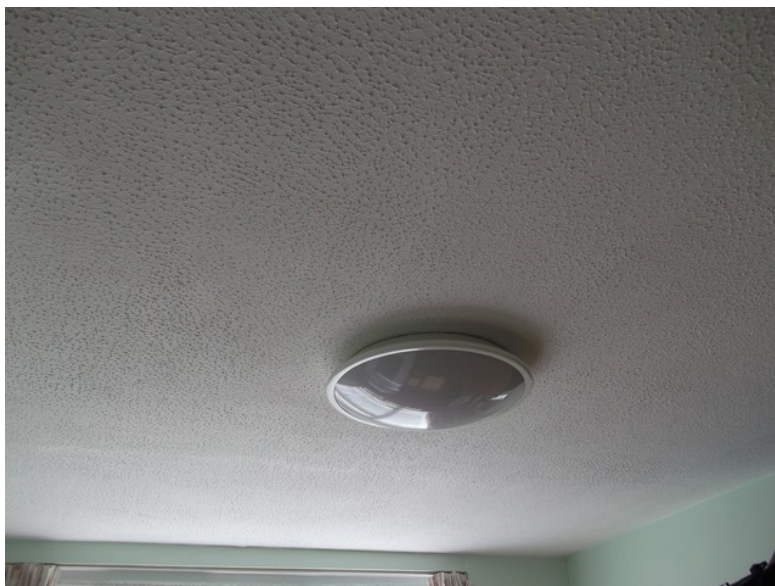
Sample No.	26462-REF 026	Product Type	Textured Coating	1
	Photo 55957-030.jpg	Condition	Good Condition	-
Building	Sandbanks	Surface Treatment	Sealed	-
Floor	First	Asbestos Type	Chrysotile	1
Room	065 - Bedroom	Material Risk Assessment		2
Item	Textured Coating	Item Risk Classification	Very Low Risk	
Extent & Location	10sqm - Ceiling	Highest Risk Classification for Room	Very Low Risk

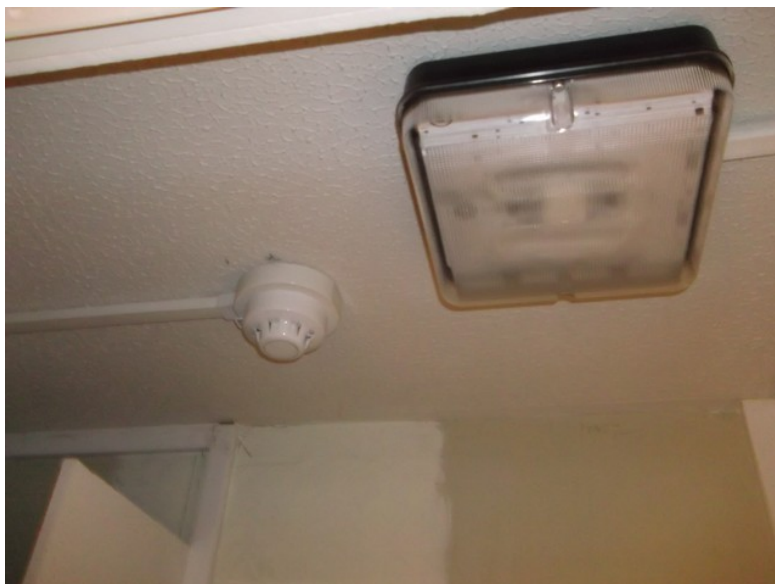
Sample No.	26462-REF 026	Product Type	Textured Coating	1
	Photo 55957-031.jpg	Condition	Good Condition	-
Building	Sandbanks	Surface Treatment	Sealed	-
Floor	First	Asbestos Type	Chrysotile	1
Room	067 - Store	Material Risk Assessment		2
Item	Textured Coating	Item Risk Classification	Very Low Risk	
Extent & Location	2sqm - Ceiling	Highest Risk Classification for Room	Very Low Risk

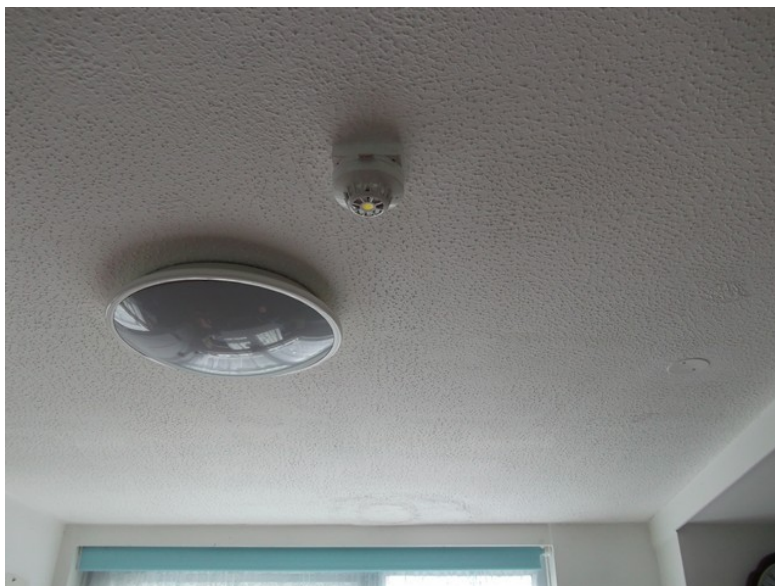
Sample No.	26462-REF 026	Product Type	Textured Coating	1
	Photo 55957-032.jpg	Condition	Good Condition	-
Building	Sandbanks	Surface Treatment	Sealed	-
Floor	First	Asbestos Type	Chrysotile	1
Room	068 - Kitchen Area	Material Risk Assessment		2
Item	Textured Coating	Item Risk Classification	Very Low Risk	
Extent & Location	24sqm - Ceiling	Highest Risk Classification for Room	Very Low Risk

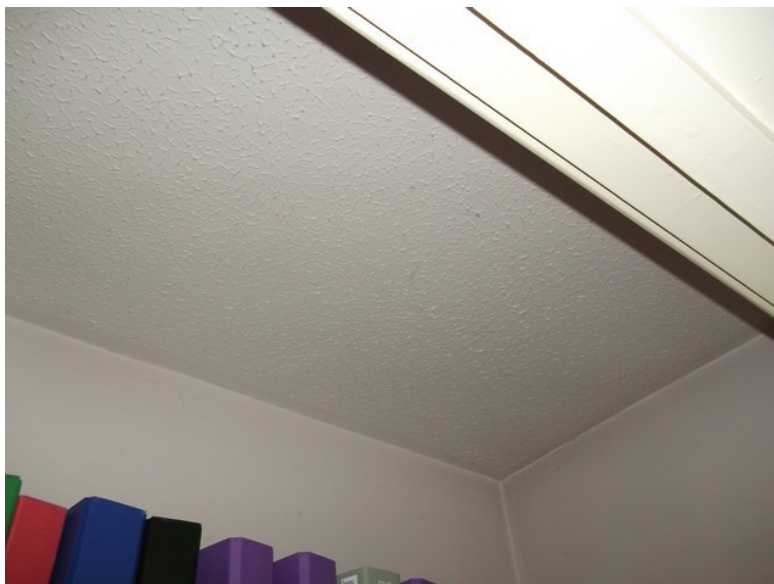
Sample No.	55957-034	Product Type	Textured Coating	1
	Photo 55957-011.jpg	Condition	Good Condition	-
Building	Sandbanks	Surface Treatment	Sealed	-
Floor	First	Asbestos Type	Chrysotile	1
Room	069 - Store	Material Risk Assessment		2
Item	Textured Coating	Item Risk Classification	Very Low Risk	
Extent & Location	1sqm - Ceiling	Highest Risk Classification for Room	Very Low Risk

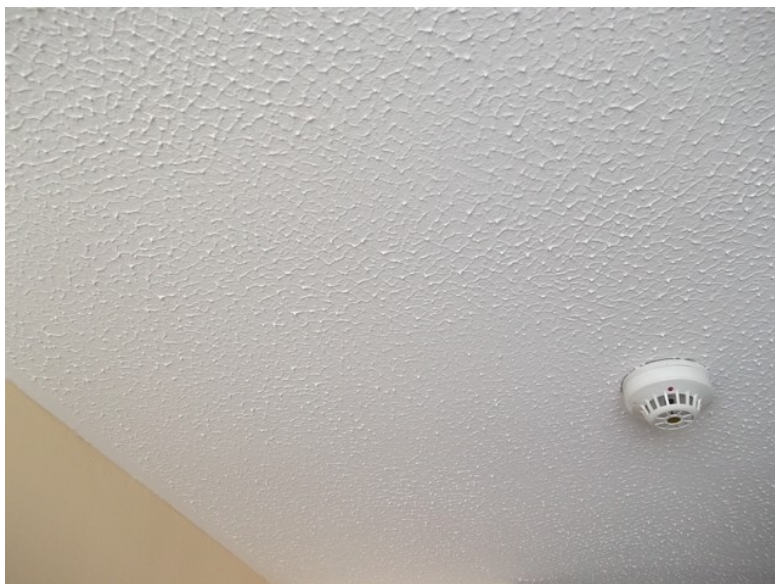
Sample No.	26462-REF 034	Product Type	Textured Coating	1
	Photo 55957-001.jpg	Condition	Good Condition	-
Building	Sandbanks	Surface Treatment	Sealed	-
Floor	First	Asbestos Type	Chrysotile	1
Room	070 - Office	Material Risk Assessment		2
Item	Textured Coating	Item Risk Classification	Very Low Risk	
Extent & Location	15sqm - Ceiling	Highest Risk Classification for Room	Very Low Risk

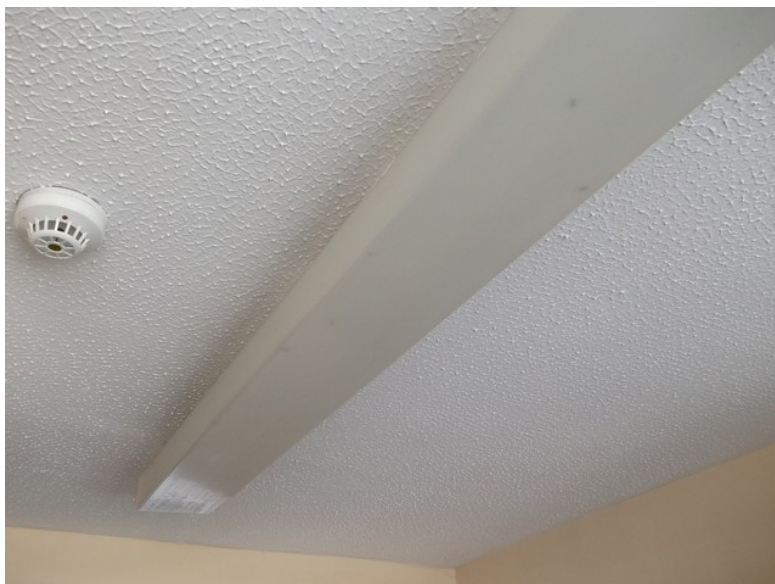
Sample No.	26462-REF 034	Product Type	Textured Coating	1
	Photo 55957-002.jpg	Condition	Good Condition	-
Building	Sandbanks	Surface Treatment	Sealed	-
Floor	First	Asbestos Type	Chrysotile	1
Room	071 - Kitchen	Material Risk Assessment		2
Item	Textured Coating	Item Risk Classification	Very Low Risk	
Extent & Location	6sqm - Ceiling	Highest Risk Classification for Room	Very Low Risk
