VISUAL STRUCTURAL SURVEY

WATER TOWER
BUILDING/OUT
HOUSE AND GARDEN
WALL

BOUGHTON MOUNT

PROJECT REF: 316289

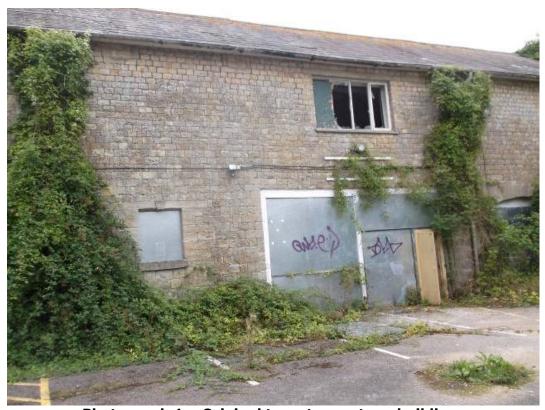
The original building consisted of a two storey stone wall structure, which supports a series of timber trusses and rafters that in turn, support a slate tilled roof. Internally, the stone wall has been finished with a lime mortar.

Photograph 1 – Original two storey stone building.

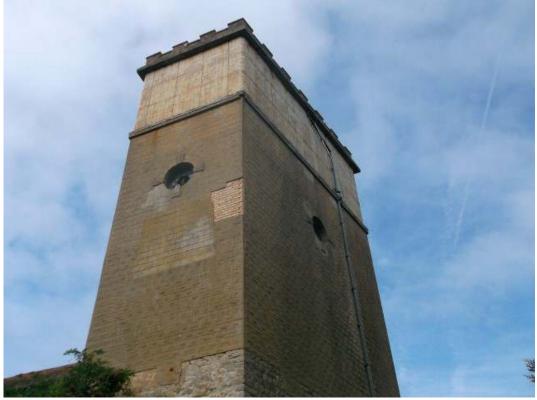
Historically a section of the roof was, removed and a brick tower constructed from the original eaves level to support a metal water tank. The brick tower has been finished with a stucco mortar to simulate the original stone walls below.

Photograph 2 – Addition of brick water tower.

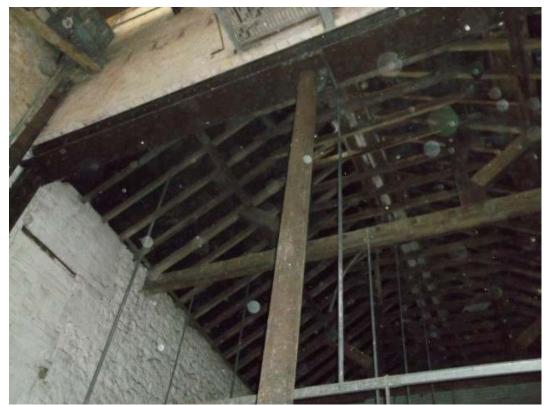
The original building adjacent to the Tower is double storey and the roof trusses are exposed.

Photograph 3 – Double height structure adjacent tower.

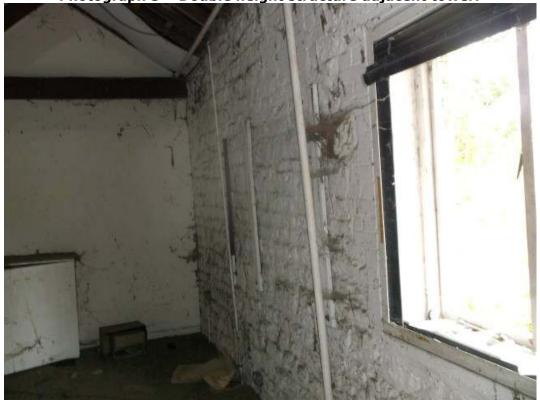
At the opposite end of the building there is a timber first floor which is accessed via stairs adjacent to the front wall. Refer to Sketch 316279/S/1 and Photographs 1-4.

Photograph 4 - Typical first floor room.

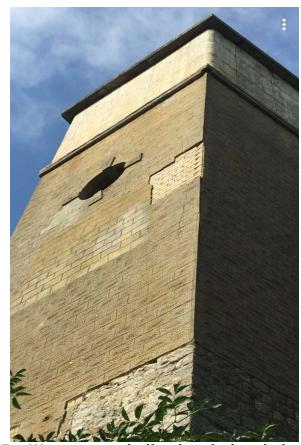
The water tower consists of brickwork that has Stucco render finish. There are large patches of render that have de-bonded and fallen way from the wall, there are also multiple cracks to the render and the writer suspects that further large areas of render has de-bonded and will also eventually fall away.

Photograph 5 - Water tower indicating de-bonded stucco render.

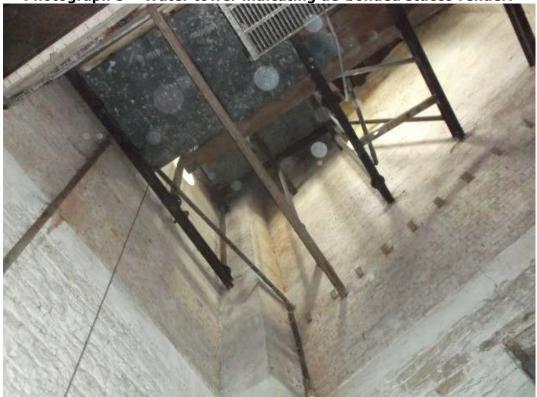
The brickwork tower internally has been painted white and could only be inspected visually from the ground floor. From this location no areas of distress was noted. Refer to Photographs 5-6.

Photograph 6 – Internal brick wall to water tower.

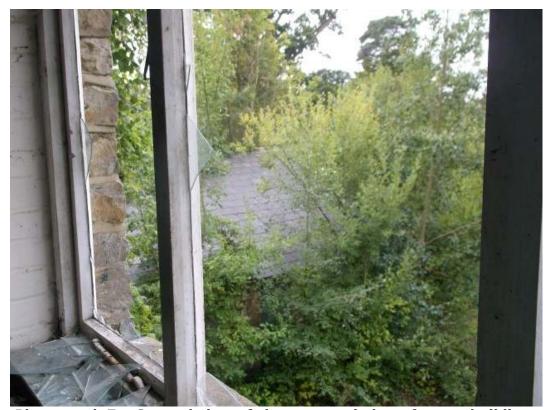
The slate roof to the out building seems to be generally in good order when viewed from the first floor window of the main building but there are areas where the roof has rotted and the tiles have fallen away exposing the internal fabric to the elements. Refer to Photographs 7-8.

Photograph 7 – General view of slate mono pitch roof to out building.

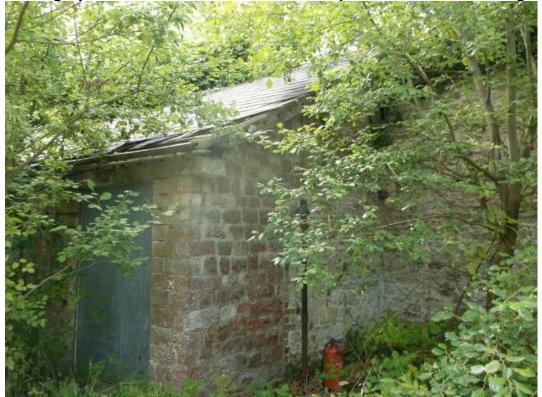
Photograph 8 - Local damage to out building slate roof.

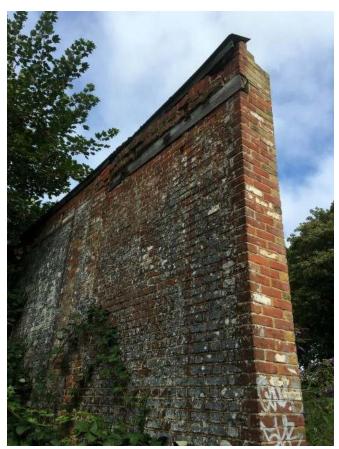
The wall is generally in good order. The defects that were noted was loose/de-bonded bricks to the head of the wall and damage to the mortar bed joints caused by the foliage of the adjacent shrubs. Refer to Photographs 9-10.

Photograph 9 – Garden wall with damage at the head.

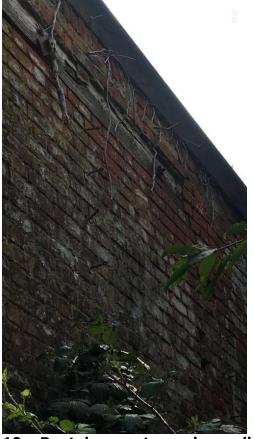
Photograph 10 - Root damage to garden wall bed joints.
