Built Heritage Advice Note – Pest House, Claygate Road, Yalding, Kent, ME18 6BB

Having now visited Pest House, the purpose of this Built Heritage Advice Note is to provide some recommendations regarding the rehabilitation and restoration of the house.

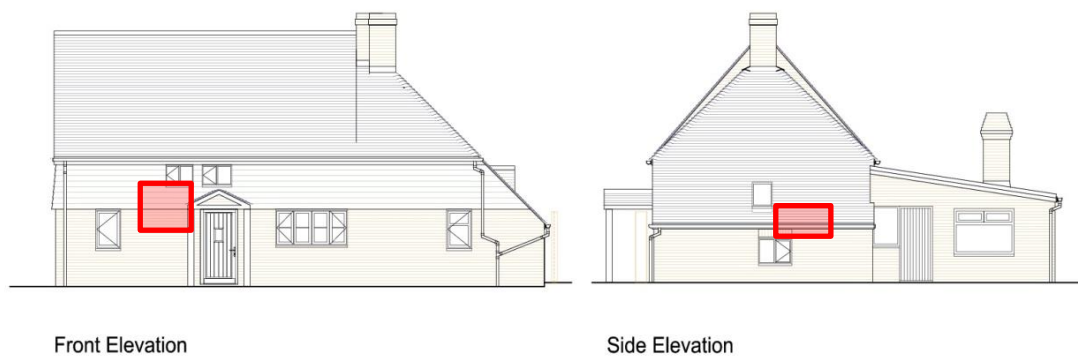
Throughout the house, there is evidence of dry-lining. This is in the form of mixed materials, including plywood, hardboard, asbestos cement, polystyrene, and some lath and plaster work. Consequently, it is not quite clear what the infill panels consist of. These would have originally been in wattle and daub, but are now more likely to consist of brick or some other material. As such, it is advisable to investigate this further. This can be done by opening up pilot holes on the exterior. Two pilot holes are suggested at the locations shown in red in Figure 1.

Figure 1: Suggested locations for pilot holes to investigate the material used for the infill panels

- First, it is advisable to establish what the house's infill panels consist of. This can be done by opening pilot holes through the external materials of no significance. Two pilot holes are suggested at the locations shown in red in Figure 1.
