# **Hutton + Rostron Environmental Investigations Limited**

## **The Pest House: Penetrating damp and retained moisture investigation**

**Site note 1 for 27 November 2018, job no. 148.73**

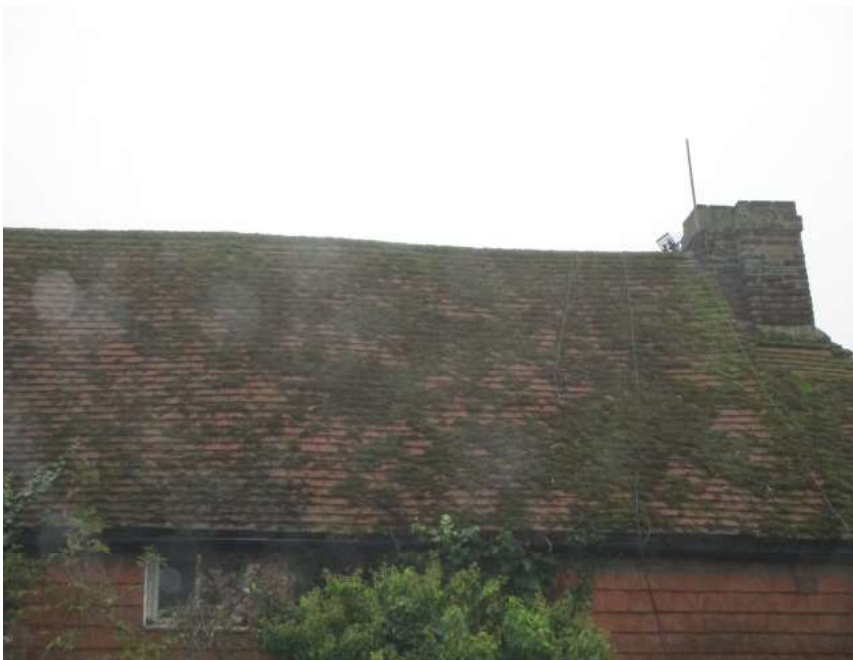
**Fig 2 :**

Exterior, north elevation; showing a general view of the roof coverings to the north pitch. These appeared to be of fired clay construction and were in good condition with no identified slipped, missing or broken tiles. However, the roof was covered with significant moss growth which in itself was not a source of damp but, when moss growth becomes dislodged it can block the roof drainage system causing damp penetration beneath

*Allowance should be made for detailed inspection of all roof coverings by H+R when access becomes available. During any roofing works, the building should be kept weathertight as a matter of priority to prevent damp penetration to the structure below. Allowance should be made for the repair of slipped or missing tiles, and for new flashings, where necessary. Consideration should be given to cleaning any moss and plant growth from the slates to reduce the risk of blockage to gutters on future occupancy*

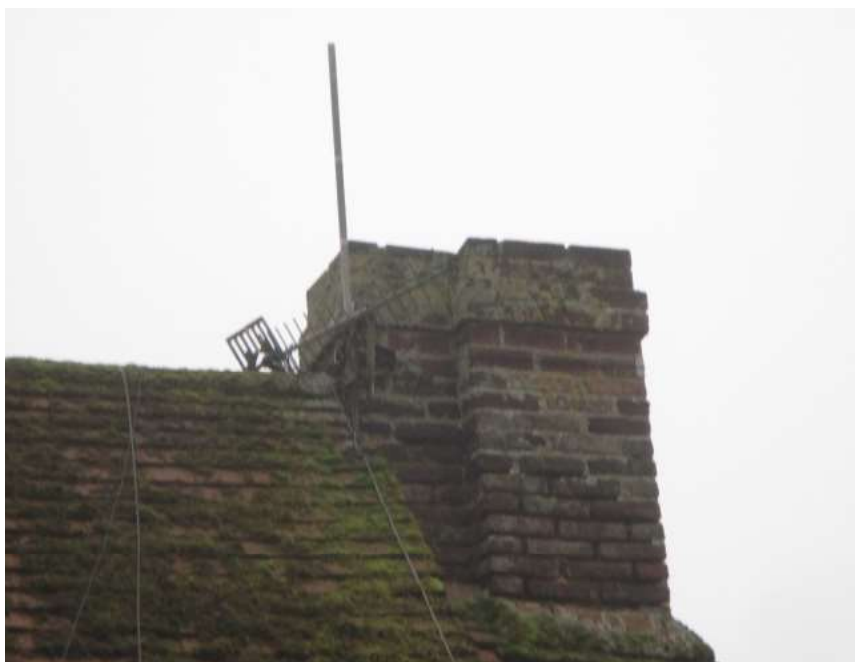
**Fig 3 :**

Masonry to the chimney at the west side of the structure showed evidence of chronically damp-affected brickwork. Mortar fillets at the joints of the chimney and roof appeared to be defective and may be allowing water ingress into the building

Exterior, north elevation; showing a view of the chimneystack at the west end. The brickwork at the head of the chimney appeared to be pointed with a cementitious material and the base of the mortar joints had been washed out. This may be source of damp penetration into the interior. It was not clear if there were any cowls to the chimneystack preventing damp penetration into the interior

- 5     *Chimneys: All redundant flues should be opened and cleared as soon as possible during enabling and refurbishment works so as to allow through ventilation and drying. All redundant flues should be capped with cowls so as to minimise water penetration but provided with permanent through ventilation during and after refurbishment, to prevent moisture accumulation in the chimney structures. H+R can advise further on detailing if required*

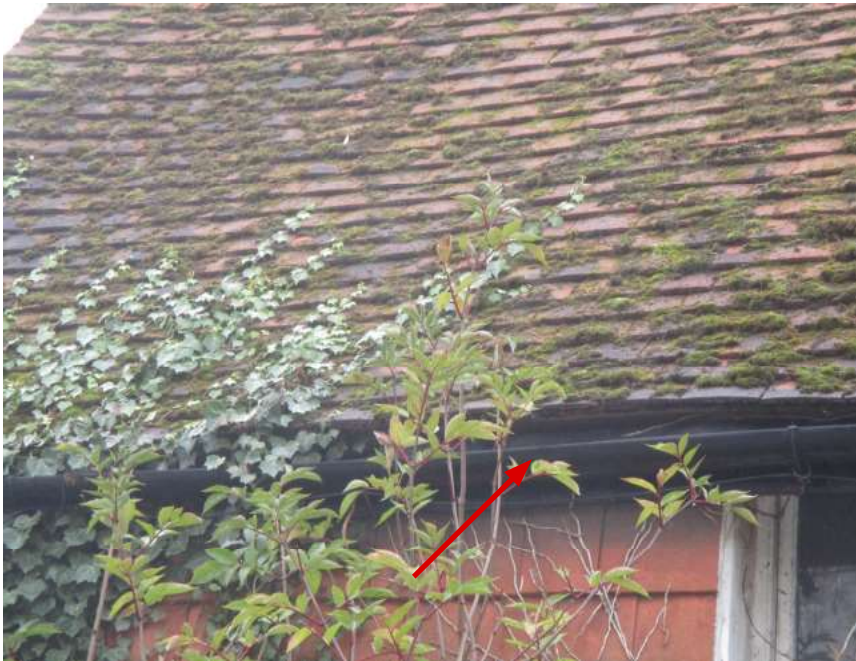
**Fig 5 :**

Exterior, north elevation; showing a view of defective guttering which had become deformed and was allowing water to cascade onto the base of the ground

*Allowance should be made for the extensive refurbishment or replacement of all gutters and downpipes. An adjustment may be required to the gutter falls to ensure that roof drainage water is discharged clear of the structure. Upon completion of refurbishment works, allowance should be made for routine cleaning and regular maintenance of the rainwater system to ensure that surface water is drained clear of the structure. Consideration should be given to replacing the provision for roof drainage based on up-to-date rainfall data and roof drainage calculations. H+R can provide further advice if required*

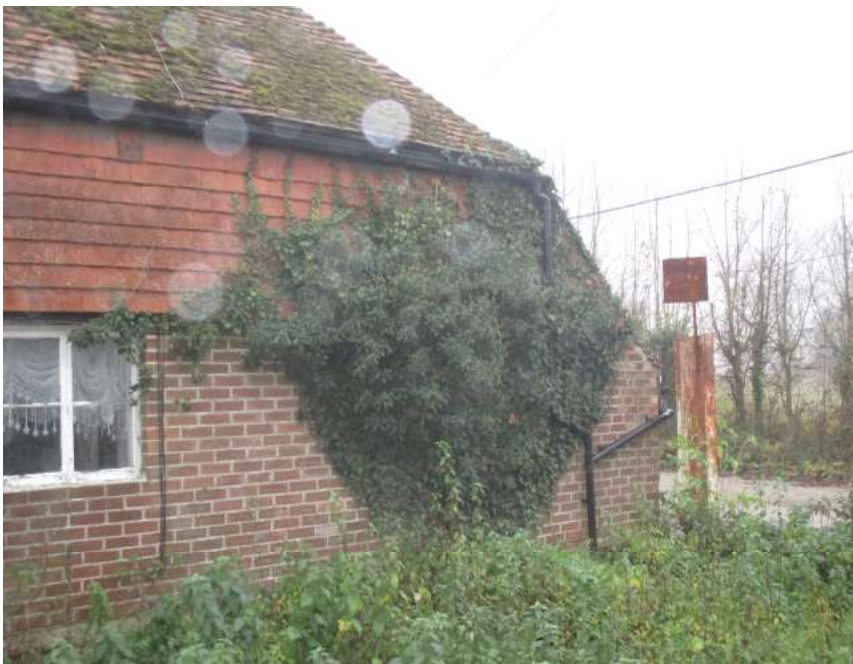
**Fig 7 :**

Exterior, north elevation; showing a view of plant and ivy growth around defective roof drainage systems

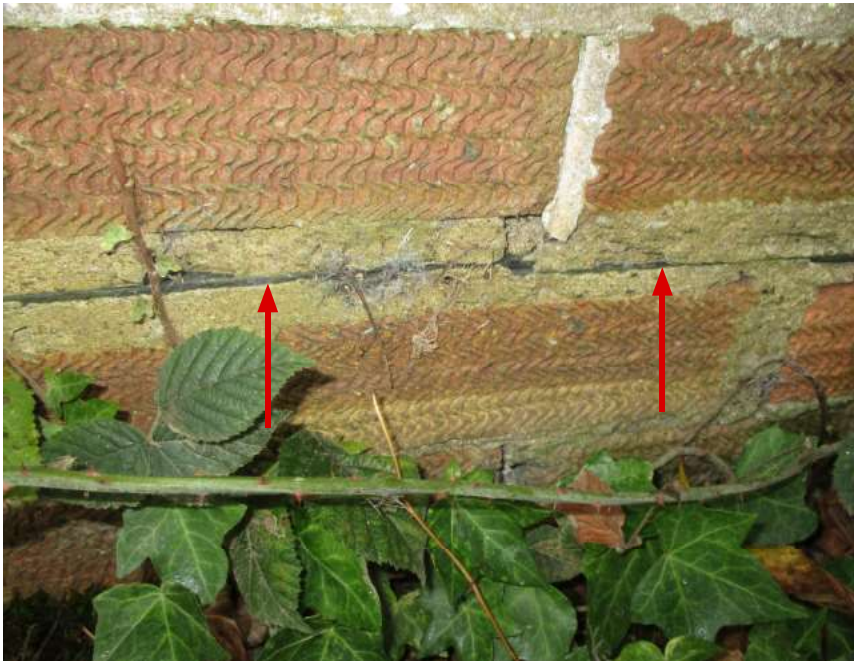
**Fig 9 :**

Exterior, north elevation; showing a view of a slate dpc which was seen to run along the north elevation. This was approximately 2 no. brick courses above the level of the external ground. However, rising ground levels towards the east left it vulnerable to being bridged if ground levels were not reduced

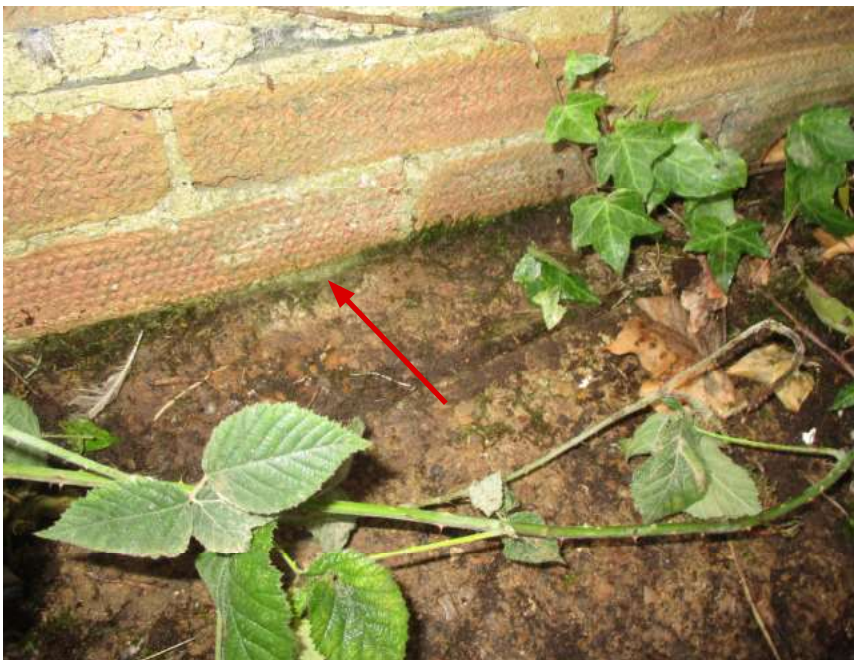
**Fig 10 :**

Exterior, north elevation; showing a view of significant moss growth cleared at the time of the survey to reveal hardstanding coverings at the base of the wall. These appeared to fall towards the north, encouraging water to drain away from the structure. However, the floor/wall junction appeared to be defective and may be allowing water to drain into the foundations

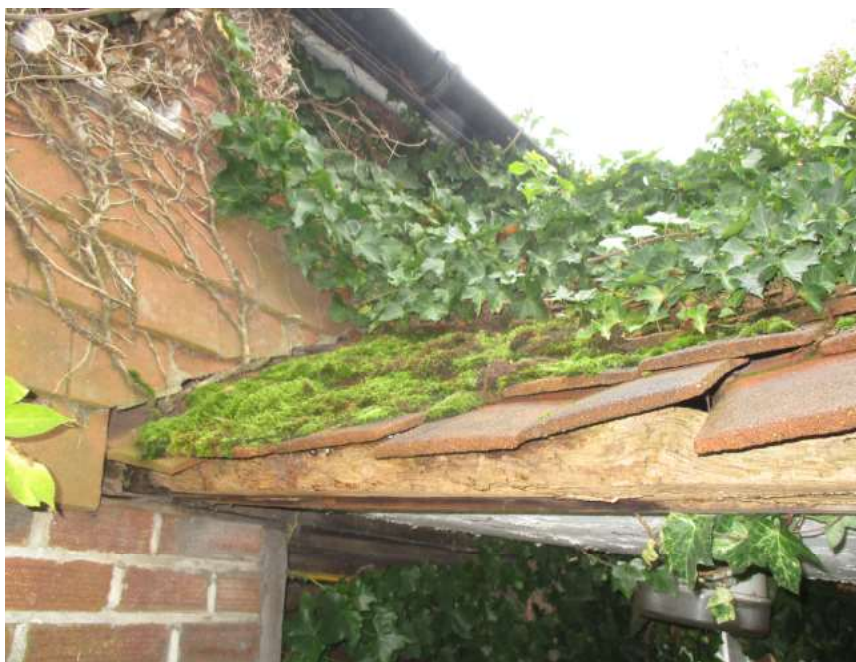
**Fig 11 :**

Exterior, north elevation; showing a view of roof coverings to the porch. The porch appeared to be deformed indicating movement to its structural elements. This was unsurprising due to heavy plant growth which indicated damp conditions and also additional weight for the porch to support. Note also gaps between the vertical tiles and porch tiles which may be allowing wind driven rain to penetrate into the structure

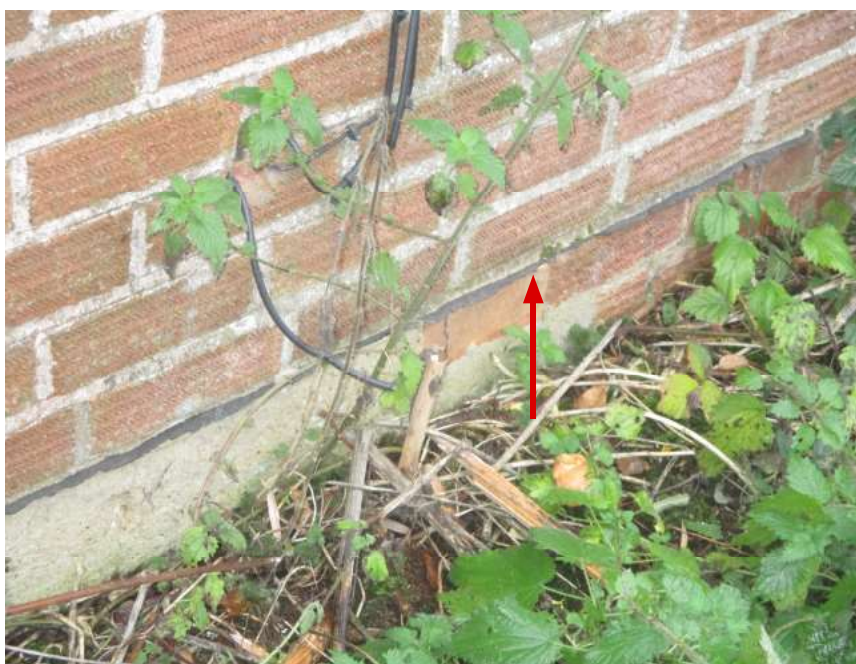
**Fig 12 :**

Exterior, north elevation; showing a view of a bitumen felt dpc which was serving the west end of the north elevation. This was approximately 2 no. brick course above the level of the external ground

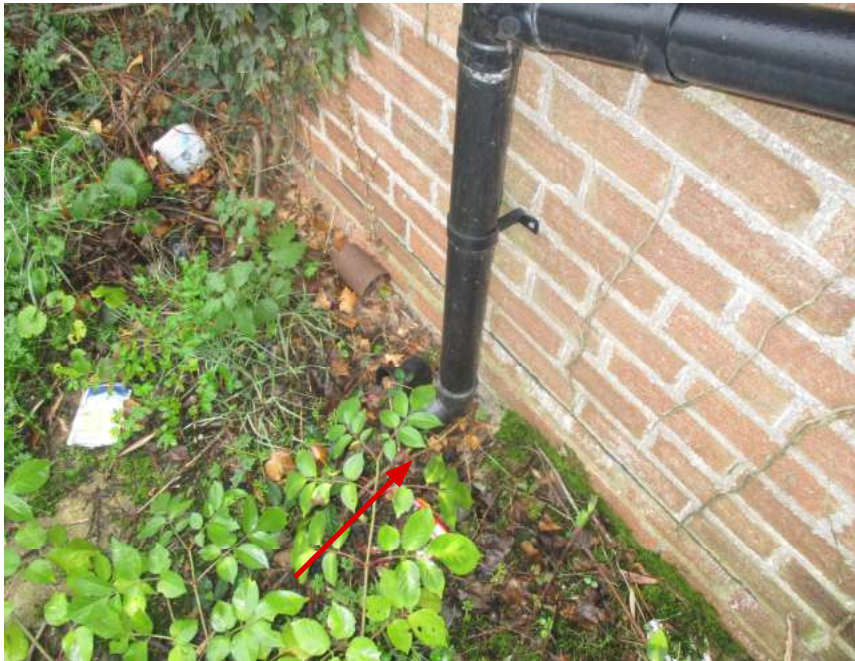
**Fig 13 :**

Exterior, north elevation; showing a view of a blocked surface drain serving a downpipe

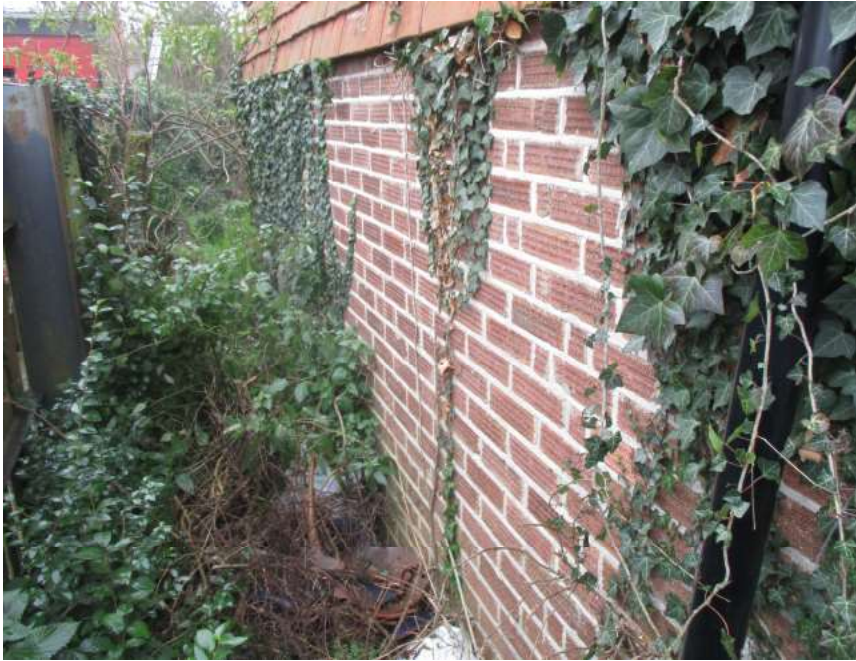
**Fig 17 :**

Exterior, east elevation; showing a view along the ground floor level of the east elevation. This was constructed in a similar way to the north elevation with modern brickwork. The damp-proof course also extended along this elevation, although rising ground levels had left the dpc bridged in some areas

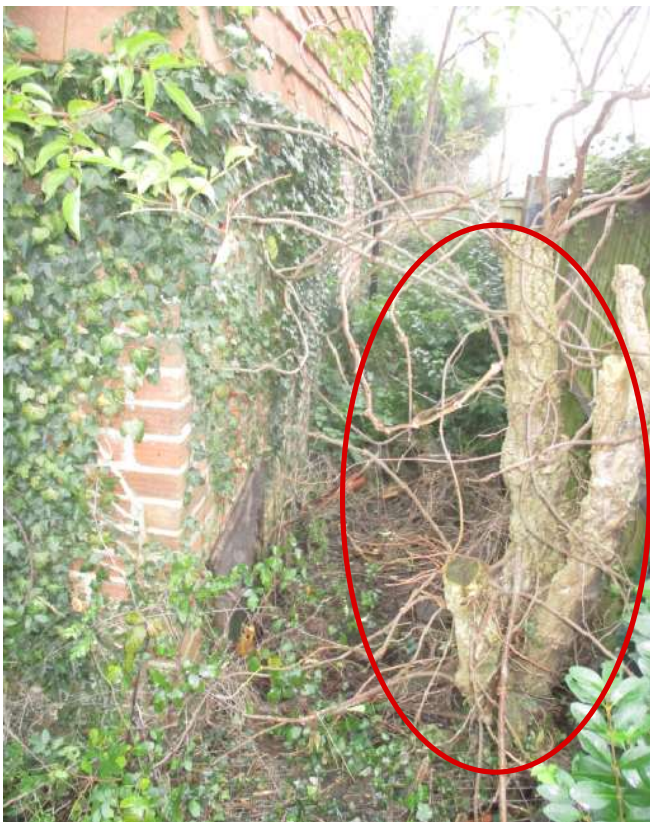
**Fig 18 :**

Exterior, east elevation; showing a view of the elevation from the south. note the presence of significant plant growth which may be affecting the foundations due to the root systems

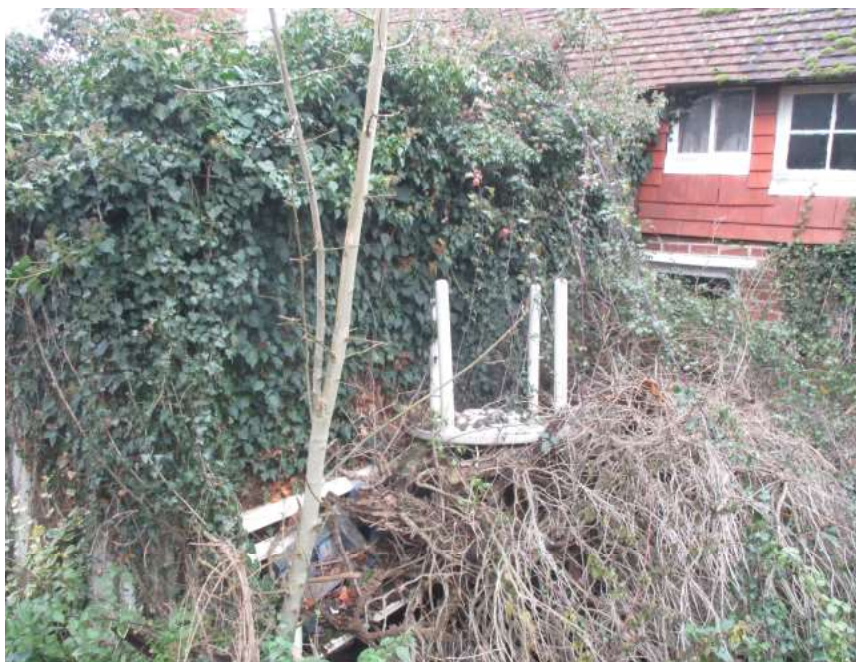
**Fig 19 :**

Exterior, east elevation; showing a view of very heavy plant growth to the entire ground floor extension at the south. This structure was due for demolition as part of the ongoing refurbishment programme. However, root systems and damp already in the structure may affect the masonry that is to be retained

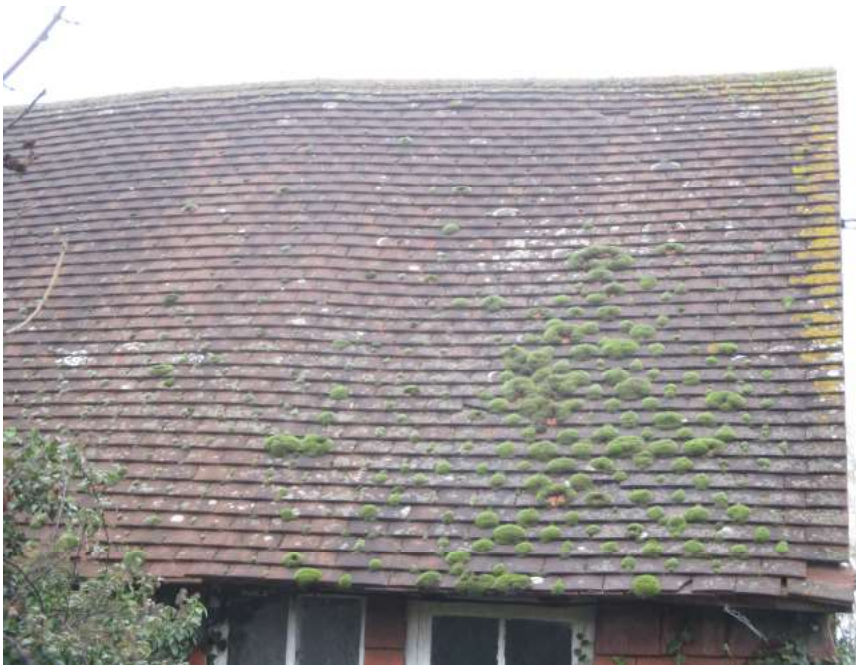
**Fig 21 :**

Exterior, south elevation; showing a view of the roof coverings to the south pitch. These were similar construction to that of the north pitch and the condition was also similar but with less moss growth to the surface of the tile

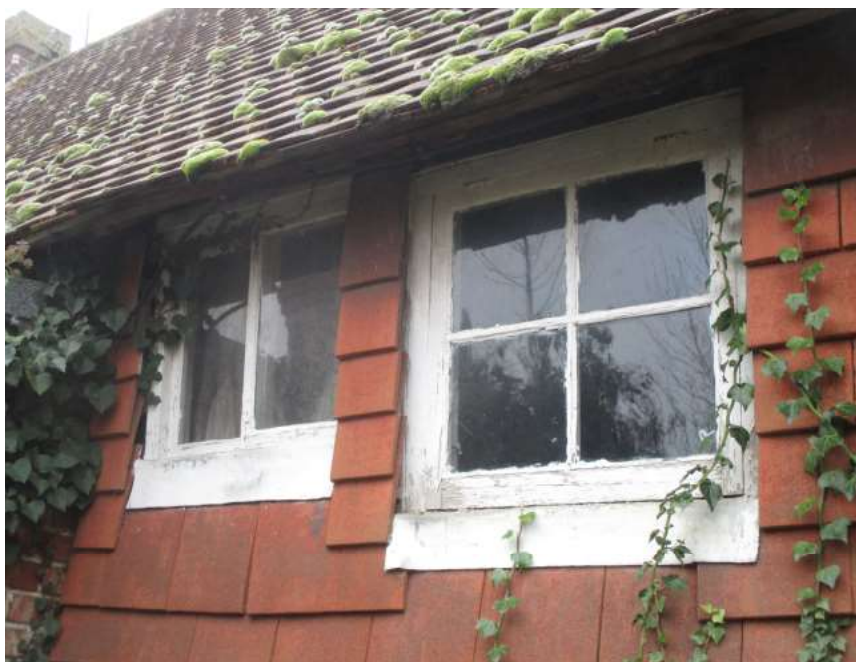
**Fig 23 :**

Exterior, south elevation; showing a view of windows at first floor level. Flashing and tiles in this area were poorly detailed and would likely be allowing water into the structure

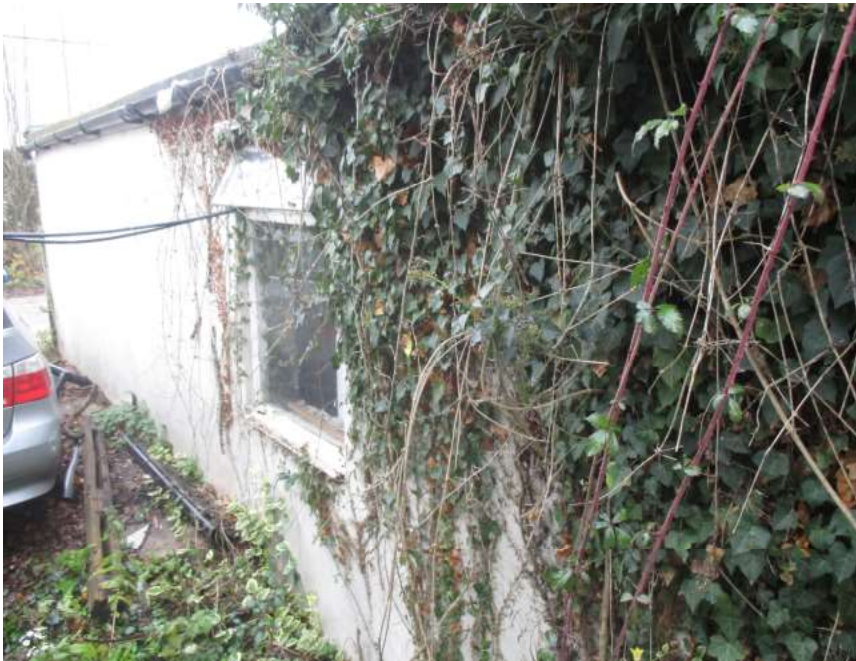
**Fig 25 :**

Exterior, south elevation; showing a view along the ground floor extension at the south. The wall appeared to be in poor condition showing evidence of damp penetration. However, it was understood by H+R that this entire ground floor extension was due for demolition

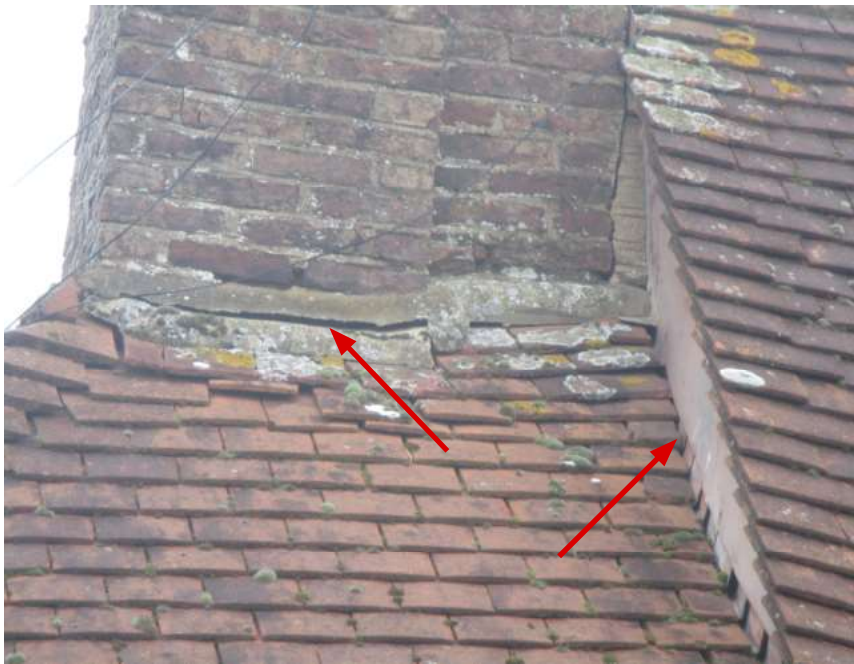
**Fig 27 :**

Exterior, south elevation; showing a close up view of defects described previously. Note also the defects to the mortar around the base of the chimneystack which would also be allowing damp penetration into the structure

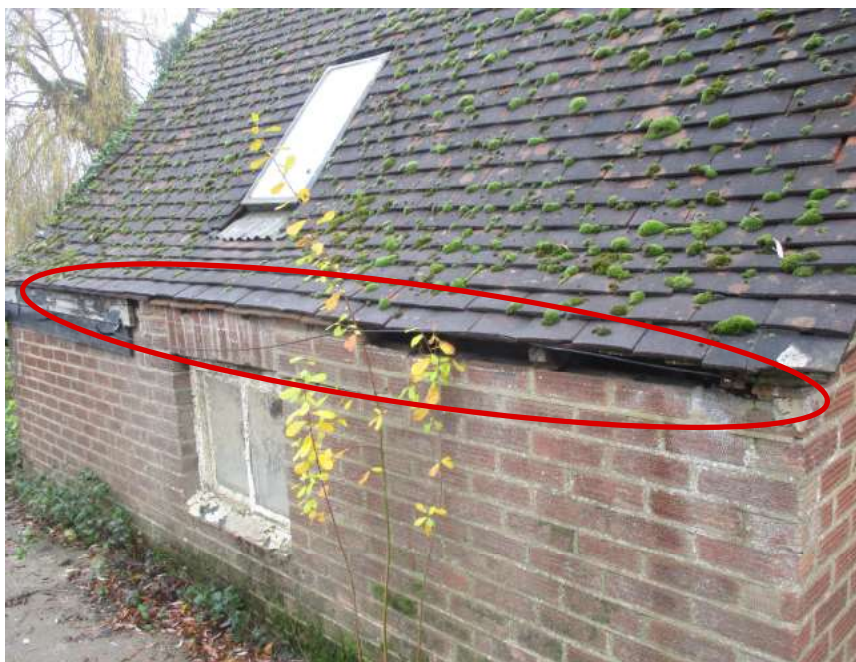
**Fig 31 :**

Exterior, west elevation; showing a view along the base of the catslide roof. There was no guttering to this area meaning water was cascading onto the ground beneath. Note also the presence of holes between the wall and the roof coverings allowing wind driven rain to enter the structure. There appeared to be movement in this area with cracks forming in some of the brickwork

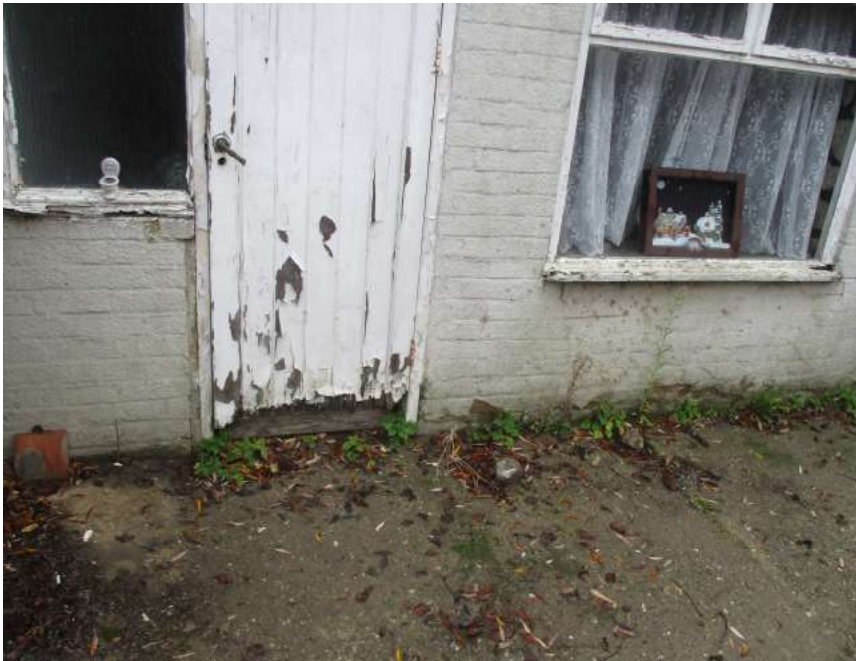
**Fig 33 :**

Exterior, west elevation; showing a view along the base of the wall of the extension. The masonry here was significantly damp which had led to timber decay of the door. However, this structure was due for demolition as part of the refurbishment programme

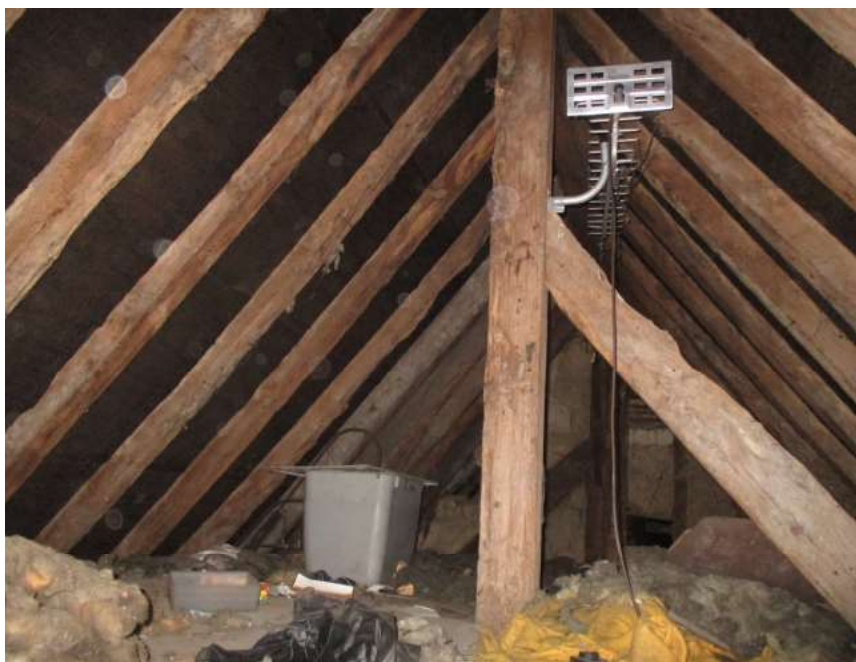
**Fig 35 :**

Interior, roof; showing a general view of the roof structure. The underside of the roof coverings appeared to be bitumen felt which was likely to be past its useful service life. However, generally there were no signs of significant damp penetration to the roof structure

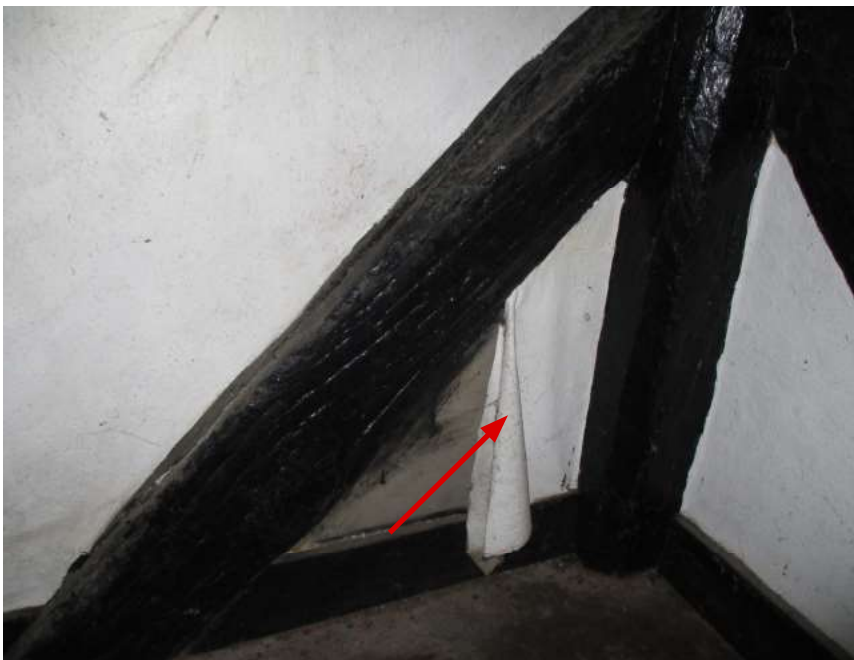
**Fig 38 :**

Interior, first floor; showing a view of peeling wallpaper suggesting previous or currently damp conditions. However, generally the master bedroom was free from signs of significant damp penetration and damp in this area was likely to be caused by condensation due to inadequate ventilation on periods of inoccupancy

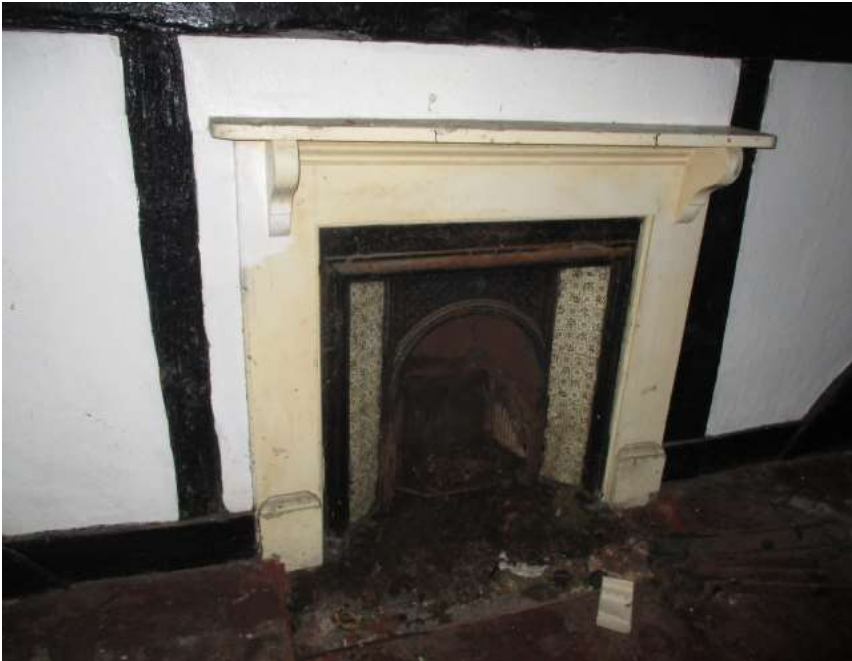
**Fig 39 :**

Interior, first floor; showing a view of a fireplace at the west end of the bedroom. There was an accumulation of debris around the hearth indicating blockages above

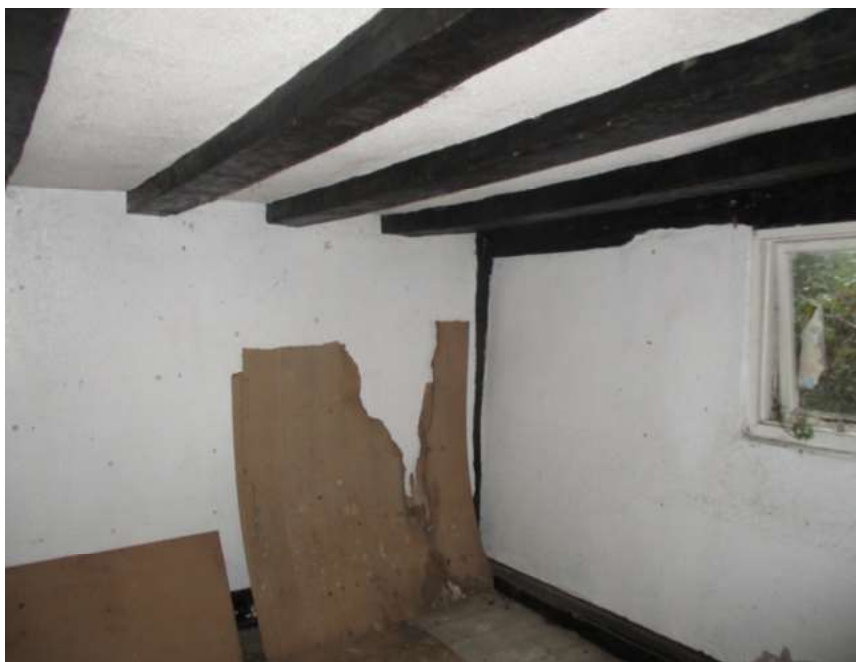
**Fig 43 :**

Interior, ground floor; showing a general view of bedroom no. 2. The walls were generally dry lined on the north and south elevations; however, the wall at the end of the building was hard plaster. There was evidence of timber decay to the floor and timbers at the base of the wall indicating previous or current damp penetration

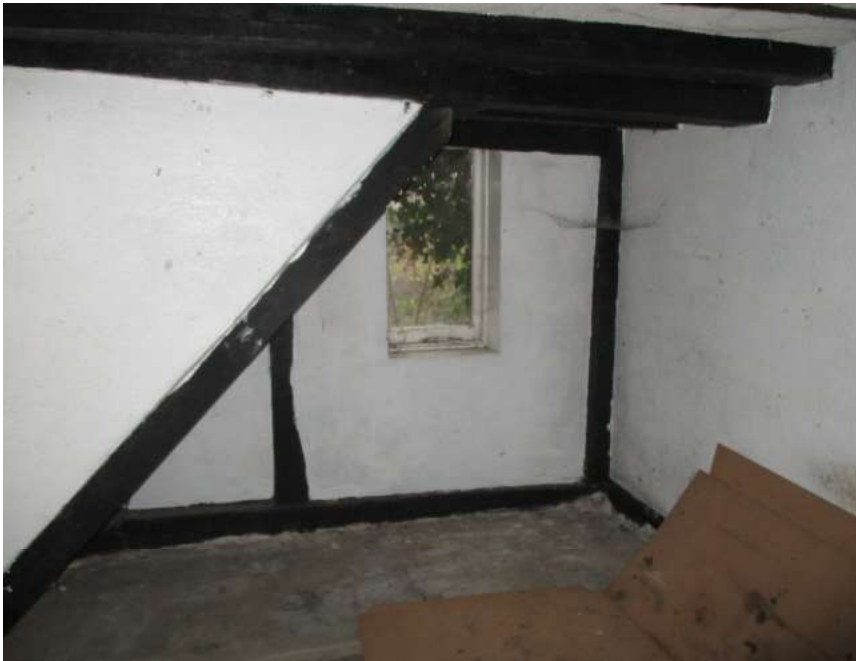
**Fig 45 :**

Interior, ground floor; showing a view towards the north beneath the staircase. There was evidence of mould growth which indicated condensation which was unsurprising due to the periods of inoccupancy of the building

- 8 *Mould growth: Any surface mould deposits should be cleaned using a 10 per cent solution of sodium hypochlorite or household bleach in cold water. Personnel carrying out cleaning work should be provided with suitable protective clothing and gloves. If a significant delay is anticipated prior to refurbishment, allowance should be made for provision of temporary background heating to be run at a constant low level, to discourage intermittent condensation and mould growth caused by natural changes in relative humidity*

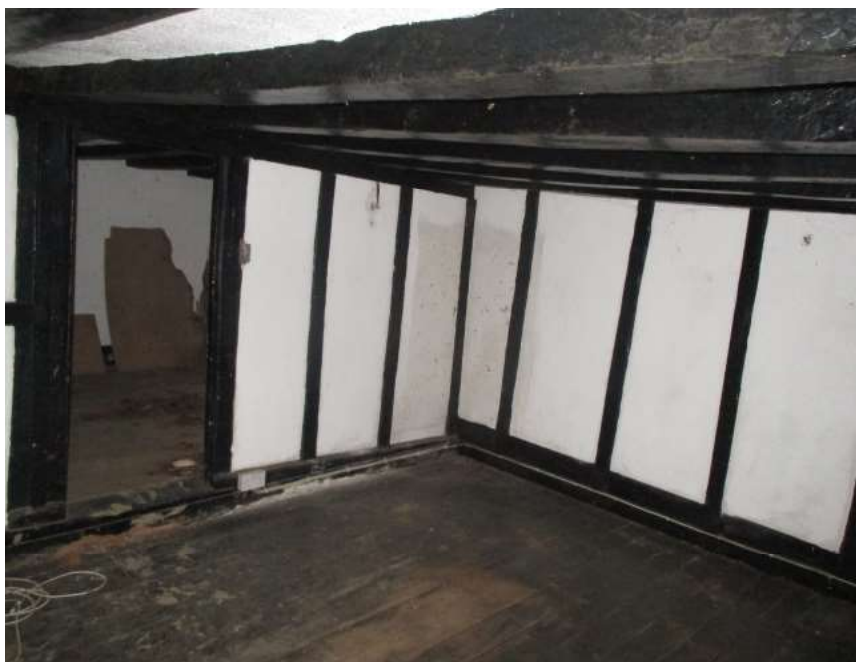
**Fig 47 :**

Interior, ground floor; showing a general view of the lounge. The internal faces of the walls appeared to be faux timber framing with infill panels. Generally, the room was free from signs of significant damp penetration, although suffered from condensation and mould build-up due to reasons described previously

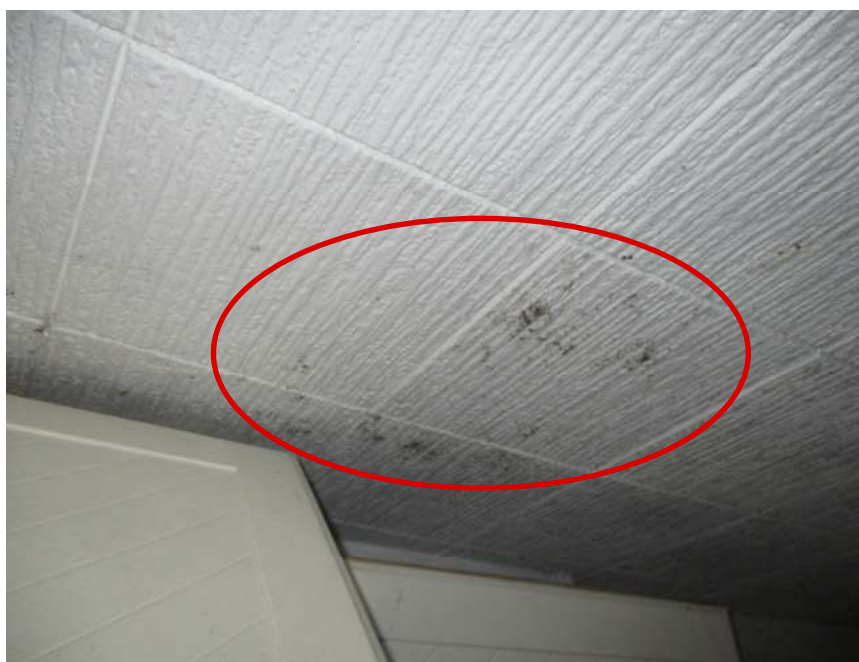
**Fig 54 :**

Interior, ground floor; showing a view of the ceiling of the kitchen. The presence of mould growth here indicated condensation due to inadequate heating and ventilation during periods of inoccupancy

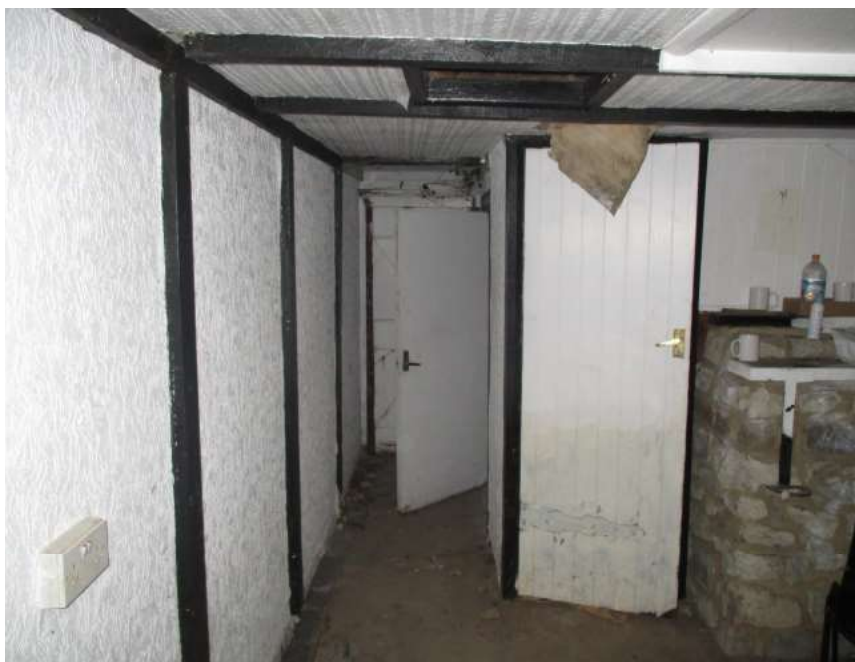
**Fig 55 :**

Interior, ground floor; showing a view within the area to the south which was due to be demolished as part of the ongoing refurbishment project. There was evidence of significant damp penetration in this area which may be affecting areas that are to be retained from the original building
