# **Hutton + Rostron Environmental Investigations Limited**

## **The Pest House: Timber roof and floor structures condition investigation**

**Site note 3 for 27 November 2018, job no. 148.73**

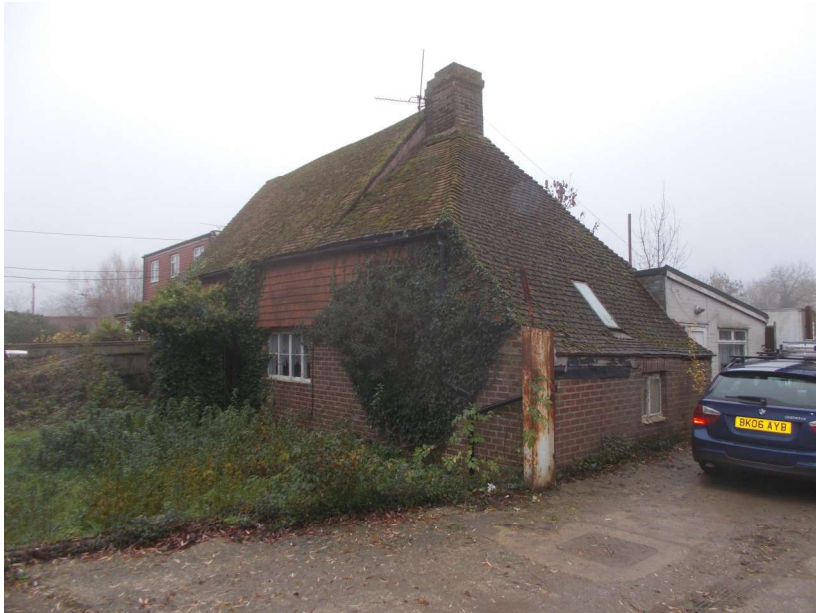
**Fig 1:**

Pest house; showing external view of hipped west end. The east end was of fully gabled construction

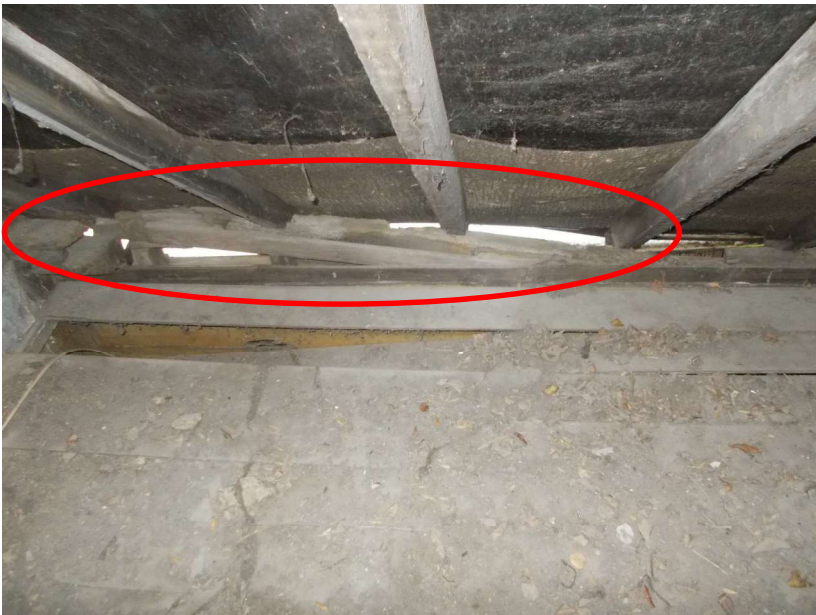
**Fig 2:**

Roof, west hipped end; showing the roof structure in this area is predominantly of softwood roof elements. Note the failed rafter plate in the south-west area

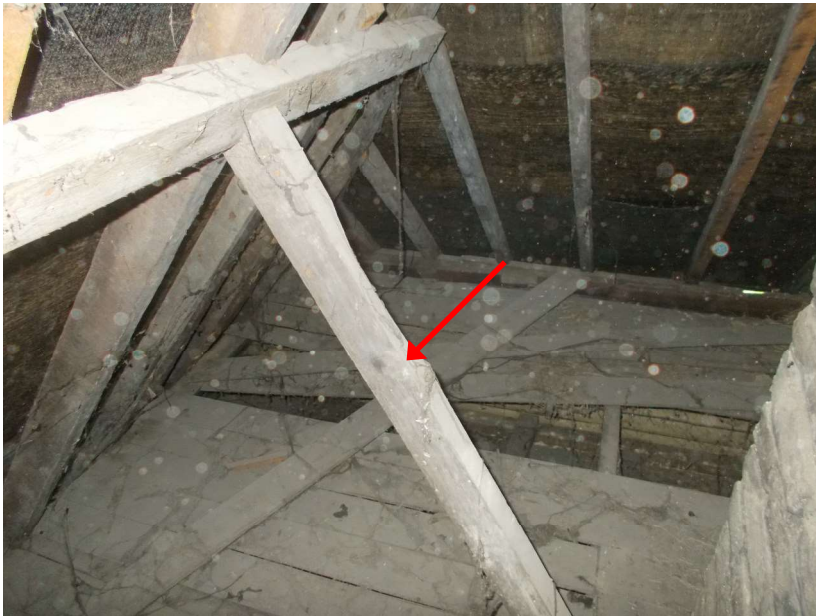
**Fig 3:**

Roof, west hipped end; showing roof structure in this area is predominantly of softwood and of markedly different construction to the oak roof to the west of the chimney stack. Note the raking

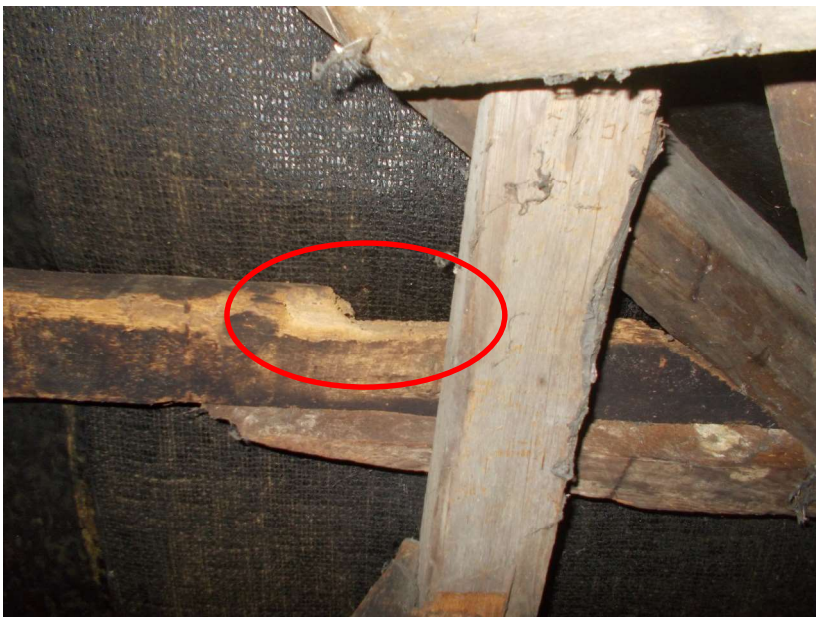
**Fig 4:**

Roof, west hipped end; showing likely salvaged oak elements being reused in a predominantly softwood roof. Now substantially decayed and often coupled with newer addition softwood timbers

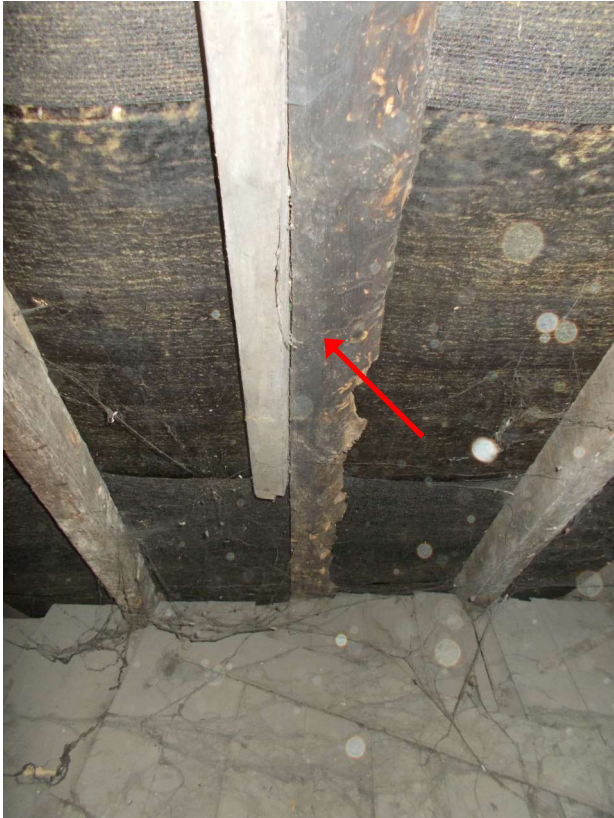
**Fig 5:**

Roof, west hipped end; showing likely salvaged oak elements being reused in a predominantly softwood roof. Now substantially decayed and often coupled with newer addition insubstantial softwood timbers

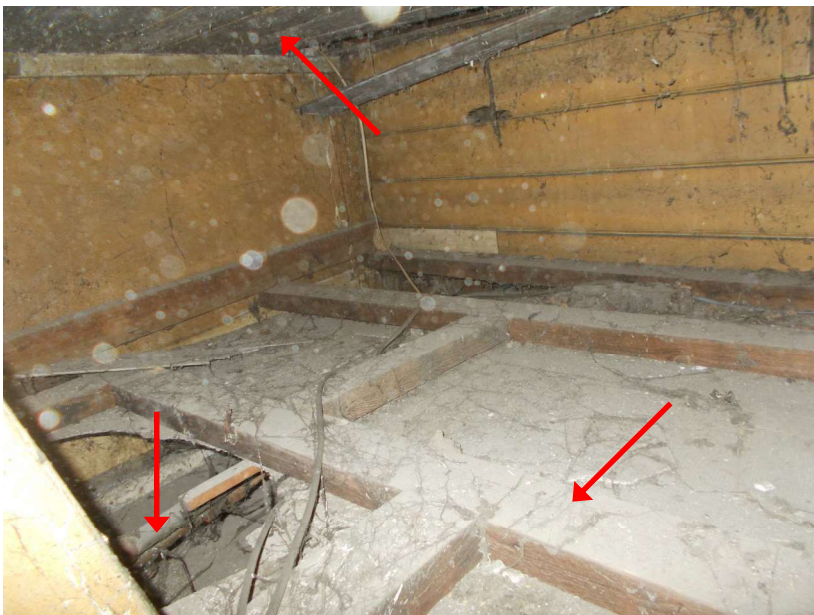
**Fig 6:**

Roof, west hipped end; showing 3no. Historic ceiling build-ups creating two separate floor voids. Each of approximately ~600mm. Access to these areas was limited at the time of investigation

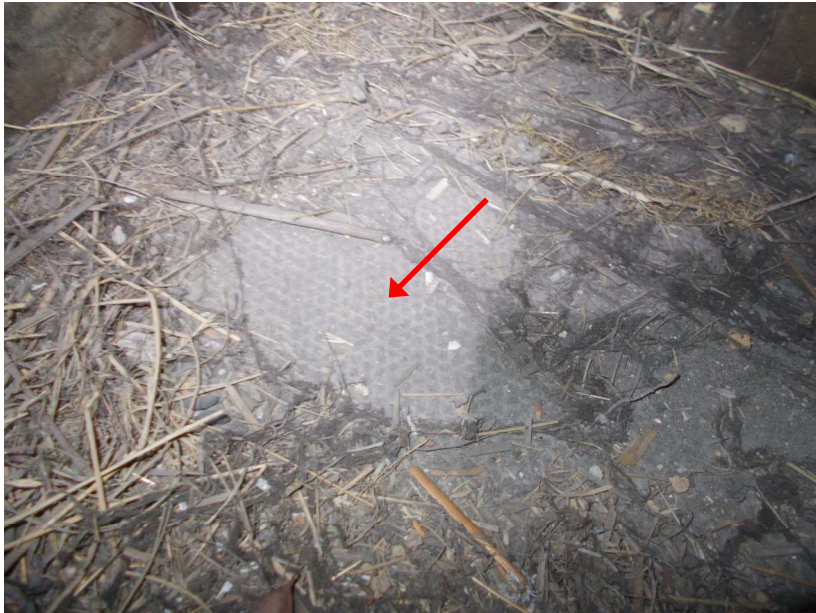
**Fig 7:**

Roof, west hipped end; showing what appeared to be an asbestos type material used for the middle ceiling build-up

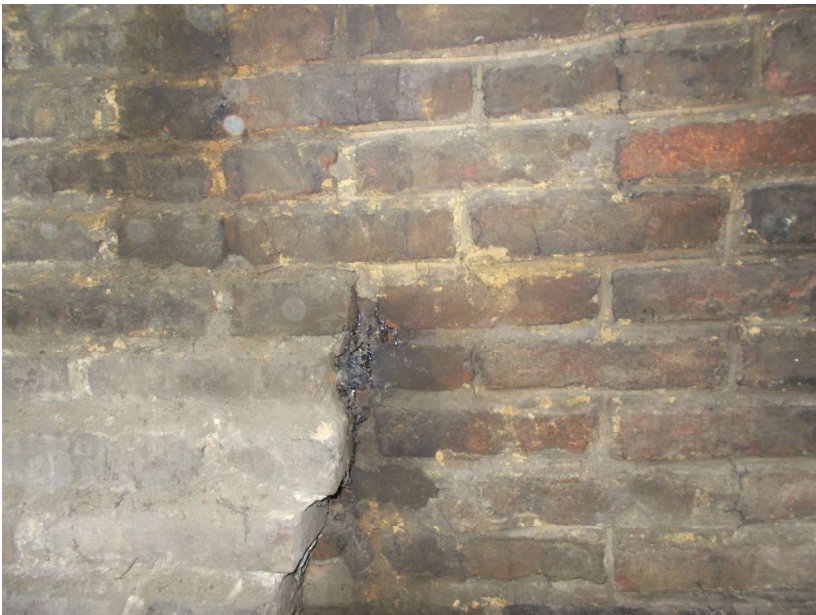
**Fig 8:**

Roof, west hipped end; showing brick structure chimney stack. Likely original to the buildings construction. Note the heavily weathered appearance of the brickwork suggesting this masonry structure was once exposed to the elements and that the hipped roof was a much later addition

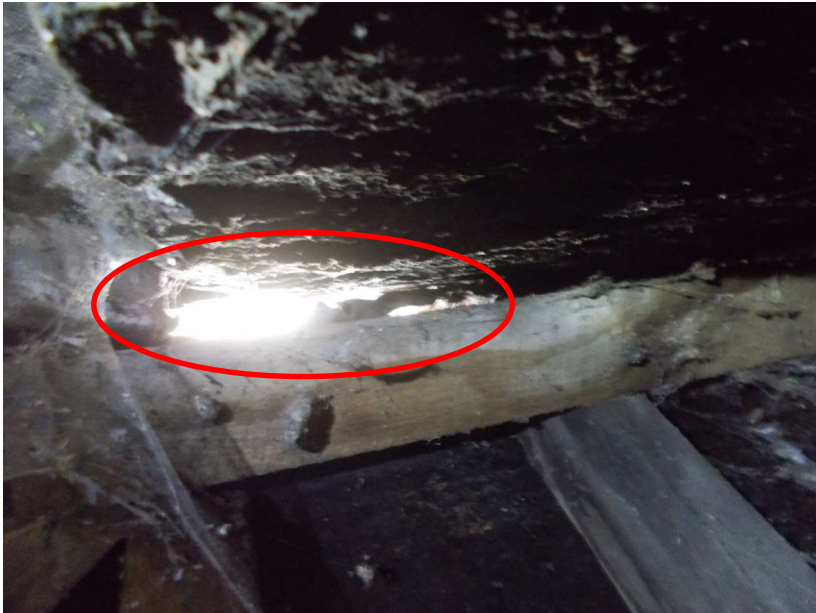
**Fig 9:**

Roof, west hipped end; showing significant failure to chimney flashing detail. Moisture is being allowed to penetrate at this juncture creating the conditions for damp and decay to the timber elements below

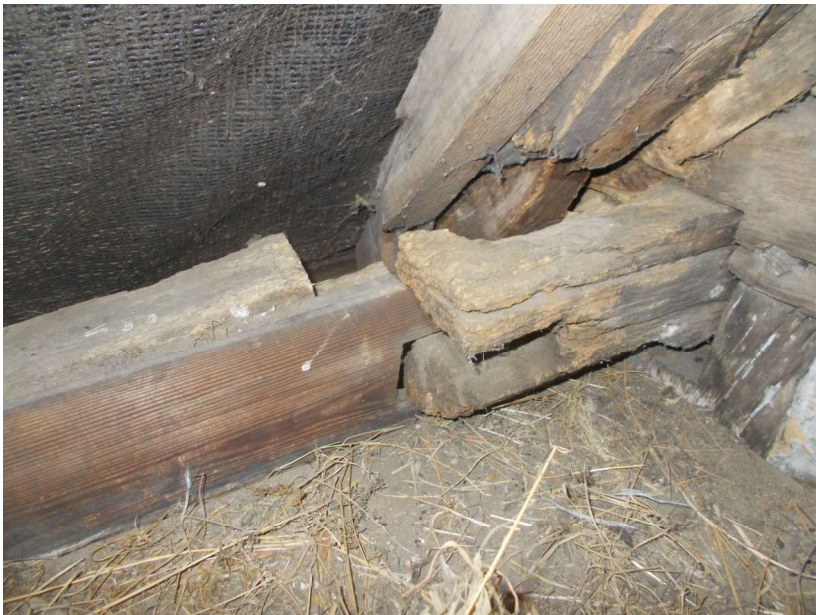
**Fig 10:**

Roof, west hipped end; showing north-west joint between the historic oak rafter plate and the later addition softwood hipped roof rafter plate. This joint was judged to be structurally innadequate

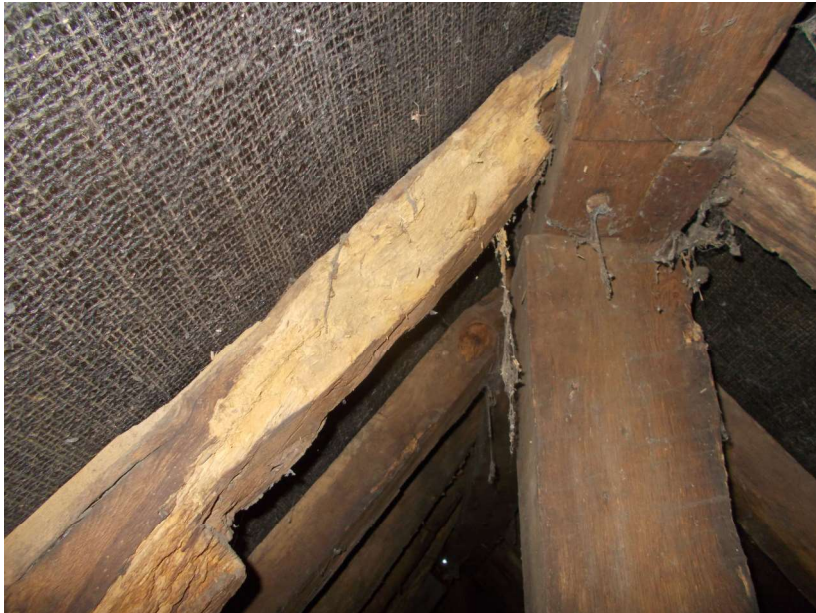
**Fig 11:**

Roof, west historic oak pitched roof; showing substantial decay to the sapwood band of the common rafter to the north of the central king post. However remaining heartwood was sound and deep moisture contents were below 8 per cent which is too low for decay to occur

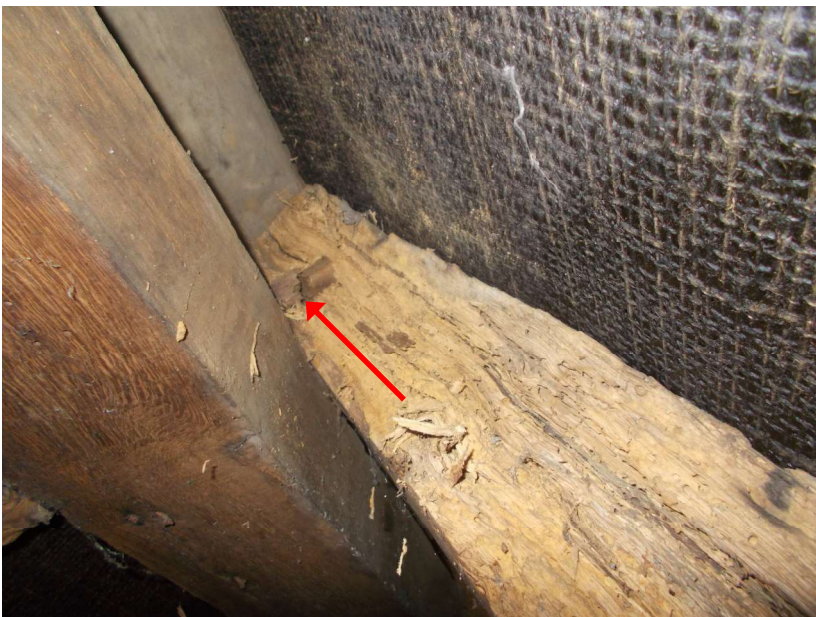
**Fig 12:**

Roof, west historic oak pitched roof; showing substantial decay to the sapwood band of a north pitch common rafter. Note also the historic peg is now visible and has failed. However remaining heartwood was sound and deep moisture contents were below 8 per cent which is too low for decay to occur

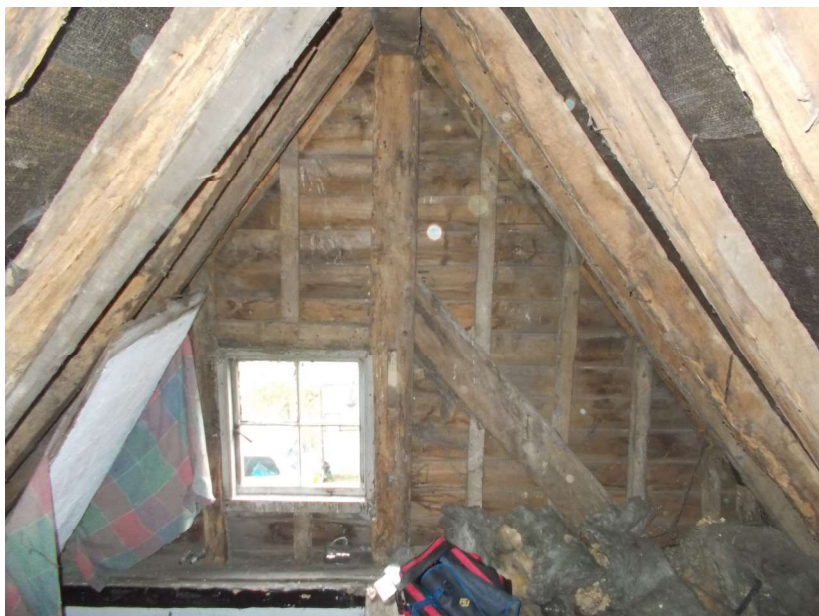
**Fig 13:**

Roof, west historic oak pitched roof; showing east gable end structure with single window and single brace. No significant decay detected during investigatory works. Deep moisture contents were below 8 per cent which is too low for decay to occur

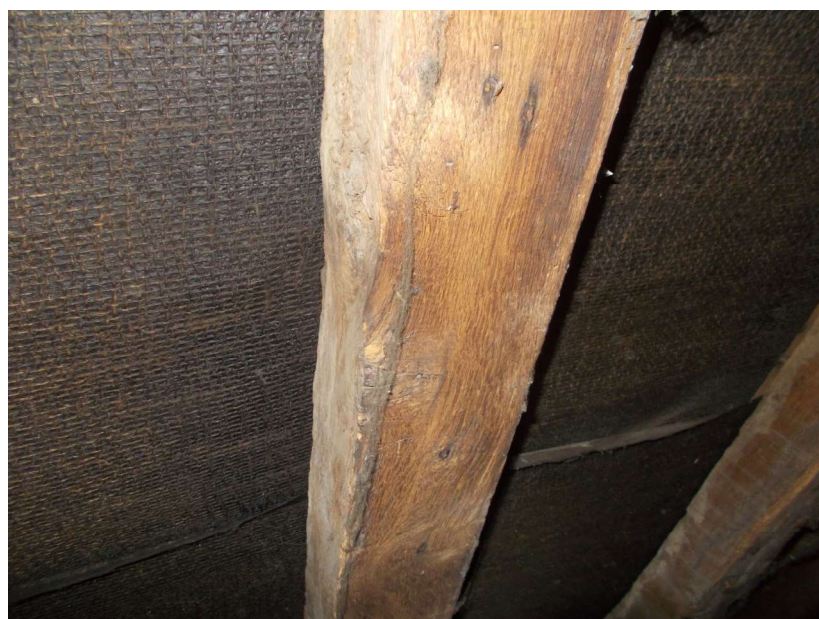
**Fig 14:**

Roof, west historic oak pitched roof; showing typical common rafter with minimal sapwood band and of good quality grade timber

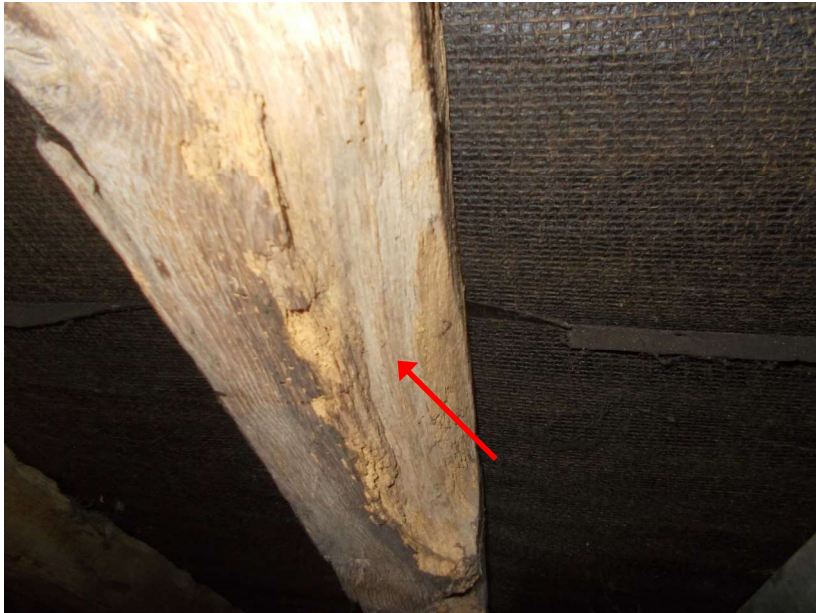
**Fig 15:**

Roof, west historic oak pitched roof; showing common rafter with sapwood band now decayed as a result of historic insect infestation and moisture penetration. However remaining heartwood was sound and deep moisture contents were below 8 per cent which is too low for decay to occur

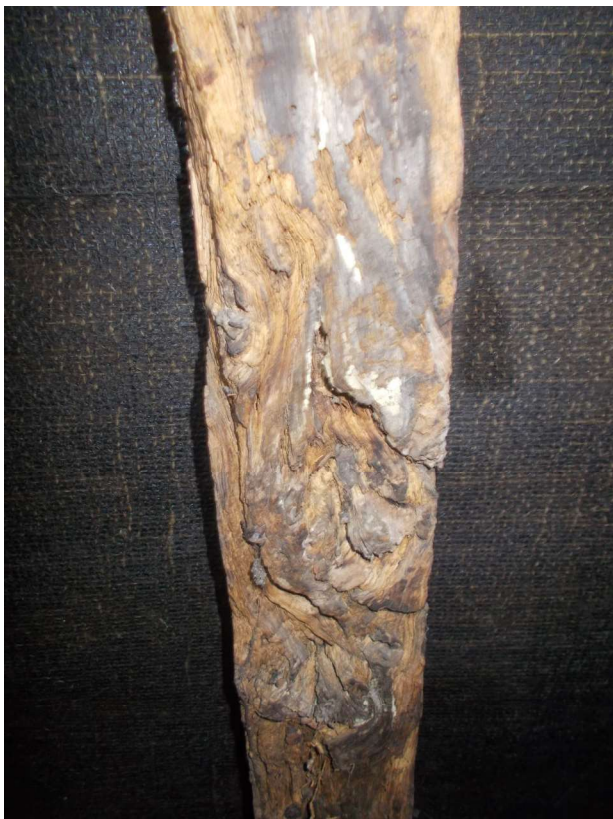
**Fig 16:**

Roof, west historic oak pitched roof; showing common rafter with knotted and distorted grain. Note that all sapwood had been subject to historic decay from insect infestation and moisture penetration. However remaining heartwood was sound and deep moisture contents were below 8 per cent which is too low for decay to occur

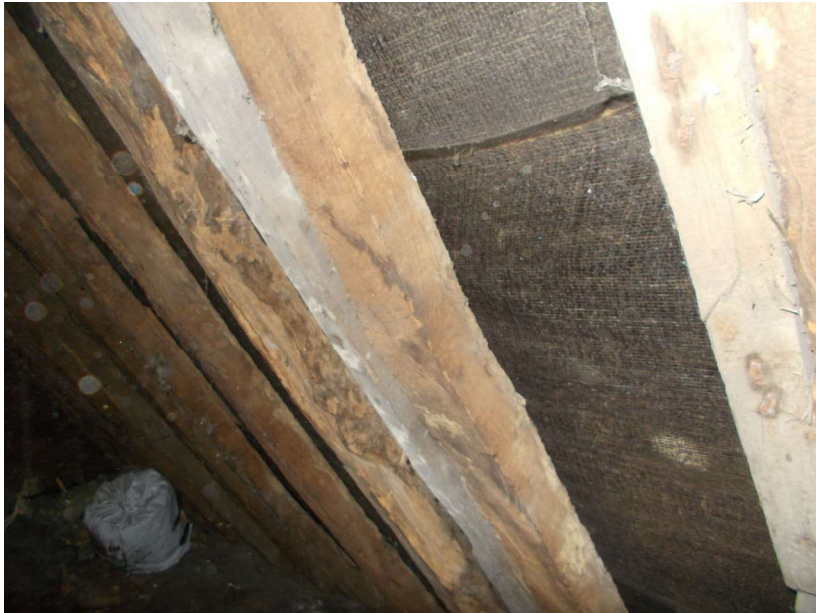
**Fig 17:**

Roof, west historic oak pitched roof; showing south-west area featuring 5 no. heavily deflected historic rafters now coupled with remedial softwood timbers for additional support. These softwood remedial timbers may not be suitable for retention during refurbishment works

<b>SN3.1.2</b>	Timber deflection	Current partnering remedial timbers are inappropriate and ineffective, providing little support to the deflected rafters	<i>Appropriate partner repairs should be conducted on the historic rafters, and should run full-length from eaves to ridge to provide adequate support</i>	
<b>SN3.1.3</b>	Timber decay	Rafter had minimal bearing support due to a loss of cross-section size from decay at the rafter head	<i>Chemical remedial treatment is neither recommended or required in relation to fungal decay organisms or wood-boring insect infestation</i>

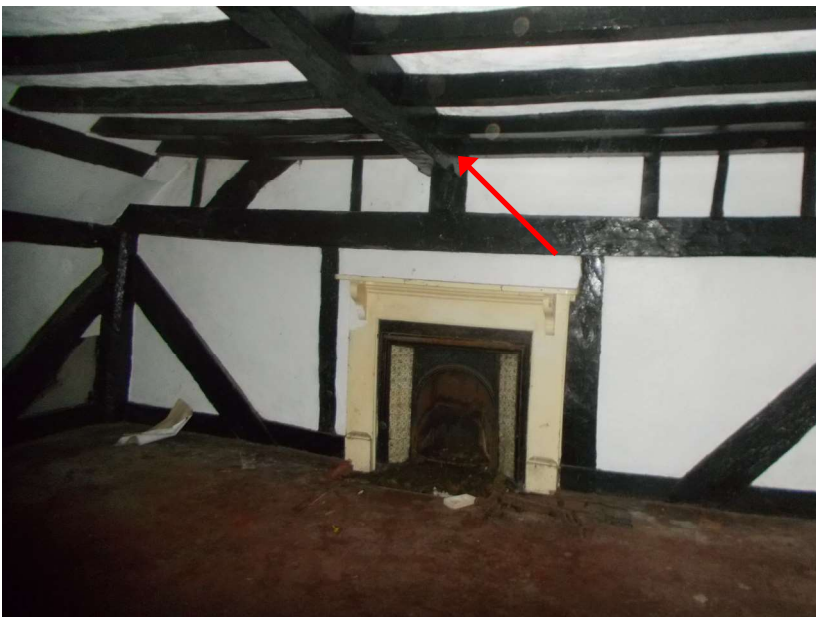
**Fig 18:**

First floor, central room looking west; showing exposed roof truss, including tie-beam, king post, bracing and studs as seen from floor below. Note unconventionally the central floor spine beam is fixed into the king posts rather than the tie beam, thus creating head room for the first floor level. However this joint appeared to have minimal structural bearing. No decay detected upon deep drilling and moisture probing

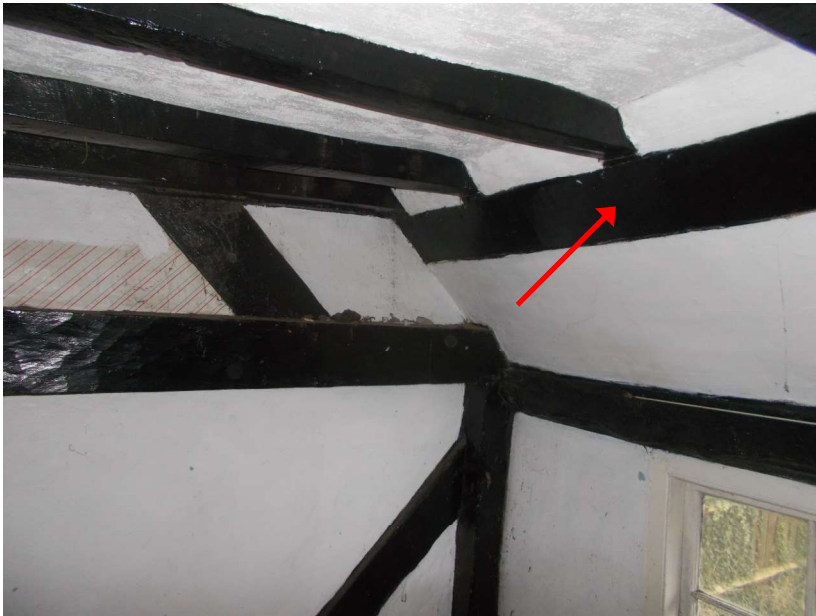
**Fig 19:**

First floor, east room looking east; showing exposed roof truss elements, including tie-beam and bracing as seen from floor below. Note the visible purlin was found to be of plank construction at ~20x150mm which was nailed to the underside of every common rafter and supported the floor/ceiling joists above

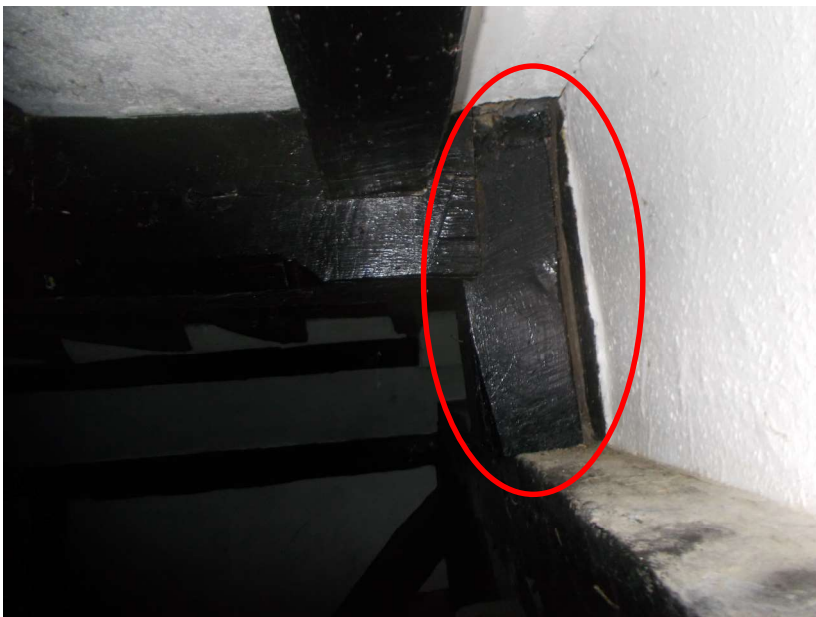
**Fig 20:**

<b>SN3.2.2</b>	Minimal bearing	Central carriage beam had minimal bearing at the east and west ends. The mortise and tenon joint appeared to have spread apart, and there was no evidence of a peg to retain the joint	<i>At the discretion of the Structural Engineer, provisionally allow for additional structural support to be afforded to the carriage/spine beam in these areas with the introduction of steel straps or supplementary traditional oak supports</i>	
<b>SN3.2.3</b>	Timber decay	Opening-up of the timber frame floor-supporting mid rail revealed some decay to the joint between the plate and the south-east corner post	<i>Chemical remedial treatment is neither recommended or required in relation to fungal decay organisms or wood-boring</i>

First floor, central room, west end of central carriage beam; showing beam with minimal bearing onto a relatively small section upright. This joint may not be suitable for during refurbishment works or future occupancy. Structural Engineer to comment

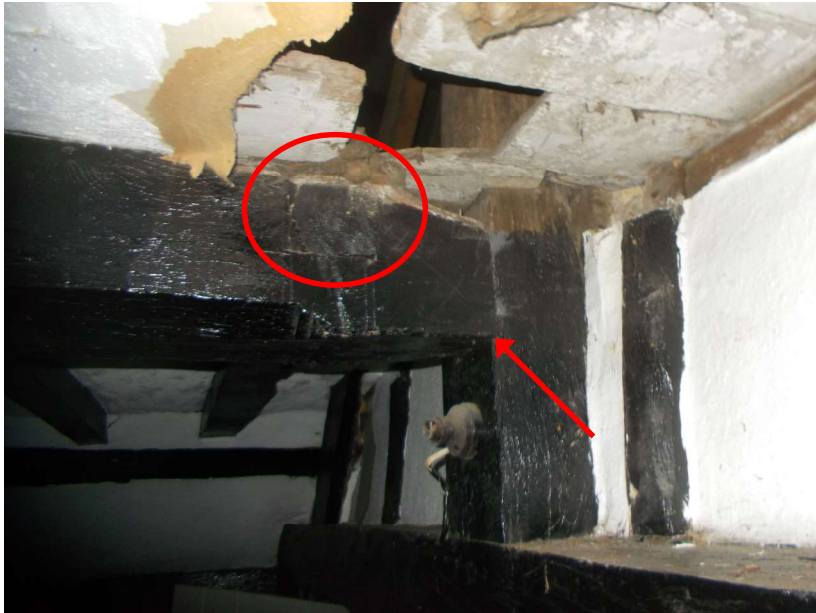
**Fig 21:**

First floor, central room, east end of central carriage beam; showing beam with minimal bearing into base of truss king post with no evidence for a pegged tenon. This joint may not be suitable for during refurbishment works or future occupancy. Also note the missing floor/ceiling joist, sawn off at its tenon location. Structural Engineer to comment

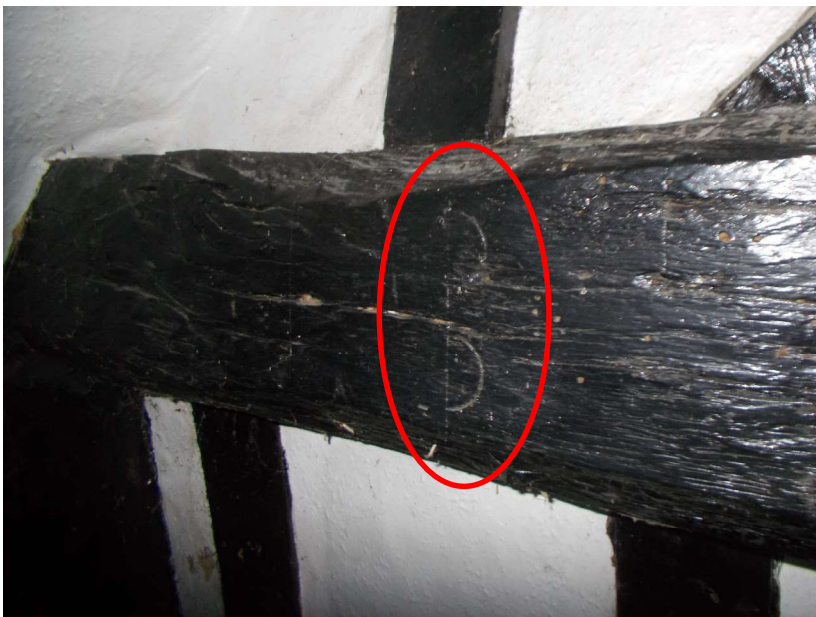
**Fig 22:**

First floor, central tie beam, showing historic carpenter's marks on to primary face of the timber. These scratched markings were an aid to the methods of construction and suitable effort should be made for historically significant markings such as these to be retained during refurbishment

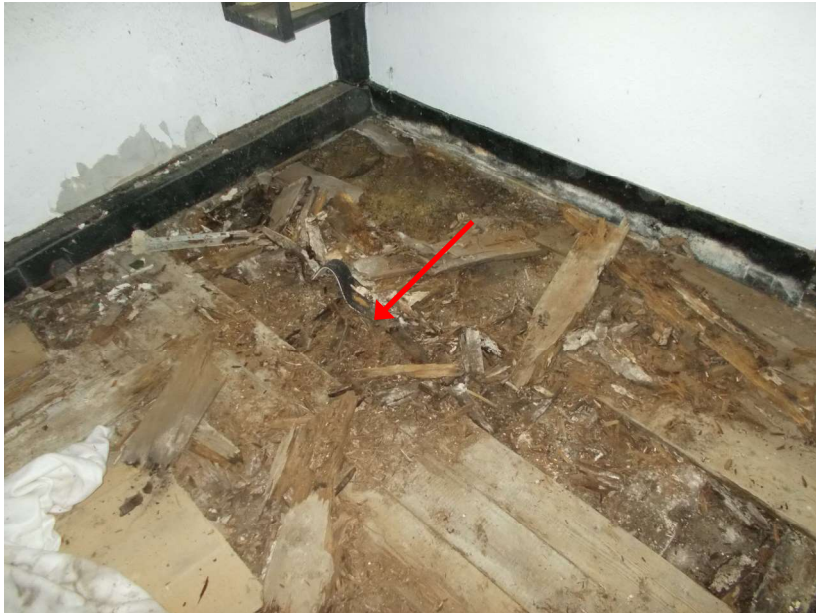
**Fig 23:**

Bedroom 2; showing the south-west corner of the room and the severely decayed section of floor boarding. The floor boards were supported by timber supports, equal in size to the floor boards, resting on the slabs below. There was no evidence of any damp-proof material being incorporated into the arrangement

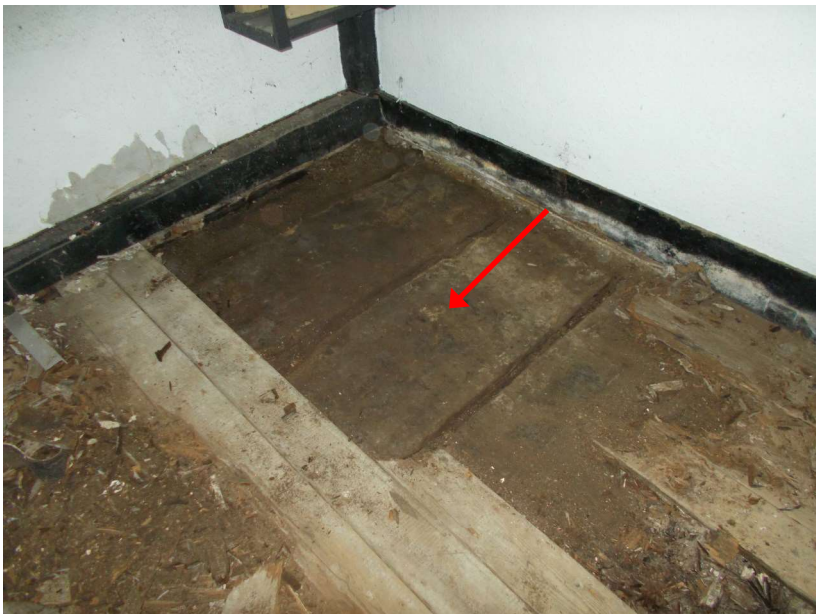
**Fig 24:**

Bedroom 2; showing the clinker ash concrete slabs below the floor in the south-west corner. Penetrating dampness from the ground below had caused the clinker ash concrete slabs to weaken and were disintegrating in localised areas

- 7 *Serious consideration should be given to lowering the floor level of the historic ground floor area to increase ventilation. This requires removal of all floor coverings and the clinker ash concrete slabs below. Timber in contact with the saturated slabs are highly vulnerable to damp and decay and the slabs are allowing free passage of water from the ground. H+R can advise further if required*

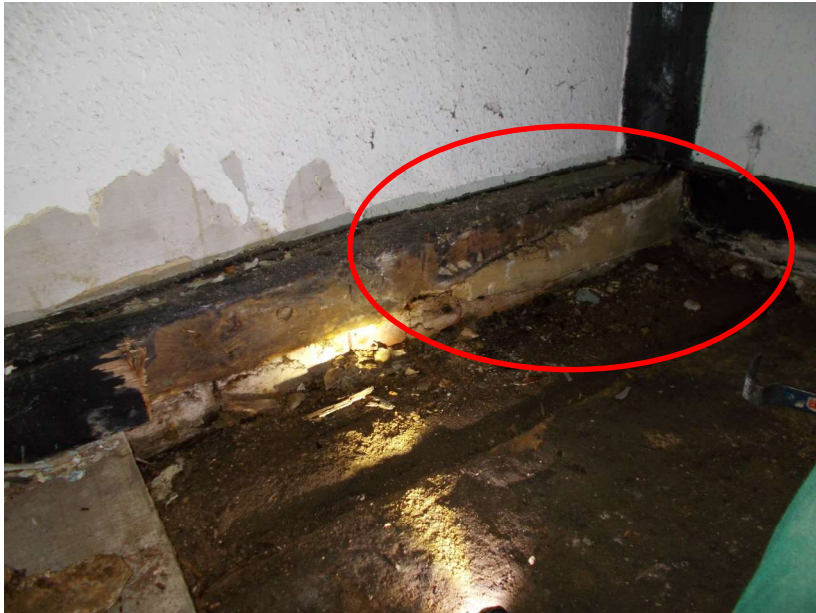
**Fig 25:**

Bedroom 2; showing the cement-based repairs to the timber frame sole plate. Historic decay has reduced the cross-section size of the sole plate by at least 50 per cent, and timber moisture contents were high enough for further decay to occur on the day of the survey

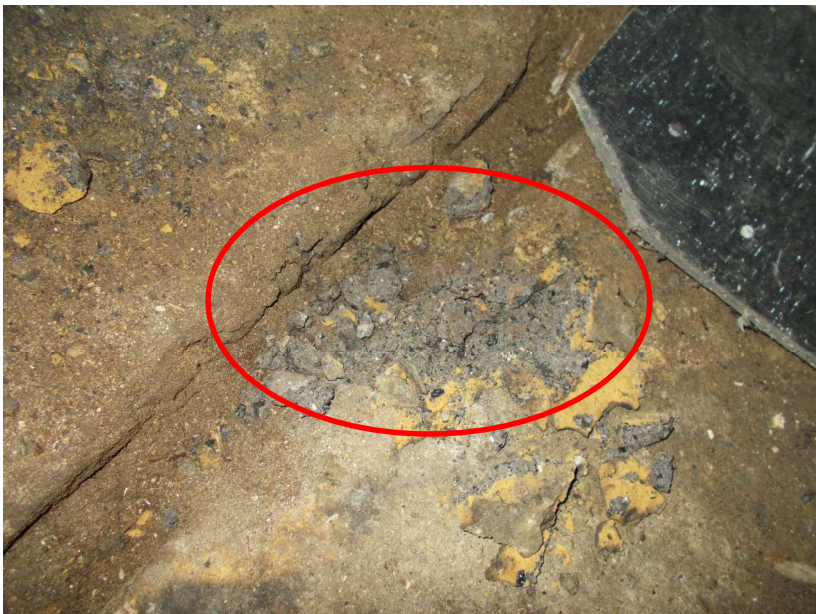
**Fig 26:**

Bedroom 2; showing the localised disintegration of the clinker ash slabs due to excessive penetrating damp from the ground below

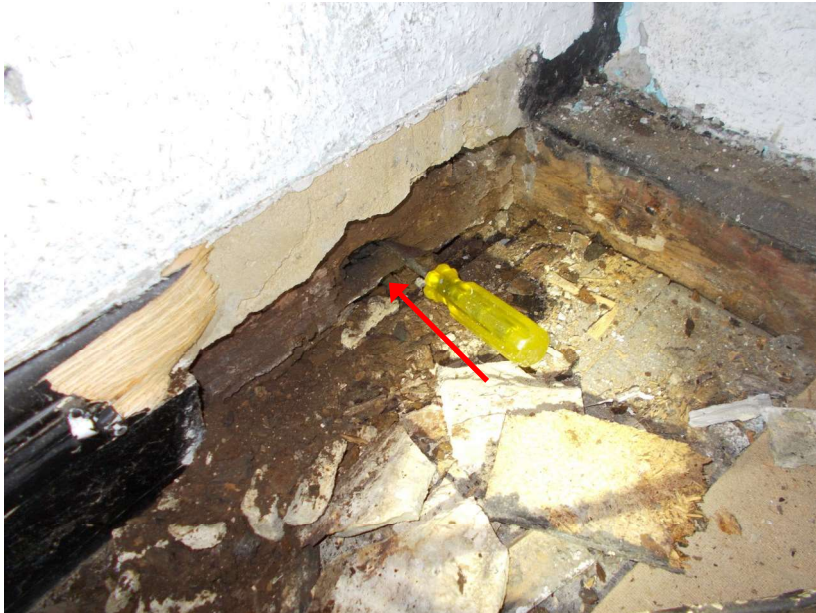
**Fig 27:**

Bedroom 2; showing the south-west corner and the structurally significant decay to the timber frame sole plate

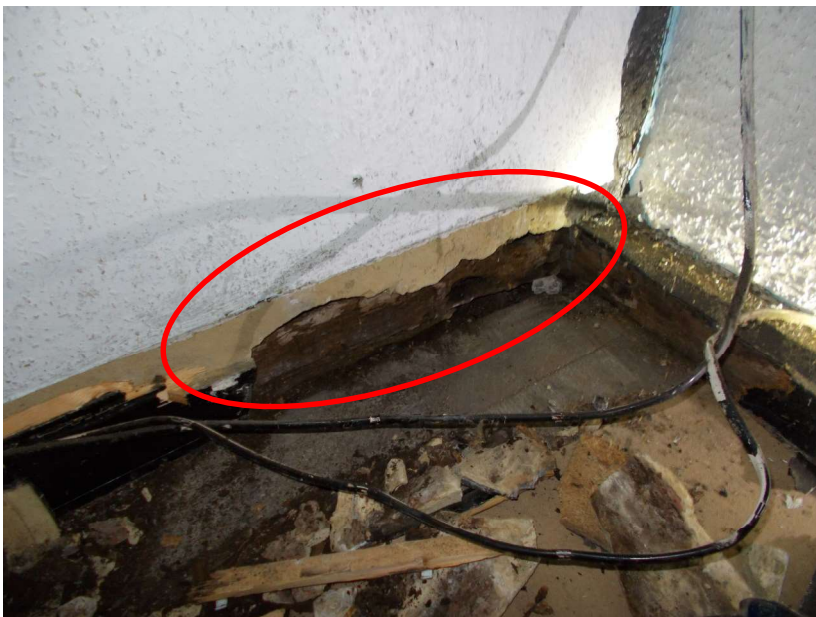
**Fig 28:**

Bedroom 2; showing the decay and cement-based repairs to the timber sole plate
