The Pest House
Photographs
27 November 2018
Not to scale

The Pest House, Roof Truss and Ceiling Joist Plans
TIMBER CONDITION INVESTIGATION
27 November 2018

Hutton + Rostron Environmental Investigations Ltd
Netley House, Gomshall, Surrey, GU5 9QA Tel: 01483 203221 Fax: 01483 202911
148-73 Site Note 3 -Not to scale- © Copyright Hutton+Rostron 2018

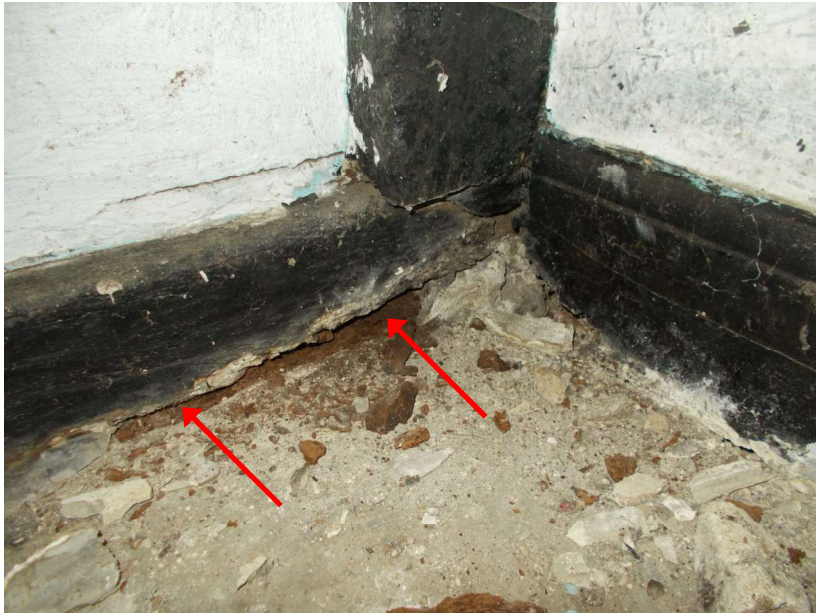
Fig 29:

Bedroom 2; showing the north-east corner and the decay to the timber sole plate where in contact with the concrete slab

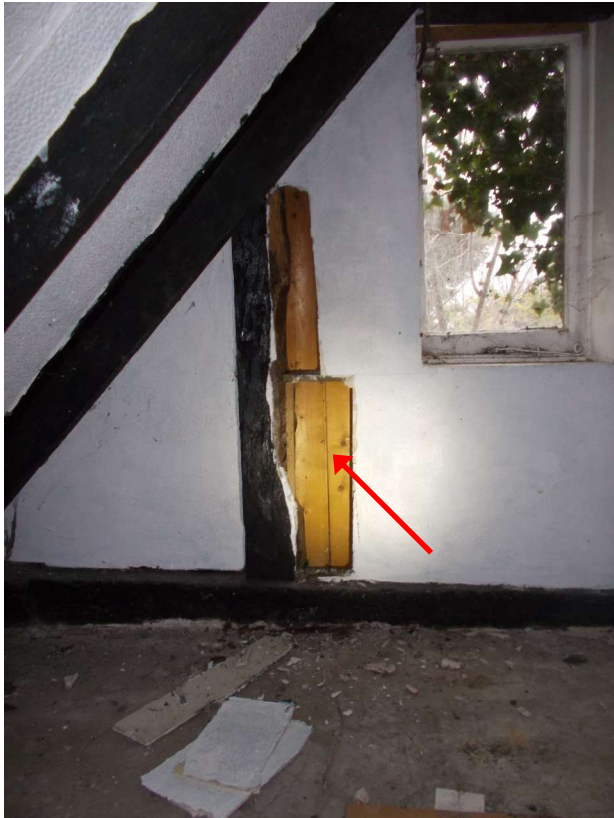
Fig 31:

Bedroom 2; showing the removal of some of the wall coverings on the north wall revealed timber boarding within

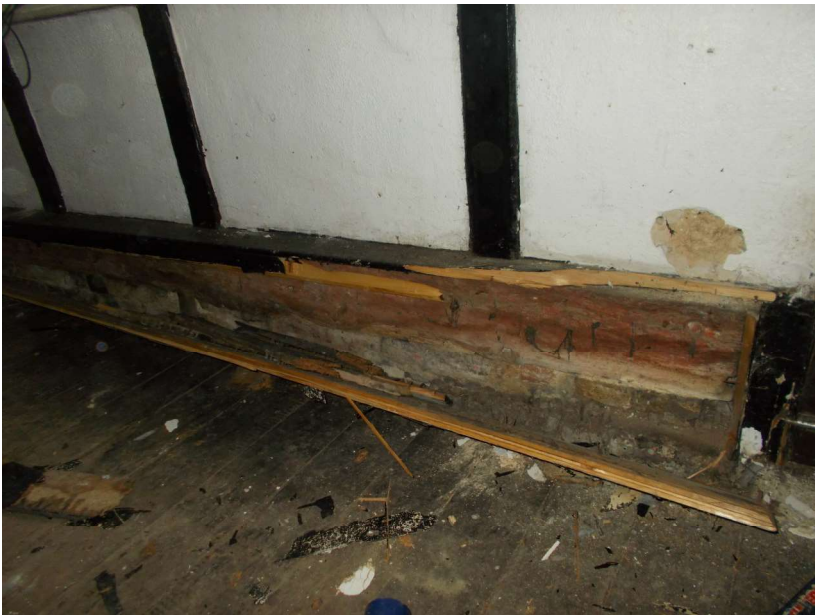
Fig 32:

Lounge; showing the timber frame sole plate behind the boxing-in on the north wall. The plate showed some evidence of historic insect attack, especially to the west end

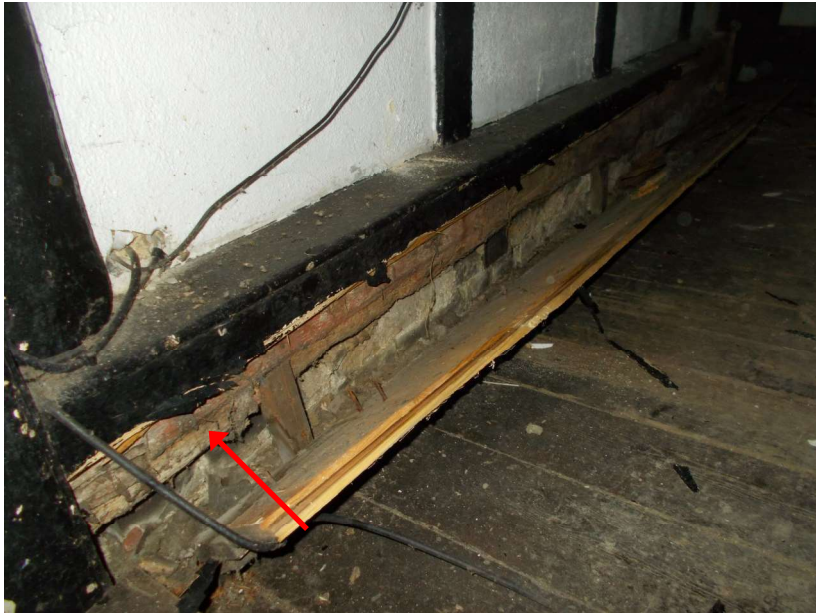
Fig 33:

Lounge; showing the north wall timber sole plate. The plate showed signs of historic insect attack especially to the west end

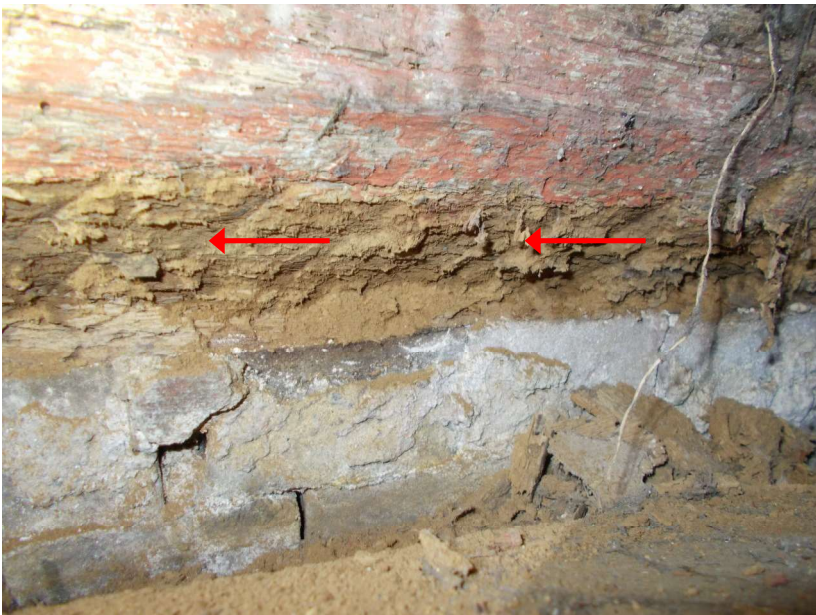
Fig 34:

Lounge; showing the historic insect attack to the north wall timber sole plate. The size and nature of the flight holes suggested the damage may have caused by Deathwatch beetle (*Xestobium rufovillosum*)

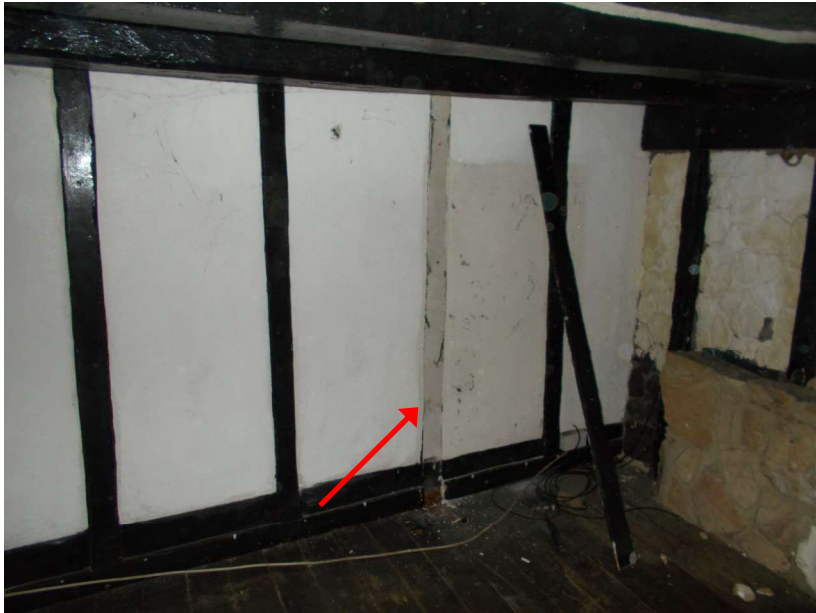
Fig 35:

Lounge; showing the faux timber framing on the south wall. The wall covering appeared to be cement-based although the original lime-based wall coverings may be intact behind

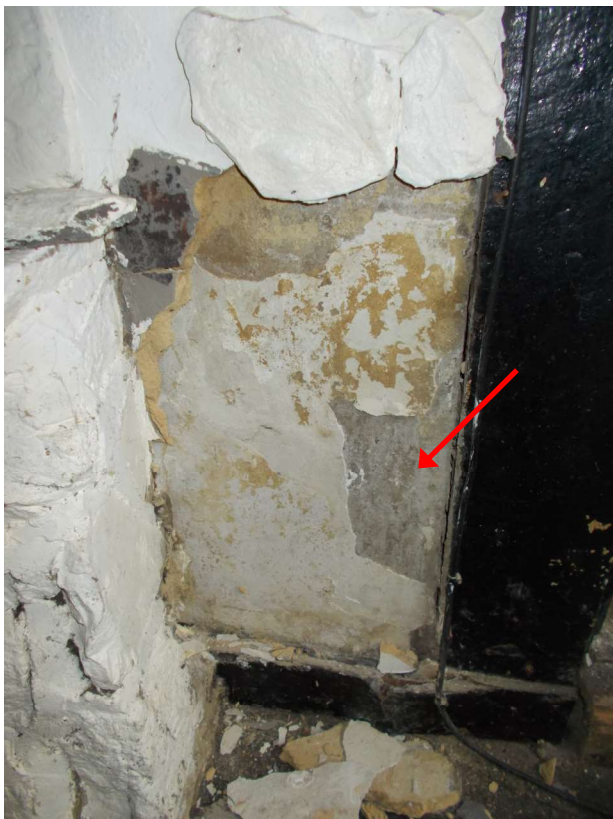
Fig 36:

Lounge; showing the cement-based render wall finish to the west wall

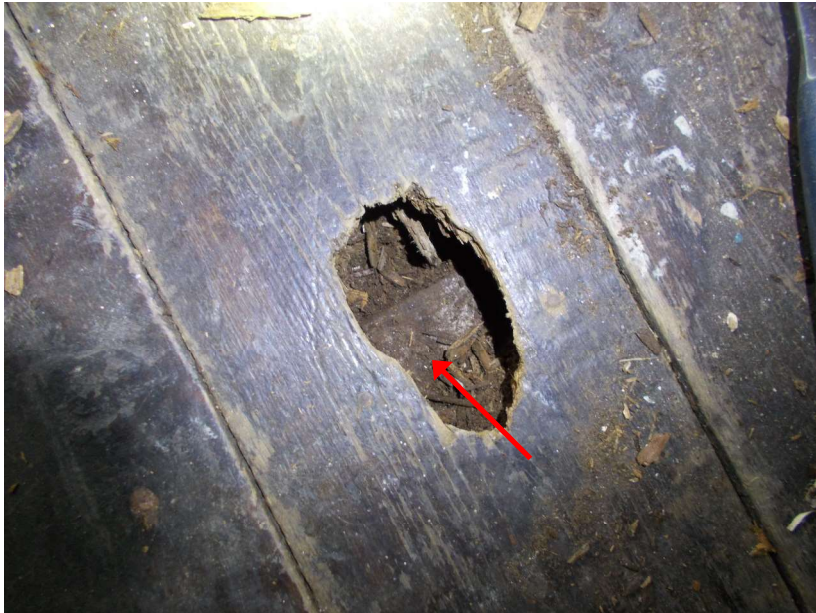
Fig 37:

Lounge; showing the small hole in the floor boards which was used to identify the sub-floor void build-up in this room. The investigation confirmed that the build-up was identical to Bedroom 2, with softwood floor boards over softwood timber supports laid onto clinker ash concrete slabs

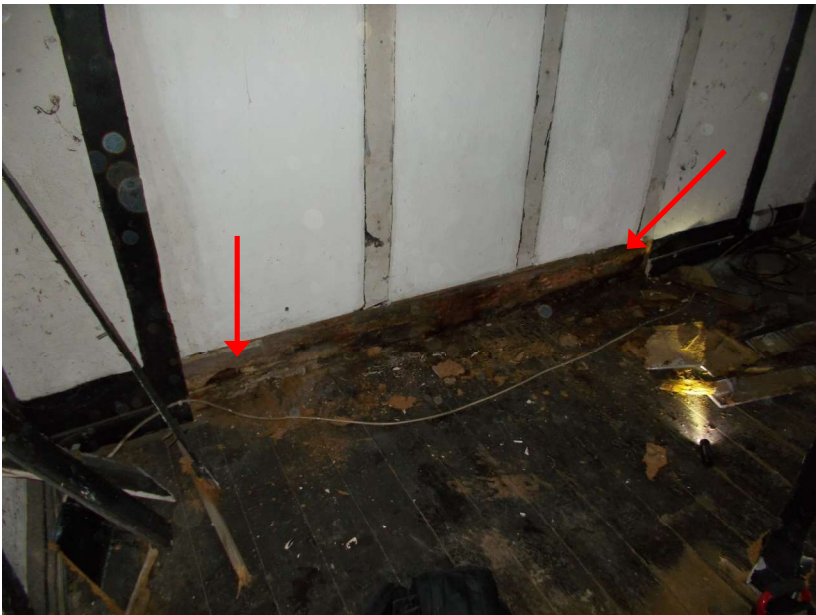
Fig 38:

Lounge; showing the opening-up of the timber frame sole plate on the south wall. Extremely damp particle board formed the skirting and blanking-in plate at floor level, and moisture contents of the timber on the day of the survey was high enough for decay to occur

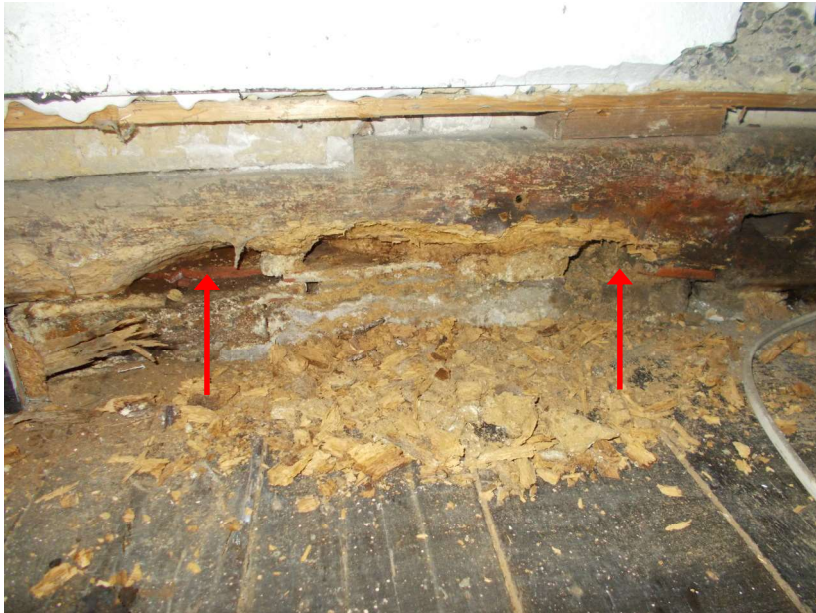
Fig 39:

Lounge; showing the decay to the timber frame sole plate on the south wall. Timber moisture content of the timber plate on the day of the survey in the room was generally high enough for decay to occur

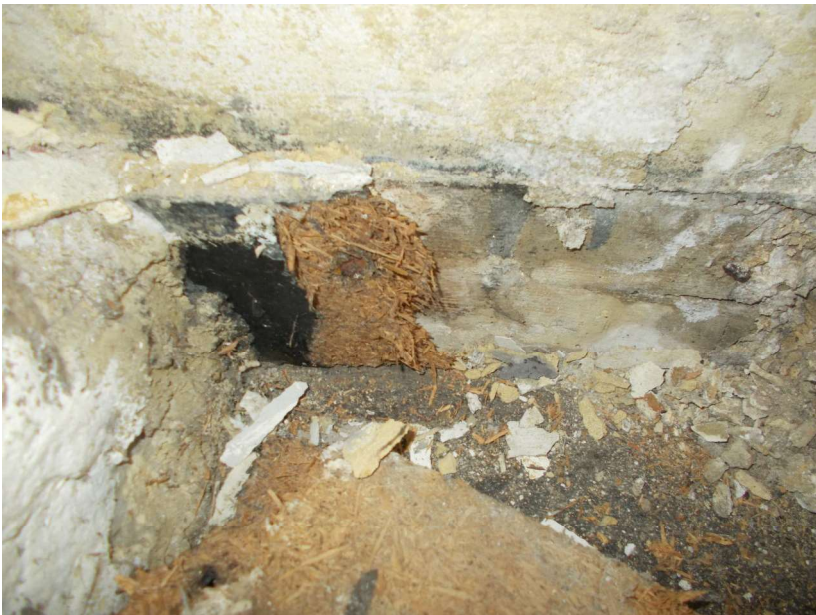
Fig 40:

Lounge; showing the particle board skirting used throughout the historic ground floor areas

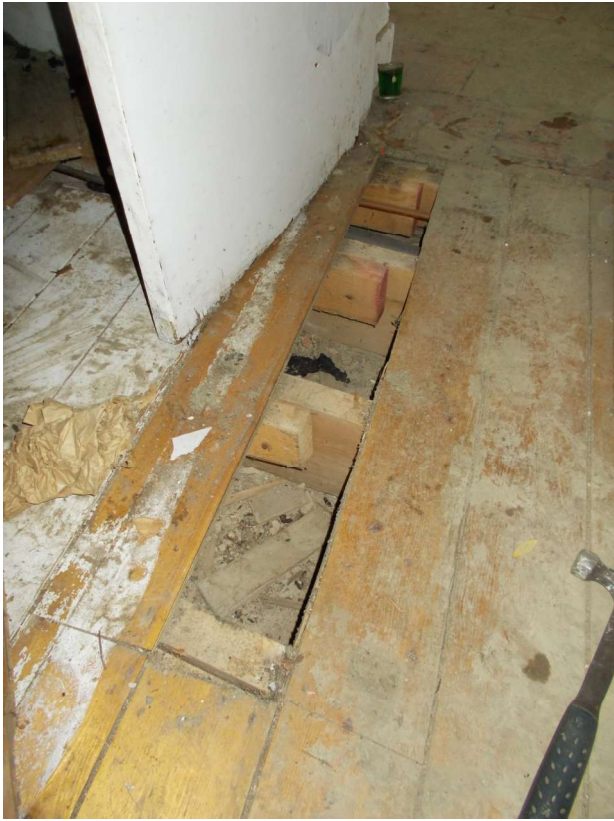
Fig 41:

Kitchen; showing the floor structure. The softwood floor joists were laid onto the concrete slab with a damp-proof material between them. Moisture contents of the timbers in the kitchen on the day of the survey were too low for decay to occur

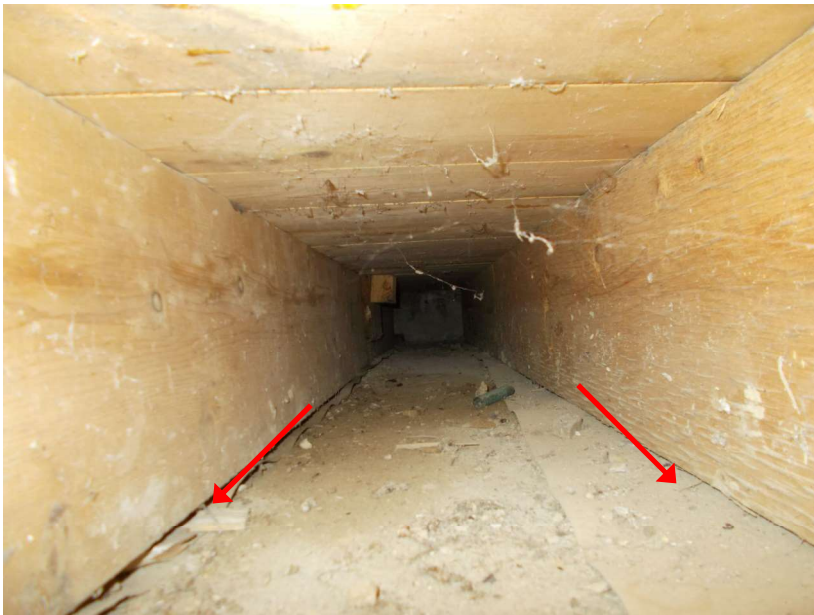
Fig 42:

Kitchen; showing the sub-floor void in the kitchen towards the west wall. Note the damp-proof material between the joists and the concrete slab
