Hutton + Rostron Environmental Investigations Ltd

The Pest House: Timber strength grading report of accessible structures

Site note 4 for 27 November 2018, job no. 148.73

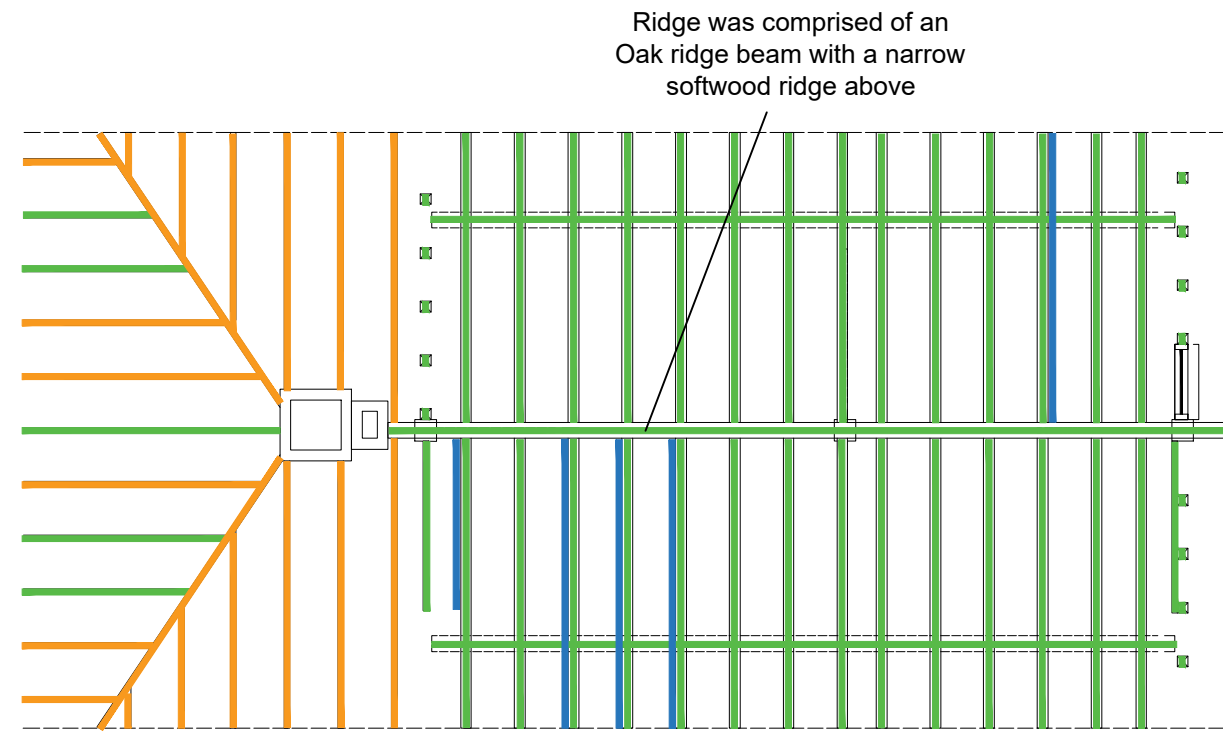
Strength Grading (non-historic roof)	
Rafters	GS 80%
Purlins	GS
Raking struts	GS
Hip rafters	GS

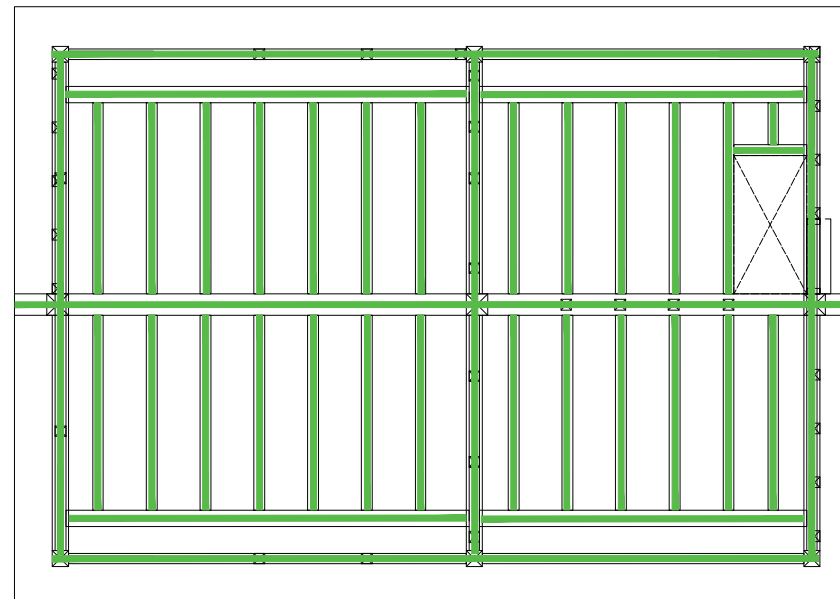
Roof Truss

Strength Grading (historic roof)	
Rafters	TH2 (50%)
Ridge beam	TH1
King posts x 3	THB
Post braces x 2	TH2
Studs	TH2

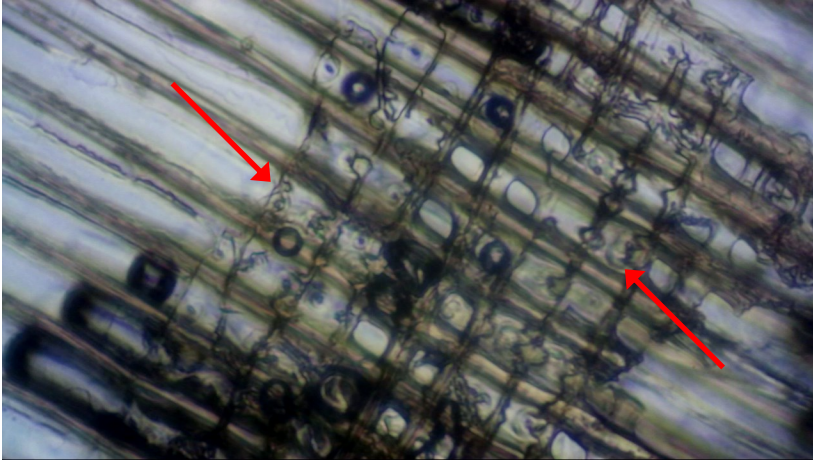
Fig 1:

Laboratory image; showing a microscopic image of Sample 1 from the bedroom 2 floor boards. The 'dentate' (toothed) ray tracheids in the cross-field pitting provide positive identification for European redwood (*Pinus spp.*)

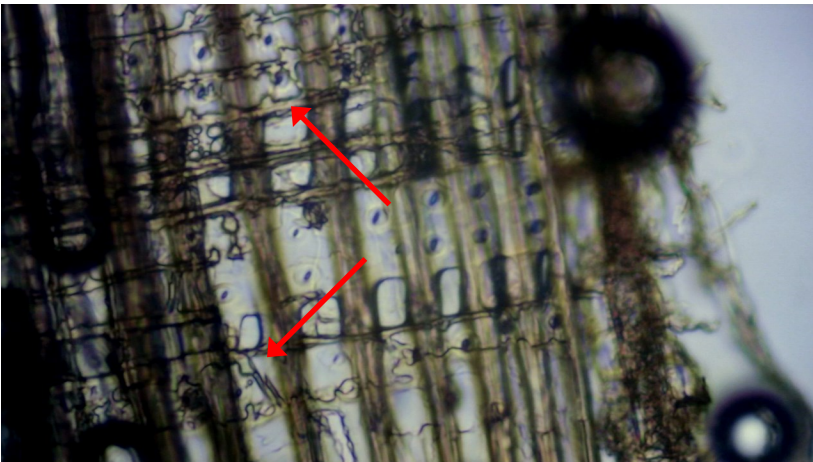
Fig 2:

Laboratory image; showing a microscopic image of Sample 2 from a purlin in the softwood roof structure. The 'dentate' (toothed) ray tracheids in the cross-field pitting provide positive identification for European redwood (*Pinus spp.*)

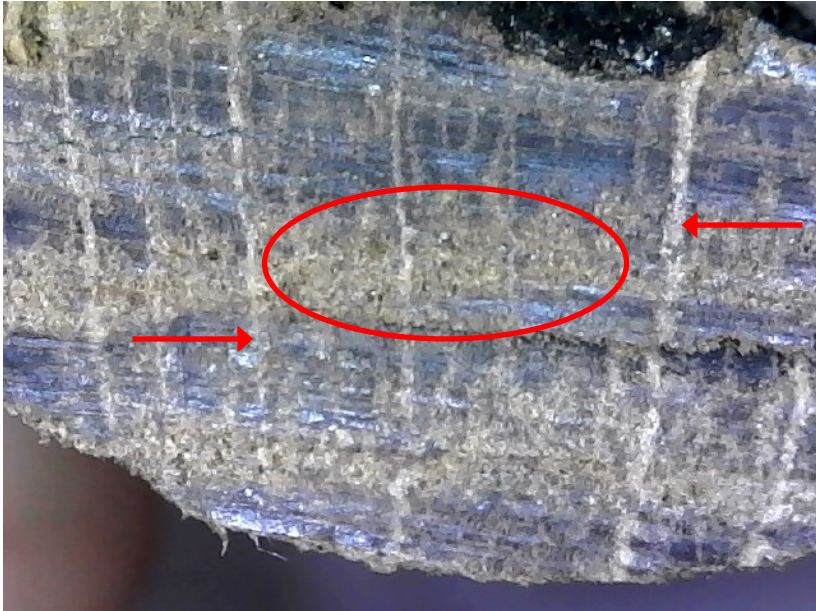
Fig 3:

Laboratory image; showing a close-up image of Sample 3 from the tie-beam supporting the first floor. The strong vertical medullary rays visible to the naked eye, and the ring-porous nature of the timber structure indicate Oak (*Quercus robur/petraea*)

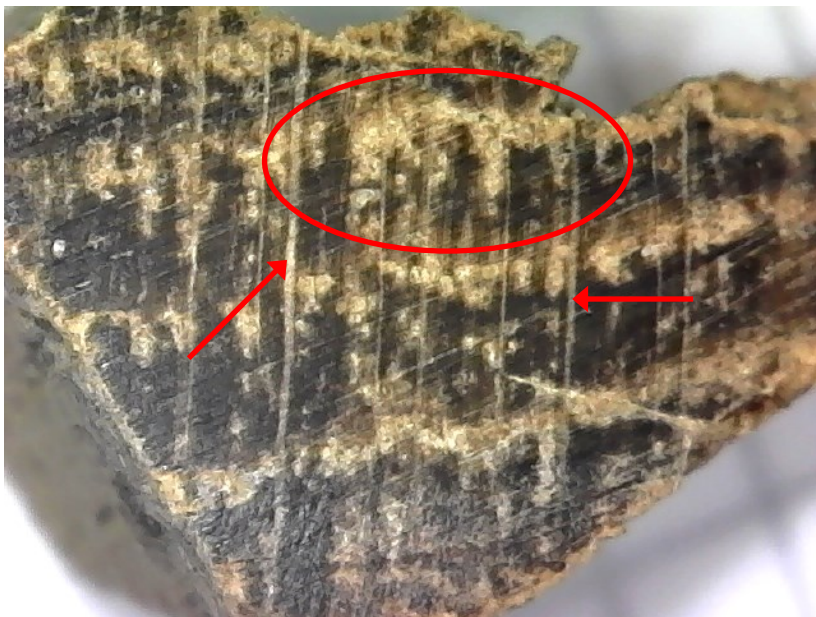
Fig 4:

Laboratory image; showing a close-up image of Sample 4 from the sole-plate on the ground floor. The strong vertical medullary rays visible to the naked eye, and the ring-porous nature of the timber structure indicate Oak (*Quercus robur/petraea*)
