East Sussex County Council

Sandbanks 1 Cacklebury Close, Hailsham,
East Sussex, BN27 3LF

WYG Asbestos Management Survey Report

15 Apr 2020

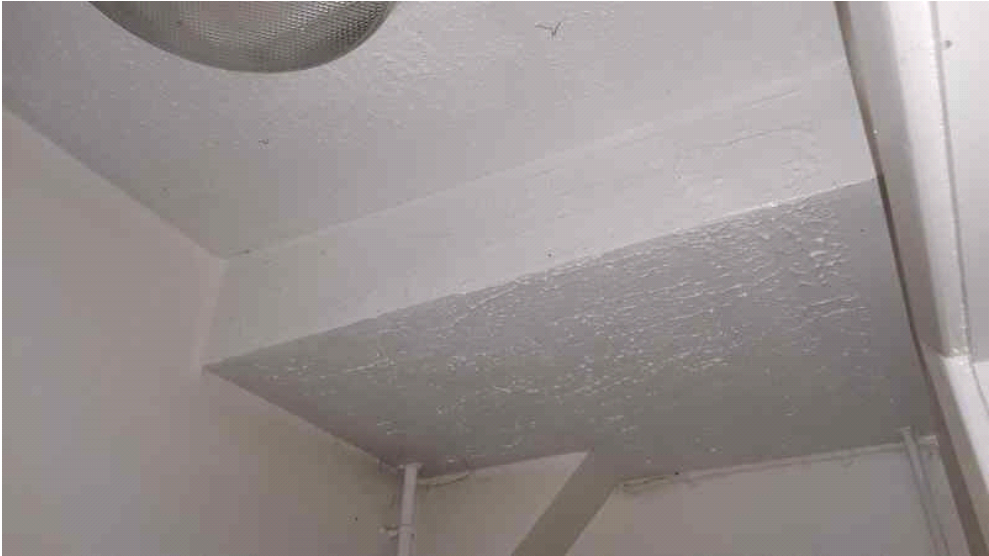
Inspection Number	3	Reference Number:	As Sample EC002540
Inspection / Sample	Visually similar to	Inspection Cross Reference / Visual I.D.	As Sample

Building	Main Building
Floor Level	Ground Floor
Area / Room	0.06 W.C
Feature	Textured coating to plasterboard ceiling
Product Type	Textured Coating
Extent Amount	2 m ²

Recommendation	Manage
----------------	--------

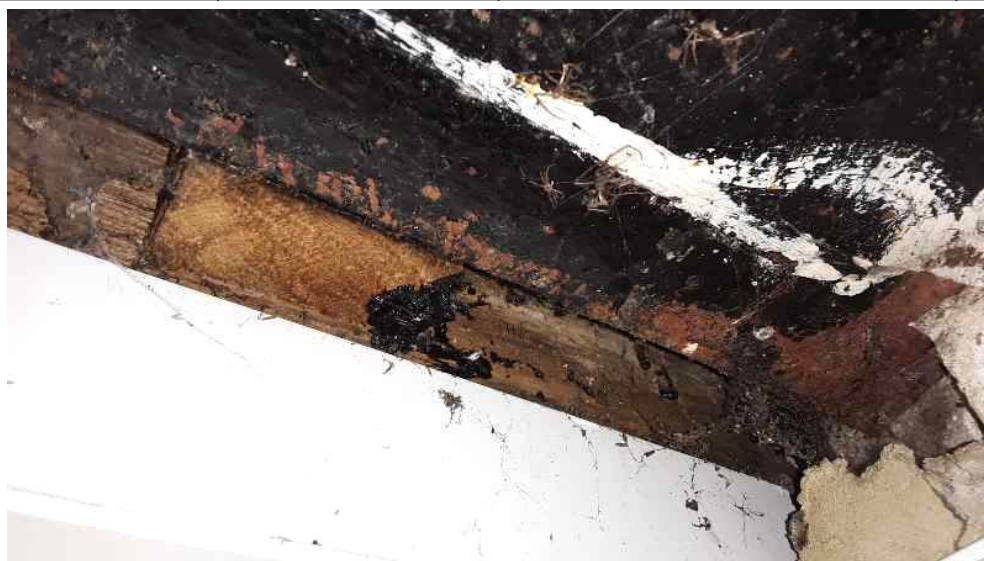
Inspection Number	8	Reference Number:	EC002532
Inspection / Sample	Sample taken	Inspection Cross Reference / Visual I.D.	N.A.D.I.S

Notes	Item presumed present throughout building
-------	---

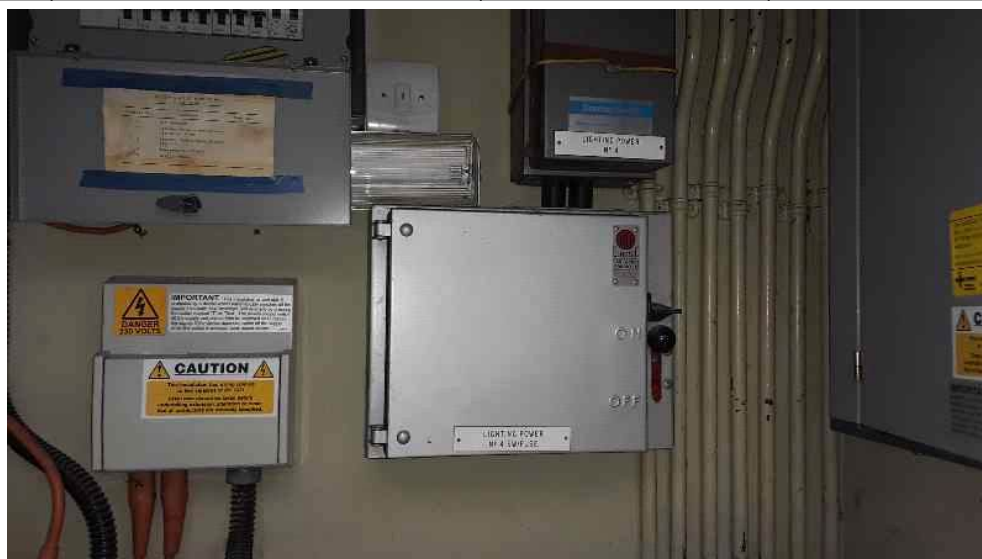
Inspection Number	12	Reference Number:	N/A
Inspection / Sample	Visual Inspection	Inspection Cross Reference / Visual I.D.	Asbestos Presumed

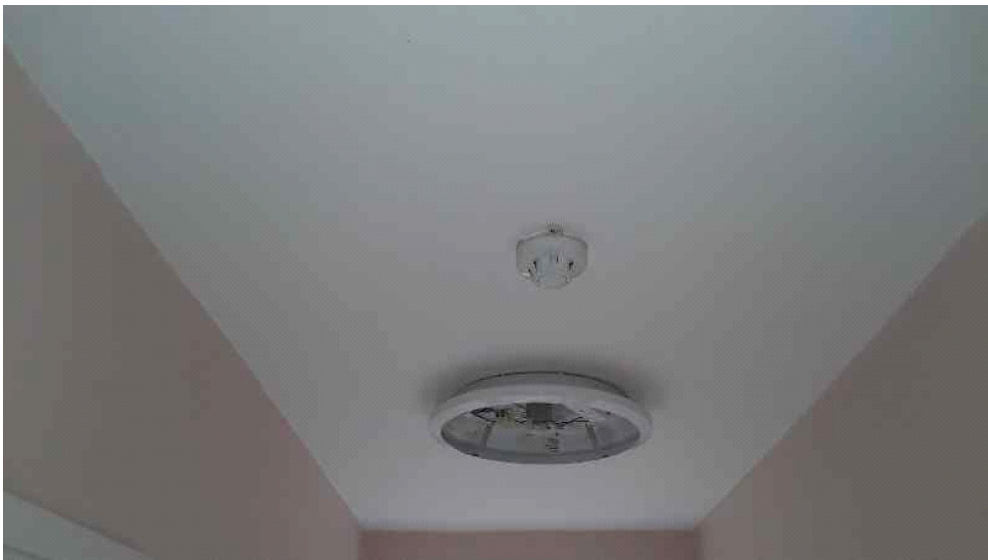
Inspection Number	31	Reference Number:	EC002540
Inspection / Sample	Sample taken	Inspection Cross Reference / Visual I.D.	Asbestos Identified

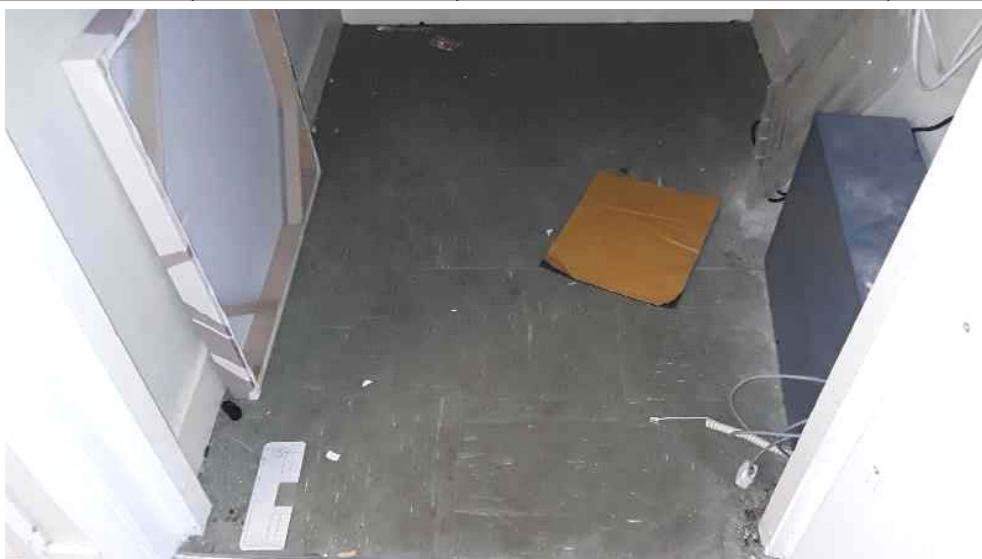
Inspection Number	37	Reference Number:	EC002589
Inspection / Sample	Sample taken	Inspection Cross Reference / Visual I.D.	Asbestos Identified

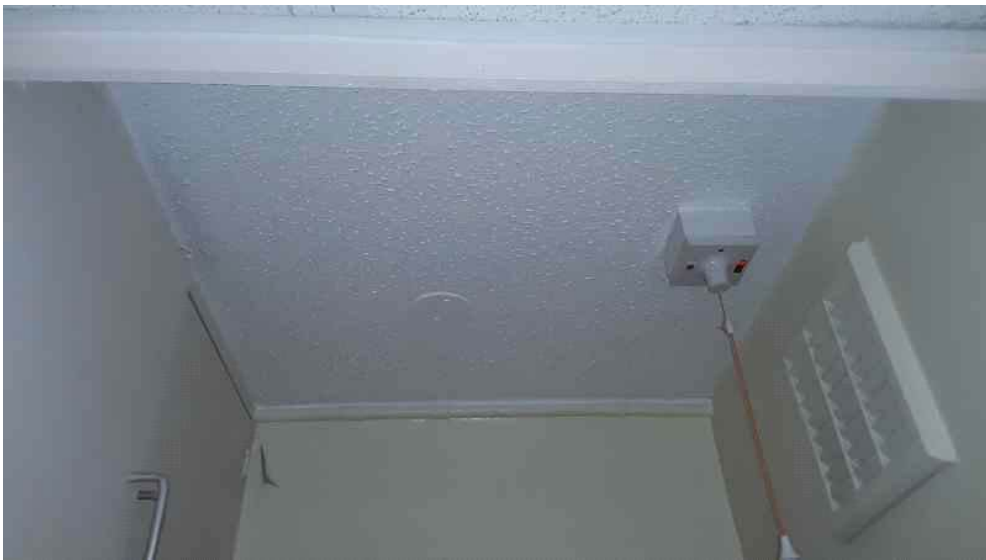
Inspection Number	44	Reference Number:	EC002593
Inspection / Sample	Sample taken	Inspection Cross Reference / Visual I.D.	Asbestos Identified

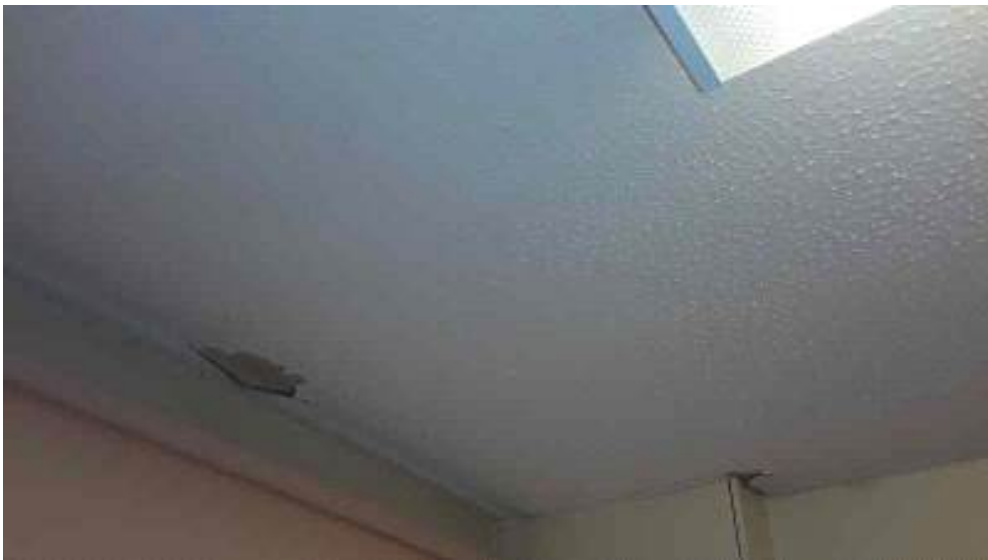
Main Building, Ground Floor, Kitchen (0.38)	102	Textured coating to plasterboard ceiling (as sample EC002593)	Textured Coating (Low)	(1) Chrysotile	5	5	10	EC002593	Repair or Remove

Inspection Number	102	Reference Number:	As Sample EC002593
Inspection / Sample	Visually similar to	Inspection Cross Reference / Visual I.D.	As Sample

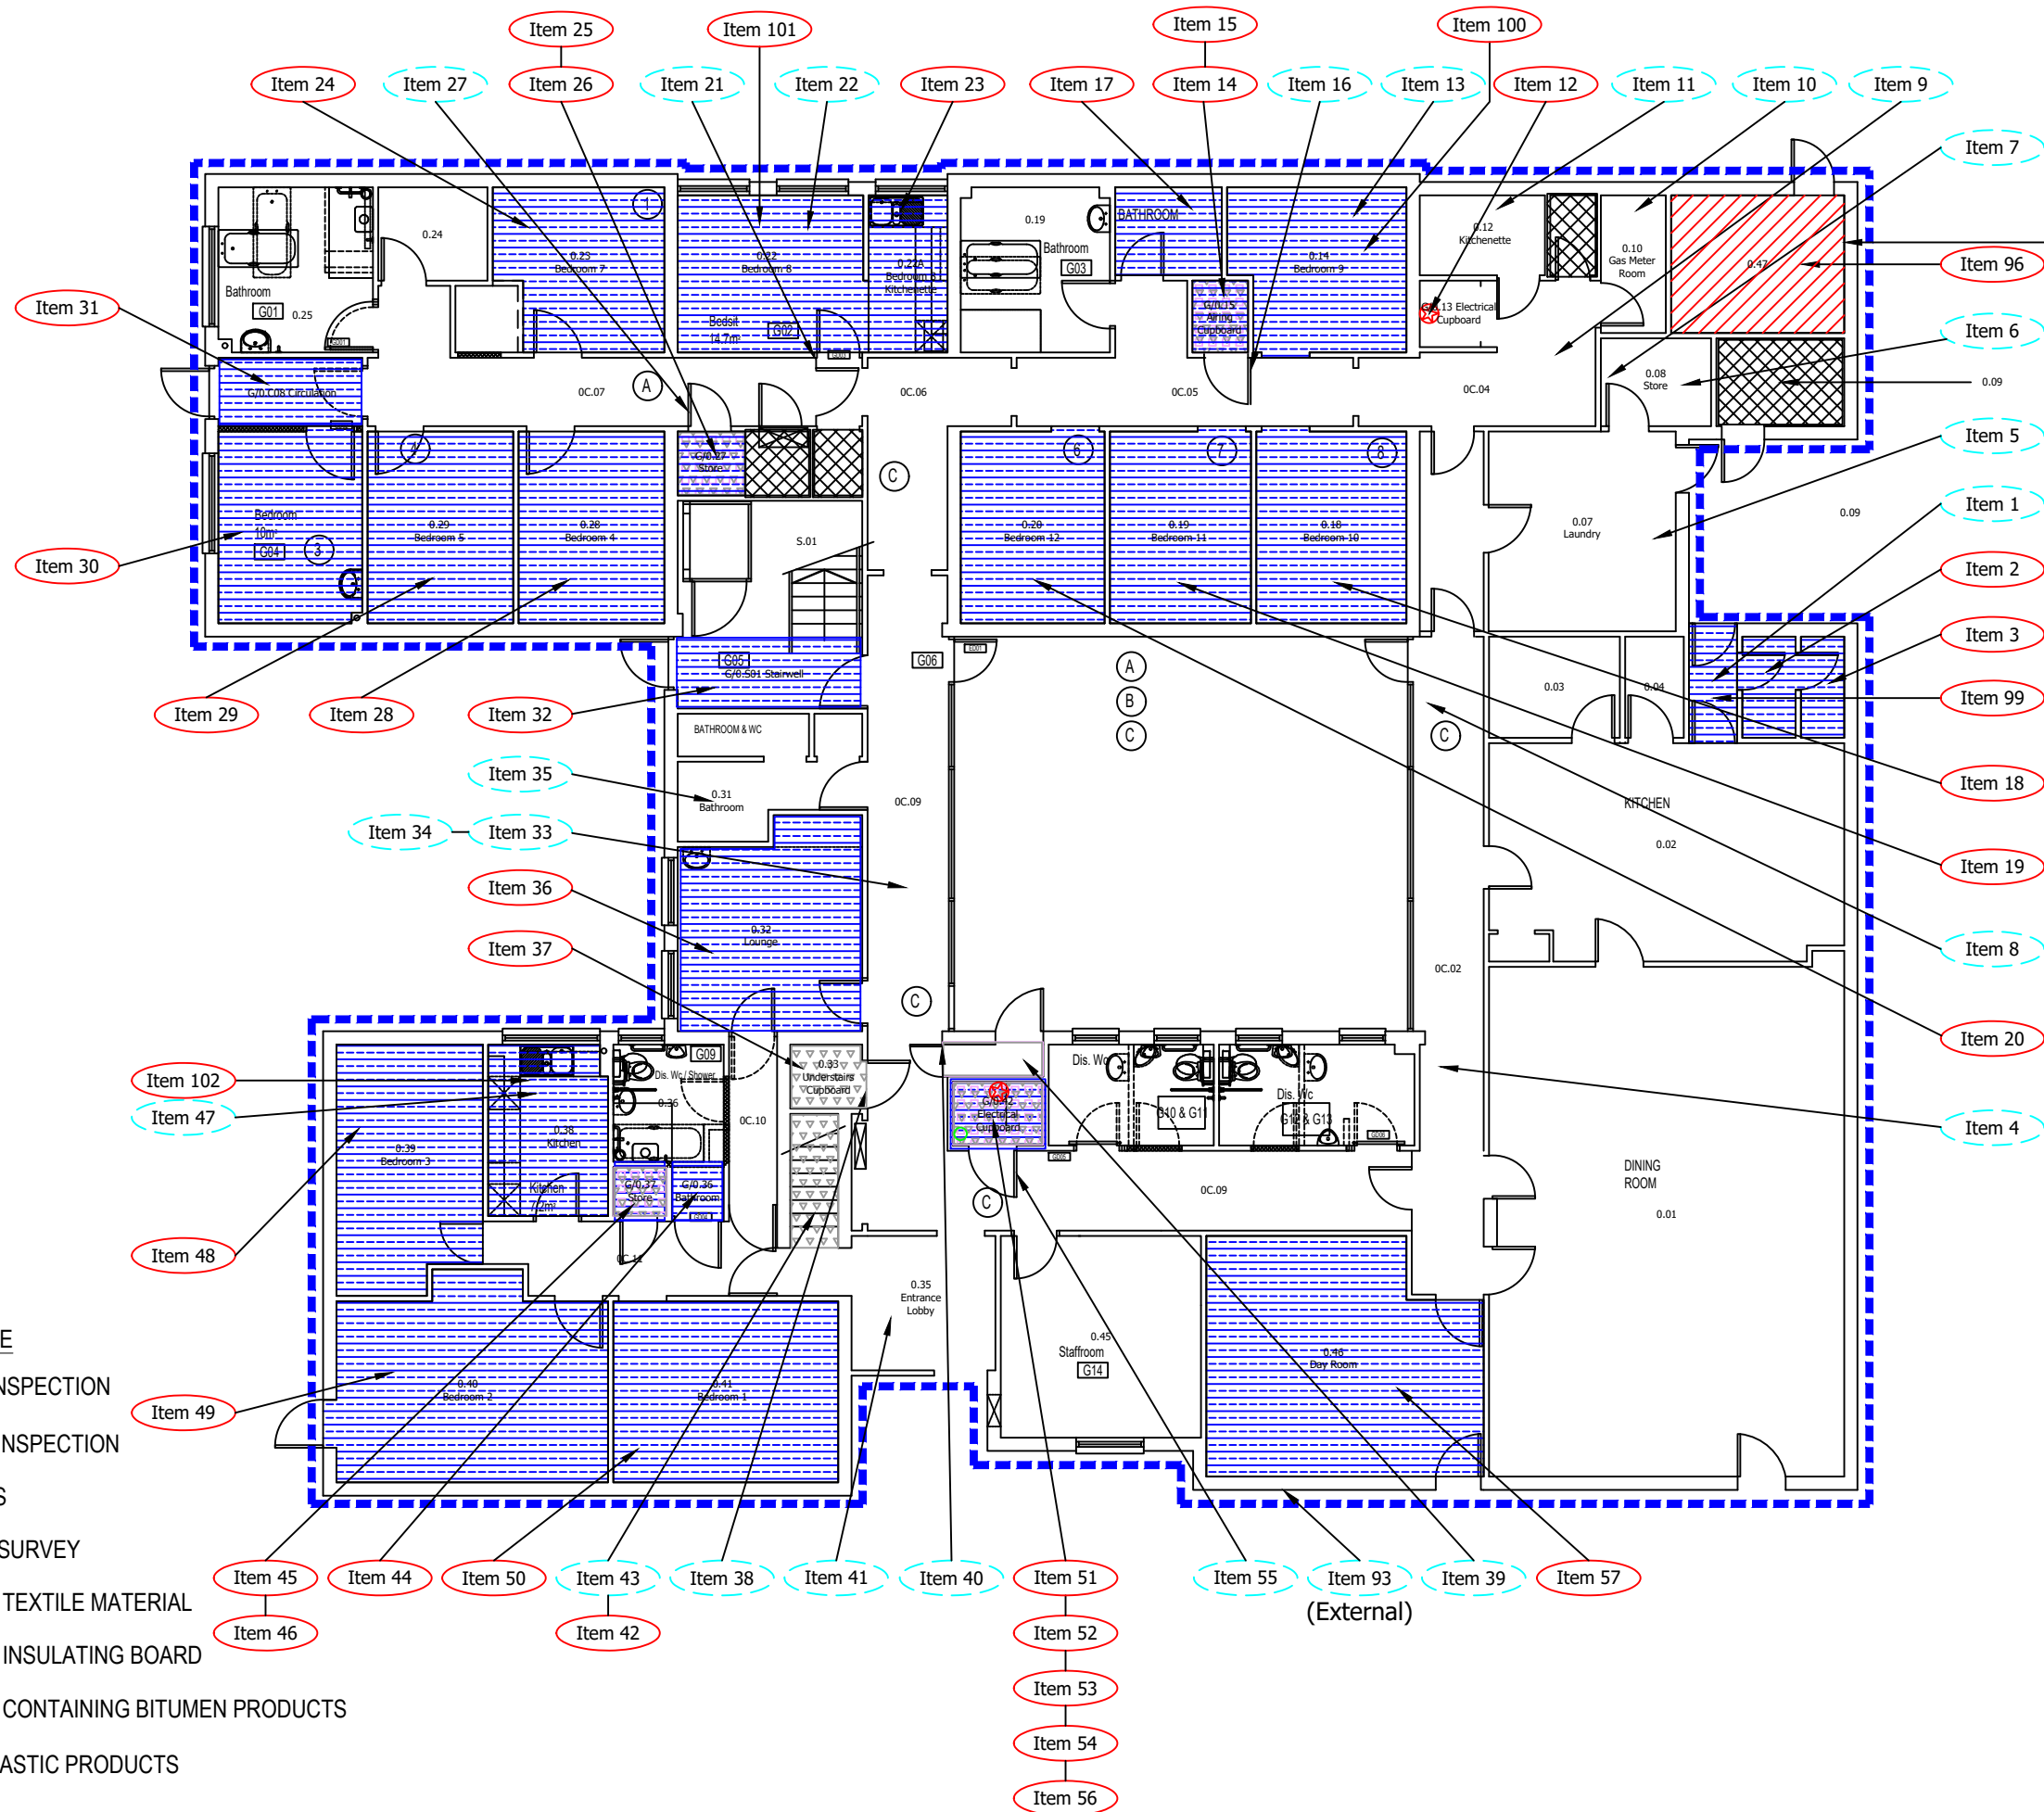
No Access to 0.47
Boiler Room
AIB to ceiling
previously
identified
