Arboricultural Report BS5837:2012

Site Name Land off Common Road	Location Common Road, Sissinghurst, Kent
Job Ref 2270117	Document Ref AS01
Site Code None	Grid Reference TQ 78954 37930
Surveyor E Maloney	Date of Survey 27.04.17
Geology/Soil Type Not needed	Designation Pastoral field with hedgerows.

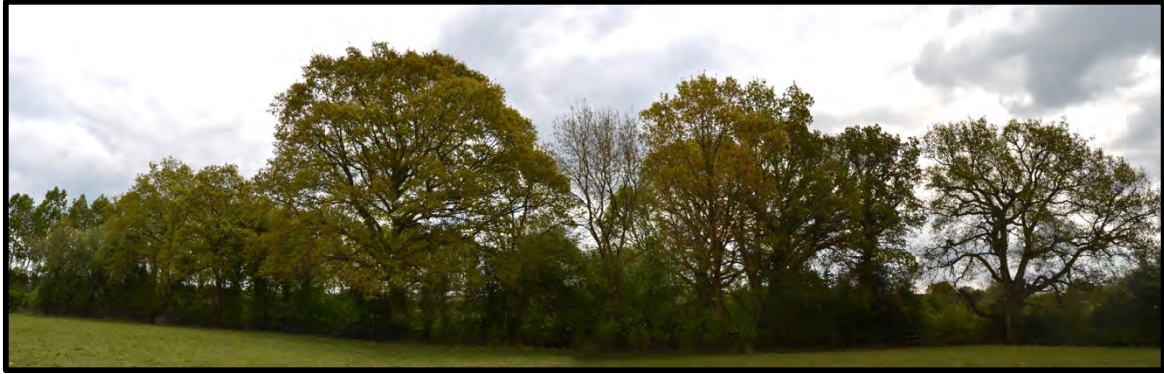
Photo 2: Panoramic showing the eastern boundary grouping T1 left to T9 far right.

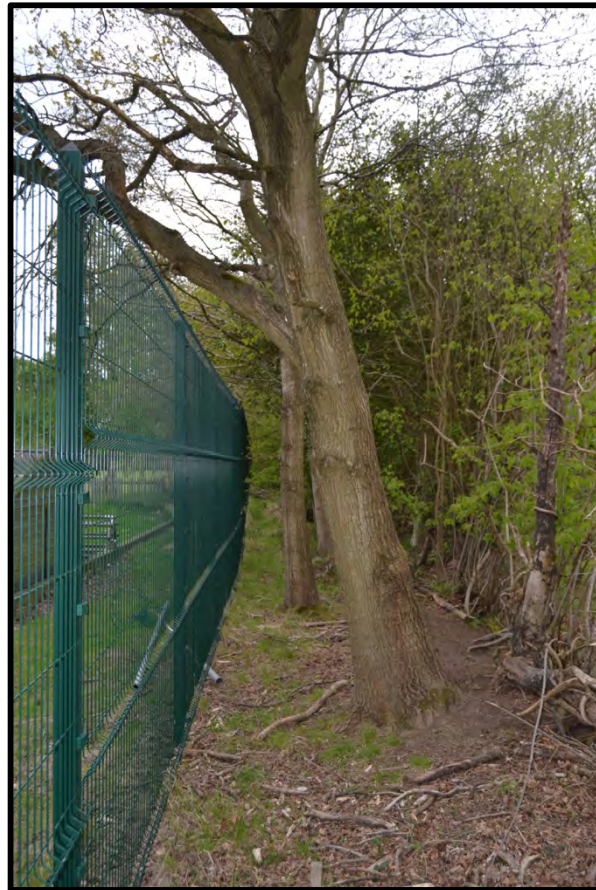
Photo 3: T14 Looking west close to school boundary fence

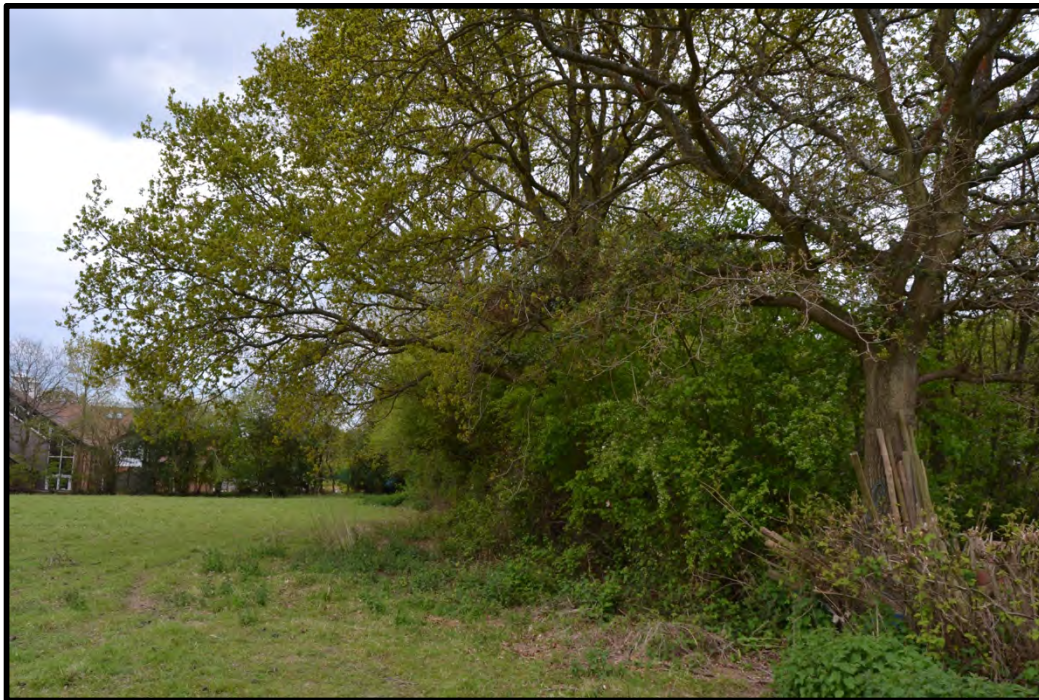
Photo 4: Showing T18-T19 overhanging crowns looking south along western boundary

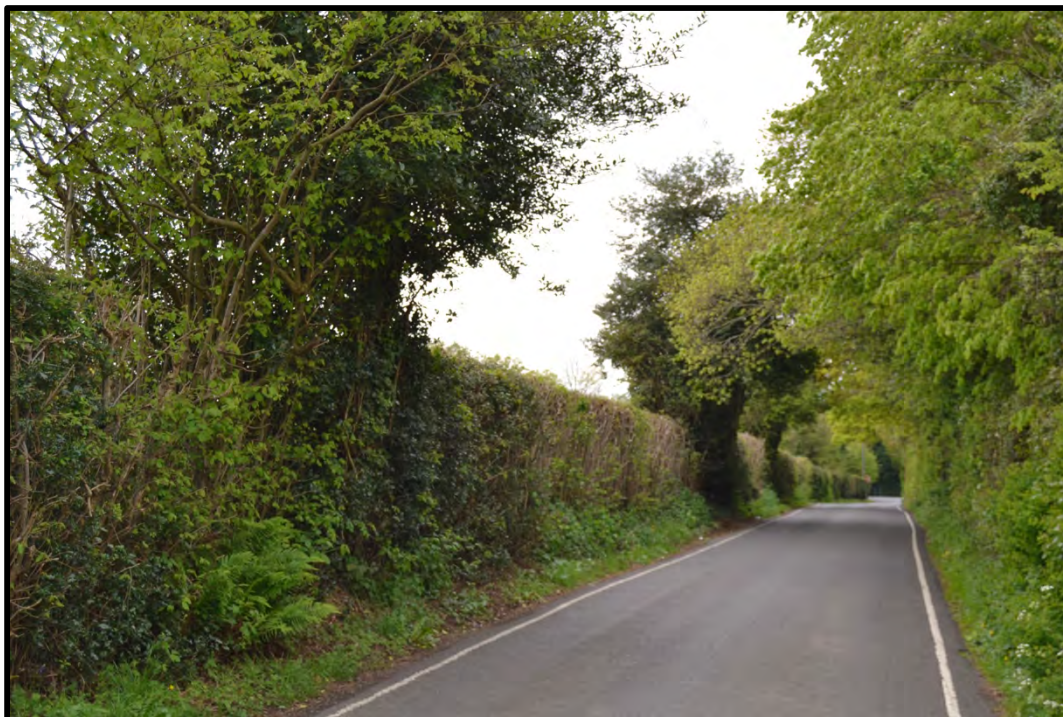
Photo 5 view looking west along Frittenden Road.
G4 left with T20 and G3 further along the road
