Appendix 2 - Bat Scoping Assessment (Trees)

Project Name:		Boughton Mount, Maidstone
Drawing title:		Tree Bat Potential Plan
Drawing number:		180337-E-03
Client:		Kent County Council
Agent:		Tim Moya Associates
Date:	17/10/2018	Drawn by:
		BP
Scale:		1:1,300

180337 - Boughton Mount 180337-ED-12

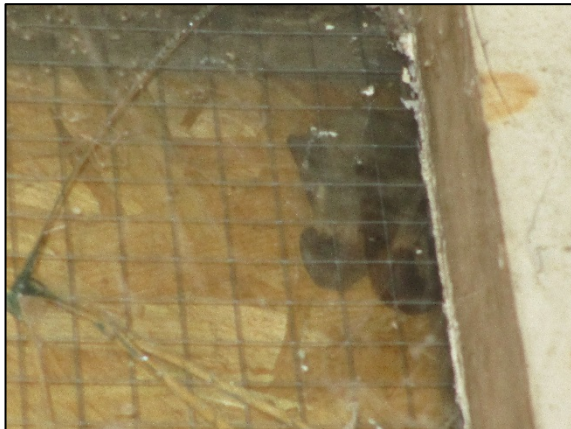
Photo 1 – Brown long-eared bat observed in B11 behind a boarded window (15/08/18)

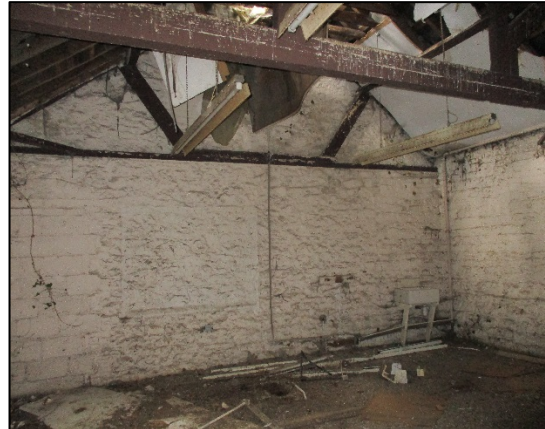
Photo 2 – 1st floor of B11

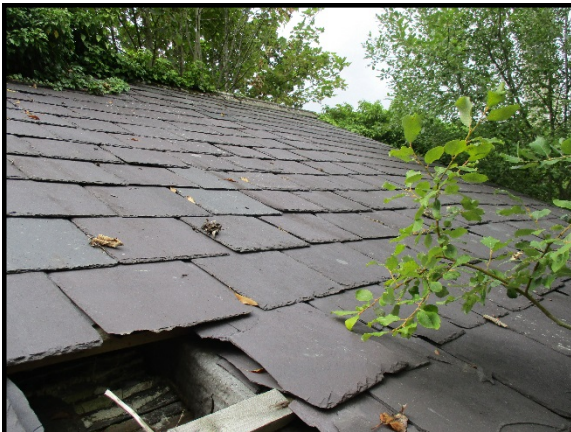
Photo 3 – Missing tiles on south 'stables' section of B11

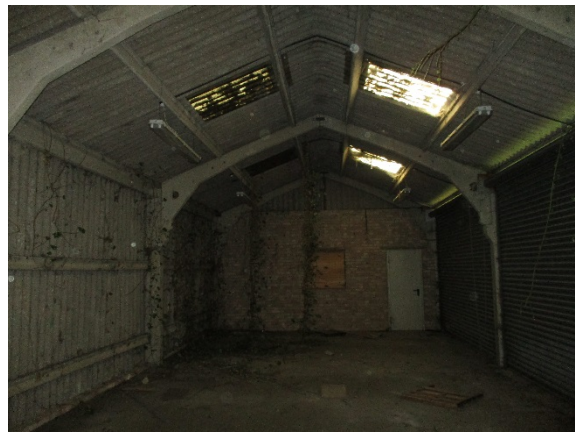
Photo 4 – Inside the garages (B12)

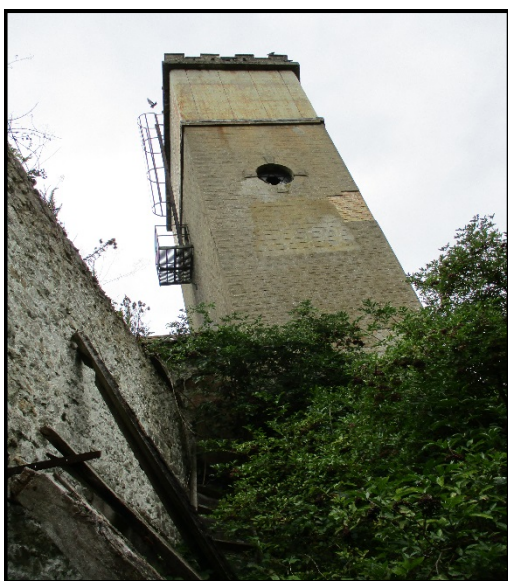
Photo 5 – Water tower of B11.

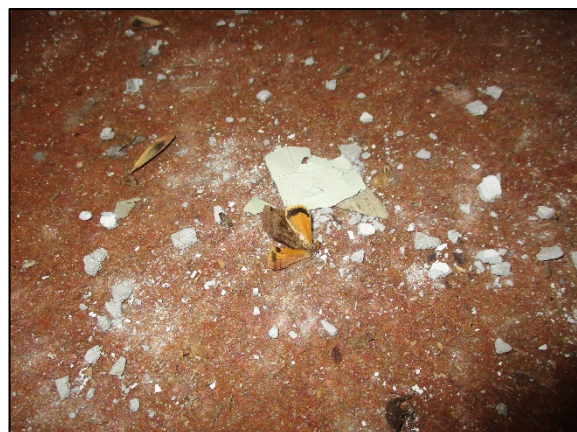
Photo 6 – Bat feeding remains found in B21.

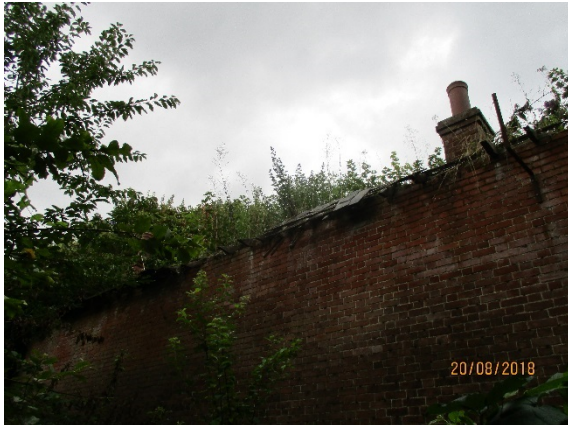
Photo 7 – Chimney visible from the ruins (B7).

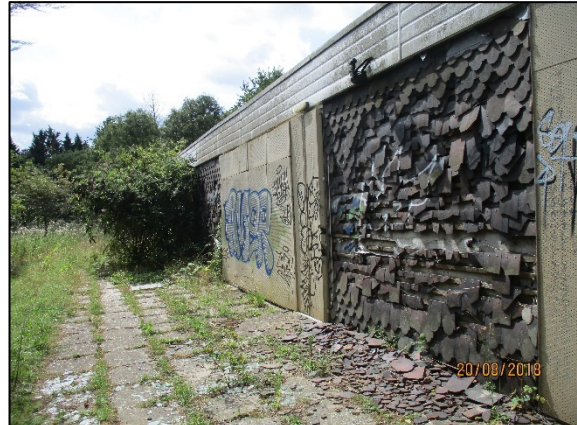
Photo 8 – Hanging tiles on B3.

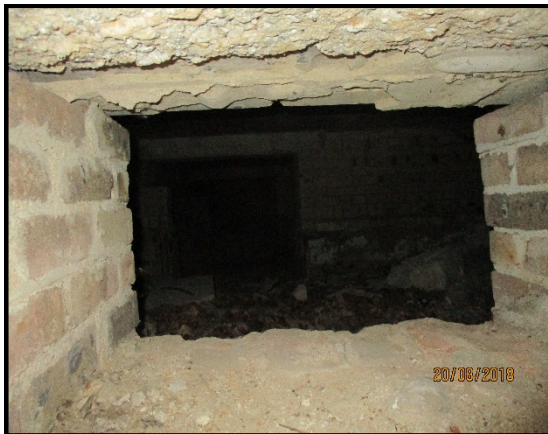
Photo 9 – Foundations of B3.

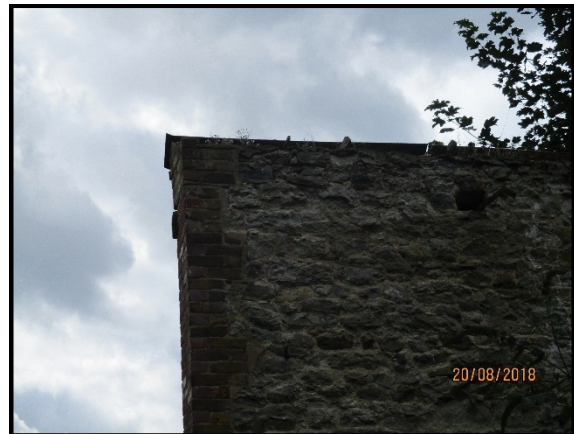
Photo 10 – Hole in ruined wall 2 (B24)

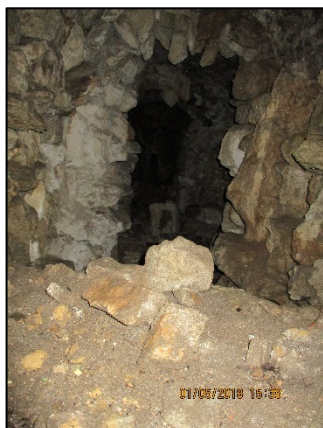
Photo 11 – Folly building (B5) – internal view through hole in wall

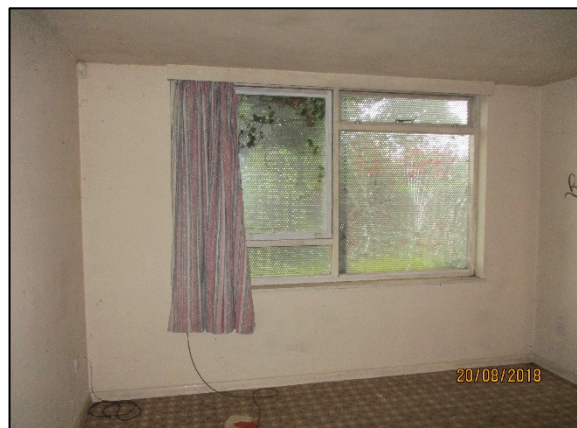
Photo 12 – Downstairs room of the Lodge (B4) – bat droppings were present below the curtain.
