Arboricultural Report

**Assessment of tree constraints for
feasibility purposes**

Boughton Mount
Maidstone
ME17 4NB

180337-FD-02

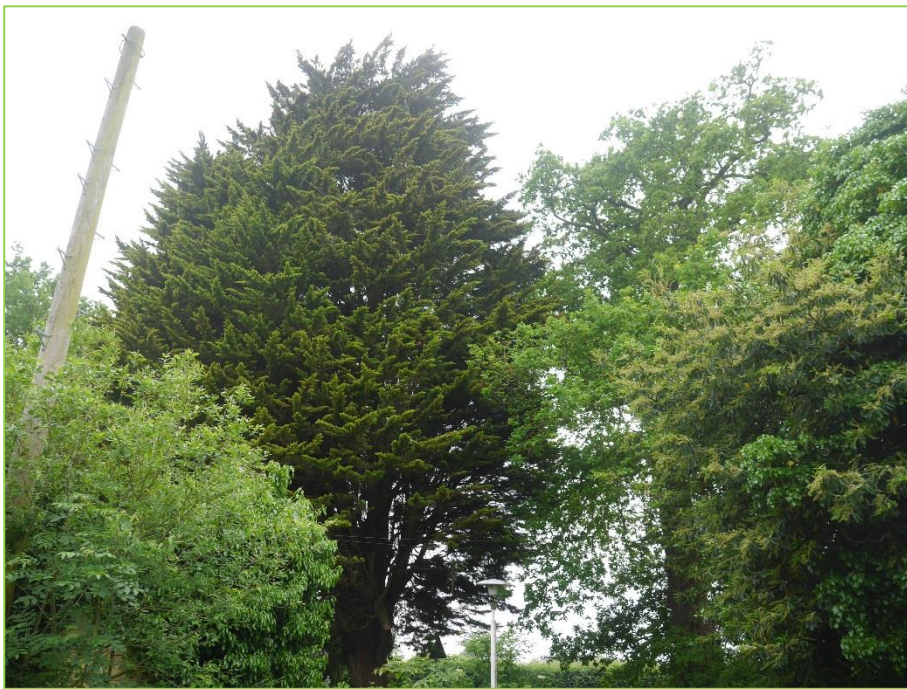
Photo 1: the site entrance with T1 oak (right) and T2 Leyland cypress (left).

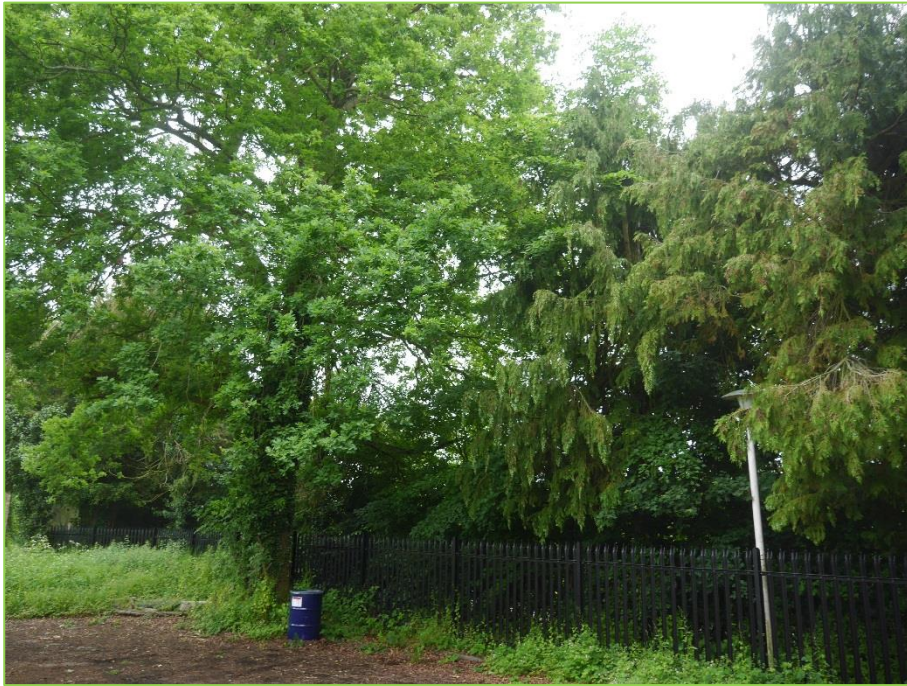
contain a mix of large mature specimens interspersed with failing screen planting and natural regeneration. The trees located within this groups are generally of low quality (C Category) but do contain a number of mature moderate quality (B Category) English oak trees and one high quality (A category) English oak tree. Although individually the understorey trees have been assessed as low quality, collectively they offer a higher value and are characteristic of the local area, offering good visual and acoustic screening to the proposed site from the adjacent road way (Boughton Lane). Wherever possible these trees and boundary vegetation groups should be retained and enhanced through selective removal of failing trees and replacement with new tree planting.

Photo 2: the western boundary trees and vegetation including low value Lawson cypress to the right of the picture and the moderate value oak tree T3 to the left.

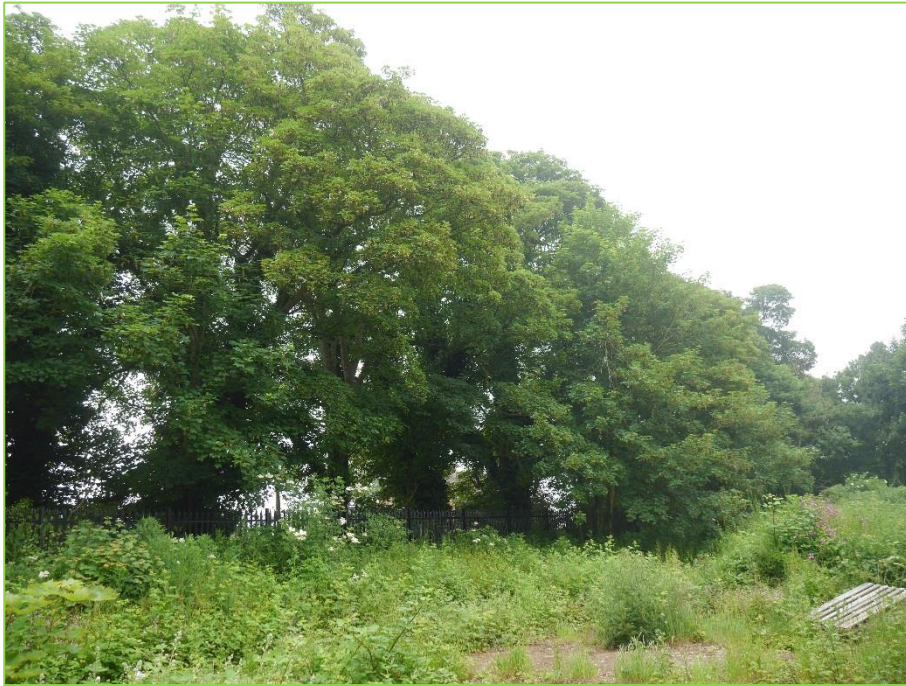
Trees within the northern boundary are mostly large mature offsite sycamore specimens with a few low quality sycamore trees growing with suppressed form beneath the canopy of with the more established offsite trees. The offsite trees are growing within raised banks or on the other side of drainage ditches that separate the site, levels vary significantly within the offsite area which will have an effect on root proliferation within the site. We therefore recommend a buffer strip of 6m from the boundary be incorporated into the design to avoid significant RPA incursions. We recommend the removal of the onsite trees T41 – T45 subject to planning approval and as part of a detailed landscaping scheme to enhance the site.

Photo 3: the offsite mature sycamore trees along the northern boundary.

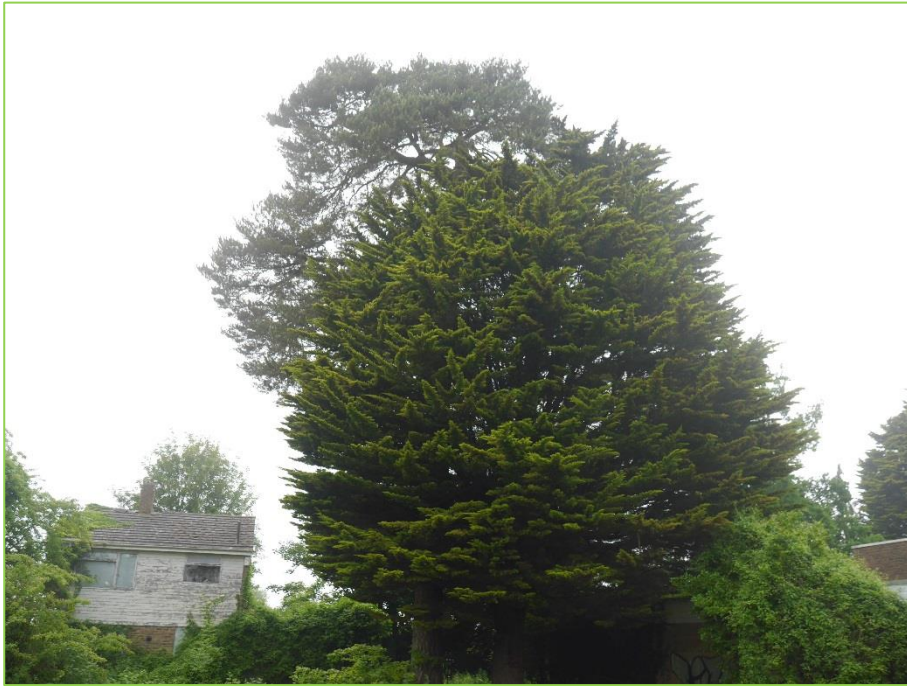
Photo 4: the Austrian pine T21 towering above the adjacent Monterey cypress T20.

Tree T21	1 Pinus nigra (Black Pine)	18.0	90	1	5.0		4.0		7.4		7.4		10.0		Late Mature	Structural condition Good. Physiological condition Good. Prominent tree.	31/05/2018	366.4	10.8	20-40	B1/B2
Tree T22	1 Chamaecyparis lawsoniana 'Aurea Nova' (Lawson's Cypress cv.)	12.0	35	1	3.5		3.5		3.5		3.5		0.0		Mature	Structural condition Fair. Physiological condition Fair.	31/05/2018	55.4	4.2	10-20	C2
Tree T23	1 Eucalyptus sp. (Eucalyptus Tree)	14.0	35	1	5.0		5.0		5.0		5.0		4.0		Early Mature	Structural condition Fair. Physiological condition Fair. Dimensions and location visually estimated	31/05/2018	55.4	4.2	10-20	C1
Tree T24	1 Quercus robur (English Oak)	20.0	100	1	8.2		8.2		6.5		6.5		2.0		Late Mature	Structural condition Fair. Physiological condition Good. Die-back - Mid crown. Fungal fruiting body - structural decay suspected.	31/05/2018	452.4	12.0	20-40	B3
Tree T25	1 Chamaecyparis lawsoniana (Lawson Cypress)	8.0	15	1	1.15		1.0		1.5		1.5		0.0		Early Mature	Structural condition Fair. Physiological condition Fair.	31/05/2018	10.2	1.8	10-20	C2

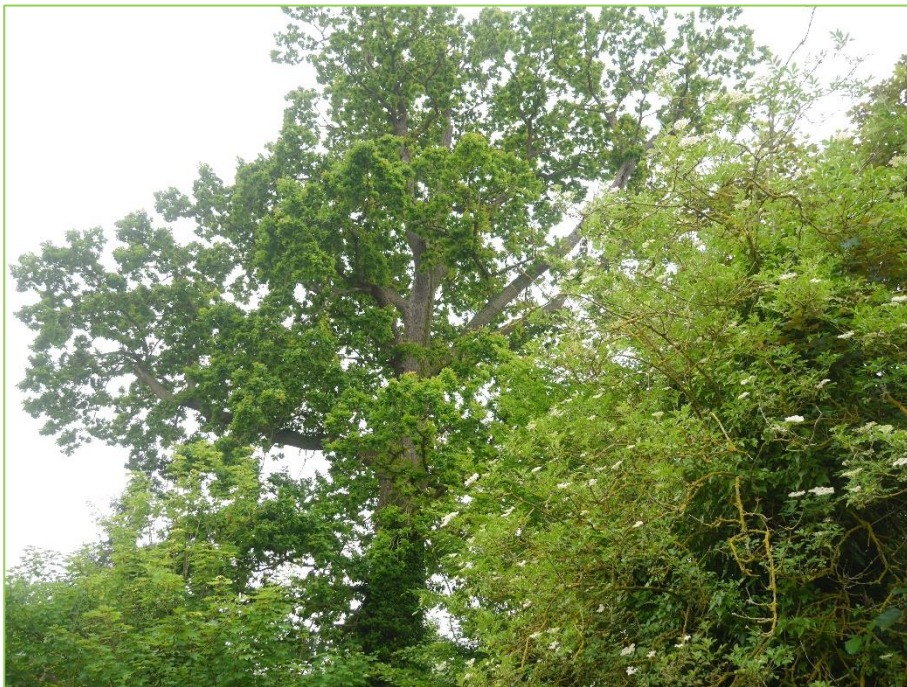
Photo 5: the prominent oak tree T24 requiring internal decay detection.

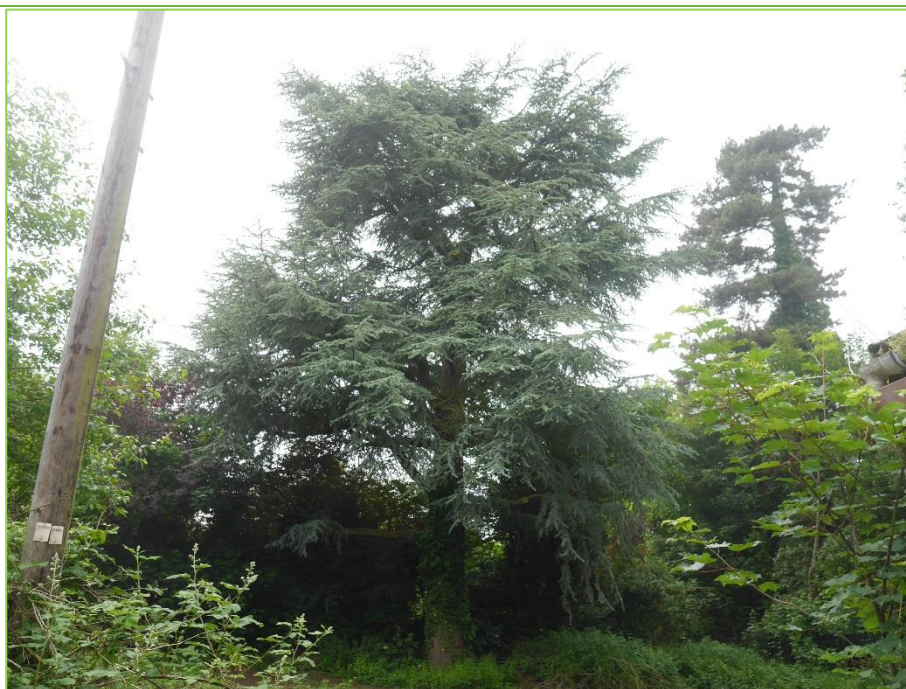
Photo 6: the high value blue atlas cedar T32 with open grown form.

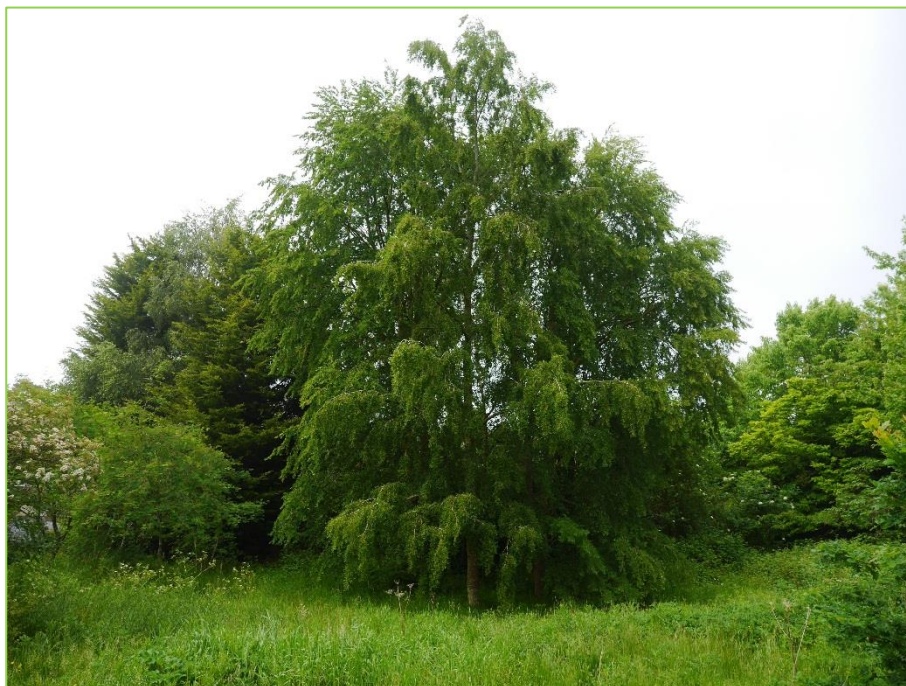
Photo 7: the southern beech trees T65 – T67, an unusual species with mature form.

Tree T66	1 Nothofagus antarctica (Antarctic Beech)	18.0	28	1	1.1	2.3		4.3		3.1			1.0		Mature	Structural condition Fair. Physiological condition Fair. Competition - Adjacent trees. Suppressed crown - Minor. Unbalanced crown - Minor.	31/05/2018	35.5	3.4	10-20	C1
Tree T67	1 Nothofagus antarctica (Antarctic Beech)	18.0	47	1	4.5	5.6		5.0		3.0			1.0		Mature	Structural condition Fair. Physiological condition Good. Deadwood - Minor. Fork - Suspected structurally sound. Reaction wood / Adaptive growth - Base.	31/05/2018	99.9	5.6	20-40	B1
Tree T68	1 Fagus sylvatica 'Fastigiata' (Fastigate Beech)	17.0	45 COM	3	4.0	4.0		3.0		2.5			1.0		Early Mature	Structural condition Fair. Physiological condition Good.	31/05/2018	91.6	5.4	20-40	B1
Tree T69	1 Betula pubescens (Downy Birch)	16.0	33 COM	3		4.80		1.6		3.0		3.6	1.0		Mature	Structural condition Fair. Physiological condition Fair.	31/05/2018	51.5	4.0	10-20	C2

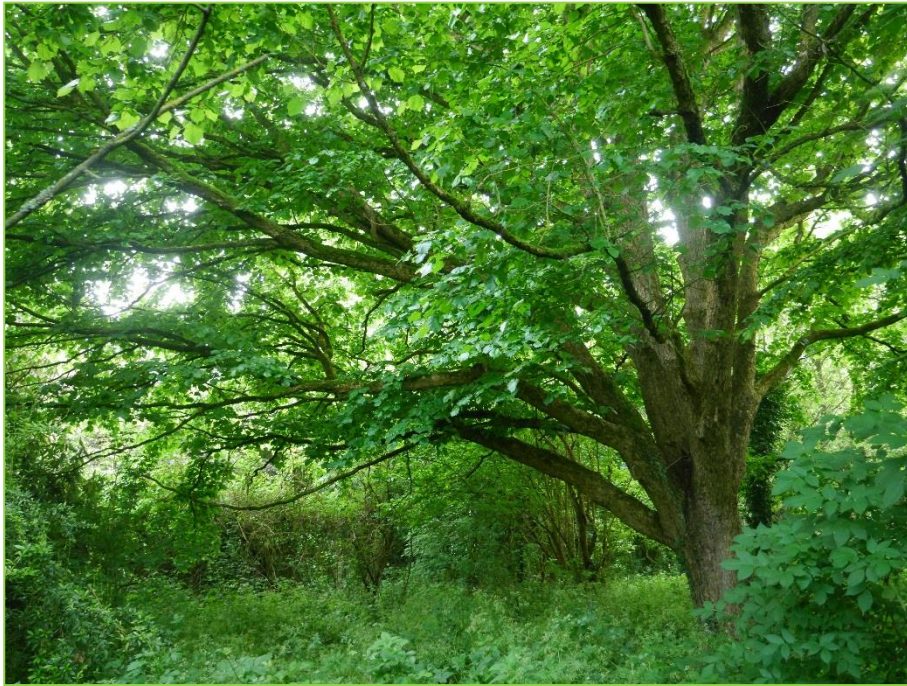
Photo 8: the specimen handkerchief tree T77

1 Acer pseudoplatanus (Sycamore)																				
	1 Fagus sylvatica (Common Beech)																				
Tree T77	1 Davidia involucrata (Dove Tree/Handkerchief Tree)	17.0	82	1	10.0	11.0	12.0	10.5					2.0		Late Mature	Structural condition Good. Physiological condition Good. Decay / structural defect - Extensive. Decay / structural defect - Open cavity / cavities.	31/05/2018	304.2	9.8	40+	A3

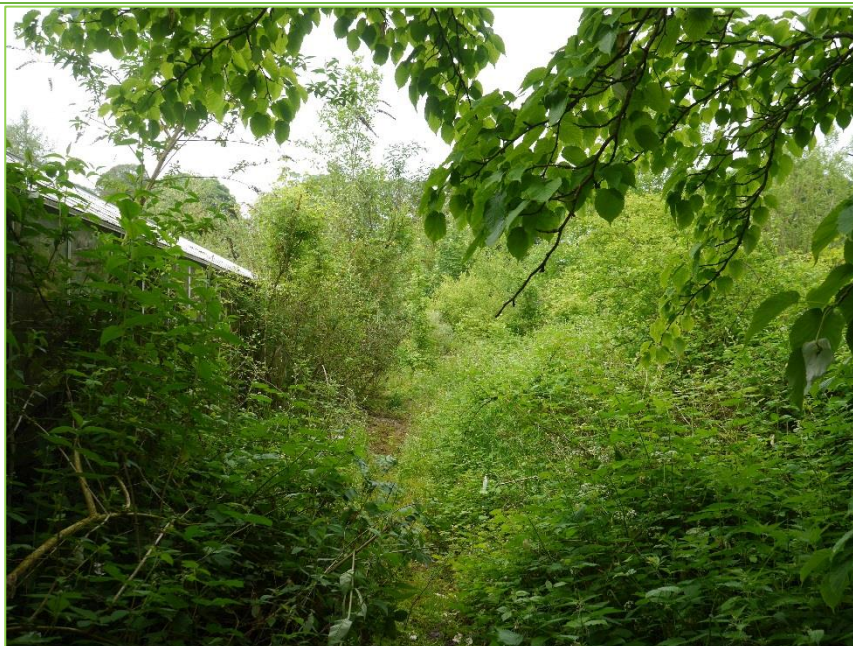
The site has been left unmanaged for several years resulting in areas of dense vegetation and regeneration. The majority of the site is covered with shrubs and scrub trees except where the buildings stand. The most distinct vegetation areas have been included on the plan with groups G75, G78, G79 and G80 forming areas of dense scrub including little or no trees of individual value but collectively form potential habitat for protected species and provide several eco-system services. As such, the clearance of these groups particularly G74 and G78 may be subject to further ecological investigation and will require mitigation within the landscape scheme to retain the verdant character of the site.

Photo 8: a view of the densely vegetated area G74.

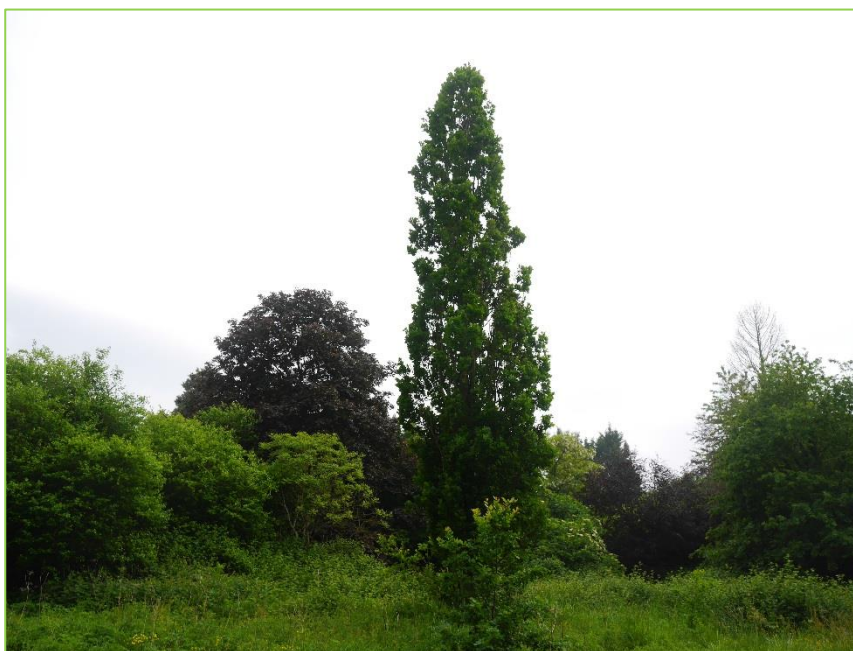
Photo 9: a view of the group G76 incorporating a mix of dense vegetation and prominent individual specimens.

The group G76 should be considered separately to those previously mentioned as it contains several individual specimen trees planted for amenity value and subsequently overgrown with scrub regeneration. Further inspection may be required once initial vegetation clearance has been undertaken to provide access to the area and a topographical survey has been undertaken to allow accurate plotting of
