The Pest House: Timber lintel investigation

Site note 2 for 27 November 2018, job no. 148.73

148.73 THE PEST HOUSE – SITE NOTE 2

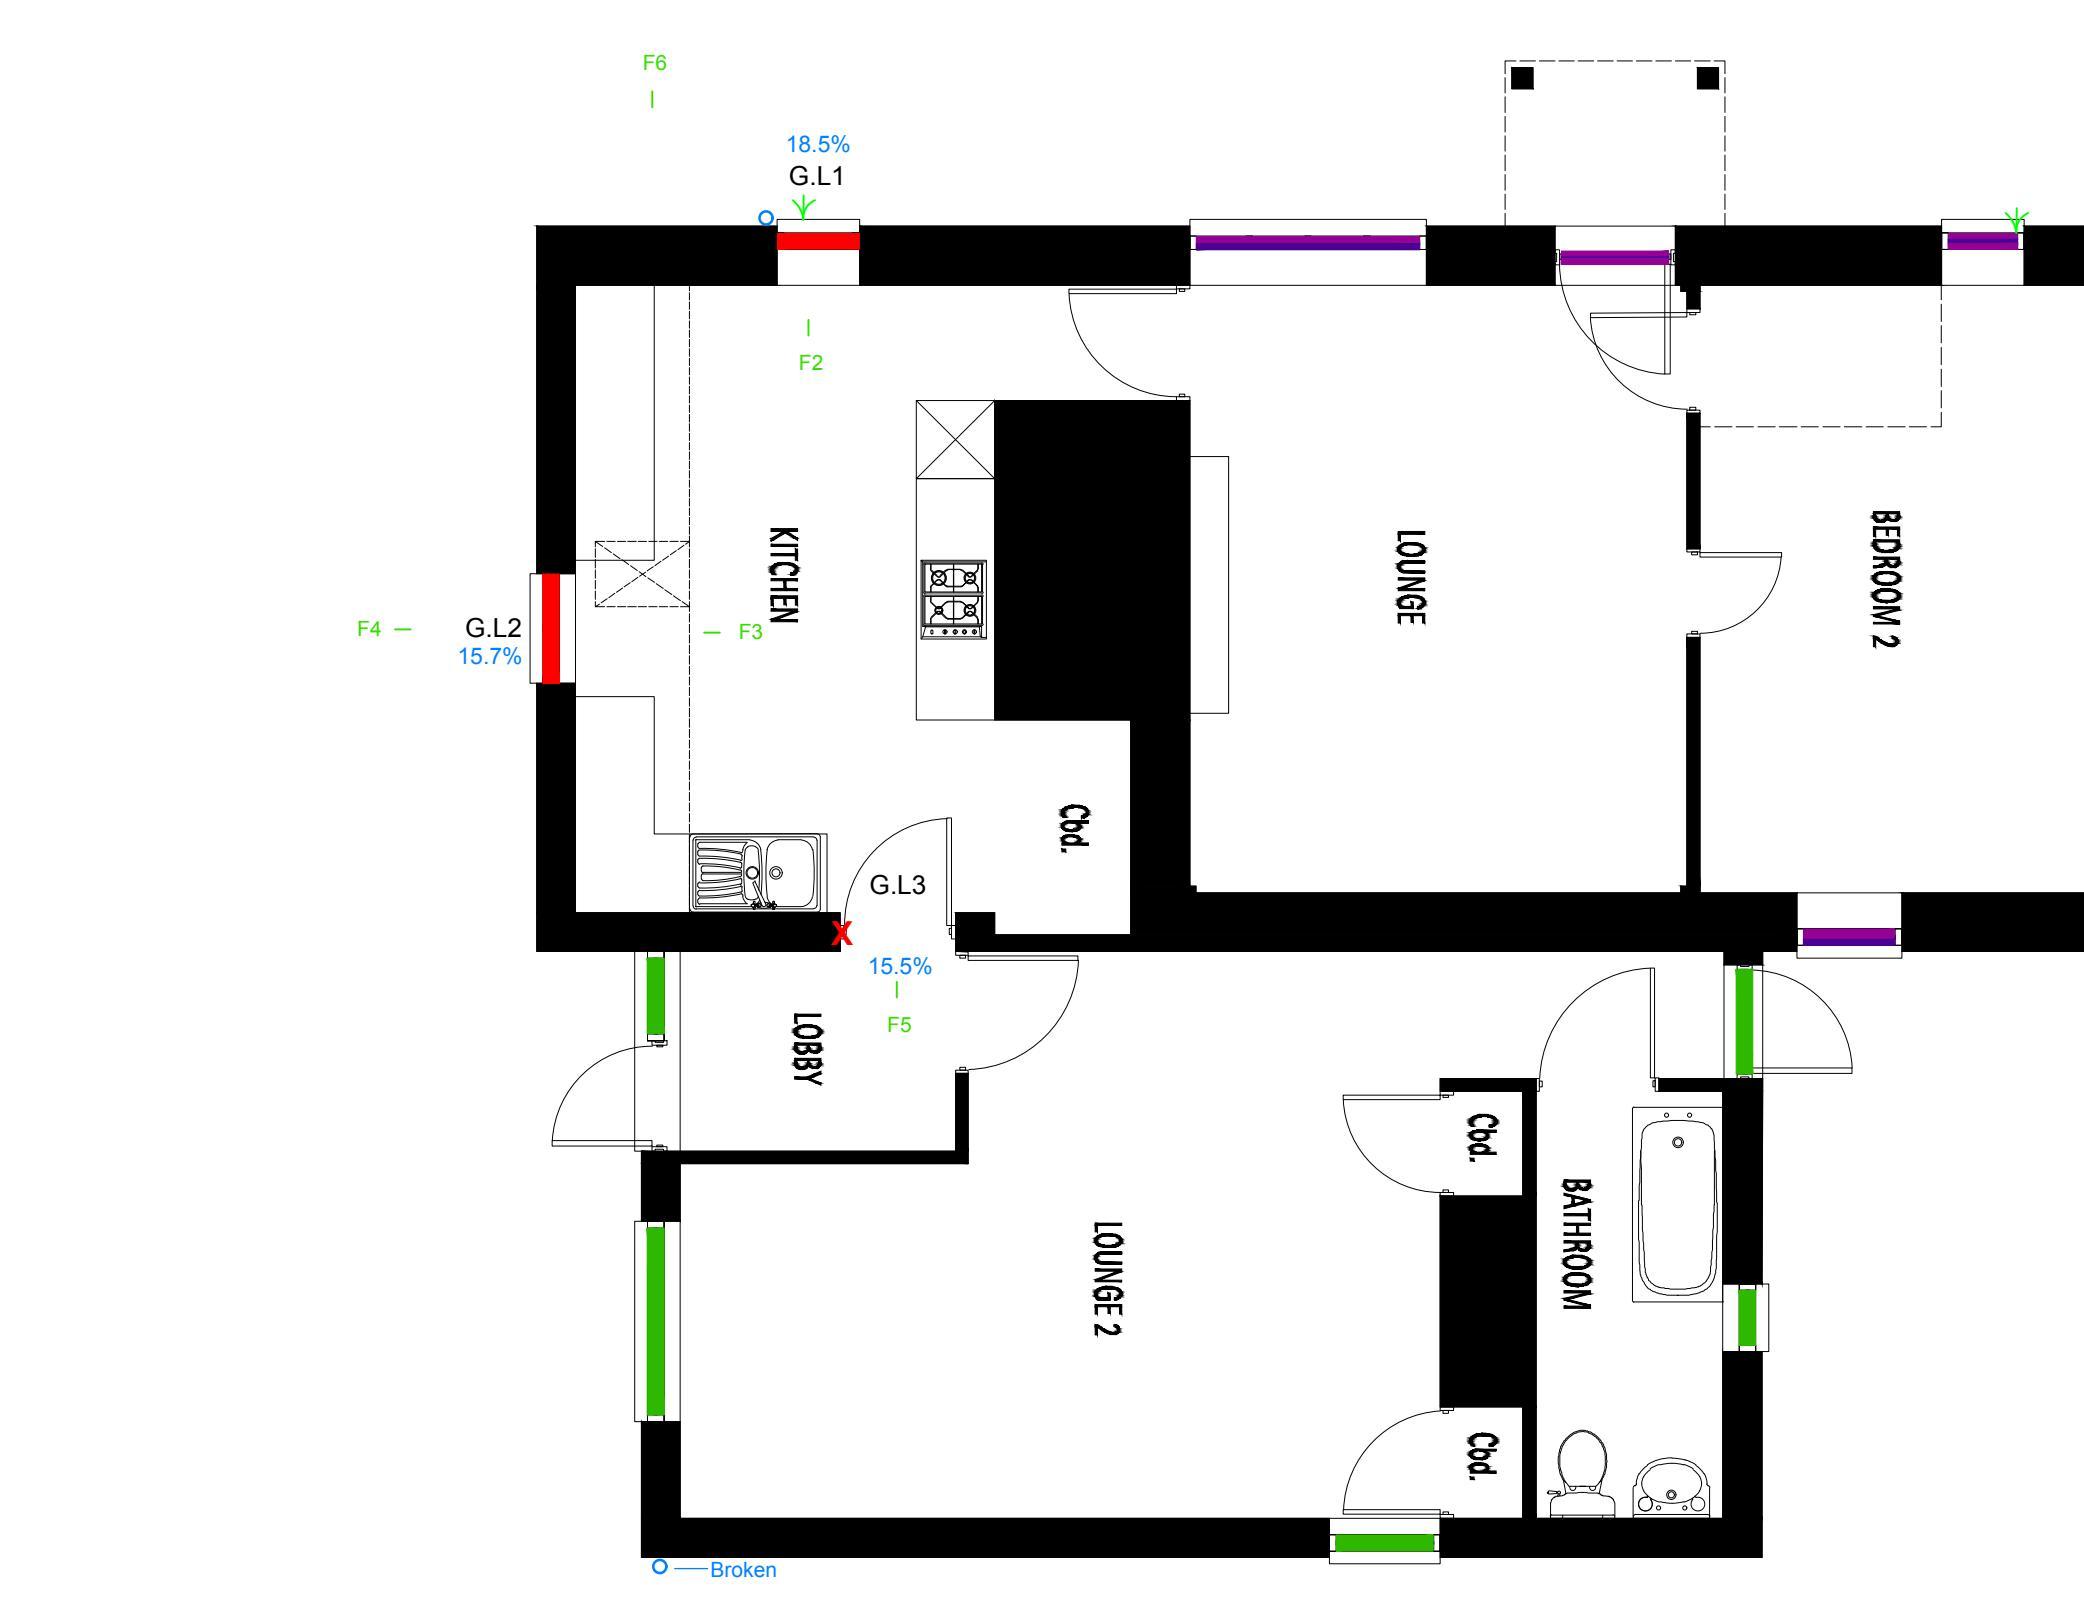
The Pest House, Ground Floor Timber lintel investigation 27 November 2018

All three "independent" lintels were found to be decayed or partially decayed as shown in the Schedule at Attachment A and on the plans at Attachment B. For further details on condition and recommendations please see Schedule at Attachment A

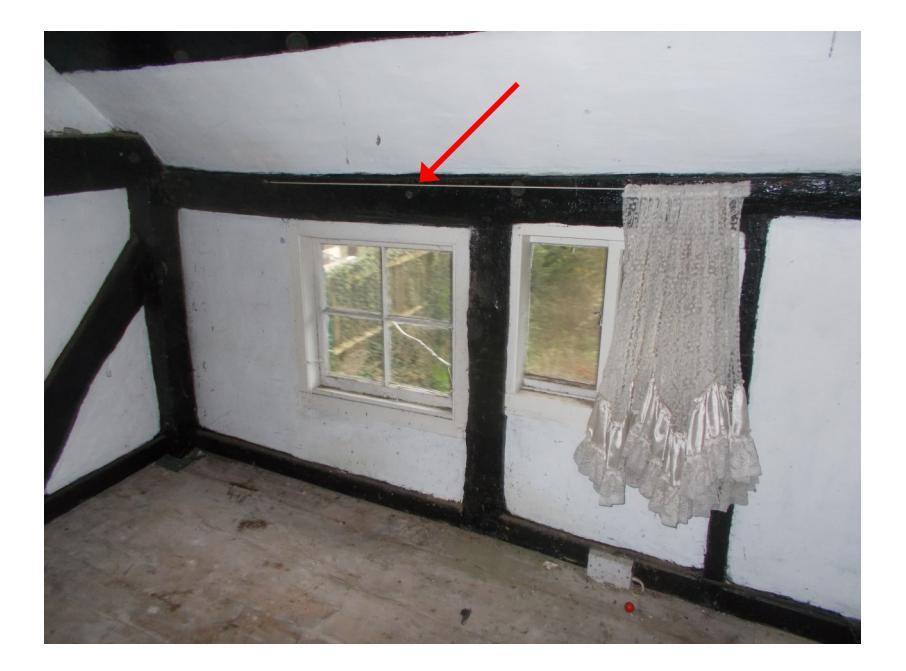
Fig 1:

First floor; showing an example of the timber plate/top rail structure above the windows. These elements were not investigated as they were surveyed as part of the timber condition survey (see site note 3)

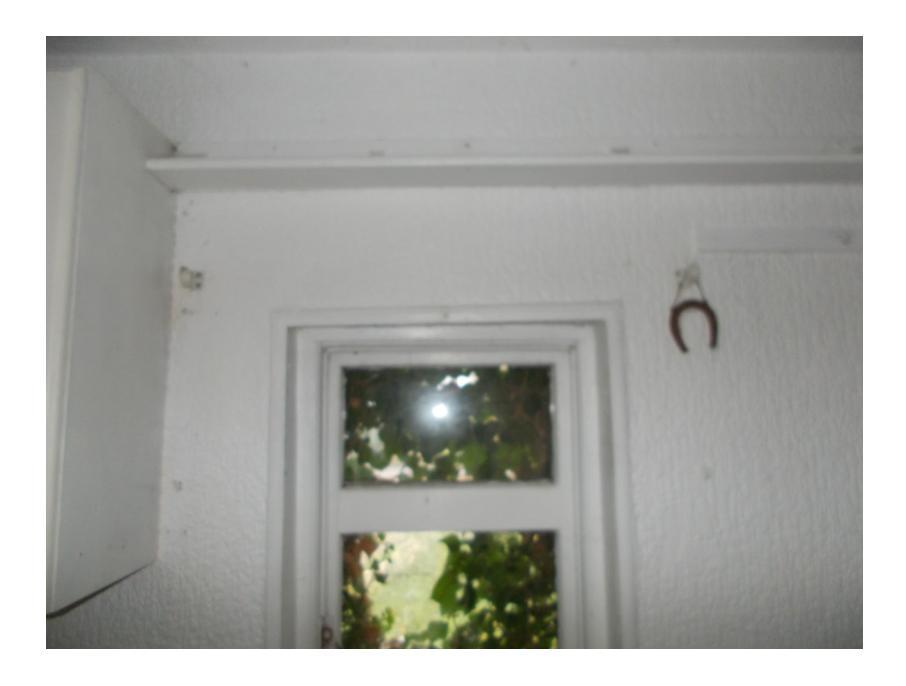
Fig 2:

REFERENCE	ITEM	OBSERVATIONS	RECOMMENDATIONS	CLIENT COMMENTS			
GROUND FLOOR							
G.L1	Timber	The lintel was found to be decayed throughout its whole length. The lintel had a heightened deep moisture content of 18.5 per cent, just below the threshold at which decay may occur which is 22 per cent. Suspected failure to the rainwater downpipe may be cause of structural decay in the past. On the north elevation plant growth covered the entire window opening and stopped it from closing properly, the plant may also be blocking the rainwater downpipe causing water ingress problems	Lintel should be replaced with concrete or steel as directed by the Structural Engineer, but, it is likely that as a listed building, the Conservation Officer will specify timber of a similar species to match the original. All roof drainage systems should be checked, cleared and repaired or replaced if necessary. Remove plant growth from window opening, drainage system and surrounding area

G.L1; showing location of lintel. This lintel was found to be decayed. Decay detection drilling and deep moisture probing resulted in a reading of 18.5 per cent

Allowance should be made for the replacement of the lintel

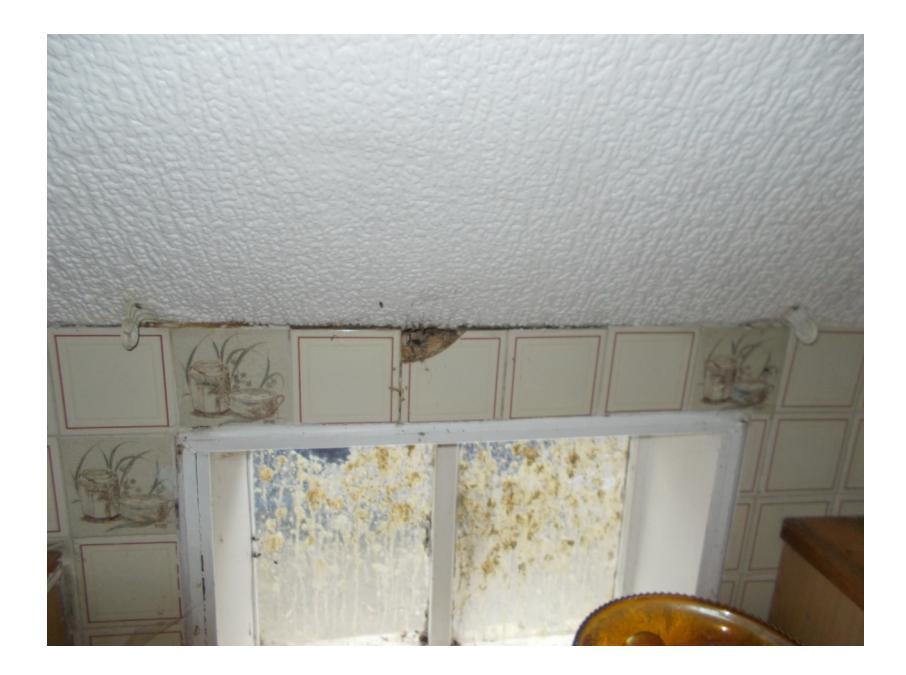
Fig 3:

G.L2	Timber (wall plate)	The timber element was found to be decayed throughout its length. The timber element had a deep moisture content of 15.7 per cent, below the threshold at which decay may occur which is 22 per cent. Lack of adequate roof drainage from missing the gutter around the lintel is likely the cause for decay	Timber element should be replaced with concrete or steel as directed by the Structural Engineer, but, it is likely that as a listed building, the Conservation Officer will specify timber of a similar species to match the original. An appropriate roof drainage system should be re-instated during refurbishment				
G.L3	Timber (above door)	The lintel was found to be decayed at its west bearing end. The lintel had a deep moisture content of 15.5 per cent, below the threshold at which decay may occur which is 22 per cent. Decay may be	Lintel should be replaced with concrete or steel as directed by the Structural Engineer, but, it is likely that as a listed building, the Conservation Officer will specify timber of a similar species to match the original. Care

G.L2; showing location of possible lintels. The timber element may be a wall plate, however, it was still investigated and was found to be decayed. Decay detection drilling and deep moisture probing resulted in a reading of 15.7 per cent

Allowance will need to be made for further investigation and replacement

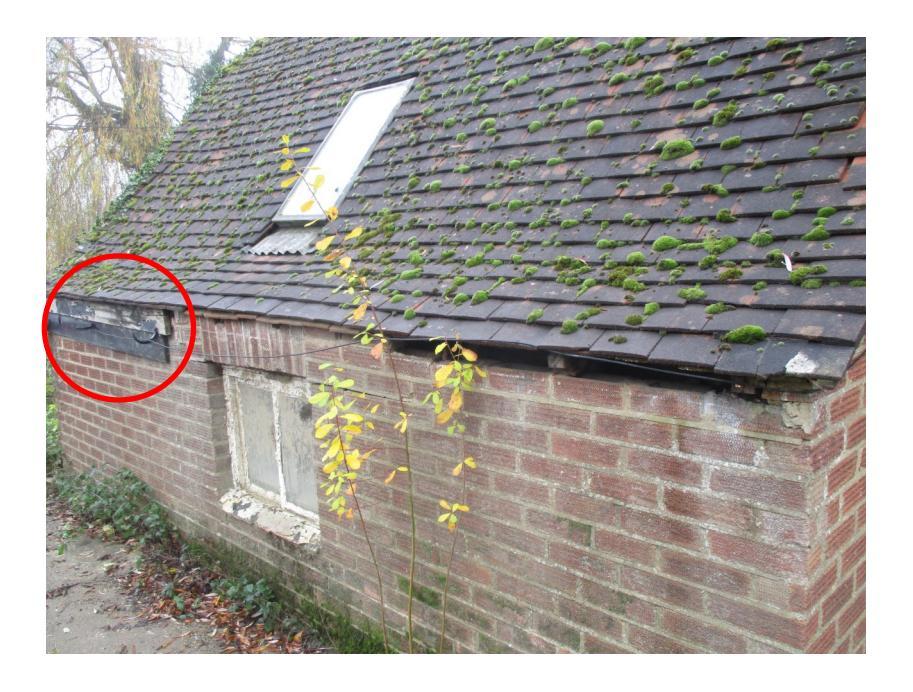
Fig 4:

G.L2 from exterior; showing missing gutter with only the gutter brackets remaining. Lack of adequate roof drainage around the lintel may be cause for decay

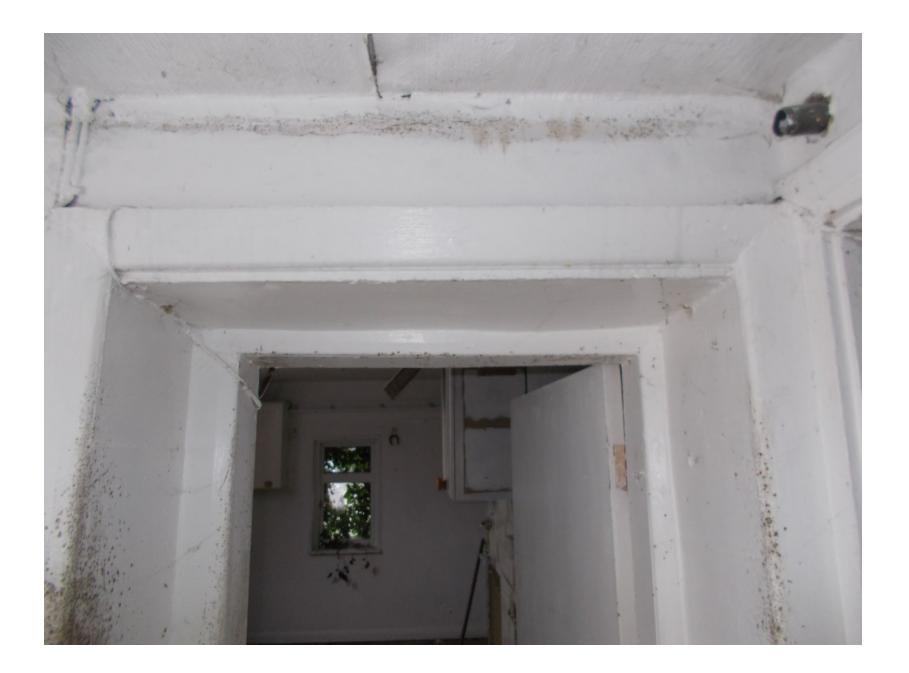
Fig 5:

REFERENCE	ITEM	OBSERVATIONS	RECOMMENDATIONS	CLIENT COMMENTS
		caused by a suspected faulty roof water course at the roof joint between the section to be retained and the old extension	should be taken during demolition to fully prevent further water ingress into the building at this point. H+R can advise further if directed

G.L3; showing location of lintel. The west bearing end of the lintel was found to be decayed on drilling. Decay detection drilling and deep moisture probing resulted in a reading of 15.5 per cent. Decay may be caused by a faulty roof water course above

Allowance should be made for the replacement of the lintel

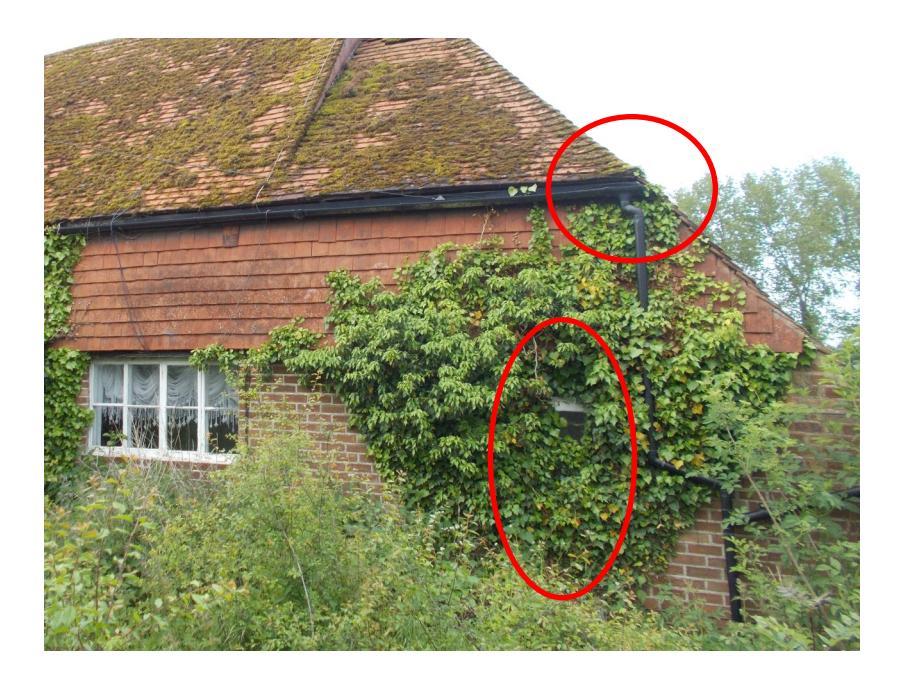
Fig 6:

Exterior of north elevation; showing plant growth over window (G.L1) and gutter. Suspected faulty roof drainage system may be the cause of decay to the lintel

Plant growth should be removed from the surrounding area around the window. All roof drainage systems should be checked, cleared and repaired or replaced if necessary
