Gladman Developments Limited

Land off Cross Road, Deal, Kent, CT14 9JN

Phase 1 Geo-environmental site assessment

302162 R01 (01)

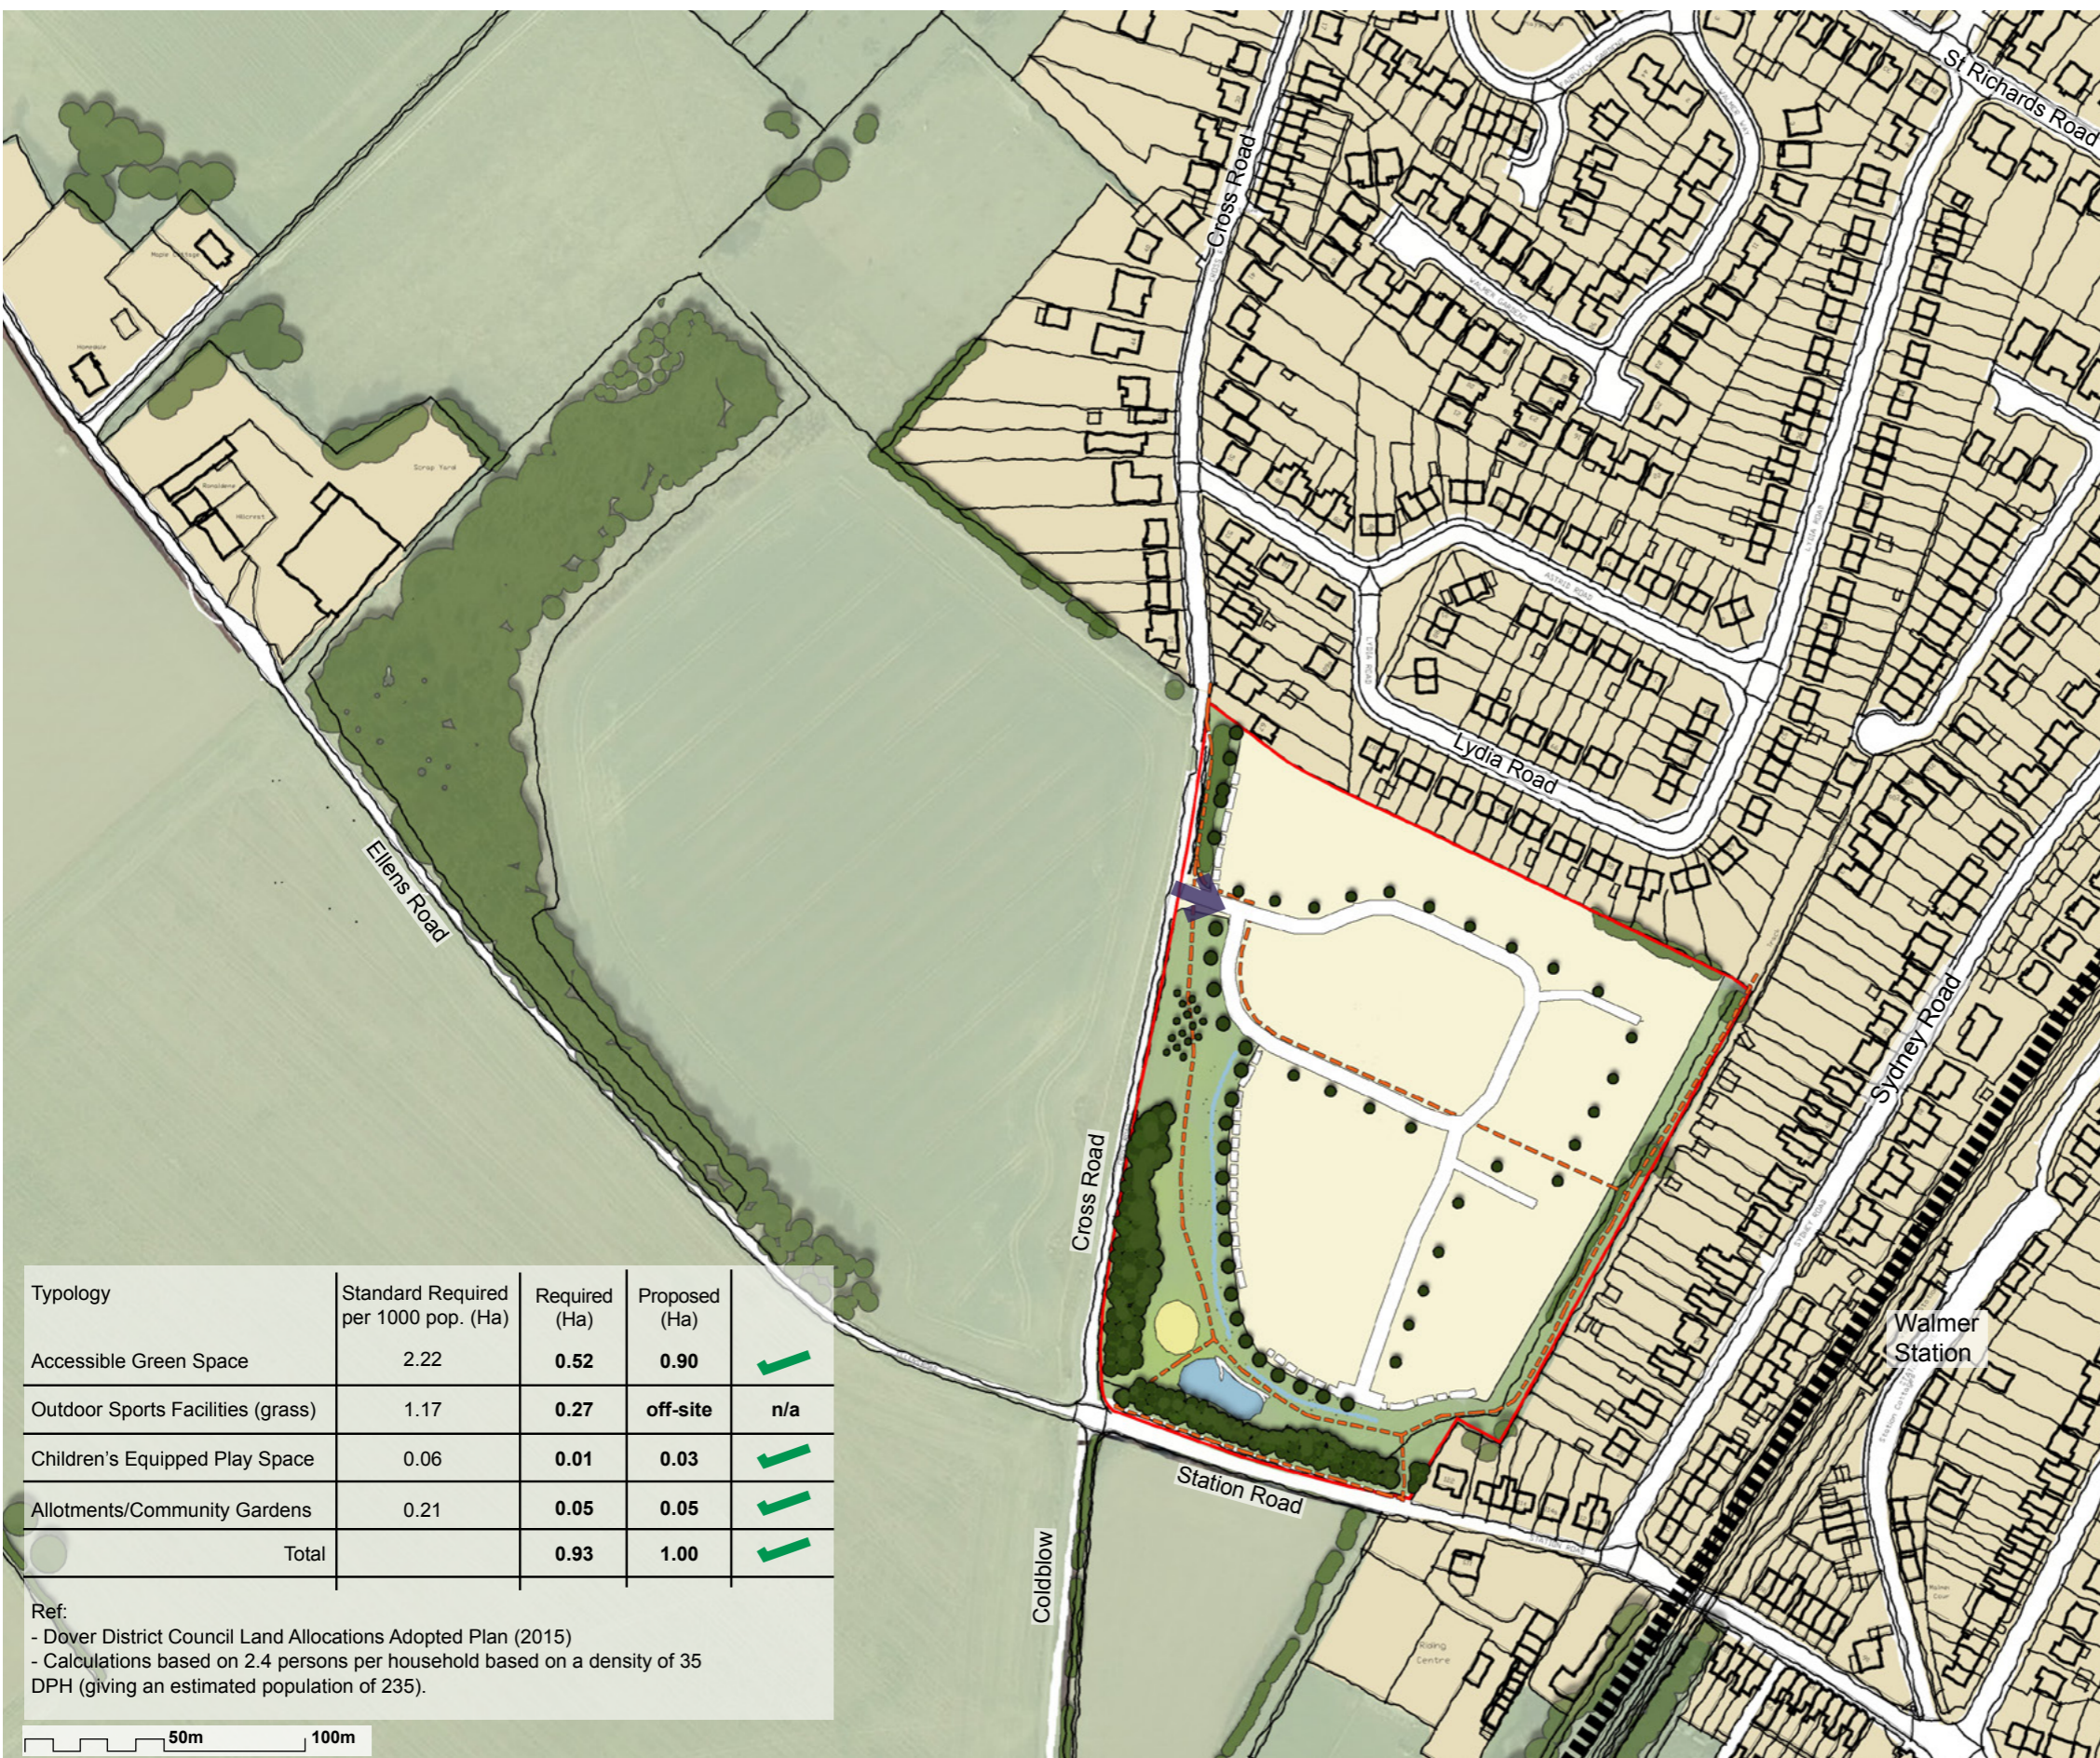
Development Framework drawing (Ref: 7572-L-03_L) shows areas of Public Open Space (POS), woodland preservation and a building development area of 2.74Ha, including 100 residential dwellings with soft landscaping and private gardens.

Proposed Attenuation Pond **365m²**
