Gladman Developments Ltd

# Land of Dover Road, Deal

Preliminary risk assessment

28927 R01 (03)

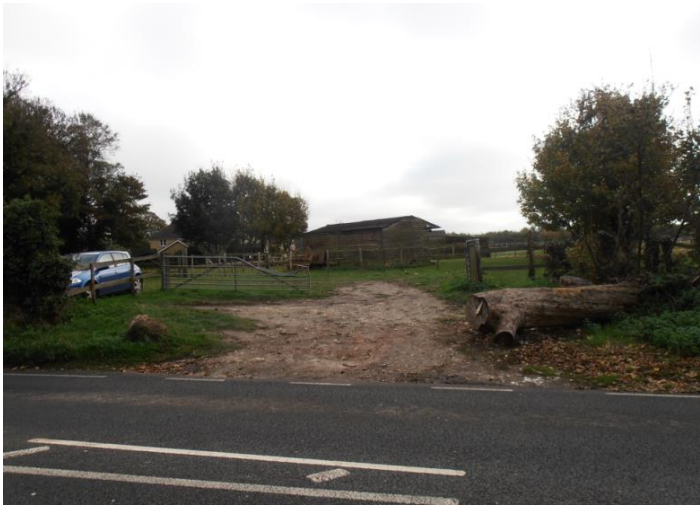
<b>Photo No.</b> 4	<b>Date:</b> 7/11/16

<b>Direction Photo Taken:</b> Looking East		
<b>Description:</b> Site entrance from Dover Road Deal
