LUSTRE
CONSULTING

**ASHPLATS HOUSE - EAST GRINSTEAD
PRELIMINARY PHASE 2 SITE
INVESTIGATION**

NON-TECHNICAL SUMMARY

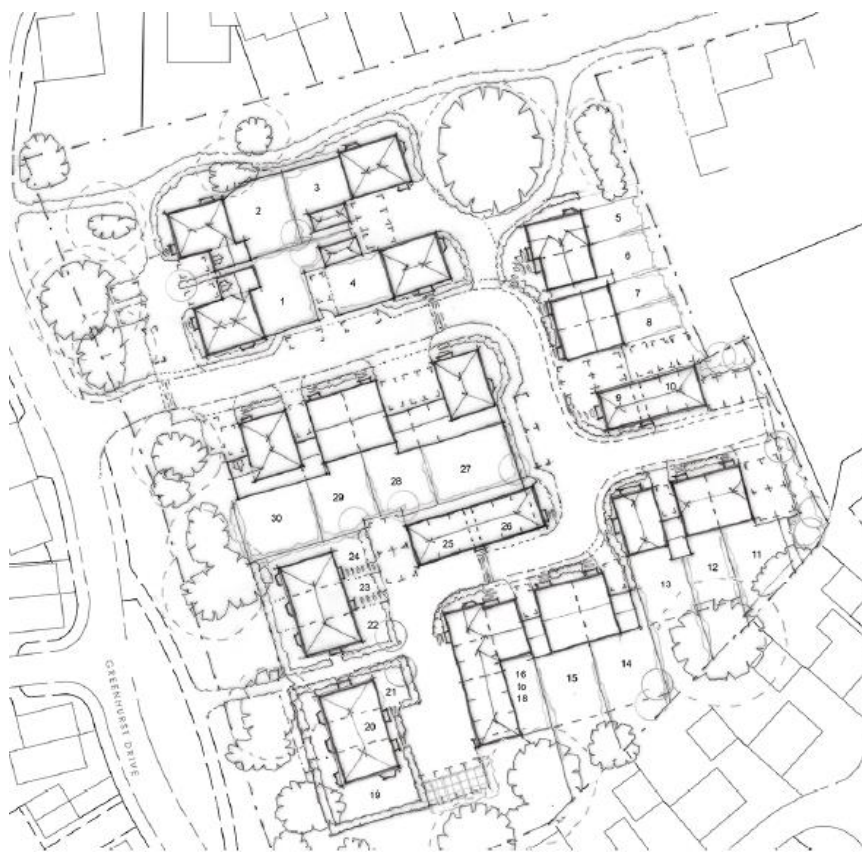
Figure 2: Proposed Site Layout

- 1.2 The site, irregular in plan, is centered at National Grid Reference 540840, 139300, and occupies an approximate area of 1.13ha, as shown in Figure 1. The site currently comprises a low rise residential dwelling with private gardens and is located within a mixed forested and residential land use area. Anoushka Bos requires this Phase 2 Site Investigation to support the sale and eventual proposed development relating to construction of several low-rise residential housing units with associated car parking and private gardens, in addition to communal garden areas and driveway / access roads. Figure 2 illustrates the proposed development scheme.

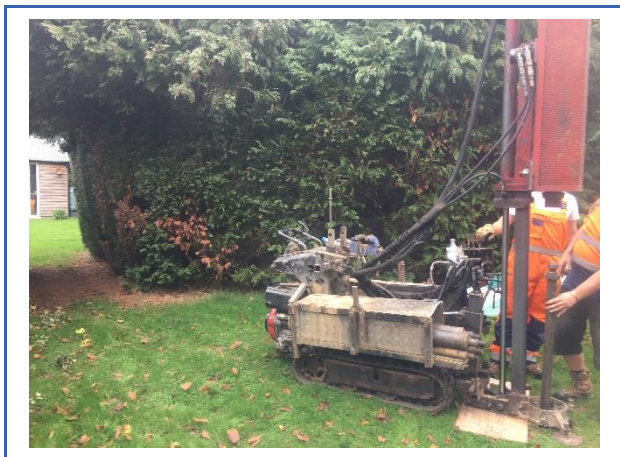
Windowless sampling rig used on site

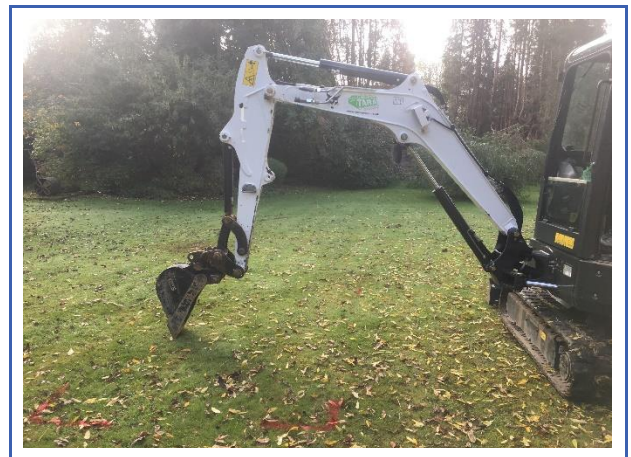
Mini digger used on site

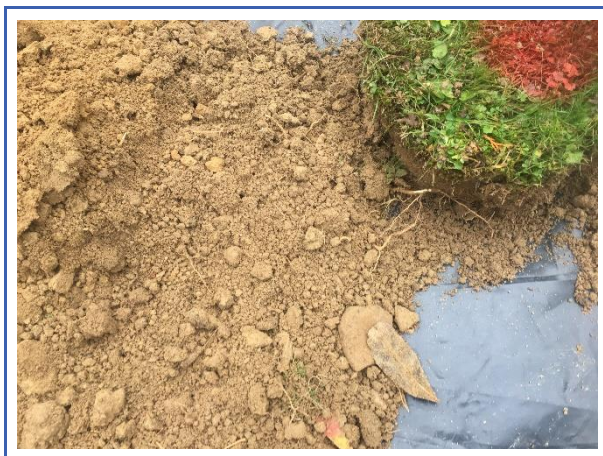
Limited topsoil overlying natural soils at WS1

- 3.2 Ground cover across the entire site comprised grass over topsoil, described as dark brown / greyish brown clayey slightly gravelly / sandy silt with roots. Gravel was recorded as angular to subangular fine flint, and coal/clinker (WS2). Sand of ash was present in all of the window samples and soakaway trial pits. The topsoil was recorded to a maximum depth of 0.20m bgl (WS2) with an average thickness of 0.1m.
- 3.3 No visual or olfactory evidence of hydrocarbon or solvent-type contamination was noted within the topsoil.
- 3.4 In-situ headspace readings within the topsoil did not indicate the presence of volatile compounds with a maximum concentration of 0.3ppm recorded in WS2 at a depth of 0.15m bgl.

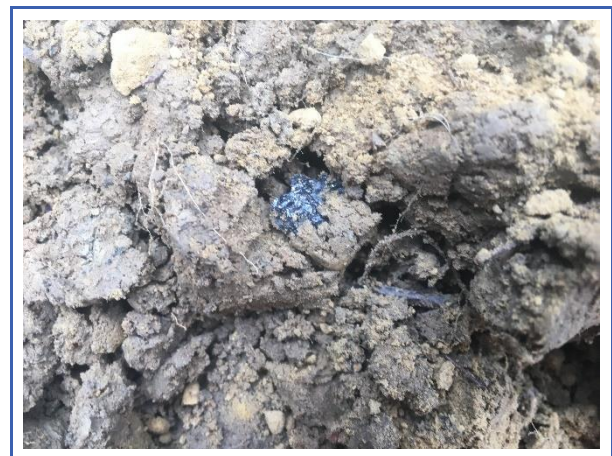
Rare coal/clinker fragments within WS4

- 3.6 In terms of composition, the Made Ground was noted to be generally homogenous, with the difference being the composition of the gravel in three of the locations. Within WS4 it was comprised of clinker/coal, in Soak 3 it was comprised of sandstone, brick and plastic fragments, whilst in TP1 it was recorded as brick and flint.

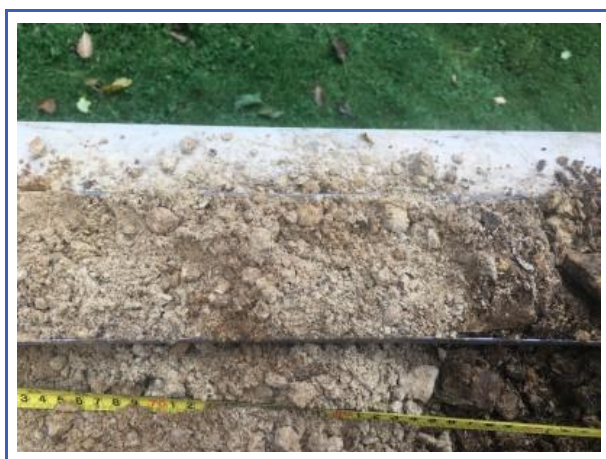
WS2 – Silt with ironstone band.

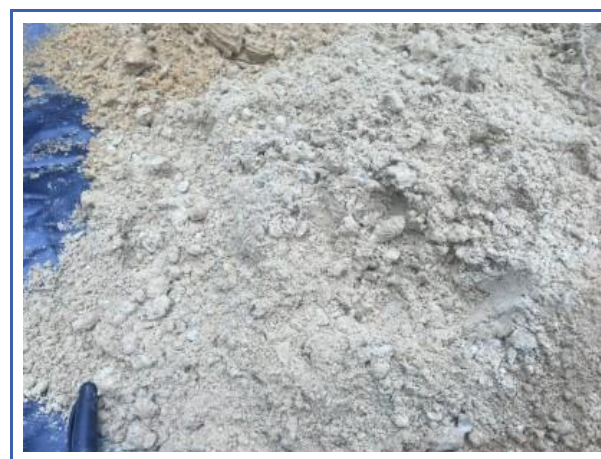
WS4 – Fine sand.
