**ASHPLATTS HOUSE - EAST GRINSTEAD**

**PHASE 1 DESK STUDY**

PROJECT RECORD		
PROJECT NAME	ASHPLATTS HOUSE - EAST GRINSTEAD	
CLIENT	DHA GROUP	
REPORT DETAILS		
TYPE	PHASE 1 DESK STUDY	
REFERENCE	2390_FP02.0-2018	
ISSUE DATE	OCTOBER 2018	
AUTHOR	AMY KHAN BSc (Hons) CONSULTANT

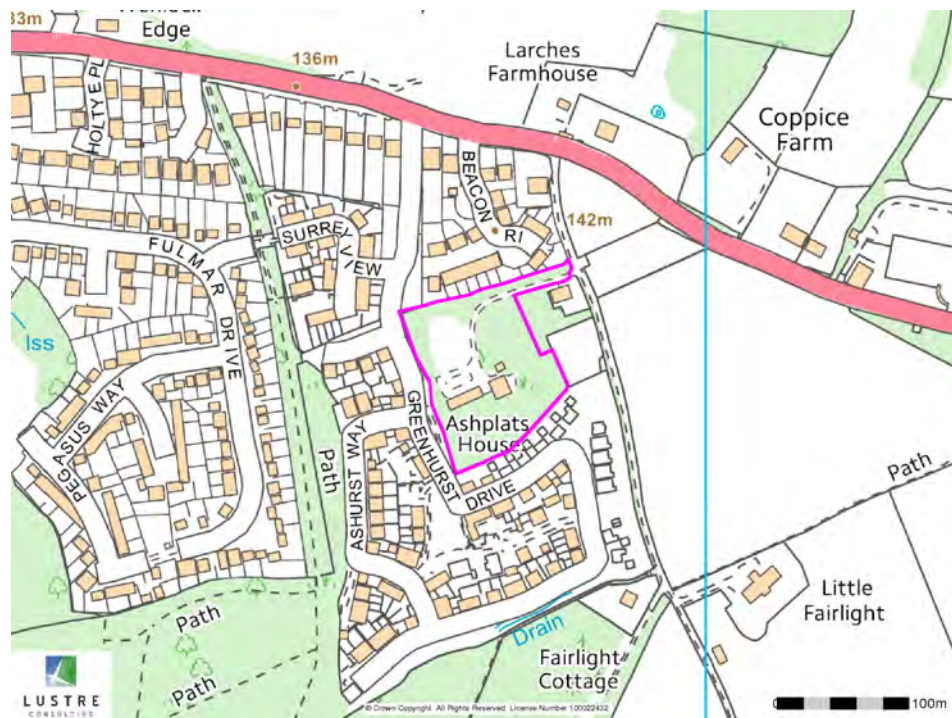
Figure 1: Site Location Plan

- 1.2 The site, irregular in plan, is centered at National Grid Reference 540840, 139300, and occupies an approximate area of 1.13ha, as shown in Figure 1. The site currently comprises a low rise residential dwelling with private gardens and is located within a mixed forested and residential land use area. DHA Group requires this Phase 1 Desk Study to support the proposed development relating to construction of several low-rise residential housing units with associated car parking and private gardens, in addition to communal garden areas and driveway / access roads. Figure 2 illustrates the proposed development scheme.

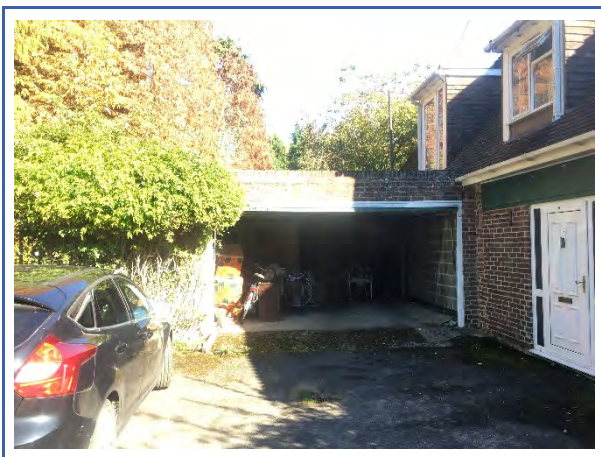
- 2.6 The garage adjoining Ashplatts Cottage stored several domestic items including bicycles, furniture, and two above ground fuel storage tanks. Anecdotal evidence from the land owner confirm the one of the two tanks is actively used. Further details of the tanks are provided below.

*Domestic garage adjoining Ashplatts Cottage*

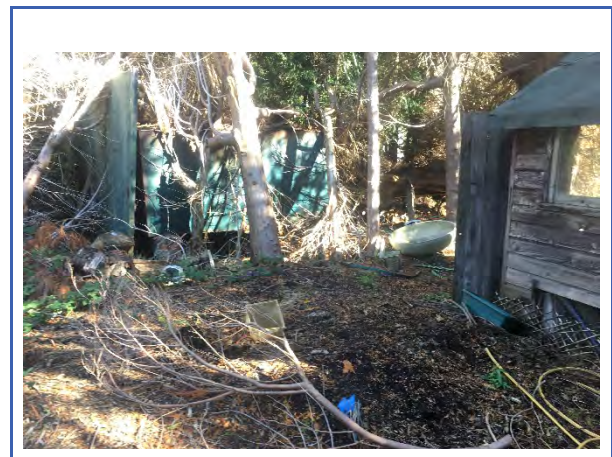
- 2.7 In general, housekeeping was good across the site. Limited visual evidence of contamination was noted on site, as follows: burnt waste dumping ground by external disused above ground fuel storage tank, and limited staining around aforementioned tank.

*Storage shed with disused AST and coal dumping ground*

- On-site: Small burnt waste dumping ground aside of AST 3: anecdotal evidence from the landowner suggests that this area is used to dispose of burnt coal waste, derived from their internal, domestic firepit. Potential contaminants associated with the burnt waste include PAHs.

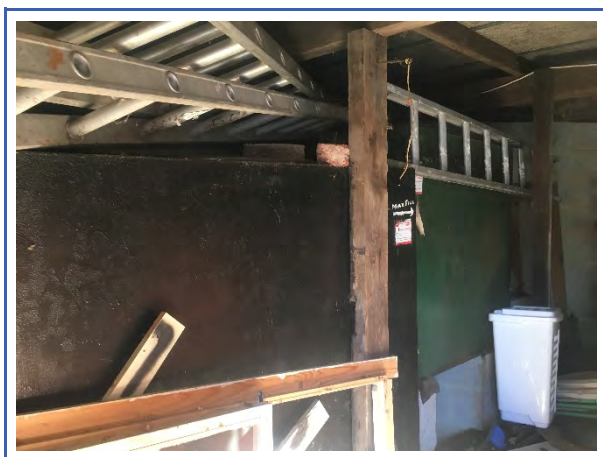
Tank Reference	AST 1	AST 2	AST 3	AST 4
Tank Volume	1500	2000 litres	2000 litres (assumed)	2000 litres
Material/Fuel Stored	Above ground – raised approximately 0.4m above ground level on concrete blocks. All tanks are understood to store or have stored kerosene.			
Tank Construction	Single-skinned, metal			
Tank Bunding	None - on hardstanding, located within garage	None - on hardstanding, located within garage	None – located over soft landscaping	None – on hardstanding
Liquid Transmission Pipework	Below ground (assumed – no overhead pipework noted)			
Evidence Of Leaks/Spills	None	None	Limited	None
Details Of Leaks/Spills	N/A	N/A	Slight darkening on concrete blocks	N/A
General Remarks on Bulk Fuel Storage	Refilled three times a year. Currently in use	Not in use	Not in use since site occupation	Refilled four to five times a year. Currently in use

*ASTs within domestic garage*

- On-site: Above ground fuel storage tanks (ASTs): two external and two internal ASTs are present in the centre of the site. Three of the four ASTs (AST 1, AST 2 and AST 4) comprised of rectangular and square metal tanks supported on brick walls directly underlain by hardstanding. The remaining rectangular, metal tank (AST 3) was also supported on a brick wall but was underlain by soft landscaping. Minor evidence of staining was noted on the brick wall of AST 3. Two of the four tanks are currently in use, and are noted to store kerosene. Tanks AST 1 and AST 4 are refilled three and up to 5 times a year, respectively. The main contaminants of concern include lead, PAH, solvents, TPH and volatile organic compounds (VOC).

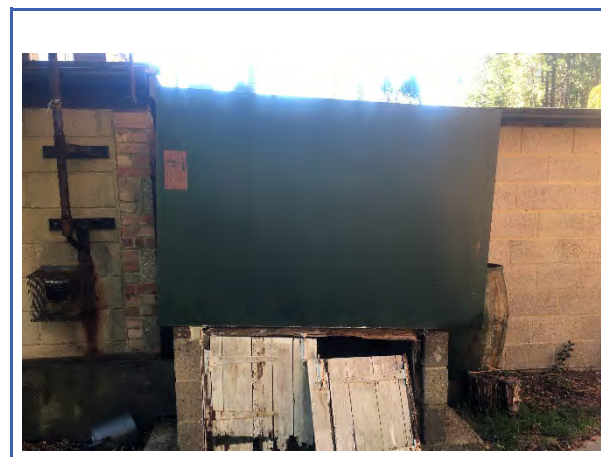
*External active tank*

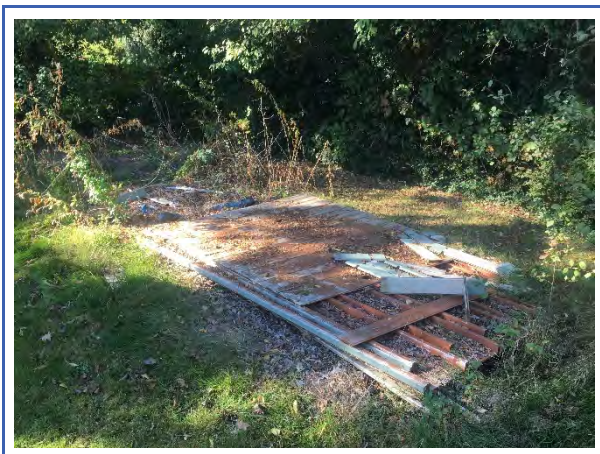
*Domestic waste at northern site boundary*

- 2.15 General domestic waste was noted within localised areas across site; towards the northern site boundary, in between the disused (external) AST and nearby storage shed. Items include wood, gardening tools and materials and corrugated sheeting.

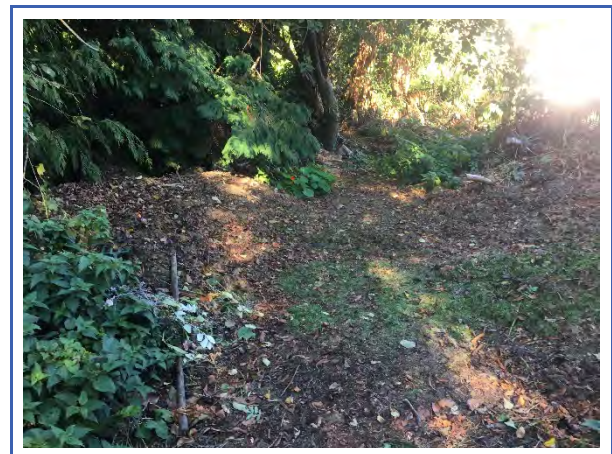
*Green waste: compost mound at south-eastern corner of site*

- 2.16 Green waste in the form of compost mounds, were noted at two areas across the site; within the centre of the northern boundary, and within the south-eastern corner.
