# PHASE III Site Investigation Report

at: Land East of Iwade,  
Sittingbourne, Kent, ME9  
8SJ

for: Bellway Homes Ltd.

Report Reference: 3741272

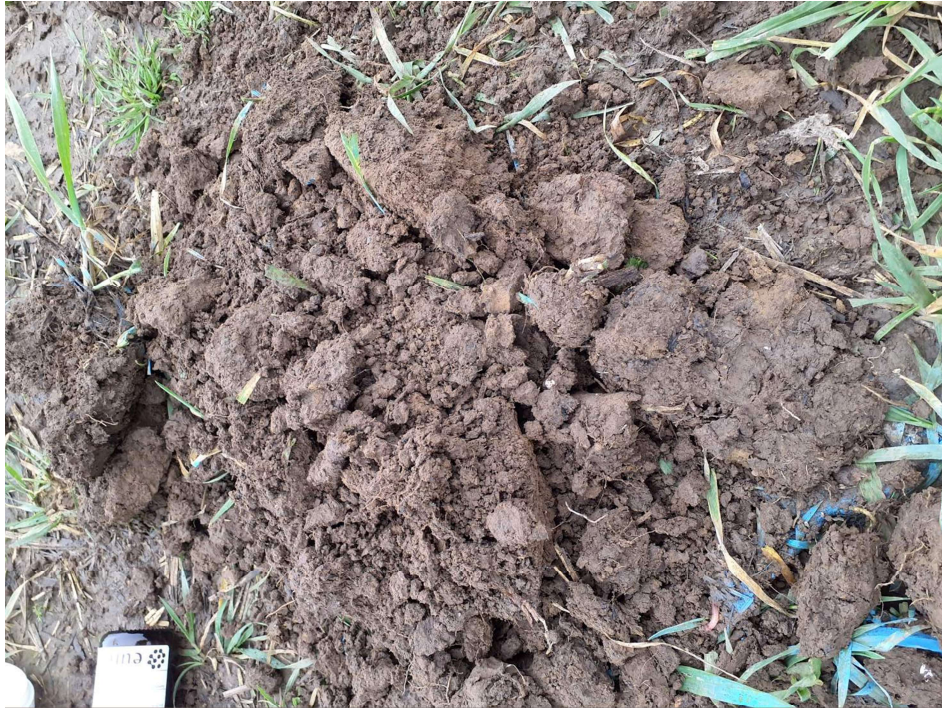
Plate 1: HA201 topsoil

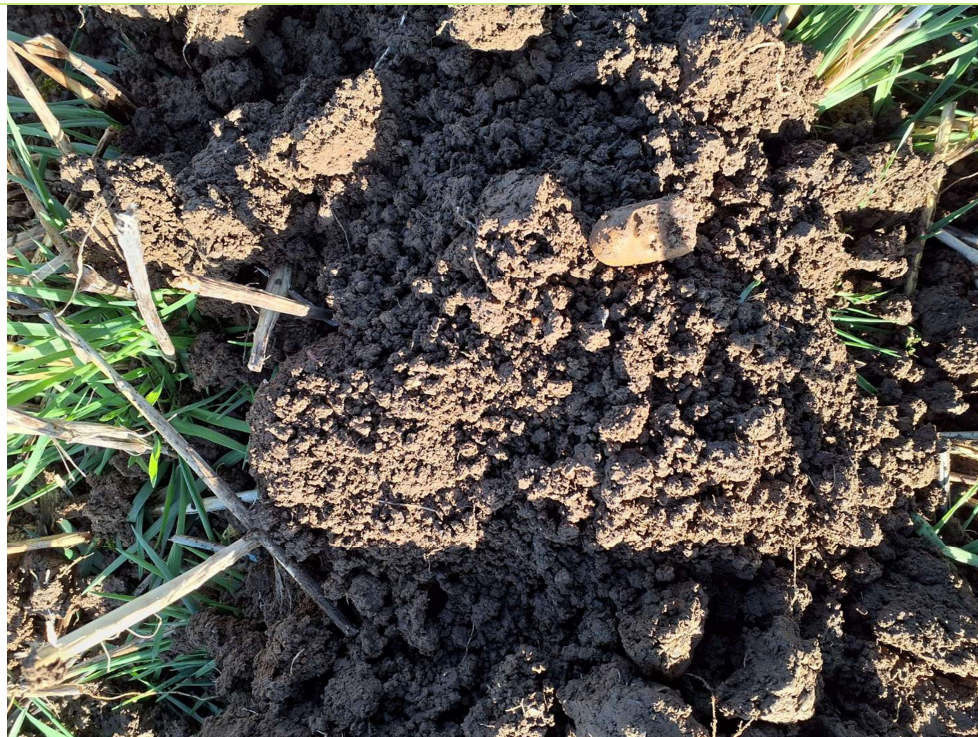
Plate 2: HA209 topsoil

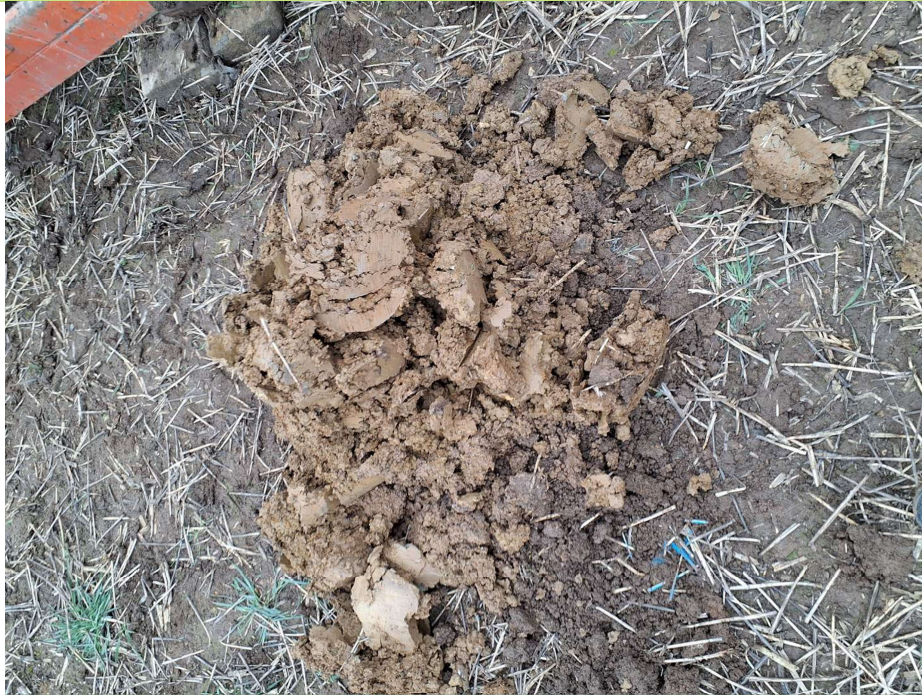
Plate 3: BH202 Head deposits

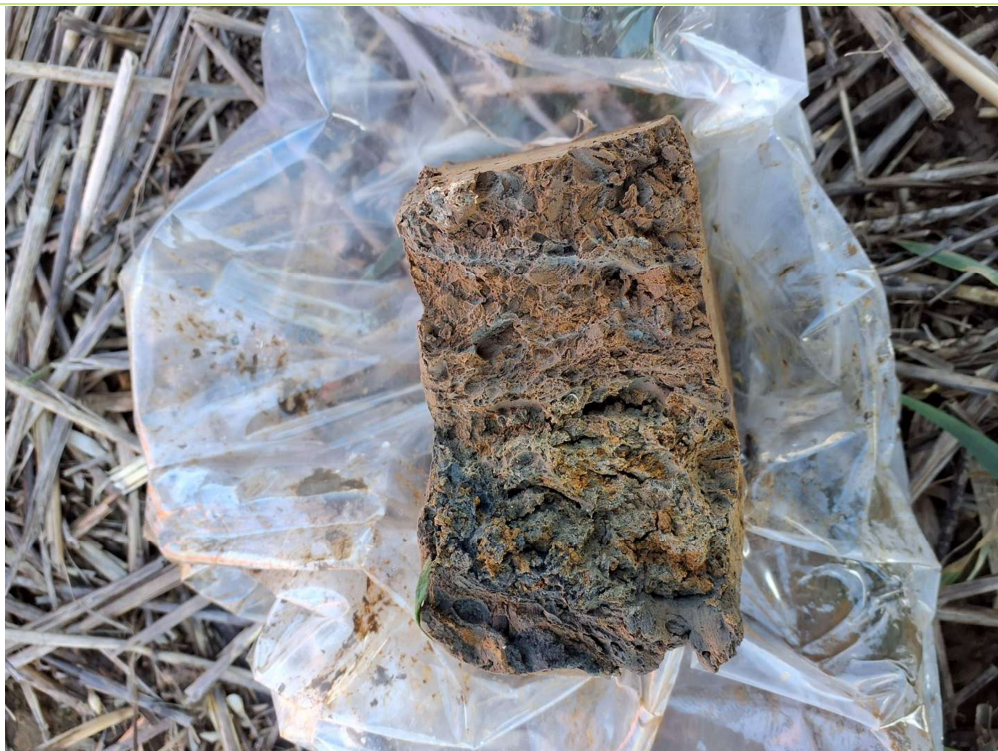
Plate 4: BH203 weathered London Clay

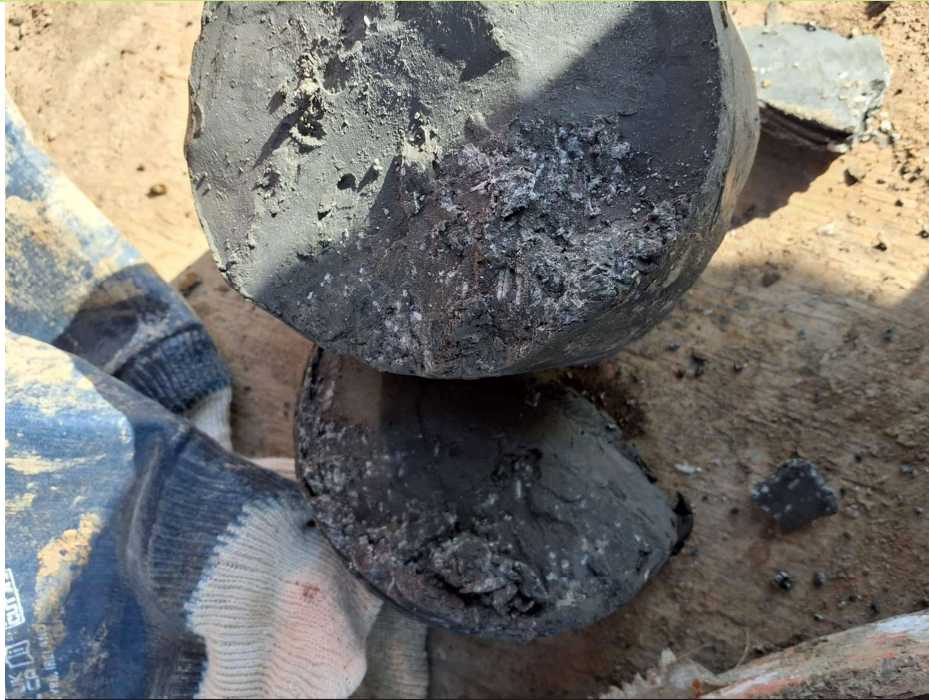
Plate 5: BH203 unweathered London Clay

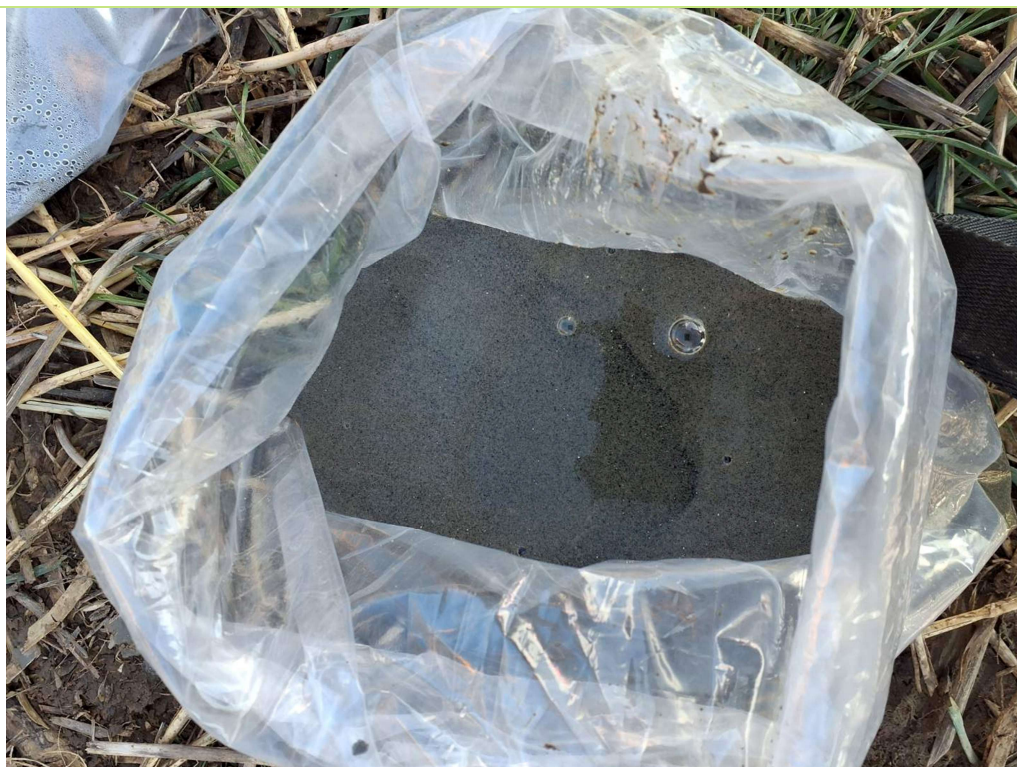
Plate 6: BH203 Harwich Fm. sands

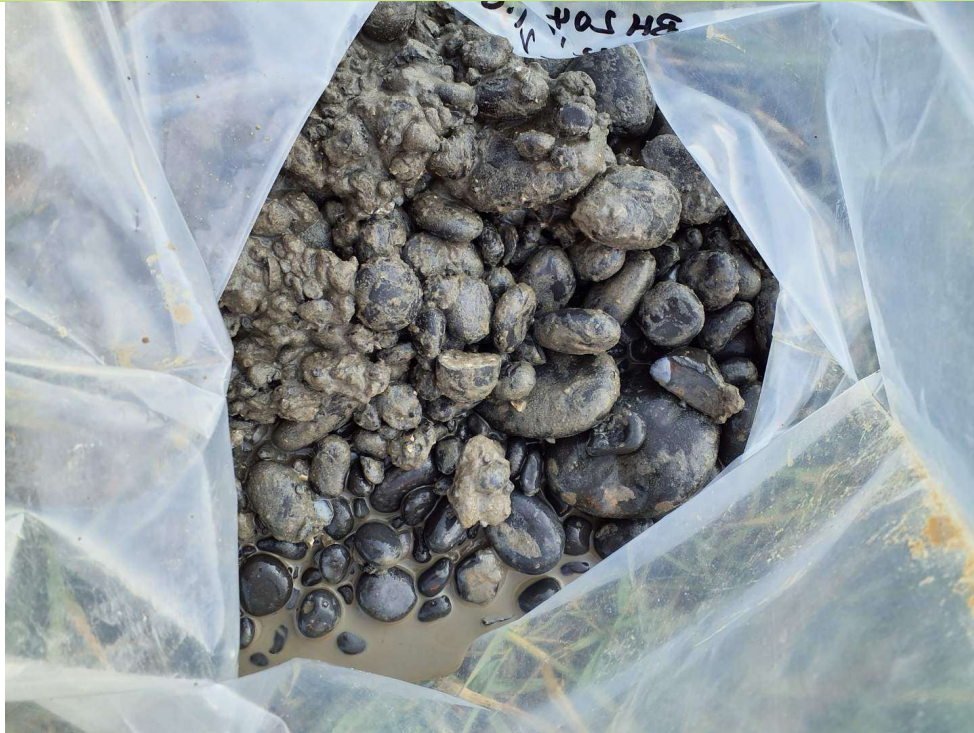
Plate 7: BH204 Harwich Formation gravels

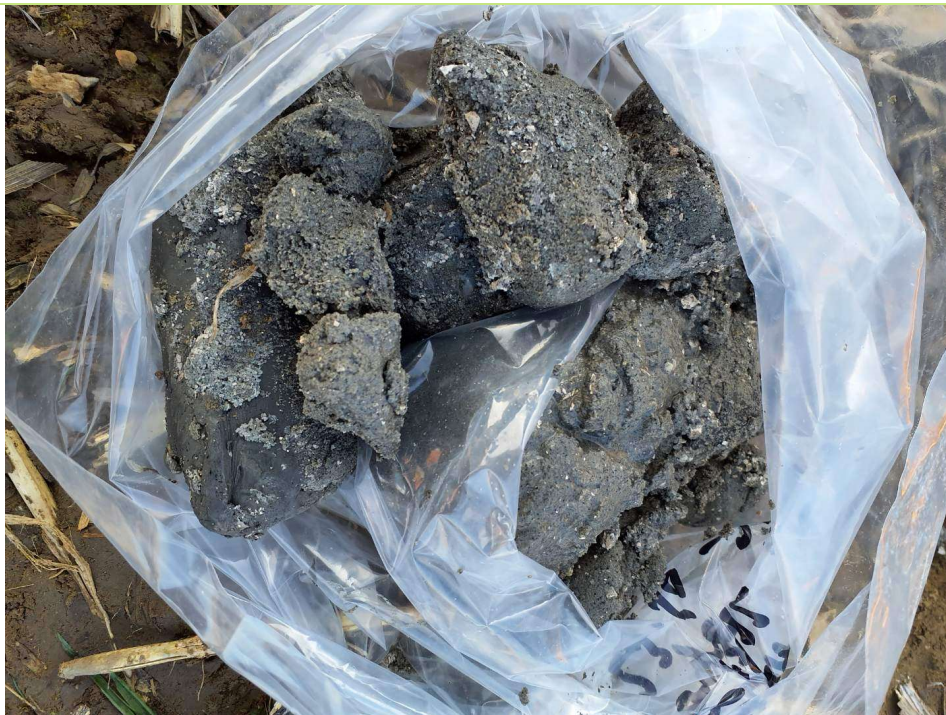
Plate 8: BH204 Lambeth Group shelly clays
