# GREAT GROVEHURST FARM, SITTINGBOURNE

## Bat Habitat Suitability Assessment

Reference: J005845

Date of Report: August 2015

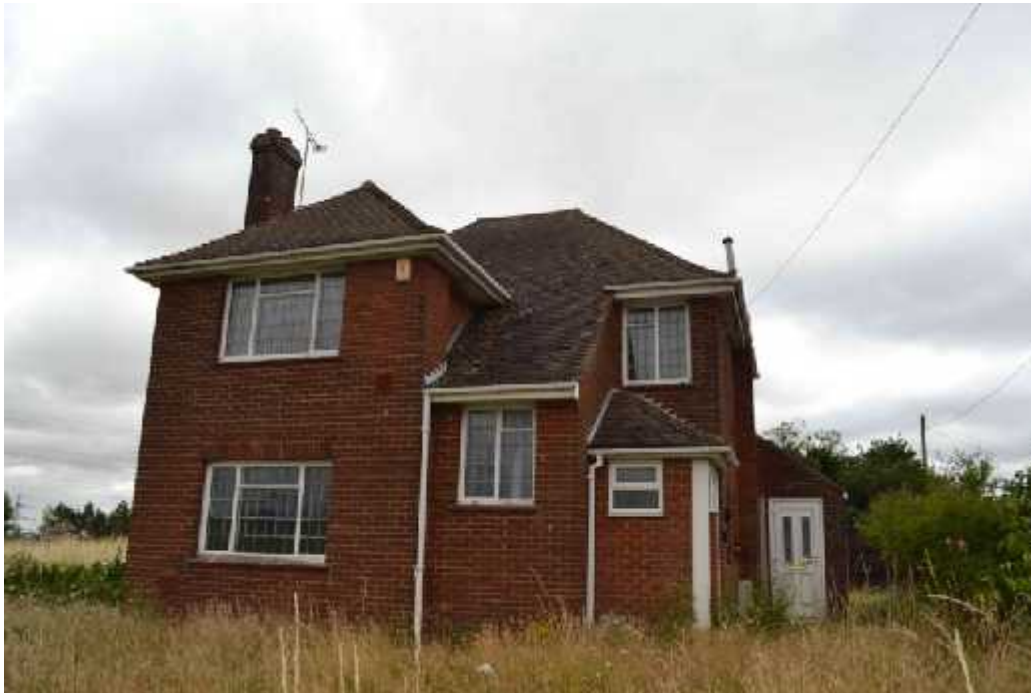
| Building Description | Suitability for roosting bats | Evidence of bats recorded | Constraints to assessment |
|--|---|--|---|
| <p><b>Building 1: Cottage</b></p> <p>An unoccupied residential property is located at the north west of the site. This is a two storey brick building with a hipped clay tiled roof. Two single storey extensions are present on the southern elevation.</p> <p>Soffits are of UPVC construction and window frames are wooden, with the exception of the two small extensions where window frames are of UPVC construction. Lead flashing is present around the chimneys and where roof sections join.</p> <p>Externally, a number of features of bat potential were noted, including:</p> <ul style="list-style-type: none"> <li>• Missing mortar around the central ridge tiles on the north and east elevations;</li> <li>• Gaps beneath lifted hip tiles on all elevations;</li> <li>• Lifted lead flashing surrounding the chimneys; and</li> <li>• Gaps where the soffits meet the main roof on the western side.</li> </ul> <p>A single roof void is present this is insulated at floor level and partially boarded. Roof lining is present throughout, which is in an apparently good condition.</p> | <p>Medium Suitability</p> <p>External features of the building have moderate potential for crevice dwelling bat species such as pipistrelles. The internal loft spaces provide low to medium potential for void dwelling bat species such as long eared bats.</p> | <p>A single, old bat dropping was found, there are no obvious access points into the building. It is not known how long the UPVC soffits have been in place, but it is possible that the dropping pre-dates the installation of these, and subsequently there may be no bat access into the roof void.</p> | <p>No constraints to assessment</p> |

Plate 1 –East facing elevation of Building 1

- 4.6 Buildings which have medium suitability to support roosting bats will require further survey work to assess whether they are in active use as bat roosts. It is recommended that an emergence and dawn swarming survey is conducted for each of these three buildings as outlined in Table 2. As part of these surveys all external access opportunities should be observed. In the event that bats are recorded emerging from the building during these surveys a further survey would be required. These surveys can only be undertaken between May and August during suitable weather conditions. Surveys can be undertaken in September during suitable weather conditions, however these are usually considered to be suboptimal.

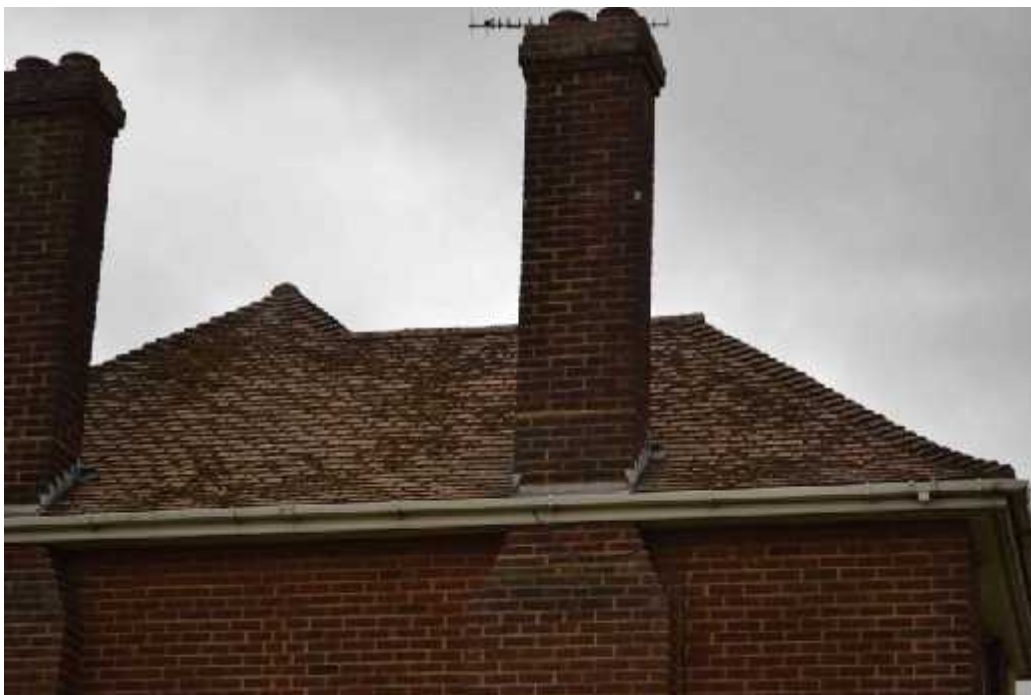
Plate 2 – North facing view of Building 1, showing gap beneath the central ridge tile, which is an example of one of the potential bat roost/access features within the building

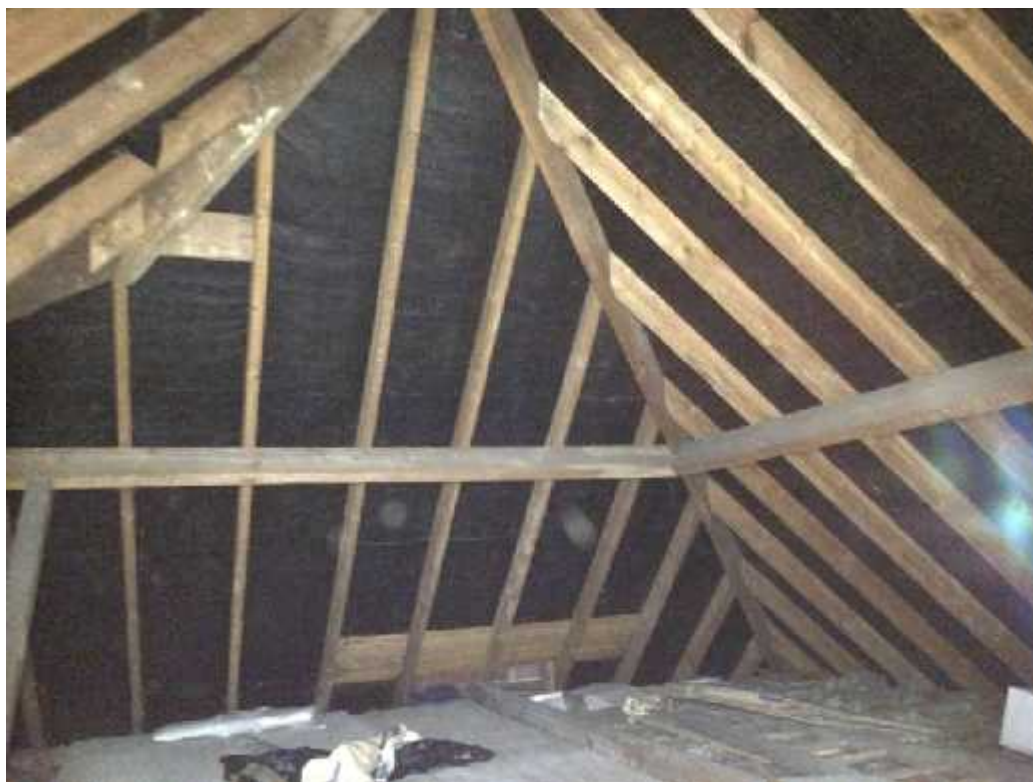
| Building Description | Suitability for roosting bats | Evidence of bats recorded | Constraints to assessment |
|--|---|---|--|
| <p>Light was seen entering the void via the eaves. However, external inspection of the eaves found that the eaves are covered by soffits with small mesh vents, which were the source of light. However, these vents are too small to allow bat access.</p> <p>A single, old bat droppings was found in the roof void. This was old and crumbly and was not possible to remove for DNA analysis.</p> | | | |

Plate 3 – Internal view of the roof void, showing lining in a good condition

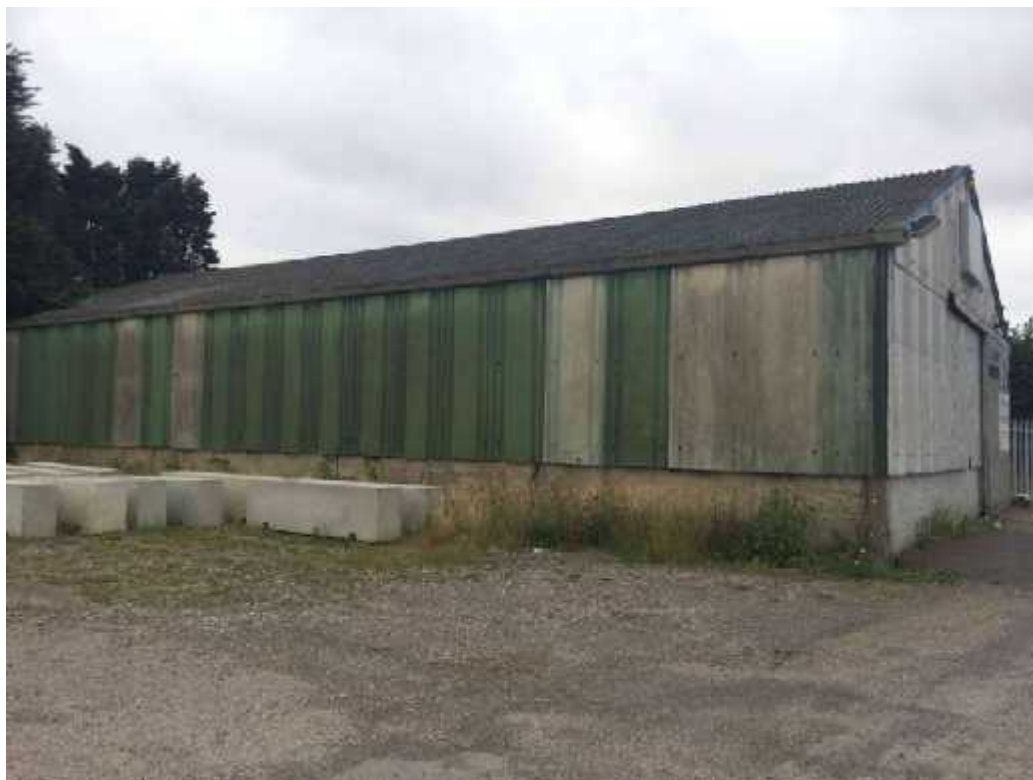
| Building Description | Suitability for roosting bats | Evidence of bats recorded | Constraints to assessment |
|--|---|---|--|
| <p><b>Building 2 – Car Sales Building</b></p> <p>A large warehouse type building, formerly a car show room, is present at the south west of the site. The building is primarily of corrugated metal and breeze block construction, with a pitched asbestos type roof with skylight panels.</p> <p>No significant features of bat roosting potential were noted on the exterior of this building.</p> <p>The bat potential of the interior of the building could not be established.</p> <p>However due to the metal and asbestos materials used in the construction which would make roof features fluctuate in temperature significantly, and the skylight panels, this building is not thought to hold significant bat roosting potential.</p> | Negligible Suitability | No evidence of bats was found. | Access was possible into the interior of the building. |

Plate 4 – External view of Building 2

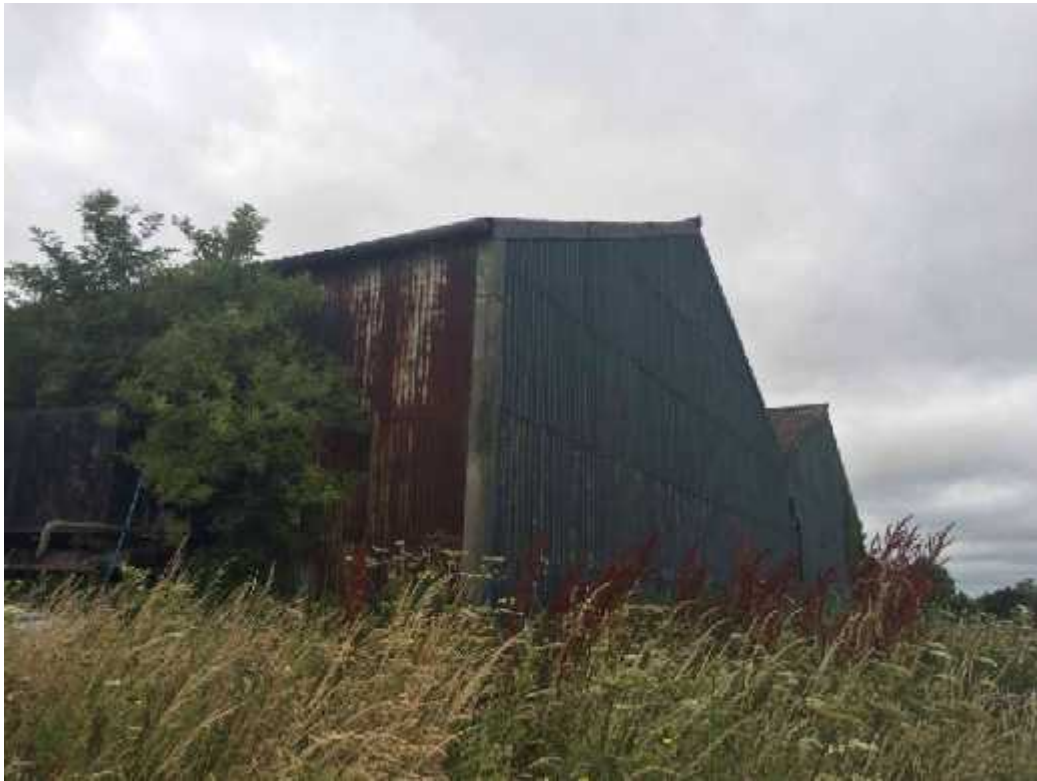
| Building Description | Suitability for roosting bats | Evidence of bats recorded | Constraints to assessment |
|--|---|---|--|
| <p><b>Building 3 – Pet food warehouse buildings</b></p> <p>A large warehouse building is present at the north east of the group of buildings within the site. This comprises a two pitched section at the west, with a single pitch section perpendicular to this at the west.</p> | Negligible Suitability | No evidence of bats was found. | No constraints to assessment |

Plate 5 – External view of Building 3

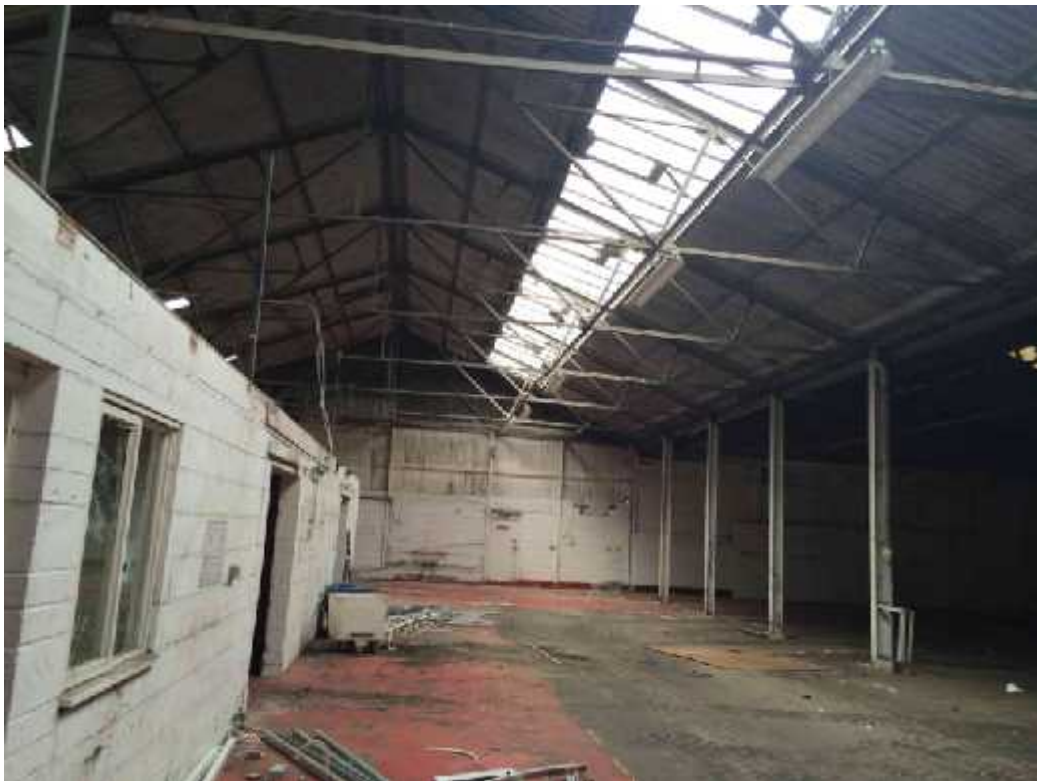
| Building Description | Suitability for roosting bats | Evidence of bats recorded | Constraints to assessment |
|--|--|---|---|
| <p>This building has part brick, part breezeblock and part corrugated metal walls, and an asbestos roof with skylights. A flat roofed brick extension is present on the south western corner.</p> <p>Internally, the building is open plan, and very light due to the skylights.</p> <p>Overall, the building is of negligible roosting bats due to the materials from which it is constructed, which are subject to temperature fluctuations. Additionally the interior is light and no significant roosting opportunities were identified</p> <p><b>Building 4 – Pet Food Shop</b></p> <p>A two storey building is present at the west of the block of buildings, which is currently in use a pet supplies shop. A smaller single storey section is present at the western end. The building is of brick construction with corrugated metal roof.</p> <p>Externally, a number of features of bat potential were noted, including:</p> <ul style="list-style-type: none"> <li>• Gaps in the wooden door on the western side, leading into the roof void/upper floor;</li> <li>• Gaps at the eaves and gable ends, leading into the roof void/upper floor; and</li> <li>• Crack in the wall of the single storey section on the eastern side.</li> </ul> | <p>Medium Suitability</p> <p>The exterior features of the building are considered to have medium potential for crevice dwelling bats, also to provide access to the interior for bats.</p> | <p>No evidence of bats was found.</p> | <p>Access was not possible into the roof space or upper floor of this building.</p> |

Plate 6 – Internal view of Building 3

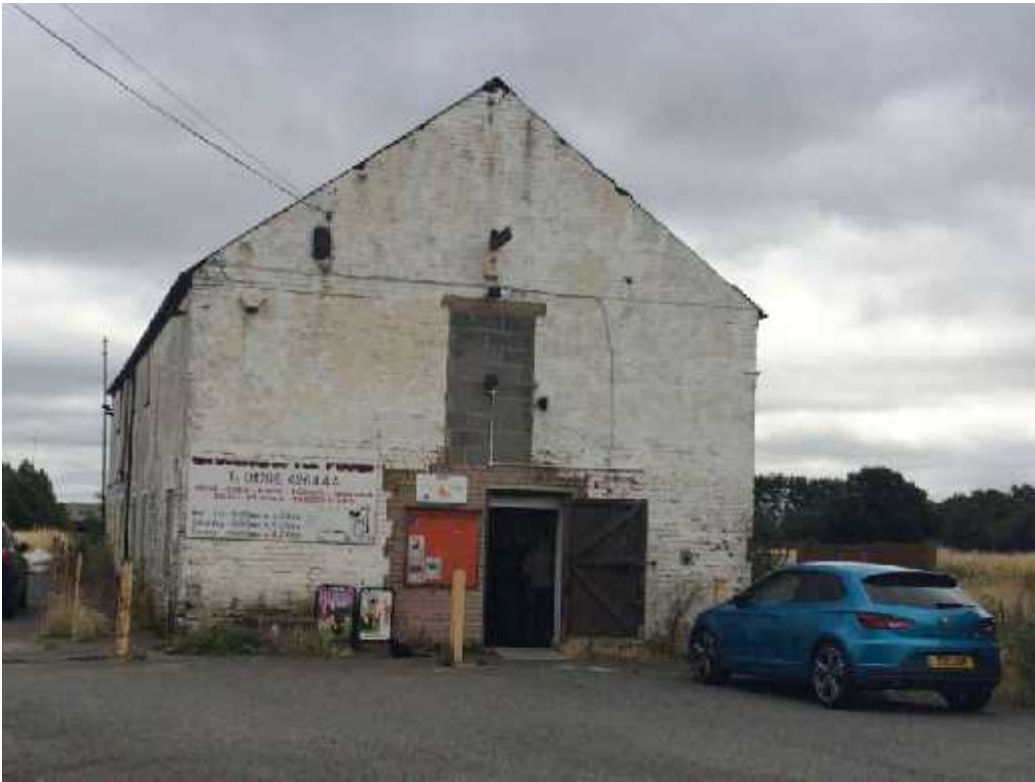
Plate 7 – West facing elevation of Building 4

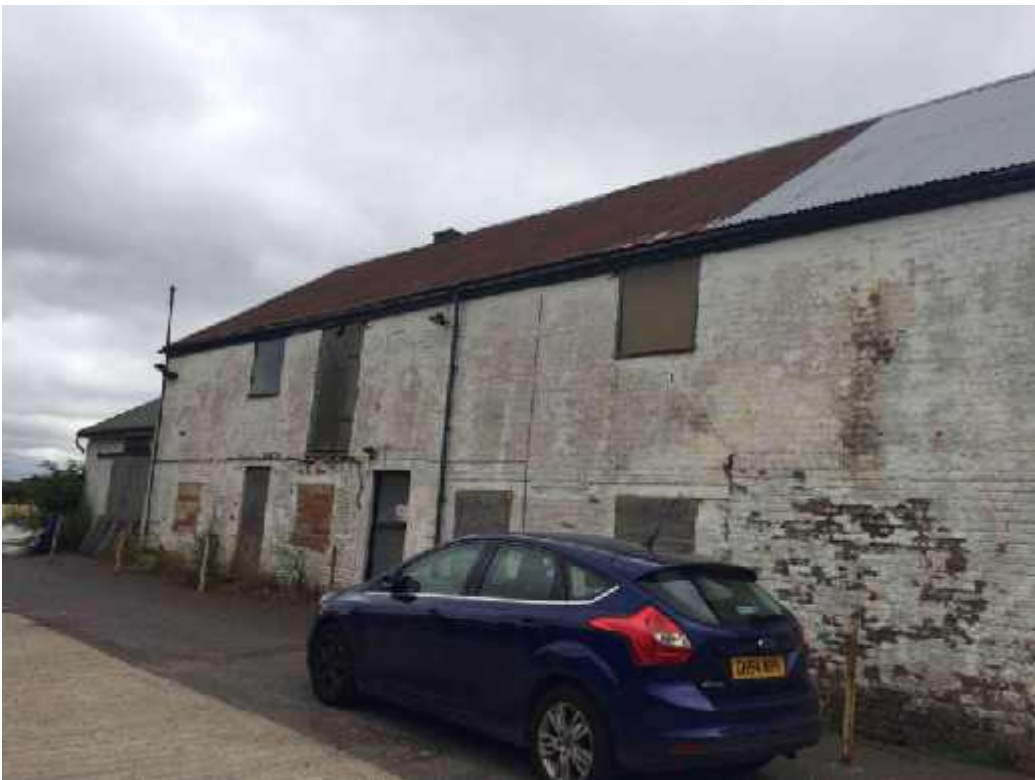
Plate 8 – North facing elevation of Building 4 showing gaps in wooden door allow potential bat access

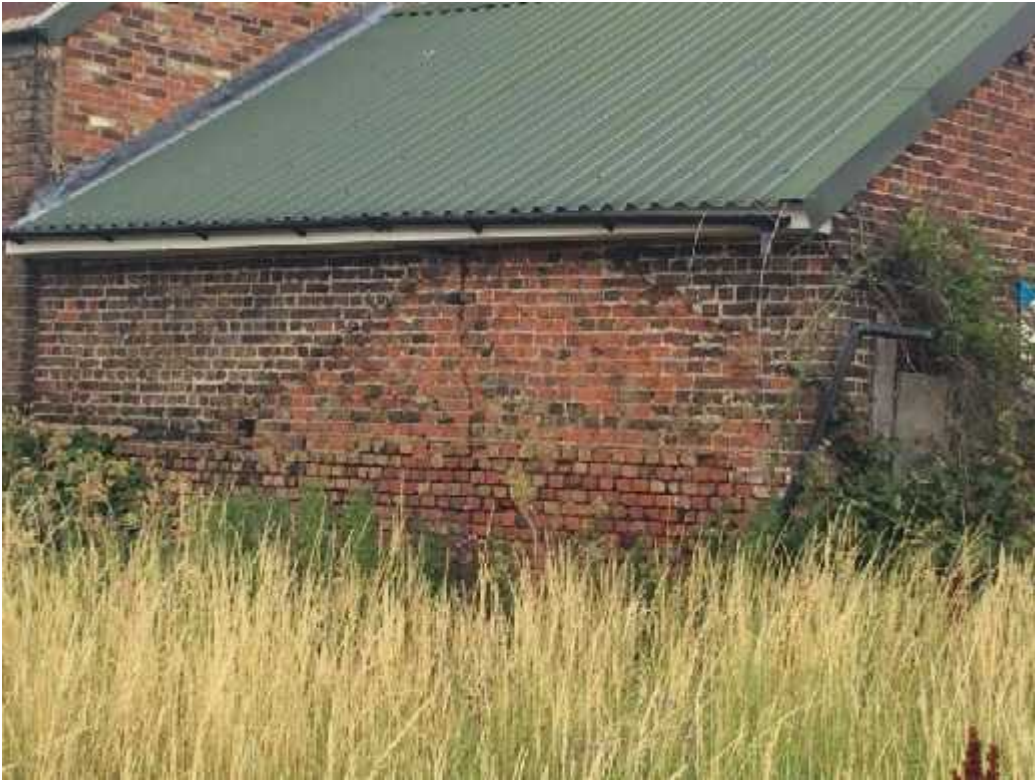
Plate 9 – Large crack in the brick wall at the south east of Building 4

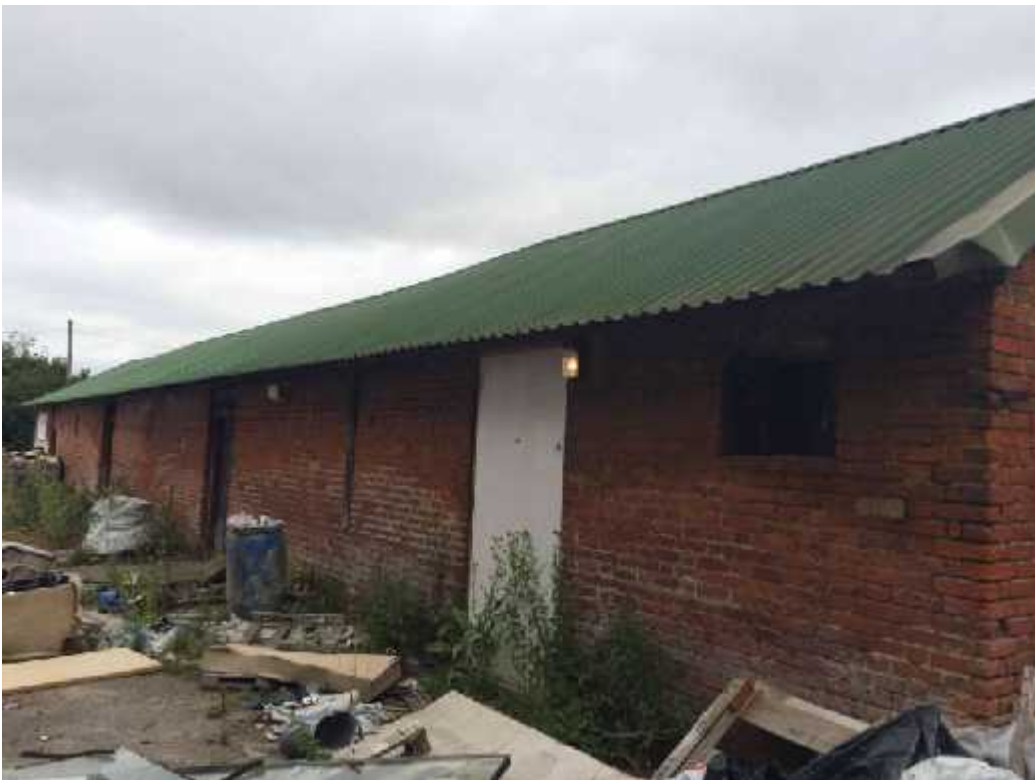
| Building Description | Suitability for roosting bats | Evidence of bats recorded | Constraints to assessment |
|---|--|---|---|
| <p><b>Building 5 – Stables</b></p> <p>At the centre/ south of the group of buildings is a block of former stables, now used for storage. The stable block is split into four self-contained units. The stables have brick walls and pitched metal roofs.</p> <p>Externally, a number of features of bat potential were noted, including:</p> <ul style="list-style-type: none"> <li>• Gaps above the doors to allow internal access for bats; and</li> <li>• Gaps under the eaves allowing internal access for bats.</li> </ul> <p>Internal access to the two western sections was possible, but not the two eastern sections. The interior sections that were accessed are used for storage. The roofs are lined with timber boarding, and timber boarding is present at the internal gable ends of each section.</p> <p>Internally, a number of features of bat roosting potential were noted, including:</p> <ul style="list-style-type: none"> <li>• Behind the wooden lining at the internal gable ends;</li> <li>• Along the ridge line; and</li> <li>• Low potential between the timber roof lining and the metal roof.</li> </ul> | <p>Medium Suitability</p> <p>The external fabric of the building has low potential for crevice roosting bats but provide access into the internal roof spaces.</p> <p>These internal loft spaces provide potential roosting opportunities for both crevice dwelling and void dwelling bat species.</p> | <p>No evidence of bats was found.</p> | <p>No constraints to assessment</p> |

Plate 11 – External view of Building 5. Possible bat access points shown in red

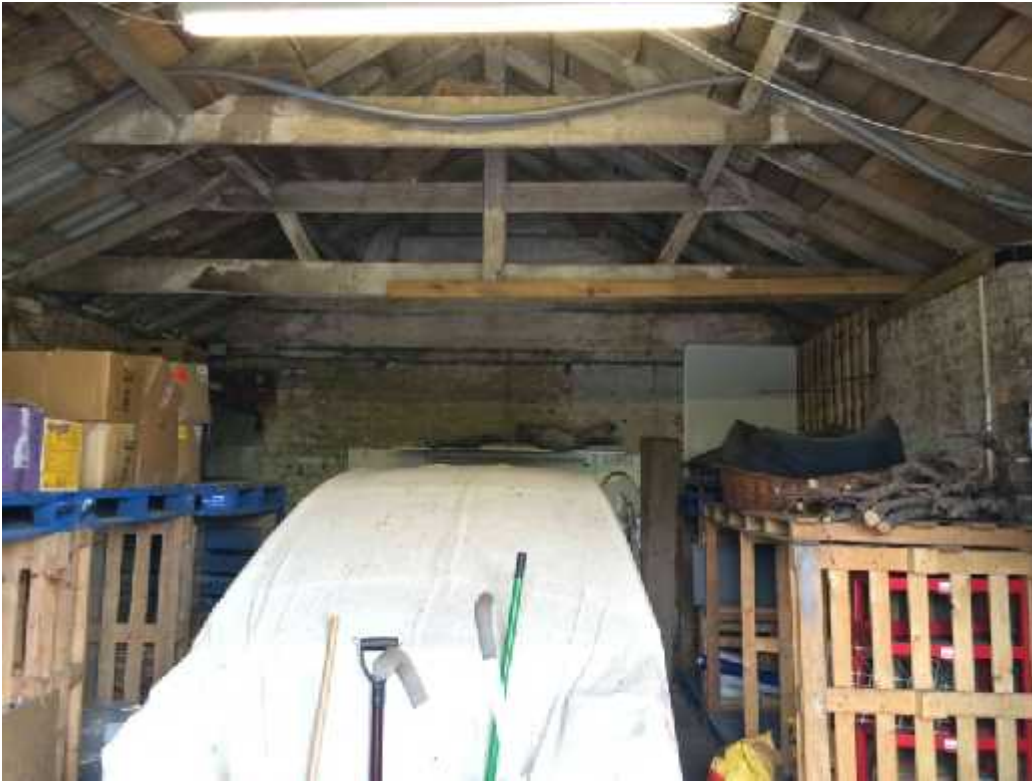
Plate 12 – Internal view of the western stable section of Building 5. Timber boards at the internal gable ends and timber roof lining have potential for crevice dwelling bats, and the internal space has potential for void dwelling bats
