Bentletts Scrap Yard, Laddingford – Bat Report

FPCR Environment & Design Ltd. were commissioned by Dandara to undertake ecology surveys, specifically for bats, on a two storey listed building referred to as the 'Pest House' (B5a) to support an application for listed building consent.

This letter details the results from a building inspection and nocturnal bat surveys carried out by FPCR ecologists on the above building in 2018. Additionally details of relevant mitigation are provided based on the results of the surveys.

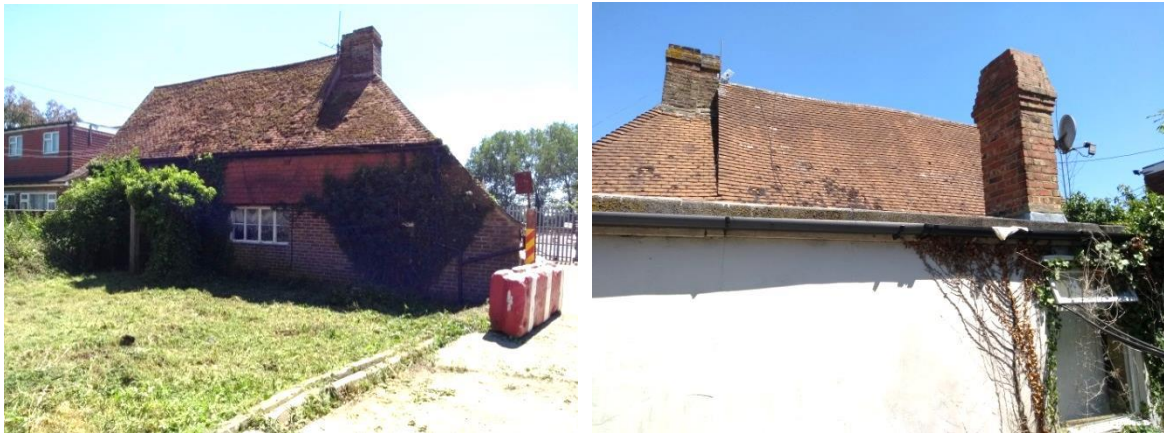
Photograph 1. Pest House Building Front View and 2. Back View with Lean to (B5b)

No internal or external evidence of bats was observed in association with this building (see Table 2), therefore it is still considered to have low potential to support roosting bats. Evidence was noted of rats nesting within the area beneath the tiles/underlining and utilising the void (rat droppings were present throughout) therefore it is considered unlikely that bats would successfully be able to roost within this building due to the likelihood of disturbance and predation.

Buildings B5a is to be retained with a full refurbishment which will affect the external areas including the roof and hanging tiles on the walls. The single storey extension (B5b) is to be removed.

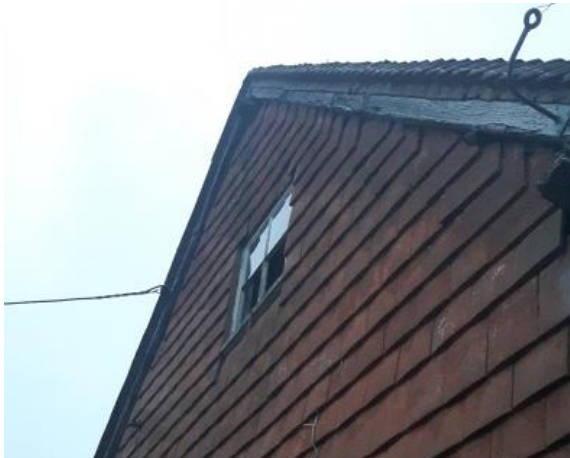
Photograph 3. Window on Eastern Aspect (note lifted tiles in top corners)

Surveyor B observed one soprano pipistrelle that emerged from beneath a hanging tile in the top left corner of the window on the eastern side of the Pest House (B5a) at 21:29 (24 minutes after sunset). No further bats were observed emerging from the Pest House (B5a). Both surveyors recorded relatively low levels of common and soprano pipistrelle and unidentified *Myotis* sp. activity in the local area.

During the surveys single common and soprano pipistrelles were observed roosting beneath hanging tiles on the eastern side of the Pest House (B5a) with no more than one bat confirmed roosting during any one survey. The presence of this bat roost is a statutory constraint to the works on the building. The destruction of the roost will therefore require a European Protected Species (EPS) licence or Low Impact Licence from Natural England to legitimise the works.

- A destructive search of B5a (Pest House) will be completed, under supervision from a licensed bat worker. This will comprise the careful removal of materials which could provide suitable bat roosting habitat. The removal of features of note include roof tiles (ridge and 1m down on both sides, eaves and 1m up on both aspects), lead flashing, fascia boards, chimneys and hanging tiles. Any bats observed (within the conditions of the licence) will be captured where possible and placed into the on-site mitigation if present or suitably contained until they can be released in the evening.

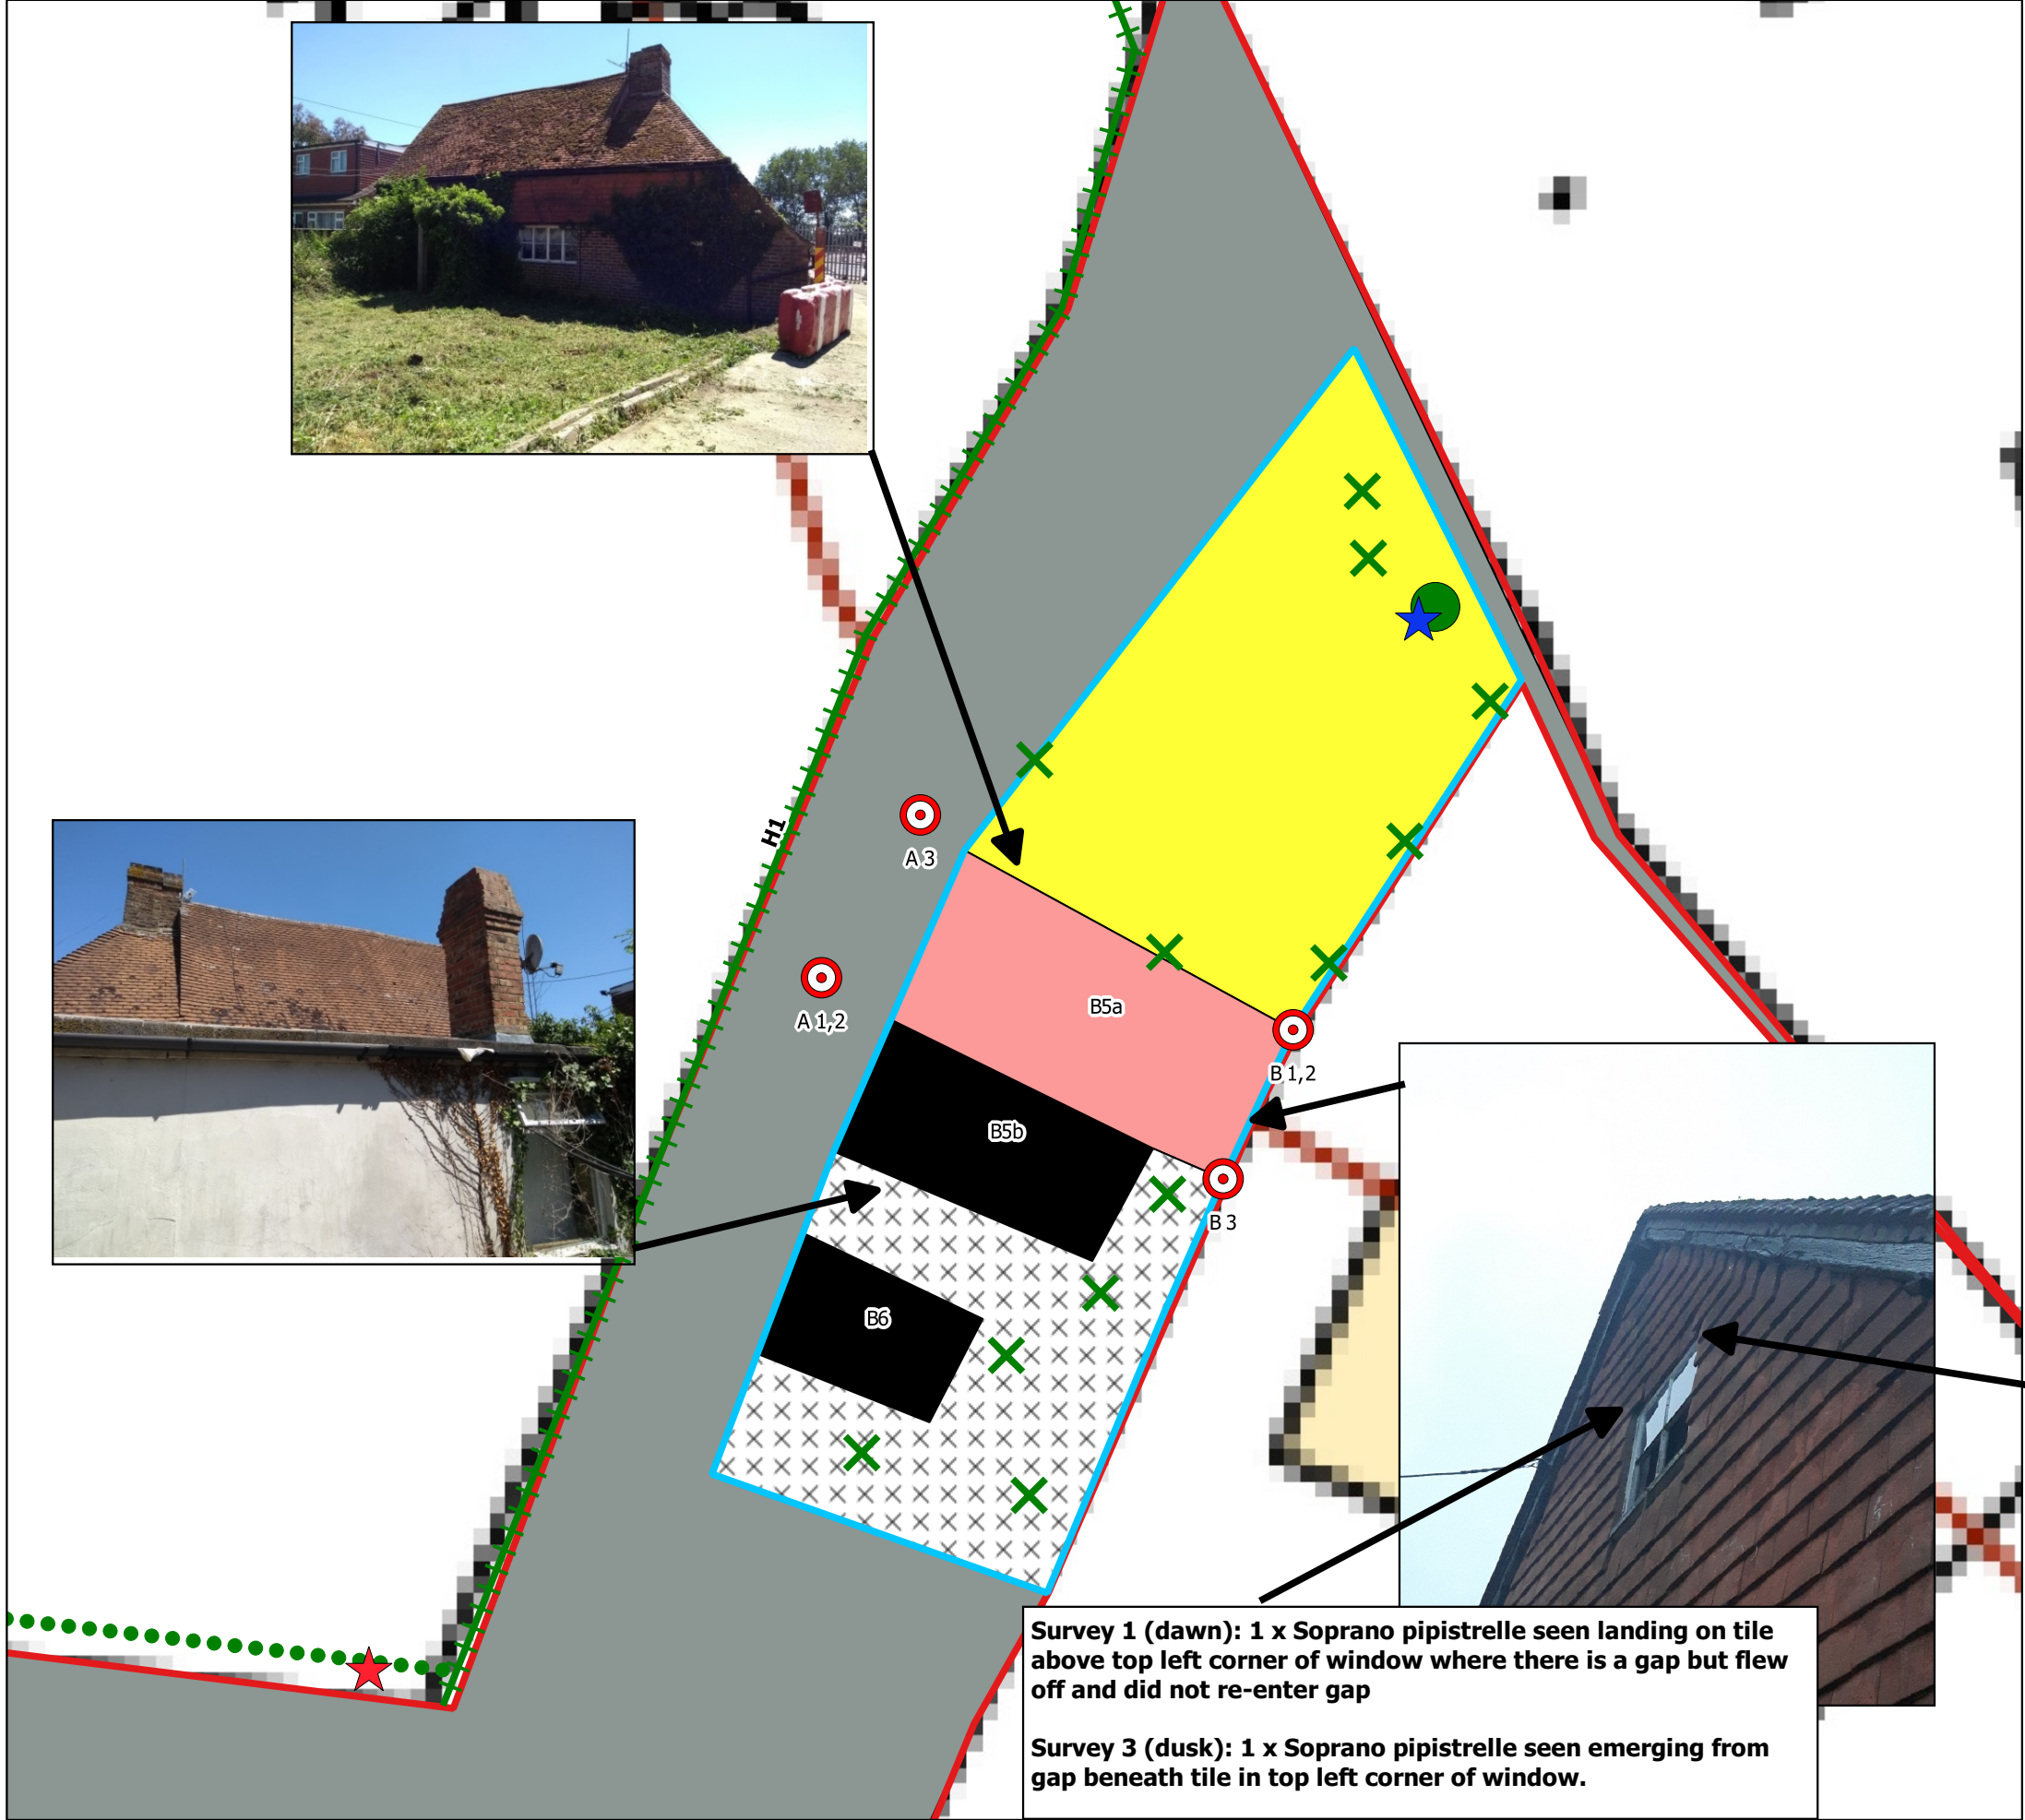
Nocturnal Surveys – see Figure 1 for Surveyor LocationsSurvey 1 - 6th June 2018 – Dawn Re-entry

Low levels of common pipistrelle, noctule *Nyctalus noctula* and unidentified *Myotis* sp. activity were recorded by both surveyors. At 04:02 Surveyor B observed multiple passes by a common pipistrelle adjacent the window on the eastern side of the Pest House (B5a) and at 04:04 a common pipistrelle was seen landing on a hanging tile in the top right corner and entering a gap beneath (see Figure 1). No further bat activity was recorded.

- Development Site Boundary
- Consented Building Application
- Hedge with trees - species-poor
- Broadleaved trees
- Hardstanding
- Buildings - Negligible Bat Potential
- Pest House (B5a) - Low Bat Potential
- Amenity grassland
- Ephemeral / short perennial
- Indicative Location for Bat Boxes
- Indicative Location for Starling Box
- Scrub - scattered
- Surveyor Locations (ref A or B)
- Broadleaved tree

- Provision of 3 x Schwegler 2F / 2FN or 1FF bat boxes, to be installed prior to works commencing on suitable tree(s) within the development (*Figure 1*).

Starlings (a Species of Principal Importance) are nesting within B5a and their nest site will be lost, it is recommended that a starling nest box is installed on a suitable tree (see *Figure 1*) in advance of demolition. The box should be located at least 2.5m above ground, facing between north and east, thus avoiding strong sunlight / winds.
