Longfield Knotweed Solutions Ltd  
71 St Davids Close  
West Wickham  
Kent  
BR4 0QY

**Quote REF:TN38 9TN 292**

**Location of Japanese Knotweed: Former Grove School/Darwell Campus of the St Leonards Academy, Darwell Close, St Leonards, TN38 9TN**

On the 31<sup>st</sup> May 2018 we walked around the site to retreat the growing Japanese knotweed. Please see overleaf for the photographs taken. It was raining in the morning when we walked around the site and took photographs; after an hour the weather improved and we were able to herbicide treat the Japanese knotweed.

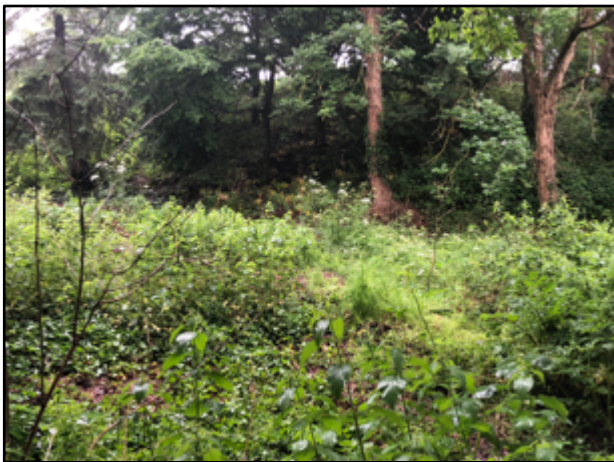
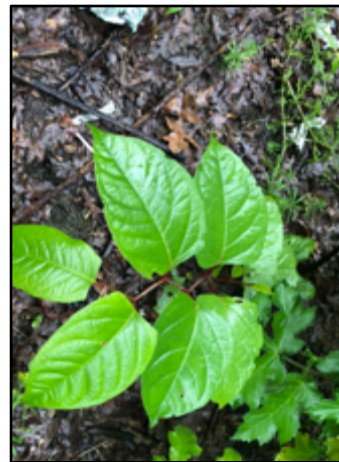
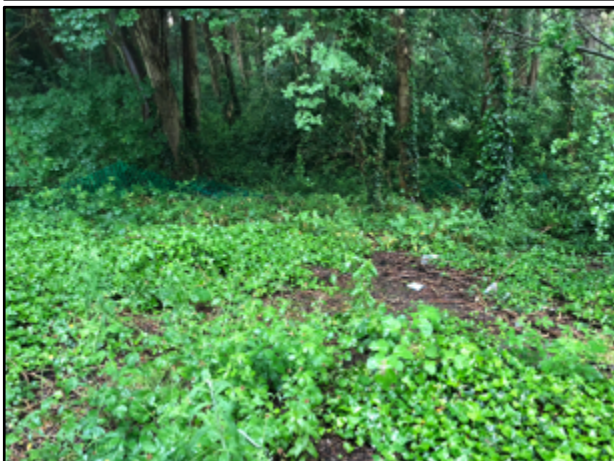
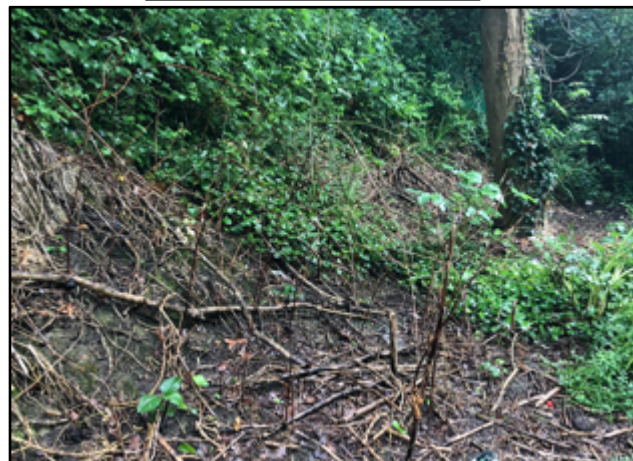
**Location – JK2. (Previously a fire occurred here).**

- Leaf wiped approximately ten stems.

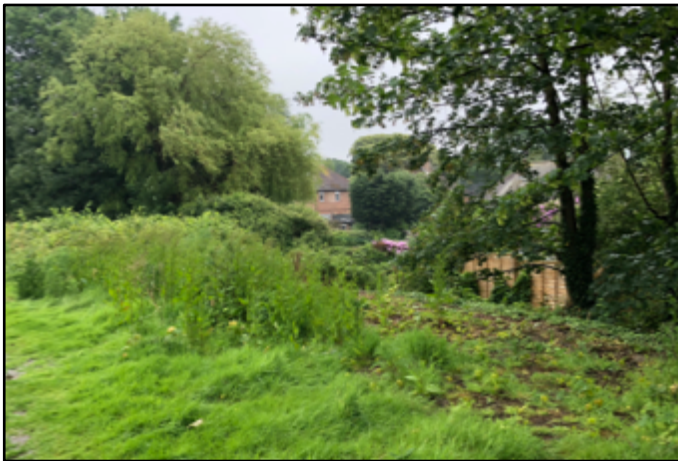
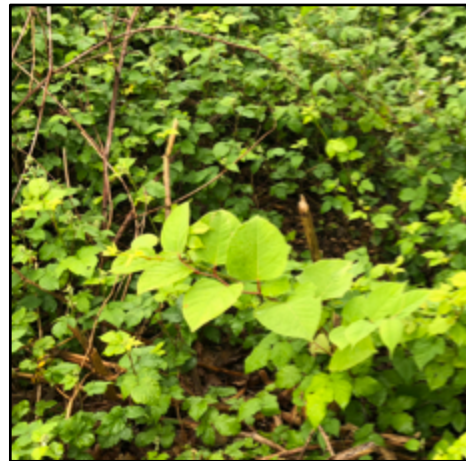
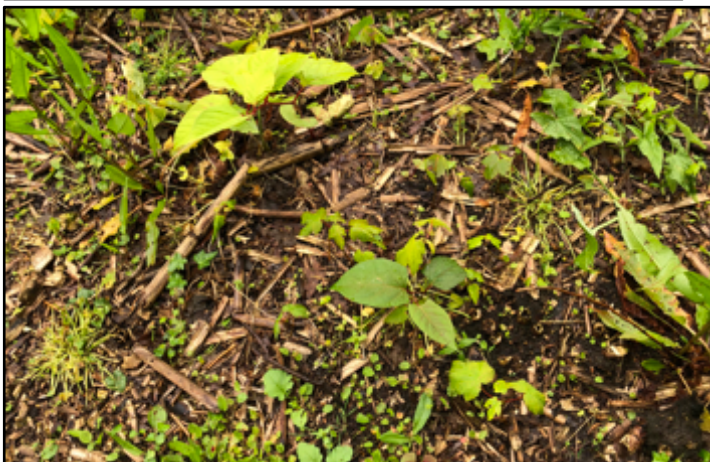
**Location - JK 3. (Area backing onto residential gardens)**

- Four small plants were identified and herbicide treated.

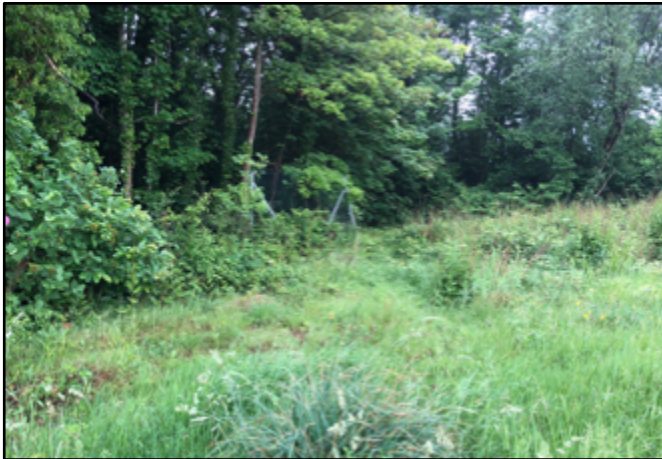
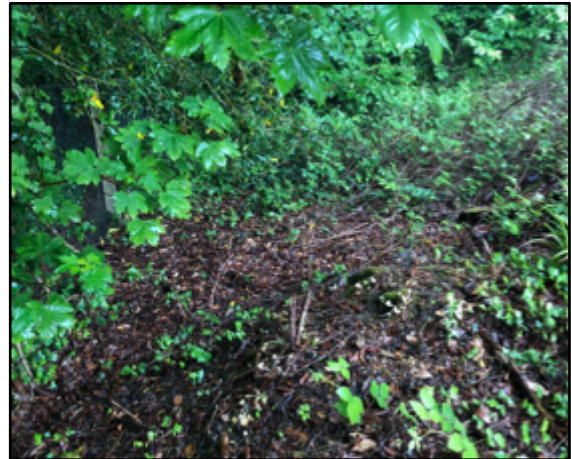
**Location - JK4. (Beside a pathway at the top end of the site)**

- No Japanese knotweed seen here at the time of the visit.

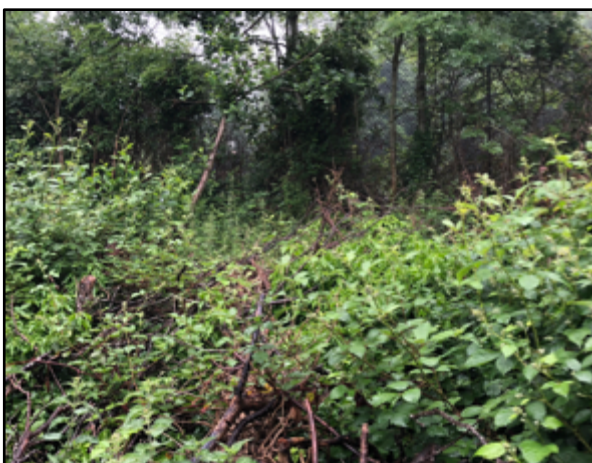
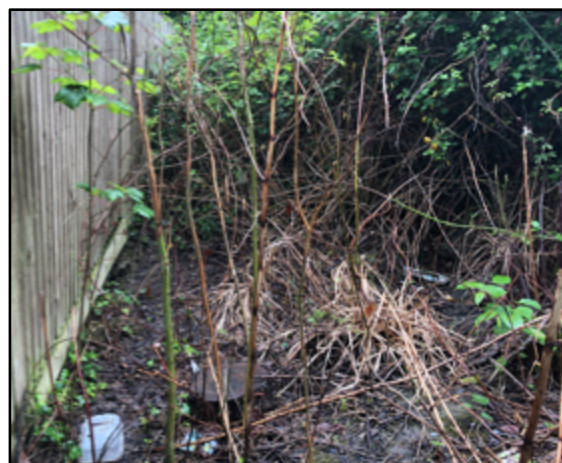
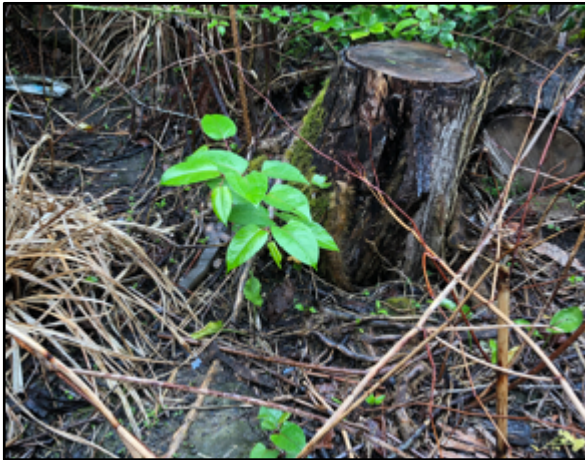
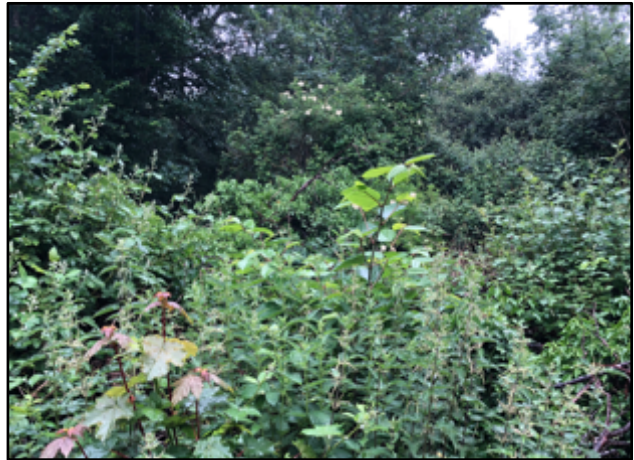
**Location - JK5. (In front the netball courts).**

- Small stunted Japanese knotweed plants seen, where appropriate they were treated. In the location where a few trees had previously been removed three stems of Japanese knotweed were seen and treated.

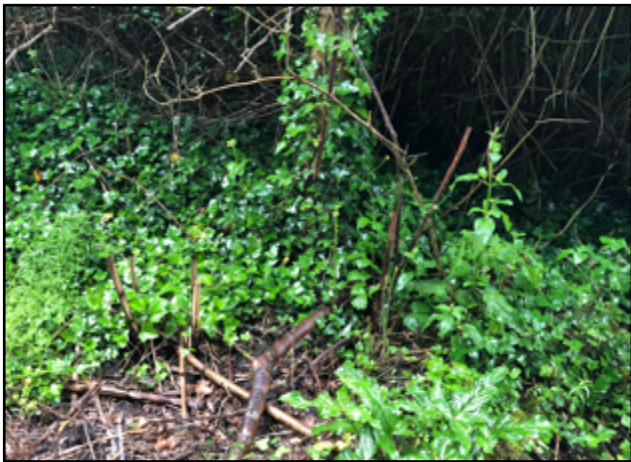
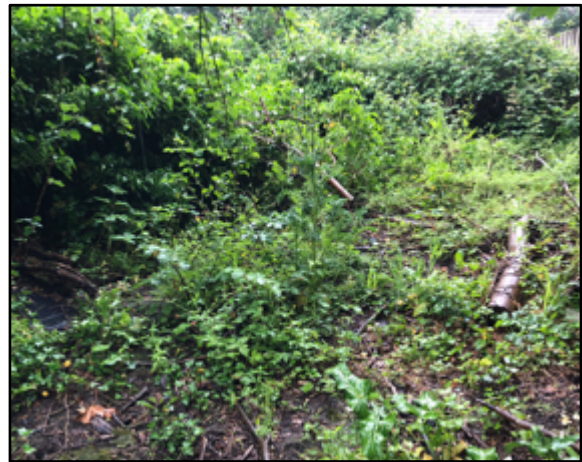
**Location - JK6. (Next to JK5.)**

- At the time of the visit no Japanese knotweed was seen here.

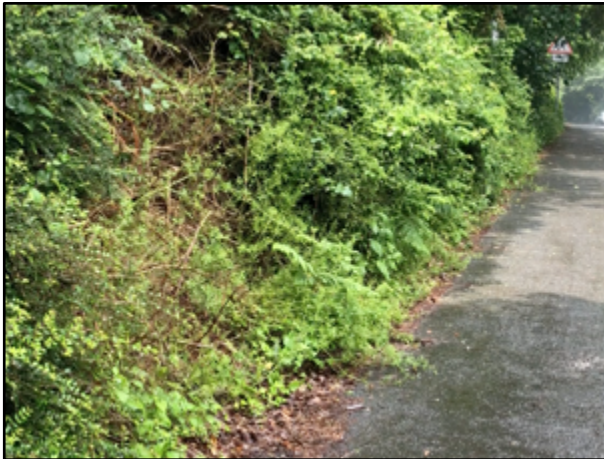
**Location - JK7 and JK8. Beside the main road.**

- Three Japanese knotweed shoots seen and herbicide treated. (They were in amongst the brambles and unable to take clear photo of them.)
