**ASHWOOD NURSING HOME  
BURWASH COMMON  
EAST SUSSEX  
ECOLOGICAL SURVEY**

1<sup>st</sup> June 2020  
(Revised 26<sup>th</sup> July 2020)

D151. Burwash Common (TQ639233). R1v2

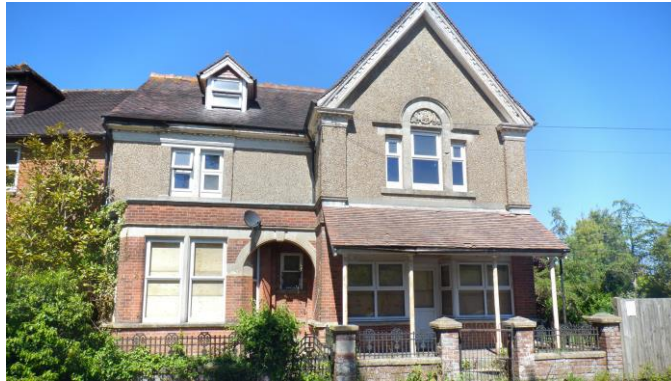
**Figure 3: THE FRONT (SOUTH) SIDE OF SECTION A, THE ORIGINAL HOUSE.**

- **Section A** is the original Victorian house, which is slightly set back from the road, from which, like section C, it is separated by a hedge. The building is typically Victorian, made of brick with a pitched roof, although the roof appears to have been altered slightly over the years. There is a veranda at the front, and a metal staircase on the eastern side. There is also a single dormer window on the southern side of the roof, which also has two skylights on the northern side. Internally, there is a side attic and a small ridge attic. Parts of the soffits and bargeboards were in a poor state of repair.

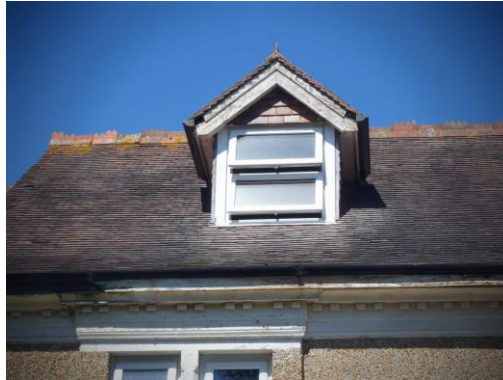
- Three **bat** droppings were observed on the main roof of section A, close to the dormer window, which had hanging tiles on a south – facing roof which offered potential bat roosting habitat.

**Figure 6: THE DORMER OF SECTION A, WHICH IS POTENTIAL BAT HABITAT.**

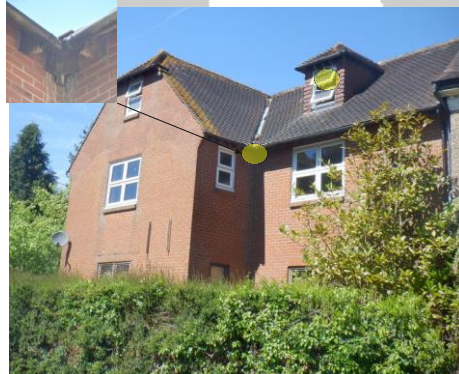
- Loose bargeboards and damaged soffits on the east end of section A were potential habitat for bats.
- Part of the flashing just underneath the roof eaves of the southern part of section C had been used by a bird<sup>9</sup> for nesting purposes. A hole led into the space between the bricks, which could also be used by roosting bats.

**Figure 7: A POTENTIAL ROOST SITE ON THE SOUTH SIDE OF SECTION C.**

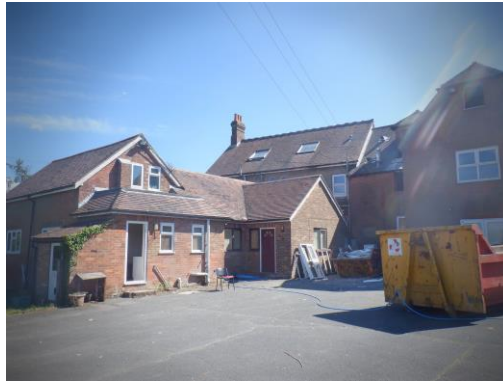
**Figure 9: THE REAR OF THE BUILDING, WITH SECTION B ON THE LEFT, A IN THE MIDDLE AND C ON THE RIGHT.**

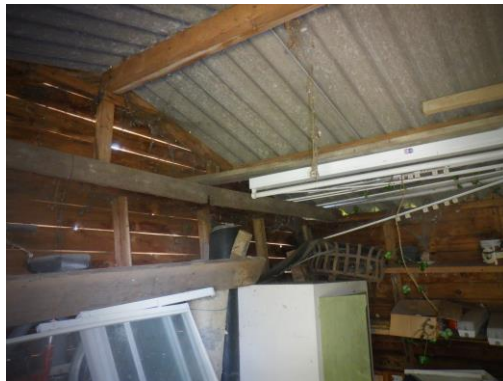
- There were no **badger**<sup>17</sup> field signs or setts. Badgers are protected by the Protection of Badgers Act 1992.
- There were no trees that were big enough to hold **bats**, and the wooden – framed shed was also unsuitable.

**Figure 10: INSIDE THE WOODEN SHED; NOT SUITABLE AS BAT HABITAT.**
