Arboricultural comments on:

20/0684/FH – Erection of detached dwelling and two garages

The Rectory, Rectory Lane, Lyminge CT18 8EG

Report: 200802 of 26 August 2020

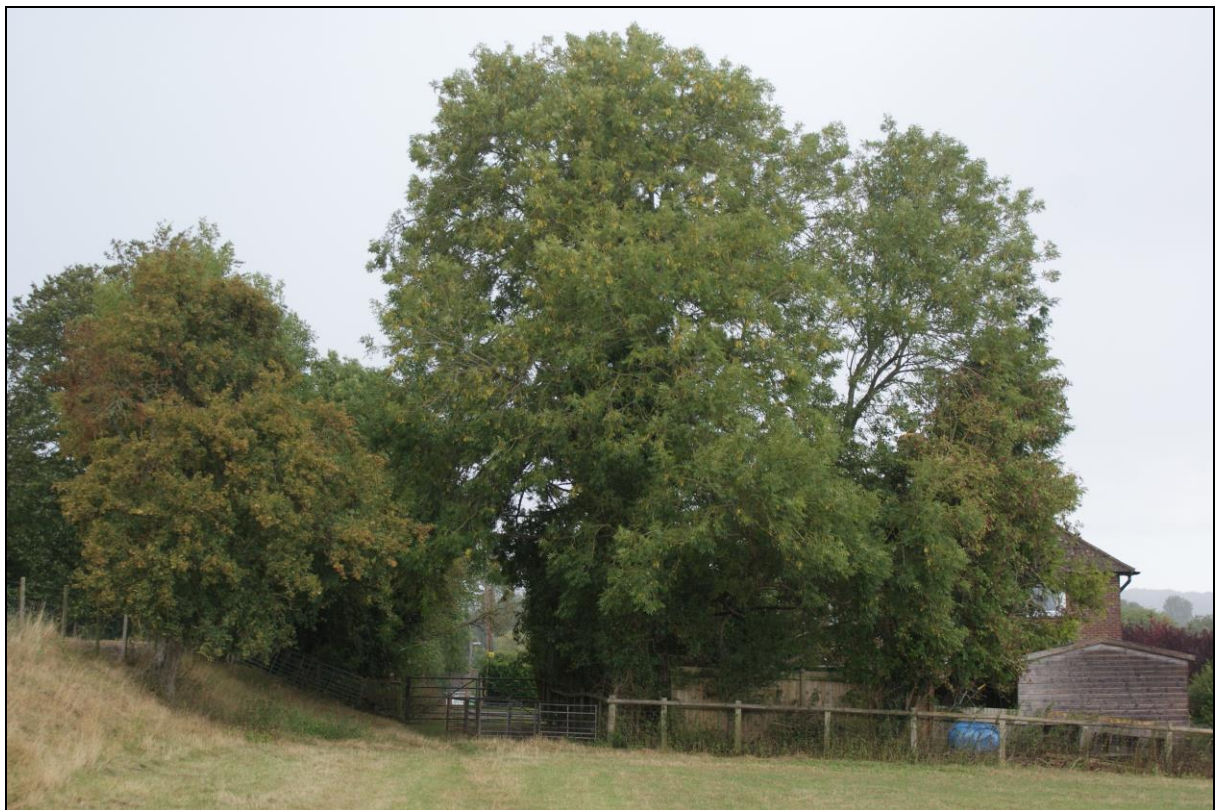
Photo 1. View of the site from the south, showing the approach to Lyminge from Etchinghill along the Elham Valley Way (also the Royal Saxon Way). The footpath continues through the opening in the middle distance, with the site to the right. The south (end) elevation of The Rectory is just visible near the right edge of the photo. The largest tree is the conspicuous T2 Common ash, the crown extending about 9m to the right (east). Other small trees (T4 Elder and T5 Cypress), not readily distinguished, contribute to the density of the screen from this perspective. Judged from some Field maples out of view the bank to the left is old and may be ancient. The course of the footpath is undoubtedly ancient.

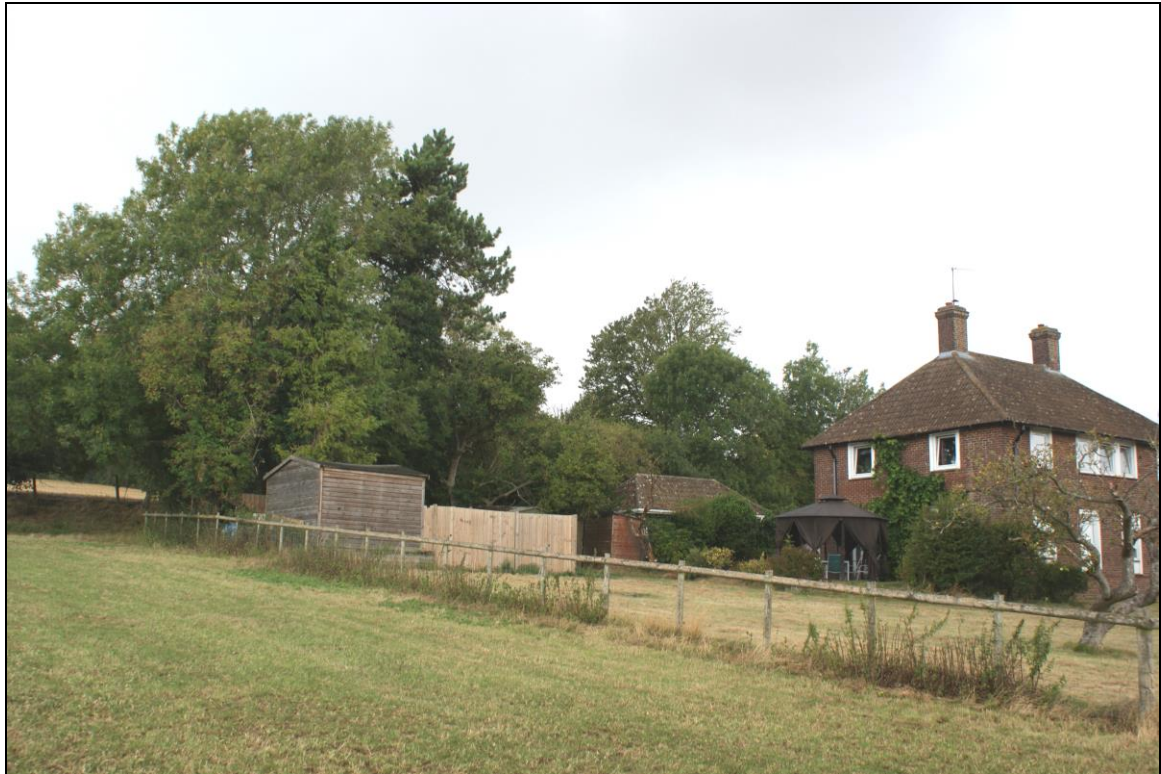
Photo 2. View from the south-east. The proposed dwelling and one of the garages would be sited between The Rectory and the fence. The garage would be about 1m from the canopied amenity area adjacent to the end elevation of The Rectory and the boundary between the two subdivided properties would be even closer, while the dwelling would be 2m from the south boundary fence, unscreened by any vegetation. The trees T1 Corsican pine, T2 Common ash and some smaller trees are seen to the left, near the south-western corner of the site.

To make way for the proposal T5 Cypress would have to be felled, while the crown of T2 Common ash would just overtop the proposed dwelling footprint and would have to be greatly reduced.

My estimates of RPA extents are open to correction but I doubt that, at the present level of detail on Dwg. 20-003/02, encroachments into the RPAs of T1 Corsican pine and T2 Common ash would be a serious constraint. The footprint of the proposed dwelling does encroach into the RPAs, and the proposed footway to the dwelling will cross the RPAs closer to the trees, but such encroachments can often be justified assuming certain tree protection measures during site works and methods of construction. More problematical are likely to be the service runs, which have yet to be specified.

There is little doubt that T1 Corsican pine and T2 Common ash would be overbearing for the new residents, their west (front) elevation being less than half the height of the trees distant from them. The trees are large and also upslope, adding to their *subjective presence*; the crown of T1 extends to the eaves; and the trees would cast much shade, especially in the afternoon and evening. I understand that the trees are unprotected so the new residents could (and probably would) cut them down at their own discretion. A Tree preservation order would not ease the conflict, just create work for F&HDC owing to the post-development pressure.

(i) The garage would be built right at the boundary of the subdivided Rectory. This is accepted to be bad practice as the owners will not have access to the exterior of their own building, and associated conflicts can arise such as the discharge of drainage water onto the neighbouring land.

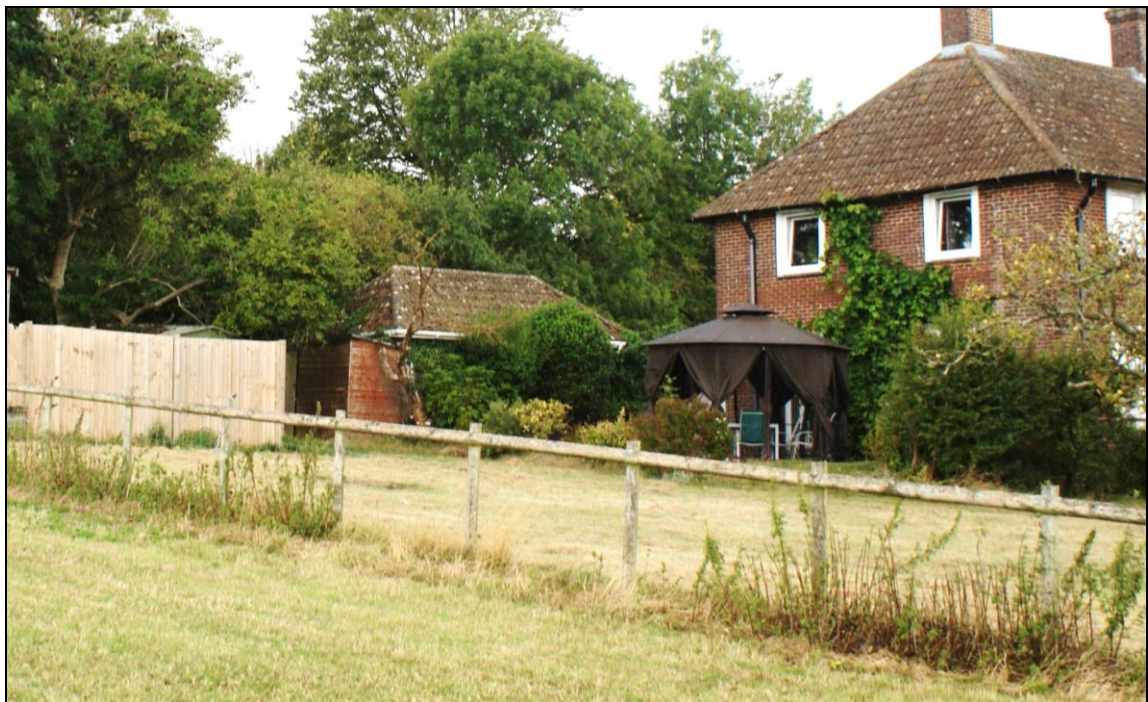
Photo 3. Part of Photo 2, magnified to show more clearly the canopied amenity area on the south side of The Rectory.

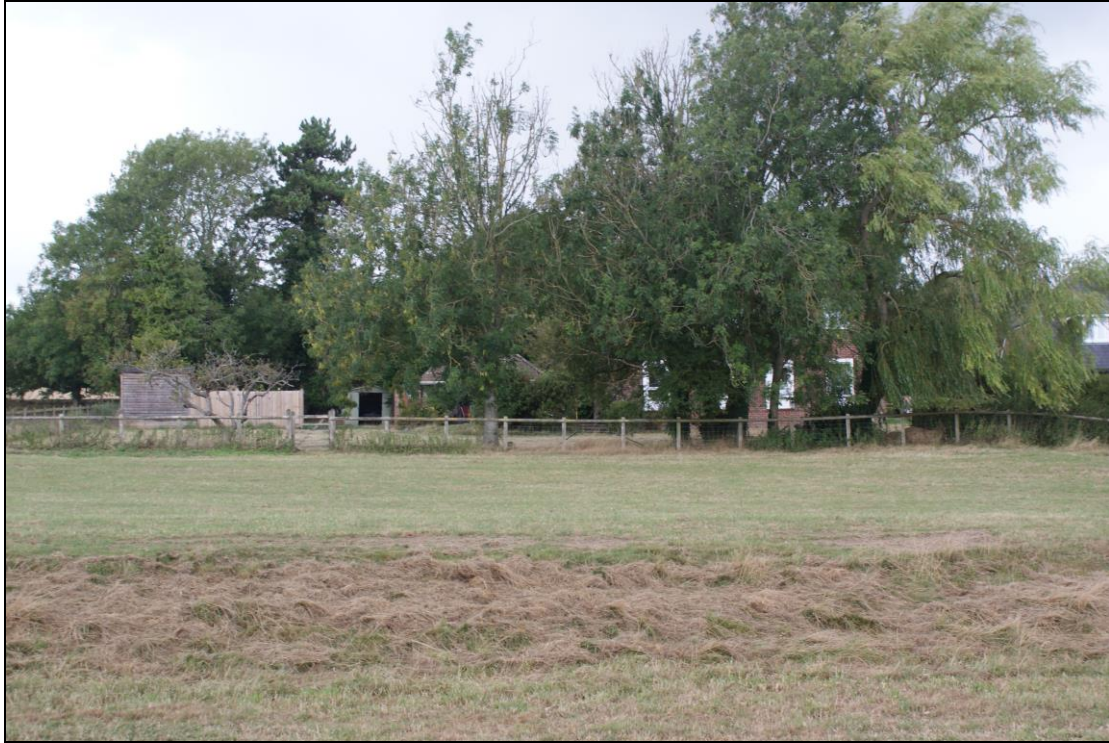
Photo 4. View of the site from the east. The main road to Lyminge from Etchinghill is 100m behind the observer. The change in level along the contour in the foreground, prominent on the approach to Lyminge by road, may be a lynchet. T1 Corsican pine, T2 Common ash etc. are visible towards the left, while the remaining trees are closer, largely on the east boundary nearest the observer (T7, G8, T9), where they screen The Rectory from the east.

(ii) The south (end) elevation of the proposed house would be just 2m from the south boundary, too close to have any screening of trees in the longer term and essentially giving the vicinity a crowded and incongruous suburban aspect. On the approach from the south, for hundreds of metres, it would stand out, transforming the character of the landscape.

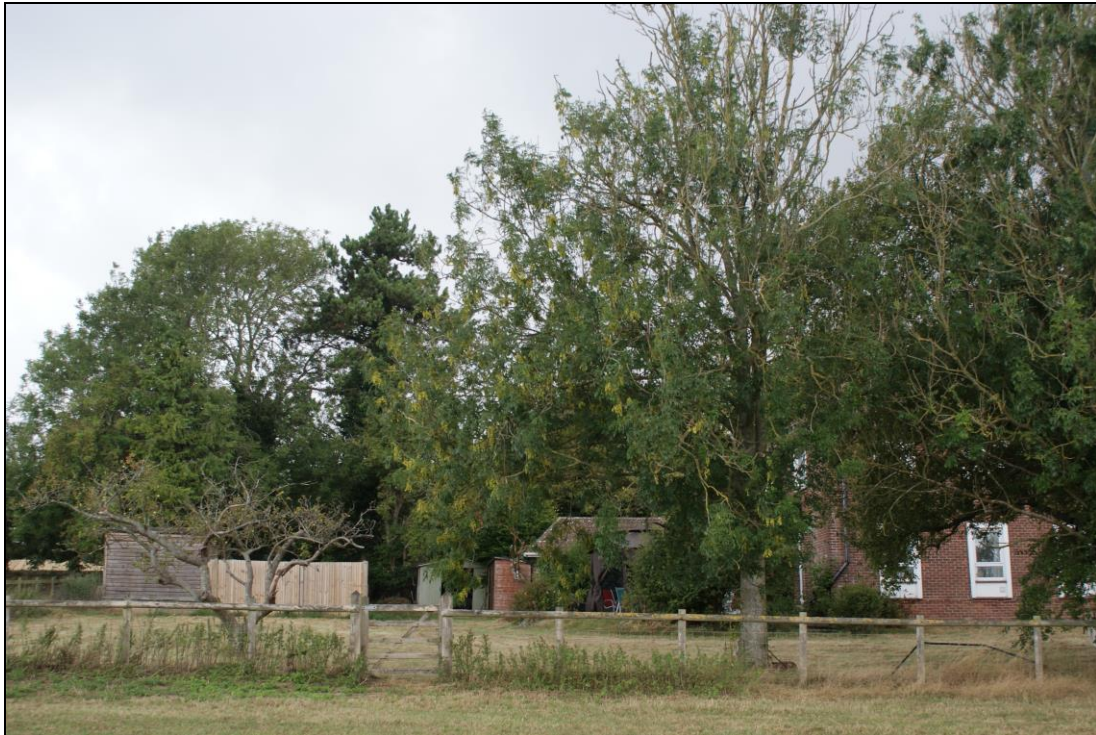
Photo 5. A closer view of the east boundary from the east. T6 Apple is just visible to the left. T7 Common ash is right-of-centre, with abundant deadwood in the upper $\frac{2}{3}$ of the crown almost certainly due to *chalara die-back*. The ash trees further to the right (G8) are also more or less affected. The photo record shows that T2 is free of the disease (see glossary).

T6	Apple	c. 20GL	3			U	2.0	Senescent.
T7	Common ash	c. 35	12- 16	to 6	1-4	U	4.2	Half-dead with large-diameter <i>stag-heads</i> , almost certainly from <i>chalara die-back</i> .
G8	Common ash			to 8)	5.0	
T9	Weeping willow	c. 20- 50GL	19	to 7)A/B)	5.0	Mature. Individually (B), collectively (A) owing to the prominence of the trees in the landscape viewed from the main road, from where they largely screen The Rectory.

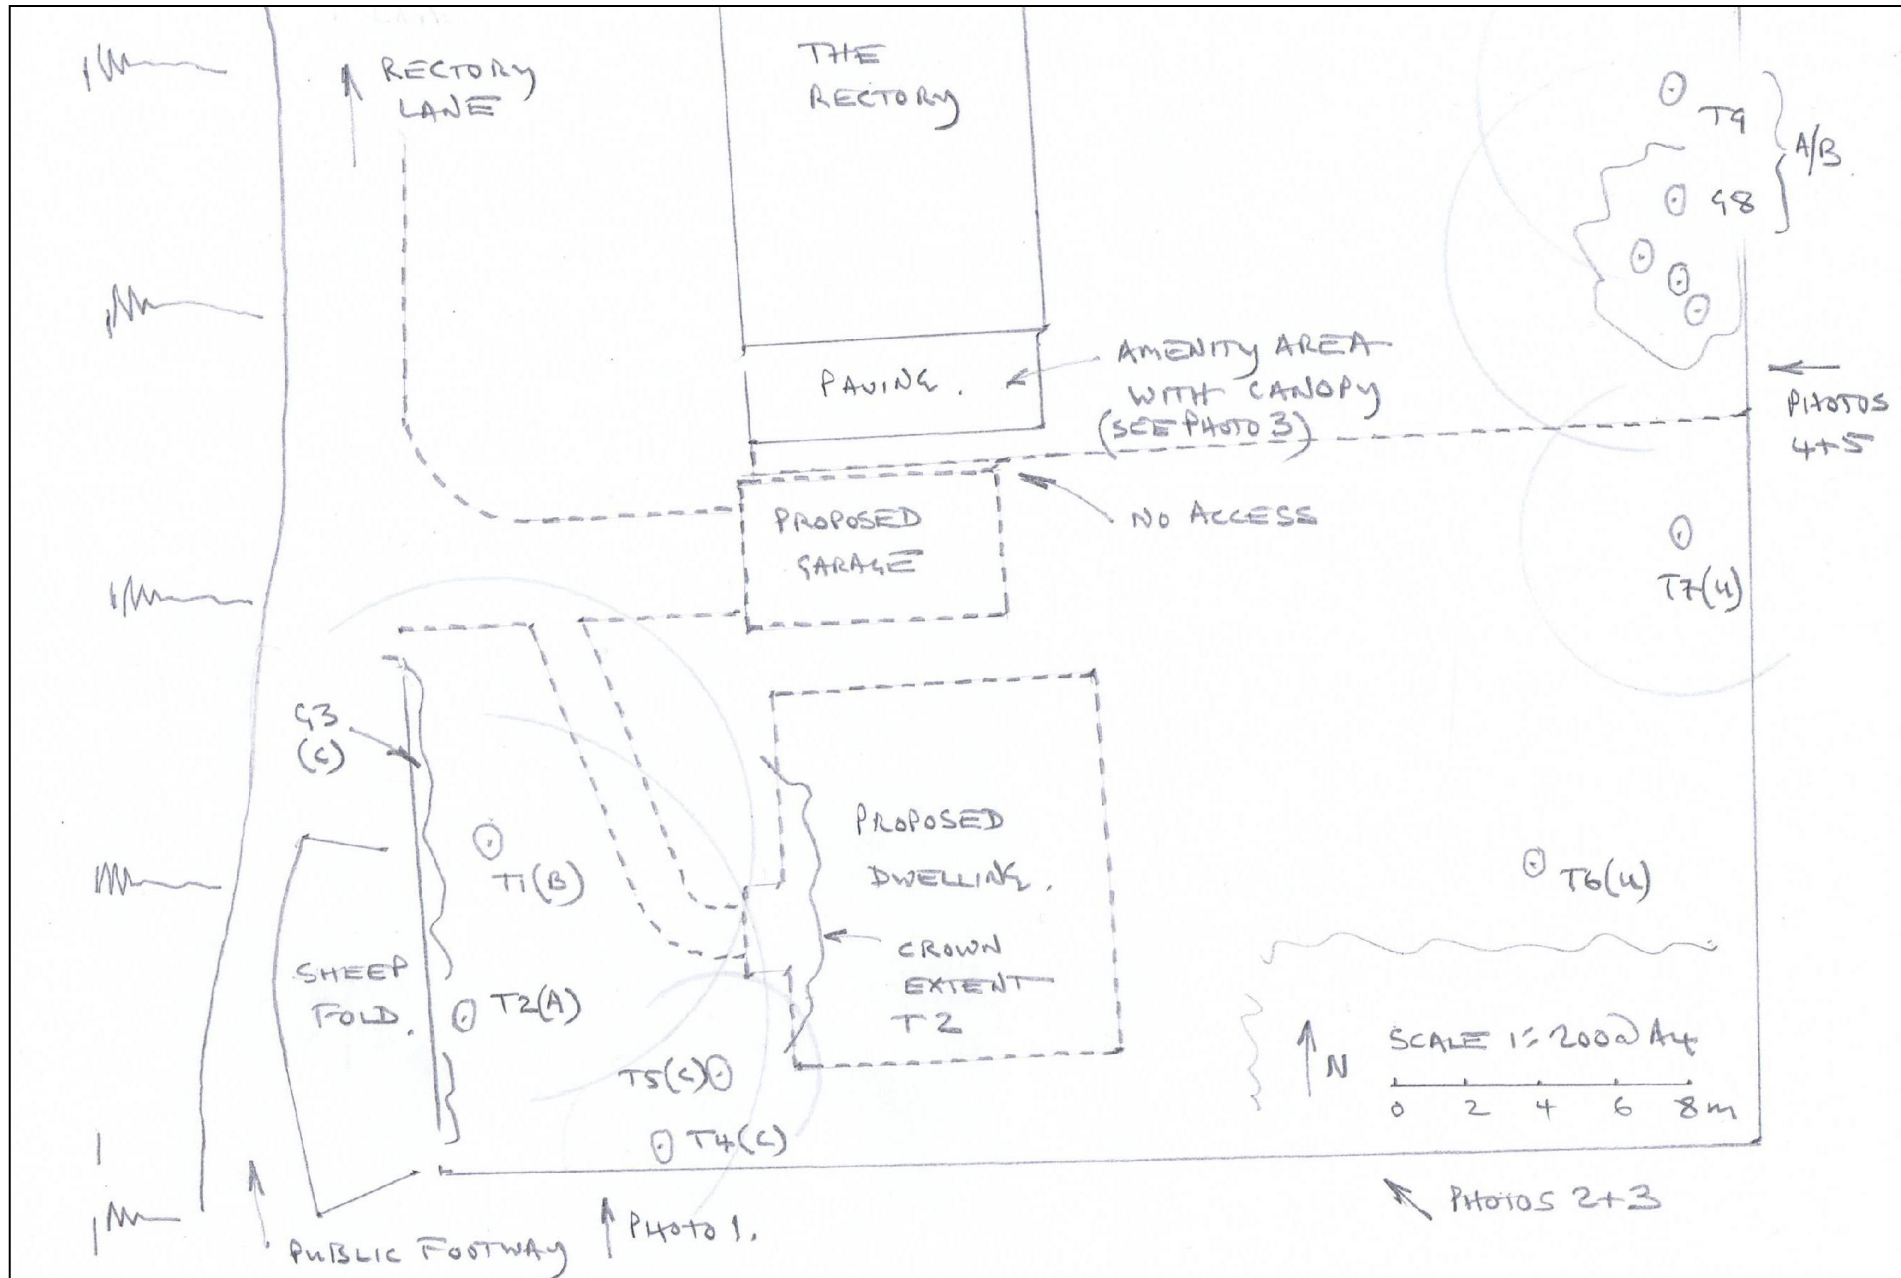
NOTE: *Tree position plan* on next page. Note RPA extents shown are sketched faintly – they are not compliant with BS 5837 (2012).
