**HENGIST ROAD,
WESTGATE ON SEA,
KENT**

**ECOLOGY
PRELIMINARY BAT SURVEY & EMERGENCE SURVEY**

**ISSUE 1
MAY 2017**

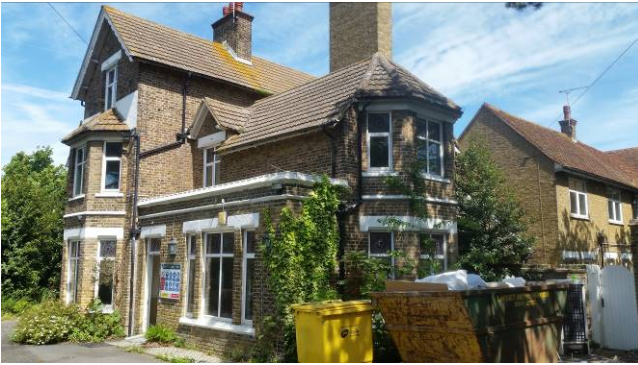
Figure 1: Southern elevation of main building

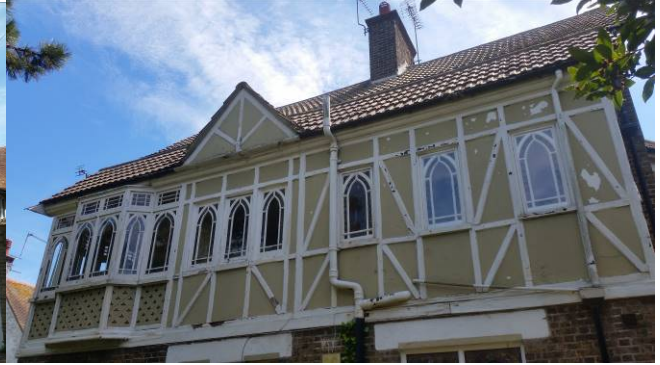
Figure 2: Northern elevation of the main building

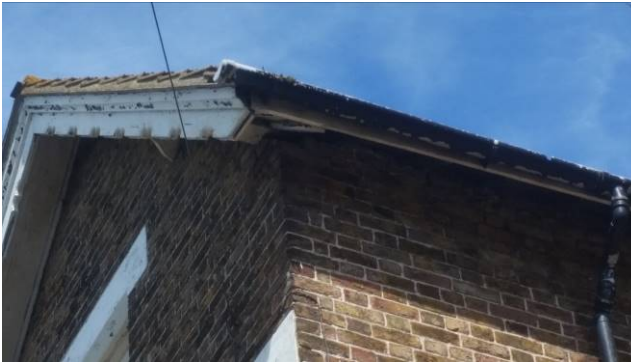
Figure 3: Areas of open eave and soffit within eastern gable end

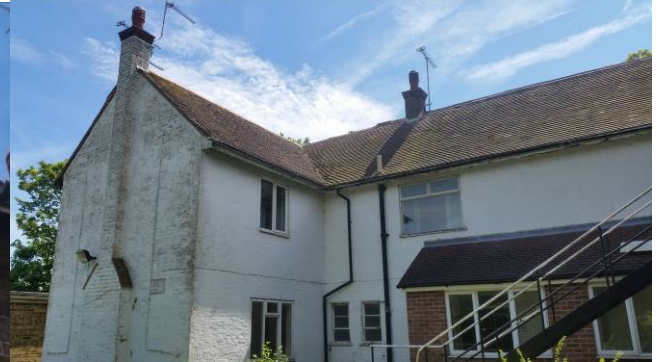
Figure 4: Northern elevation of modern two storey extension

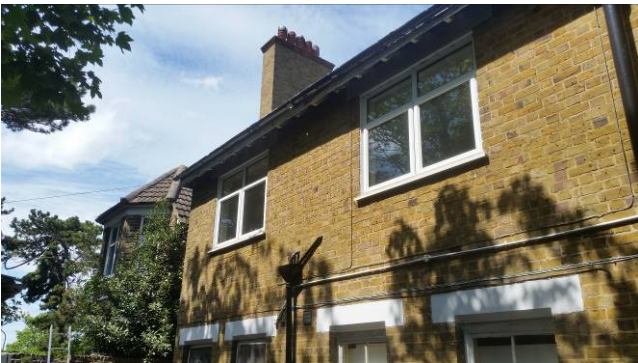
Figure 5: Southern elevation of modern two storey extension

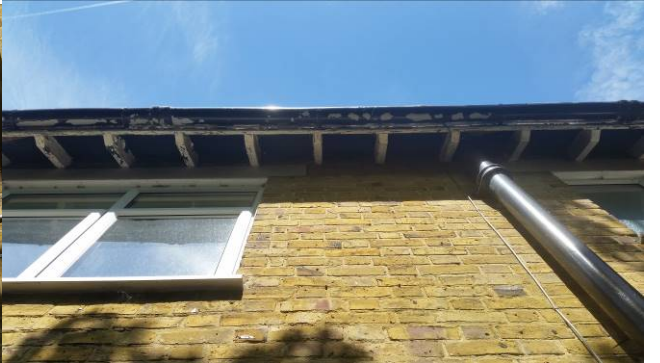
Figure 6: Eaves extending beyond the wall

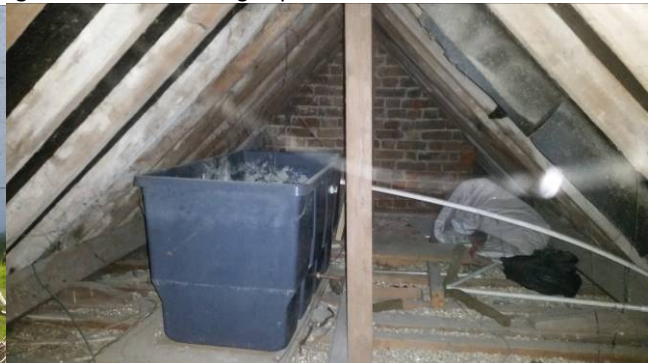
This void is located above the third storey section of the main building and runs east to west. The void is of pitch and gable end design with insulation lining the void floor (**Figure 8**). The roof tiles are underlined with bitumen felt and a large brick chimney breast is present within the centre of the void. The void was heavily cobwebbed along the ridge board located within the apex of the void.

Figure 8: Internal spaces of roof void 1

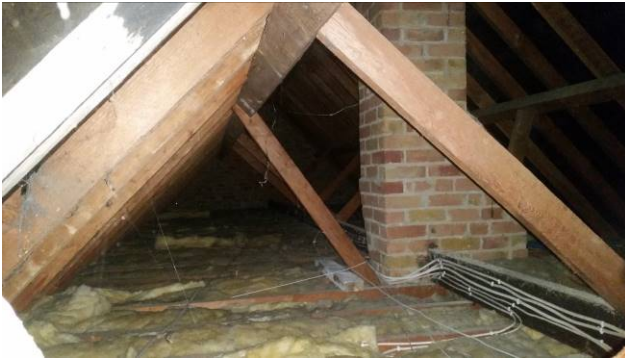
This large void is located above the modern two storey section. The void is of pitch and gable design with rock wool insulation lining the void floor (**Figure 9**). The roof tiles are underlined with bitumen felt. The void was also heavily cobwebbed along the ridge board located within the apex of the void.

Figure 9: Internal spaces of roof void 4

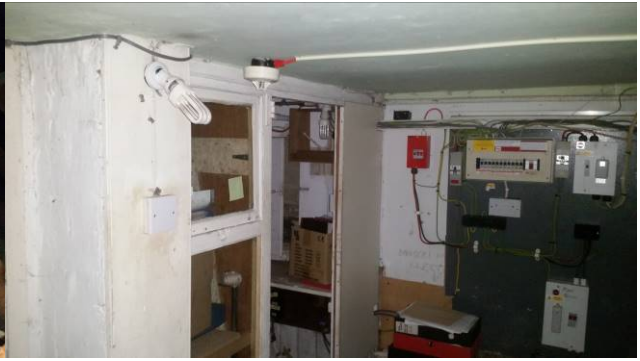
A small cellar is located centrally within the building (**Figure 10**). The cellar has no external access and has been utilised for storage.

Figure 10: Internal space of Cellar

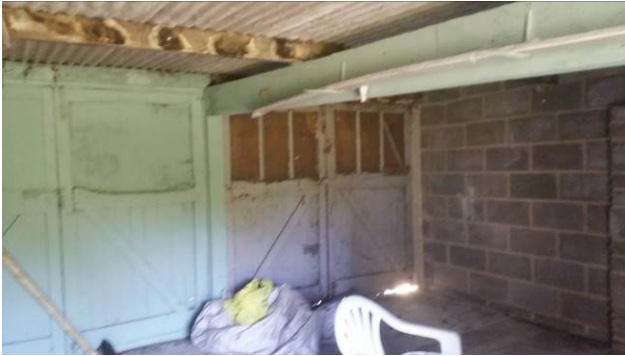
The single storey outbuilding extends from the northern elevation of the main building. The building does not support a roof void as internal spaces are open to the asbestos roof (**Figure 11**).

Figure 11: Internal space of outbuilding

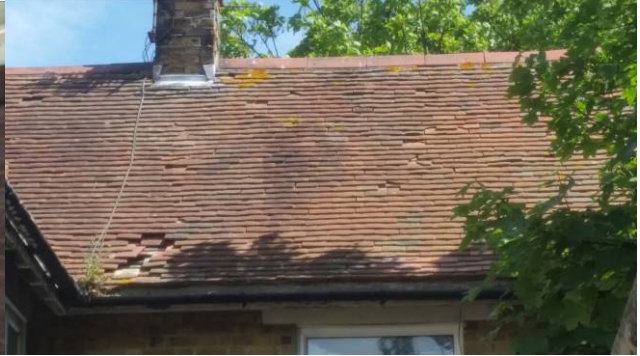
- 3.6 The building supports low numbers of potential bat roost features. Gaps beneath missing and broken tiles were located on the western elevation of the modern two storey extension (**Figure 12**). Occasional gaps were also present within the underlining located at the eaves of the modern two storey extension building on the eastern elevation (**Figure 13**). A small gap was located within area of soffit on the eastern elevation of the main building (**Figure 14**), occasional minor gaps were also present beneath roof tiles. There were no obvious entrance or exit locations to the roof voids or cellar area, bats may use gaps beneath roof tiles to access holes that may be present within bitumen felt linings.

Figure 12: Gaps located beneath missing tiles

- 5.2 During the survey at the site low numbers of gaps were present beneath tiles that may offer suitable nesting locations for birds. If demolition proceeds during the bird nesting season, which runs from late April – September inclusive, then a check for breeding bird activity should be undertaken by a suitably qualified ecologist no longer than 24 hours prior to demolition. If nesting birds are confirmed the nest should remain undisturbed until young have fledged and the nest is no longer in use. To compensate the loss of any potential nesting habitat it is recommended two sparrow terrace bird boxes should be erected, where possible, on new buildings within the site in order to compensate for the loss of nesting bird opportunities.

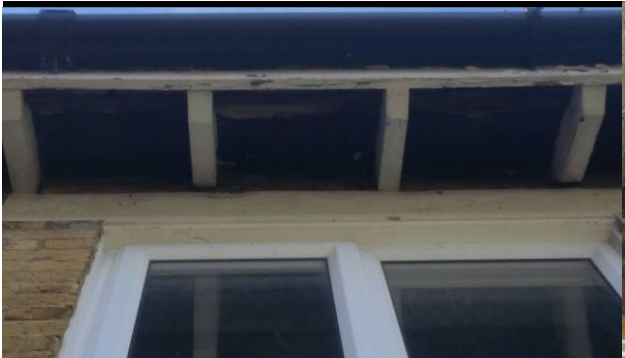
Figure 13: Gap within felt underlining at eaves

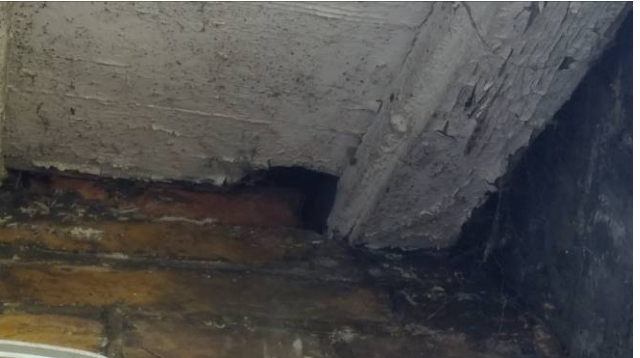
Figure 14: Gap located within soffit on eastern ele. of building

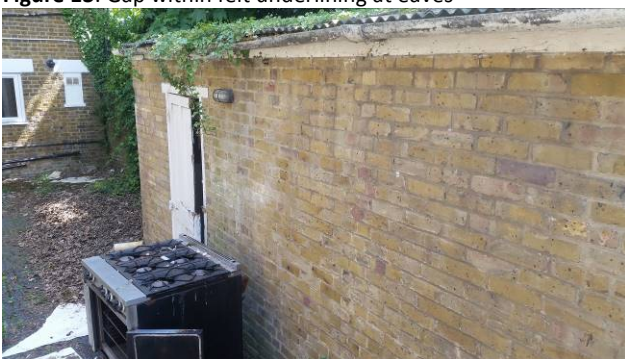
- 3.11 This building comprises a single storey, brick built building with a shallow single pitched roof lined with sheet asbestos (**Figure 15**). Windows were present on the eastern and northern elevations and a large timber door is present on the western elevation.

Figure 15: Northern elevation of garage building

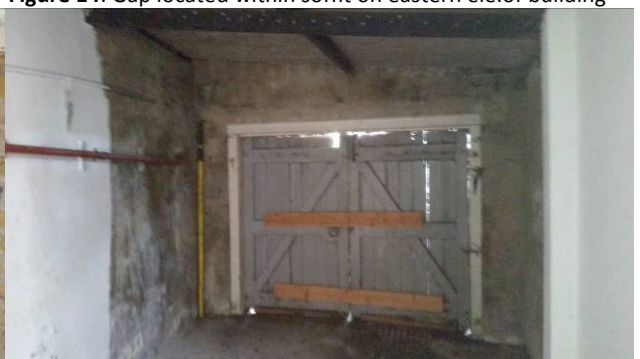
- 3.12 The building does not support any roof voids and with internal areas open to the sheet asbestos roofing (**Figure 16**). Internal areas are lit by daylight entering through windows present on the building.

Figure 16: Internal spaces of garage building

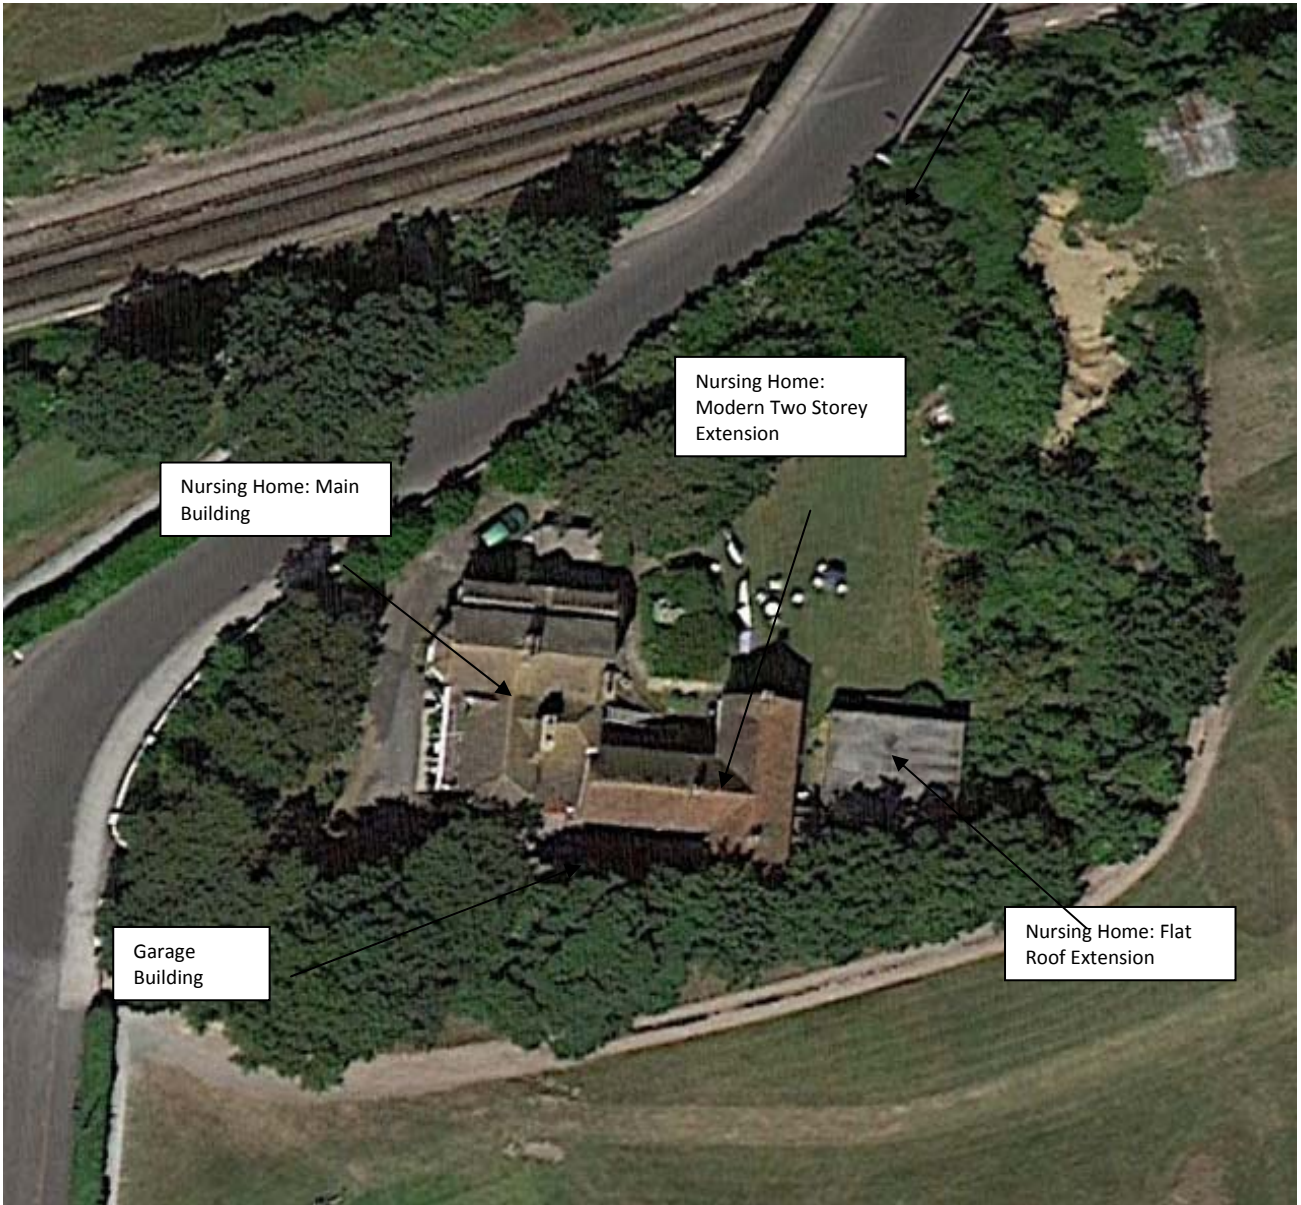
MAP 2 – Building locations

- 3.2 The following section provides results of the preliminary bat survey at the site including an assessment of the buildings (as shown on **Map 2**), trees and general habitat at the site.

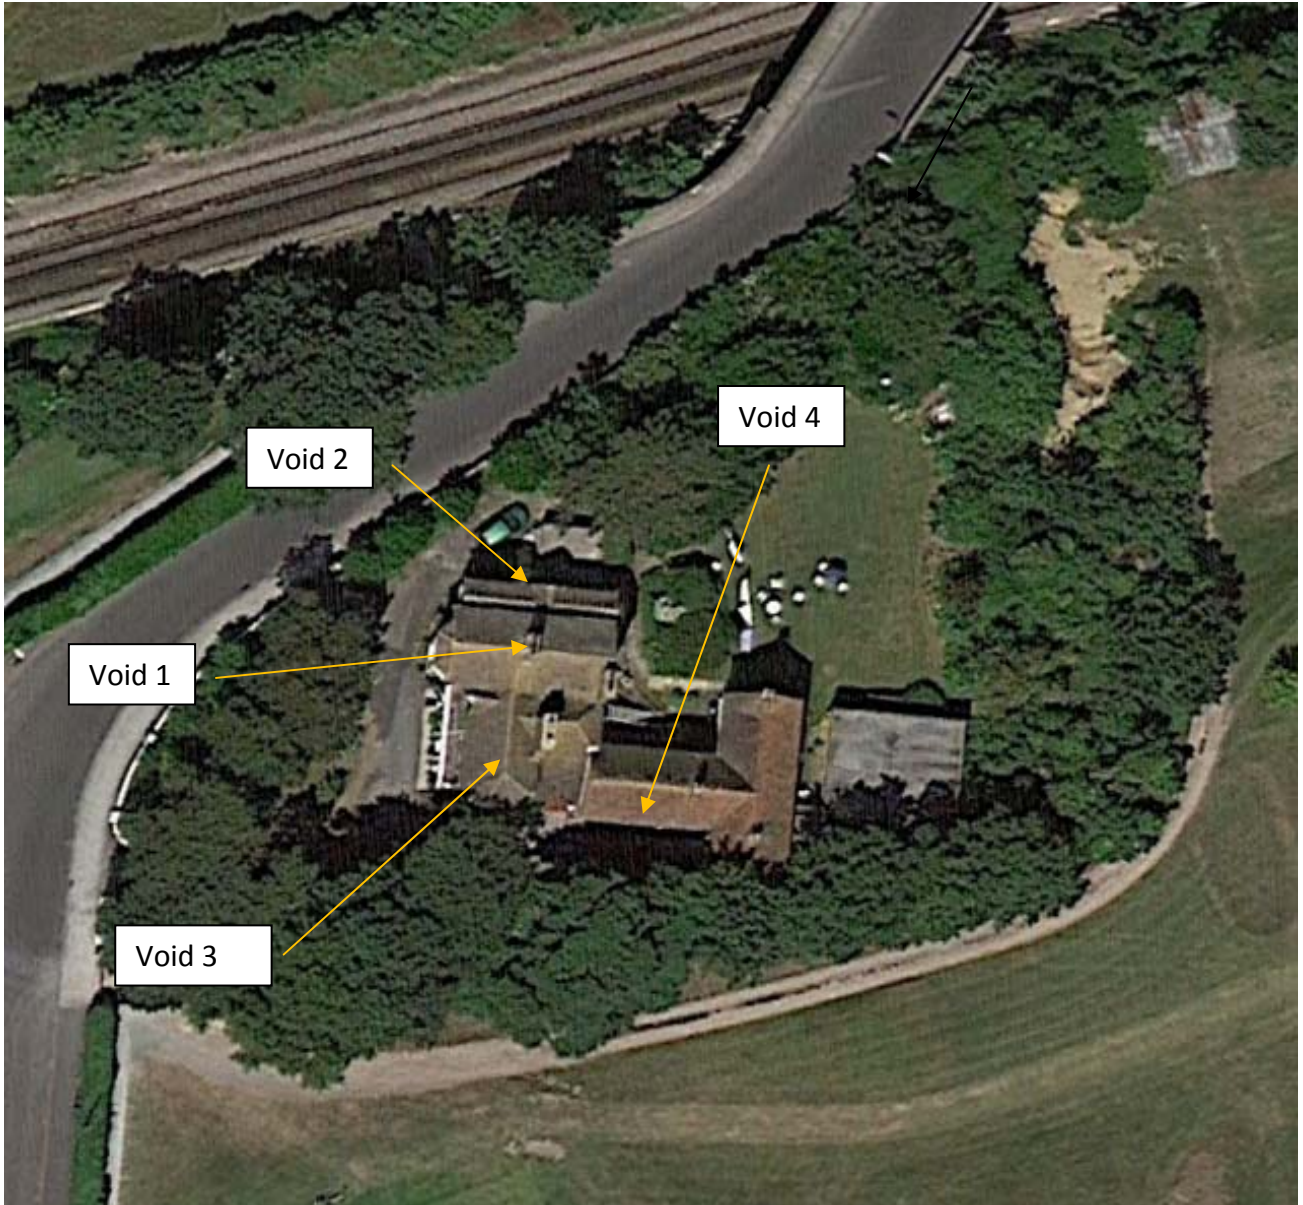
MAP 3 – Roof Void locations

- 3.4 Three separate voids are present within the main section of the building. A single large roof void is present above the modern two storey extension. **Map 3** shows the location of roof voids within the building.

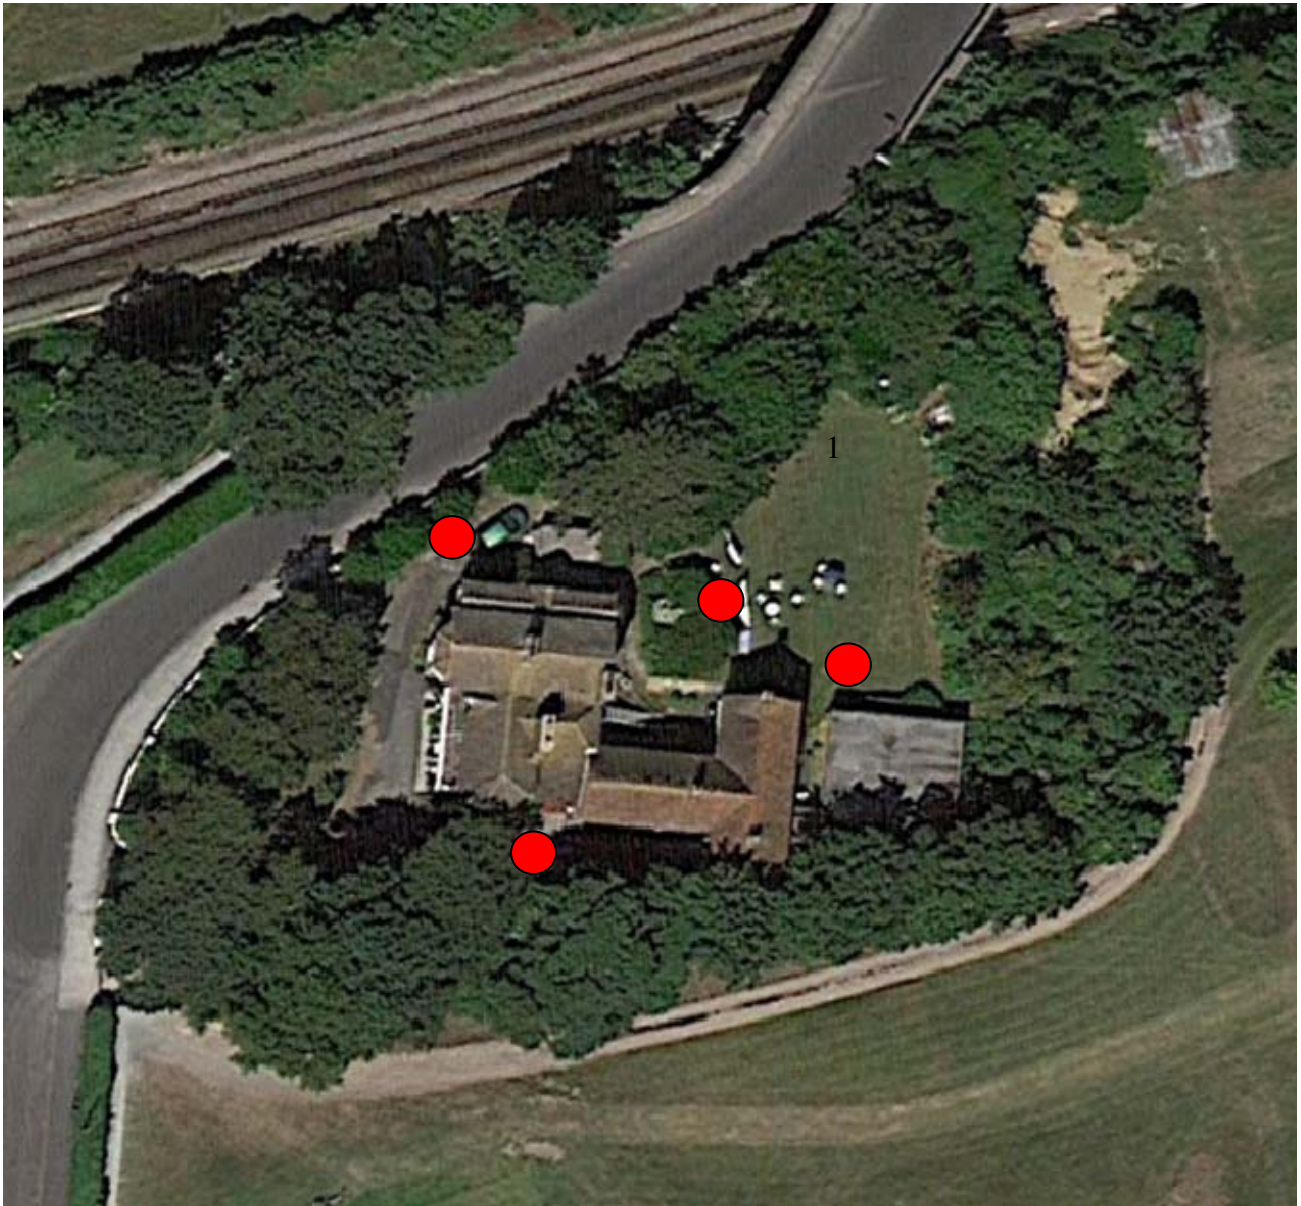
MAP 3 – EMERGENCE SURVEY, SURVEYOR POSITIONS

3.18 As a result of the preliminary bat survey further emergence bat survey was recommended for the nursing home building located at the site. Surveyor locations are shown in **Map 3**.

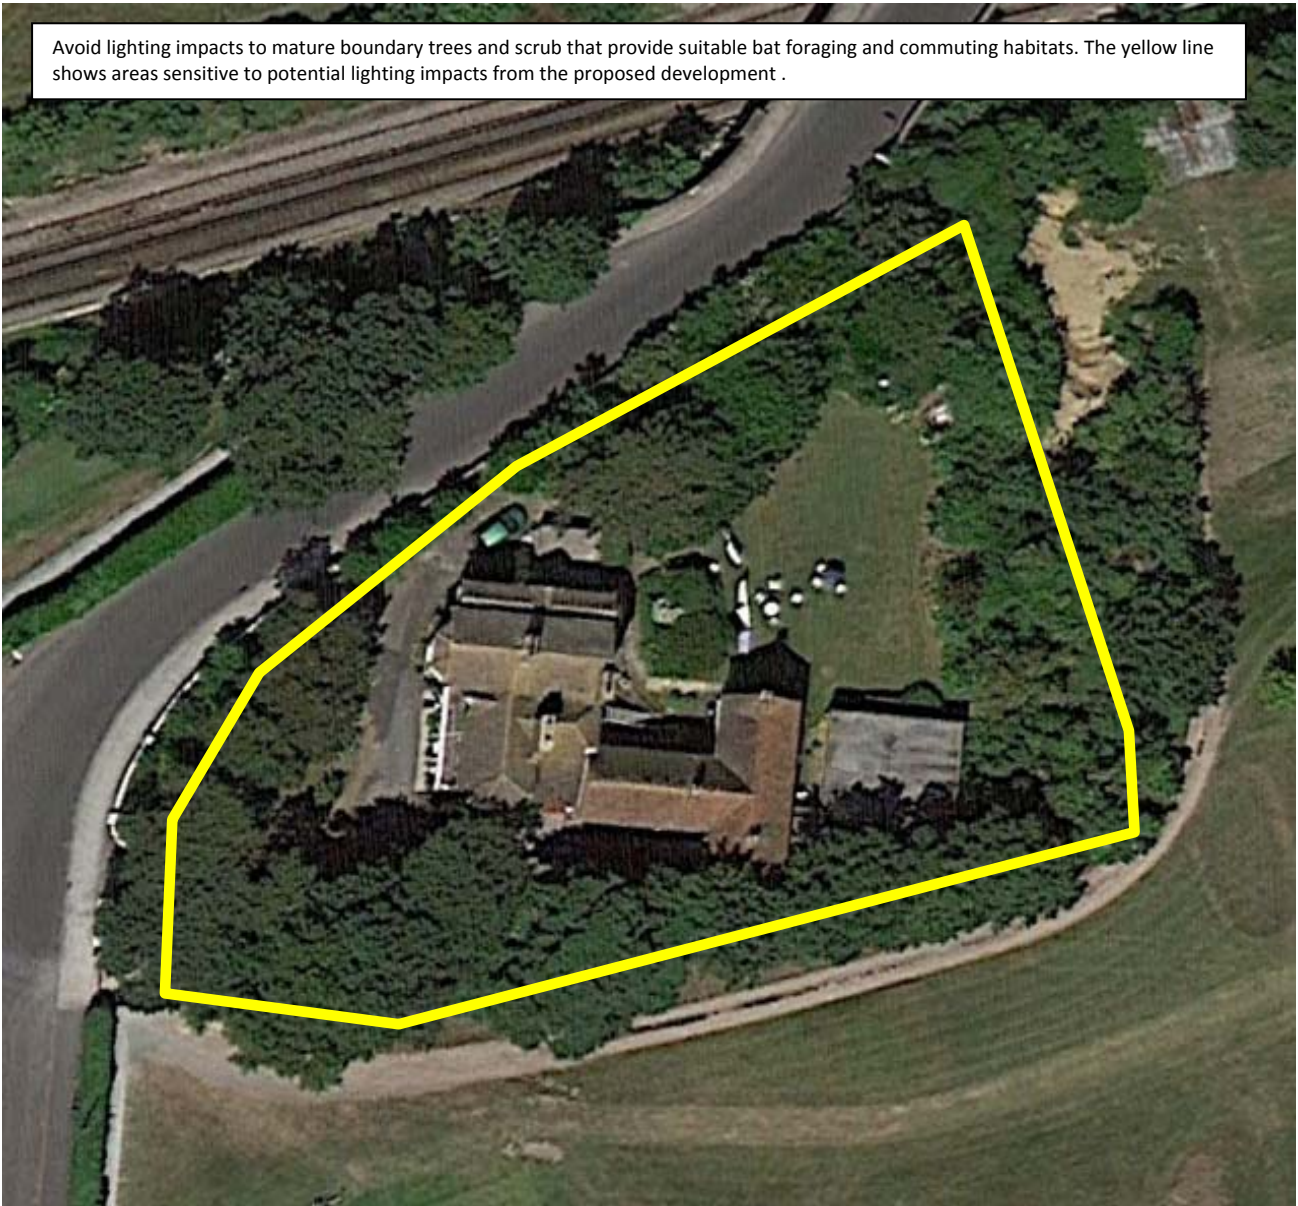
MAP 4 – LOCATION OF POTENTIAL LIGHTING IMPACT

Avoid lighting impacts to mature boundary trees and scrub that provide suitable bat foraging and commuting habitats. The yellow line shows areas sensitive to potential lighting impacts from the proposed development .
