The Grove School, St Leonards, East Sussex
Historic Environment Desk-Based Assessment
and Historic Buildings Record

Ellen Heppell
Contributions by Hannah Green & Guy Hopkinson

Project No. 6959
Report No. 2014304

September 2014

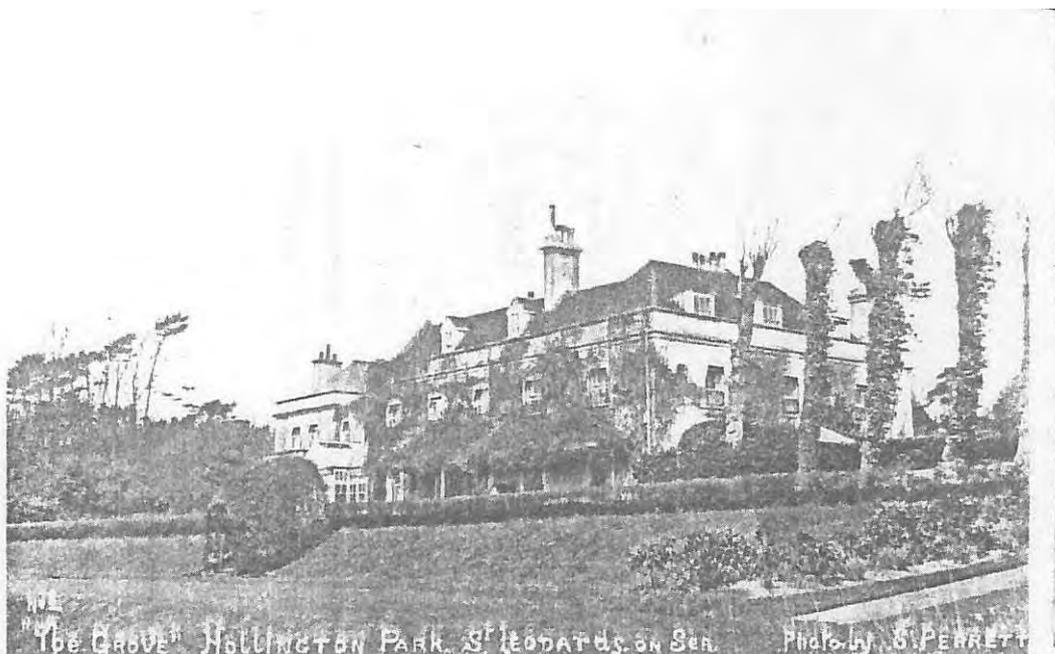
Plate 2. Post-1804 mansion showing terracing (6959-0067)

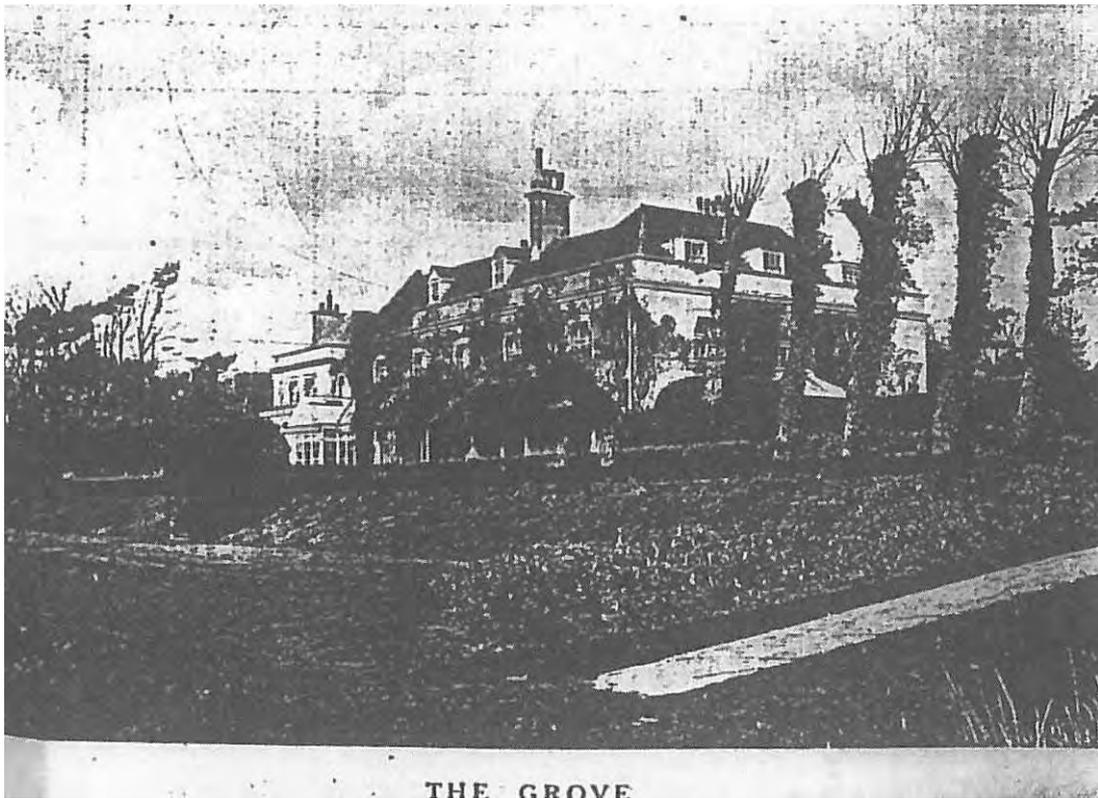
Plate 3. Post-1804 mansion showing terracing (6959-0068)

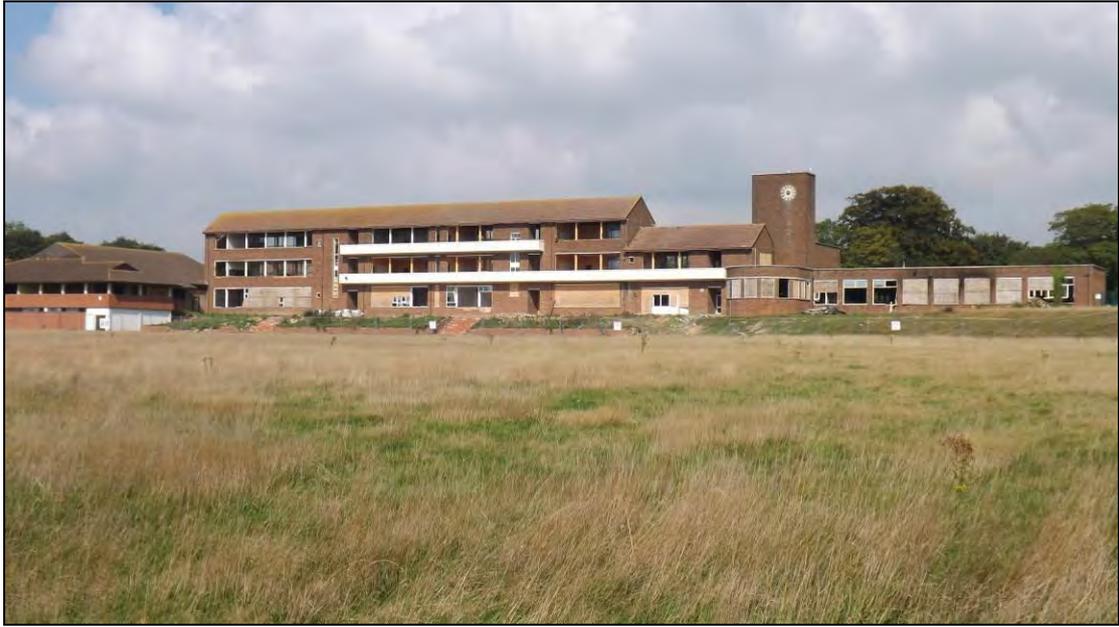
Plate 5. The school, facing north (6959-0070)

- 4.10.9 The original school buildings are the eastern block of buildings (Figure 2) and are modernist in style (e.g. Plate 5 and Plate 6). In addition to the school buildings an extensive sports field was constructed to the south of the main school buildings, this included a significant amount of earthmoving to create a flat area which was

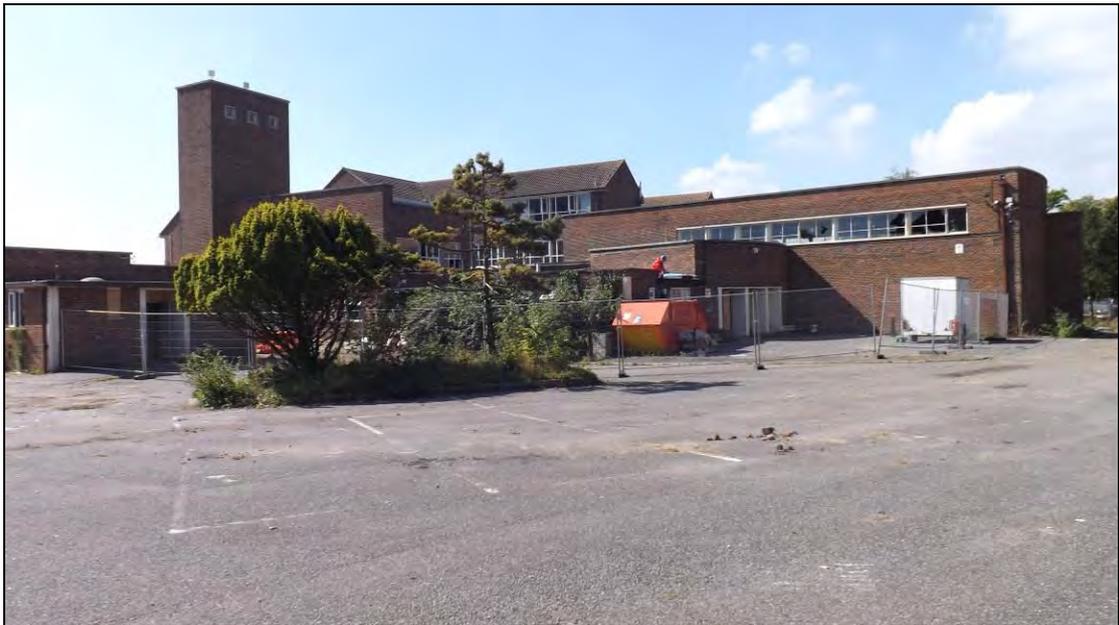
Plate 6. Rear of the school (6959-0071)

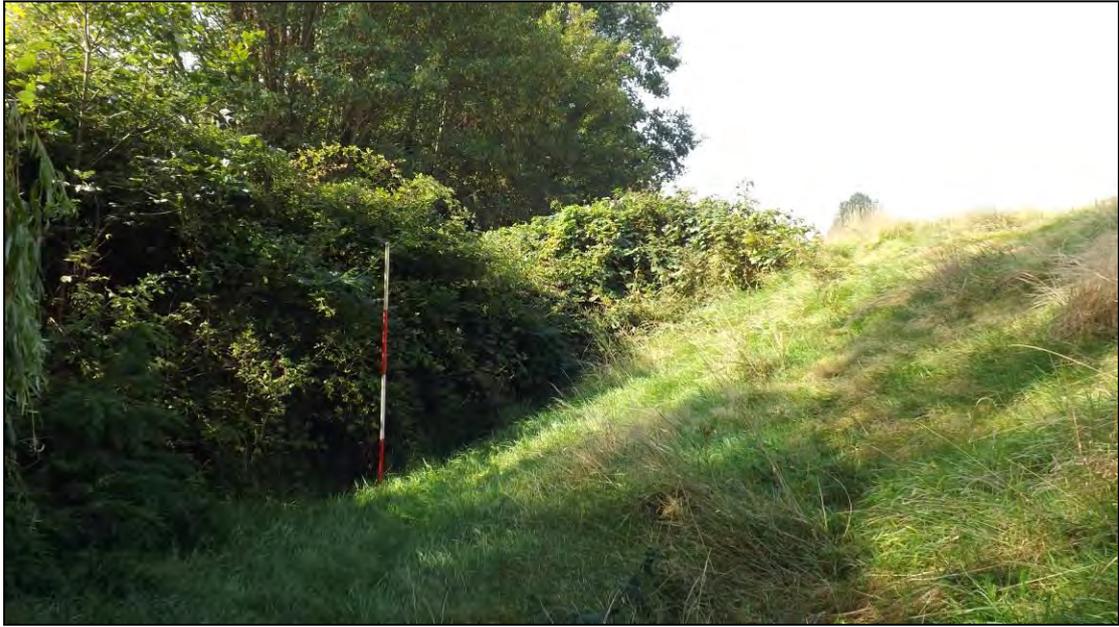
Plate 7. Bank on the south side of the school field (6959-0072)

- 5.4 Post 1950s mapping (e.g. Figure 10 to Figure 12) show the establishment and extension of the school on the site. The most significant features to be noted on these maps are the banks and terrace in the vicinity of the sports court and sports field and courts which are indicative of a significant amount of earthmoving. These are still extant and are indicated on Figure 2 and illustrated on Plate 7 and Plate 8.

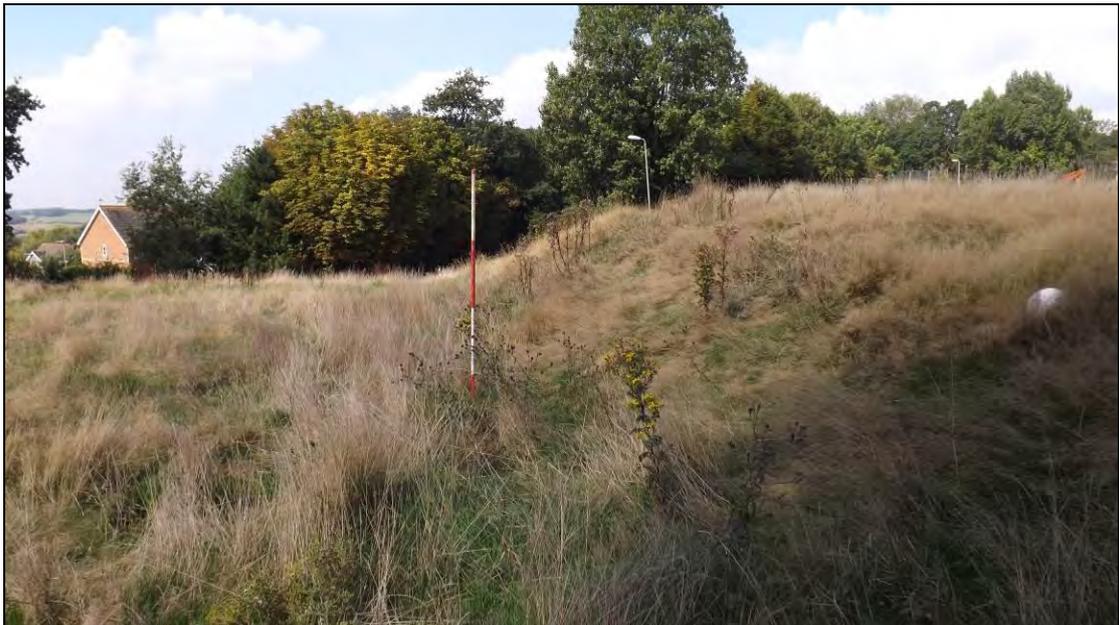
Plate 8. Bank on the west side of the school field (6959-0073)

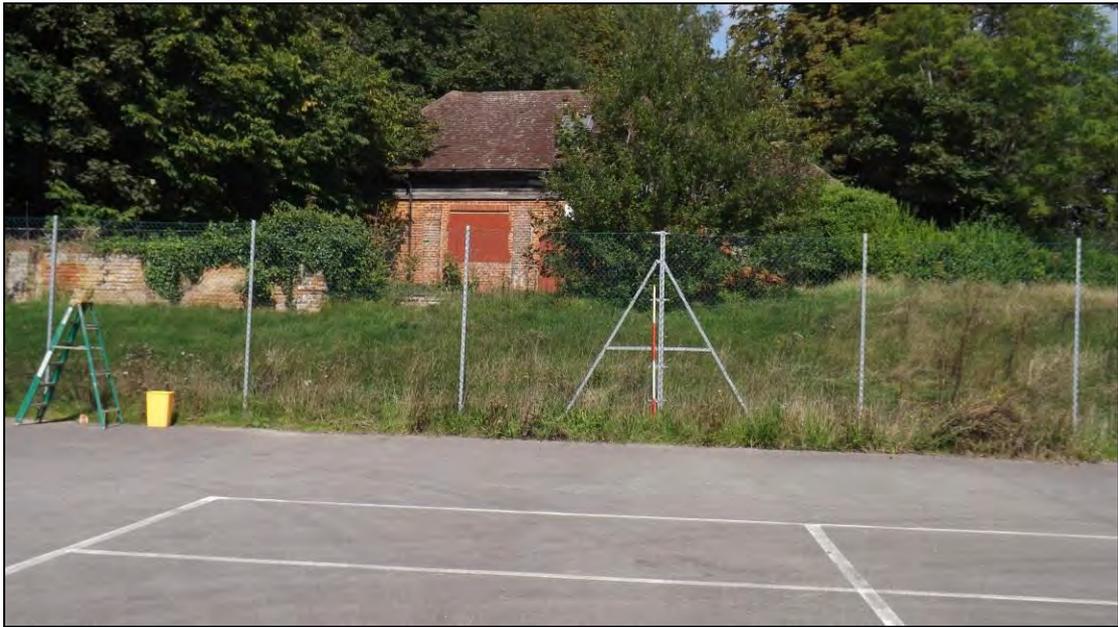
Plate 9. Bank between the car park and stables (6959-0074)

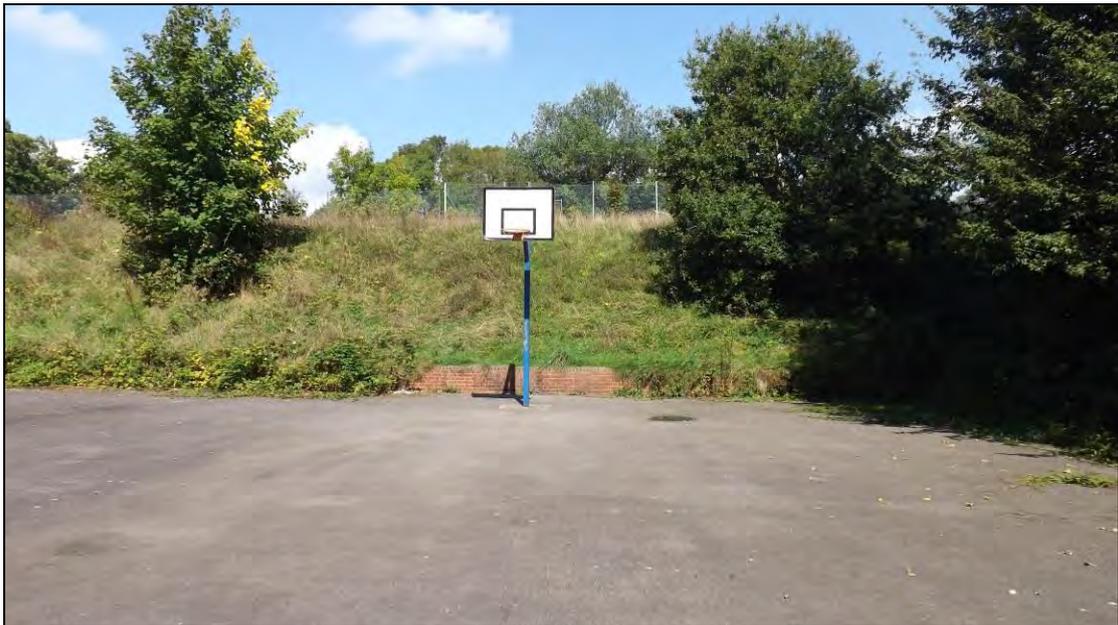
Plate 10. View up to the car park area (6959-0066)

school itself. Selected levels have been marked on Figure 2 and are derived from a site survey provided by the client. It would appear likely that the school buildings sit along the highest point of the ridge and that there may be some localised cut and fill in this area to create the platforms for the building. To the south of these it is likely that the northern part of the sports field has been cut into the natural slope, evidenced by the presence of banks. The material from this bank is likely to have been used to raise the ground level towards the south and west of the field where there are steep drops to the surrounding land (e.g. Plate 9 and Plate 10).

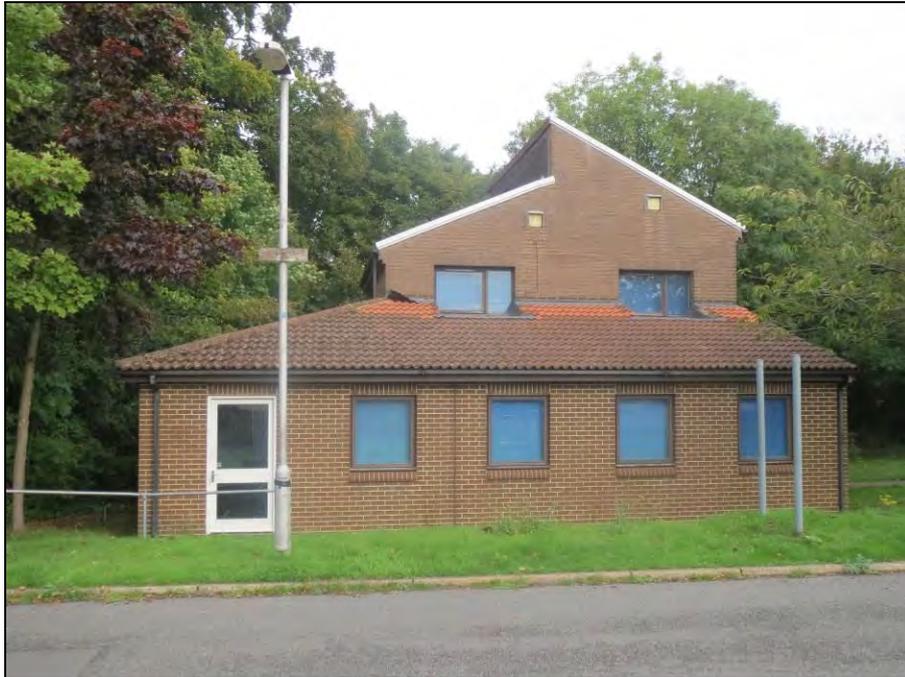
Plate 2.1 This detached rectangular structure is of a later construction date than the main school building and consists of two storeys, with a projection on its northern elevation. Situated at the northeast corner of the main school building, facing north (6959-0036)

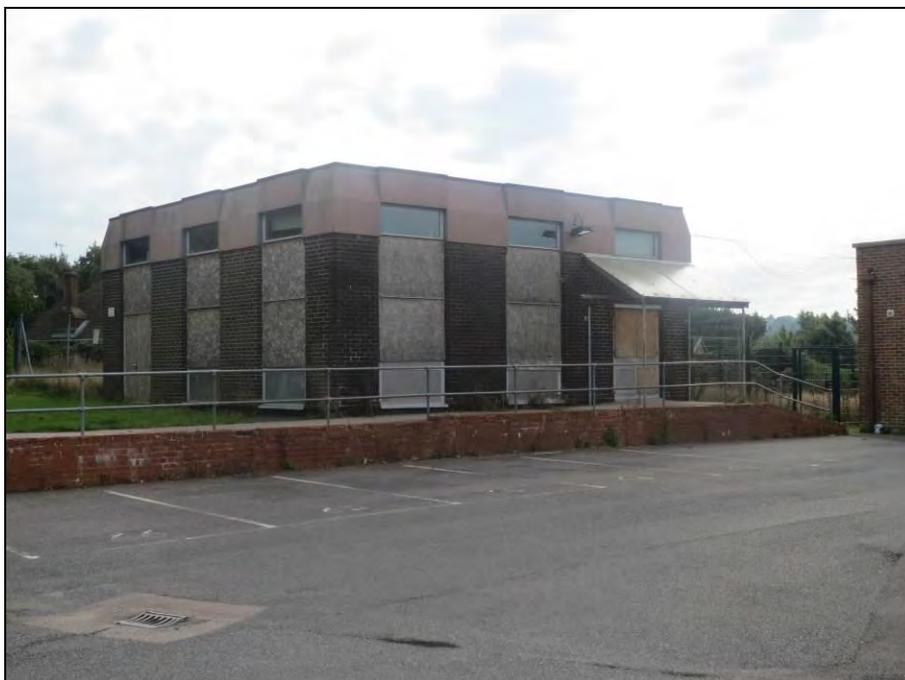
Plate 2.2 This detached building follows a square layout with porch and access ramp running along its western elevation. It occupies an elevated position located to the extreme eastern end of the main school building, facing southeast (6959-0033)

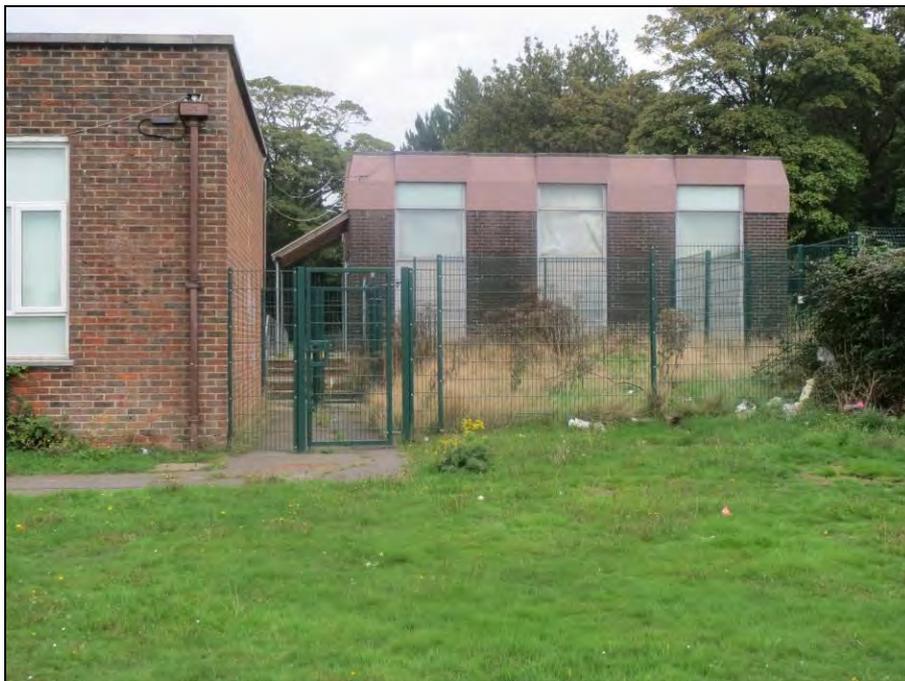
Plate 2.3 Eastern elevation and southern elevation of the detached building located to the far eastern end of the northern elevation of the main school building, facing north (6959-0059)

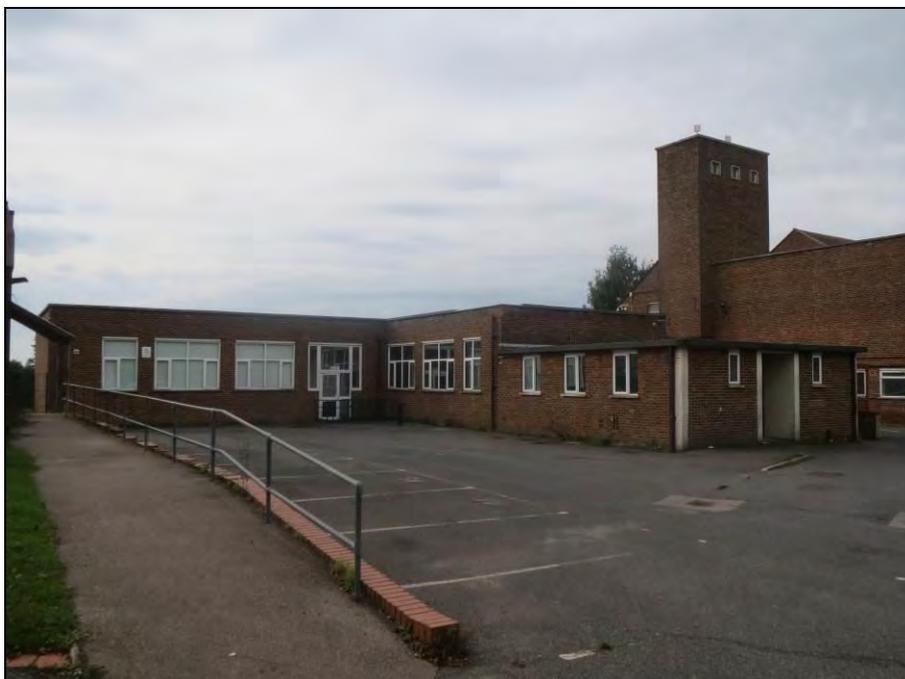
Plate 2.4 Eastern elevation and extreme eastern end of the northern elevation. This section is a one-storey, flat roof structure with its north and west faces looking out onto a small forecourt, facing southwest (6959-0034)

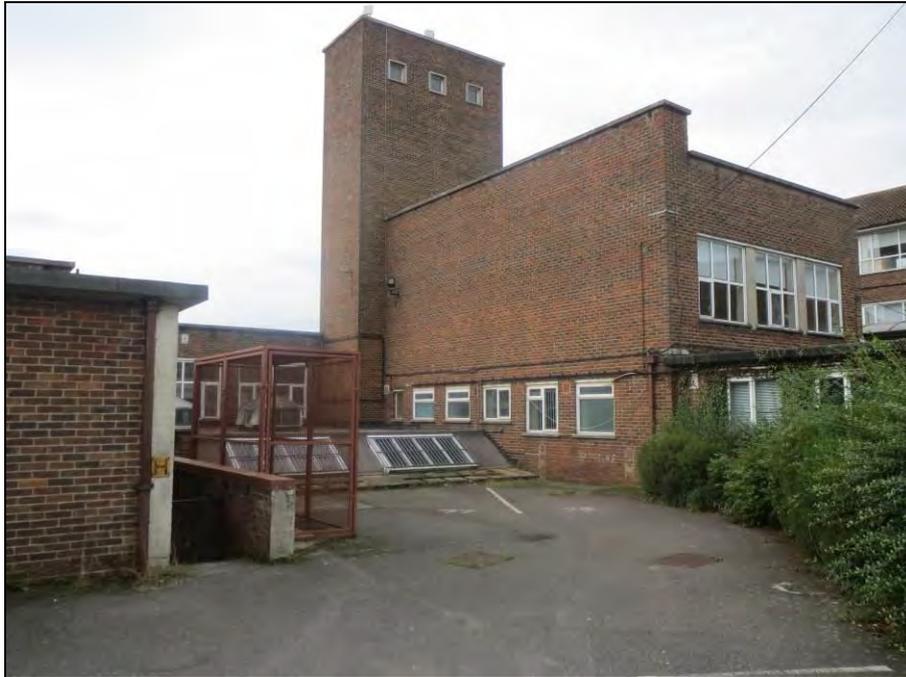
Plate 2.5 Eastern end of the northern elevation, facing southwest towards a partially enclosed courtyard (open at the north end) (6959-0035)

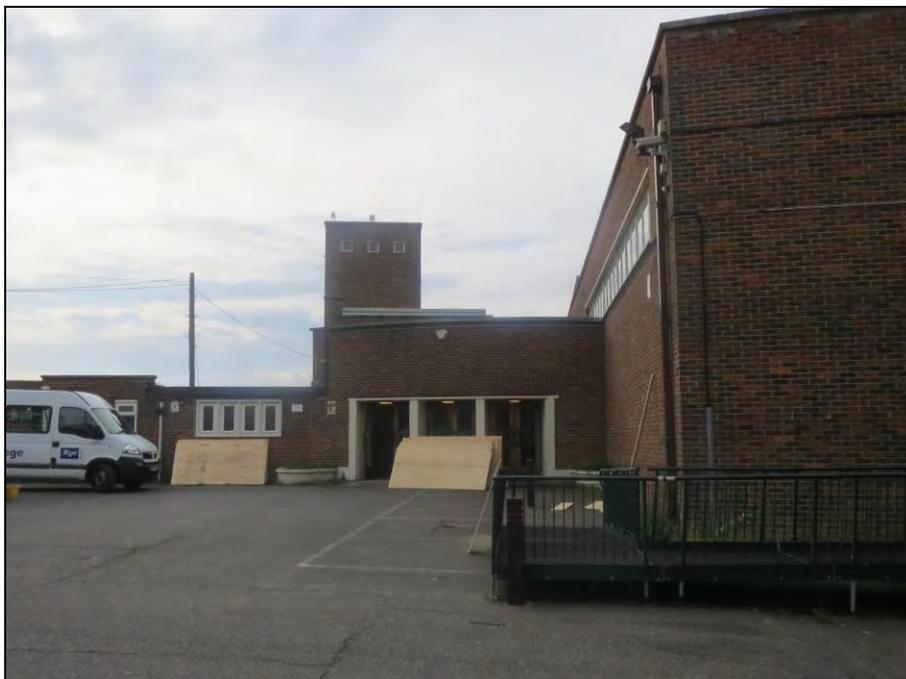
Plate 2.6 Eastern end of the north elevation, facing south (6959-0037)

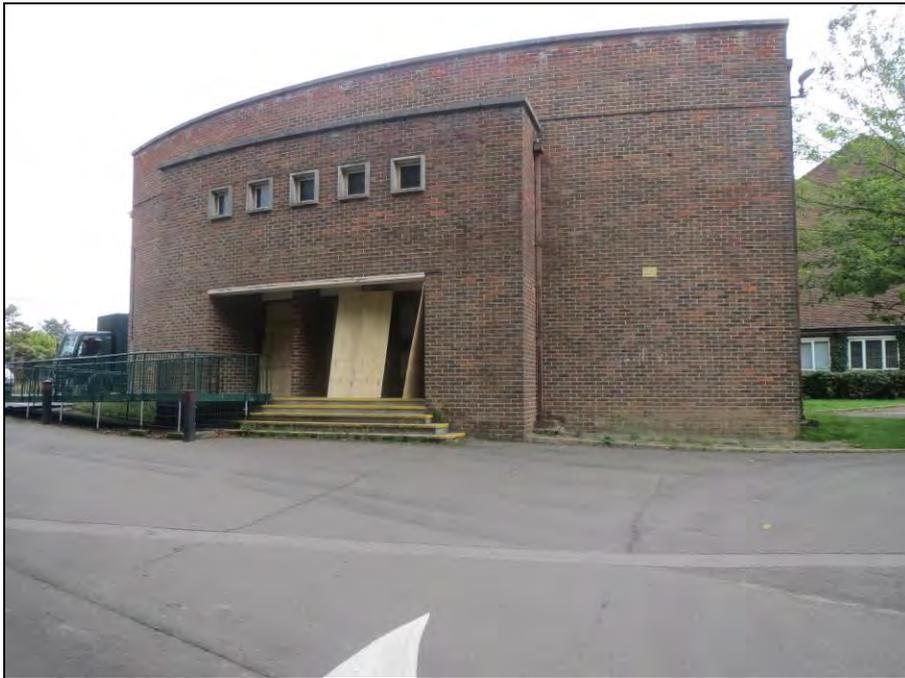
Plate 2.7 Curved façade and access ramp of the eastern projection located on the northern elevation, facing south (6959-0064)

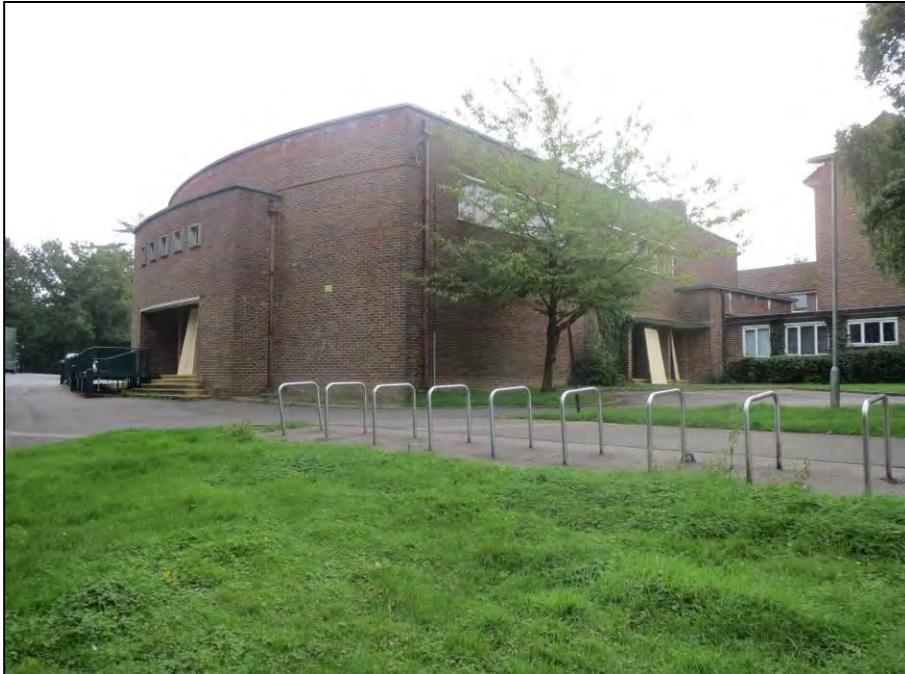
Plate 2.8 Curved façade and western side of the eastern projection located on the northern elevation, facing southeast (6959-0038)

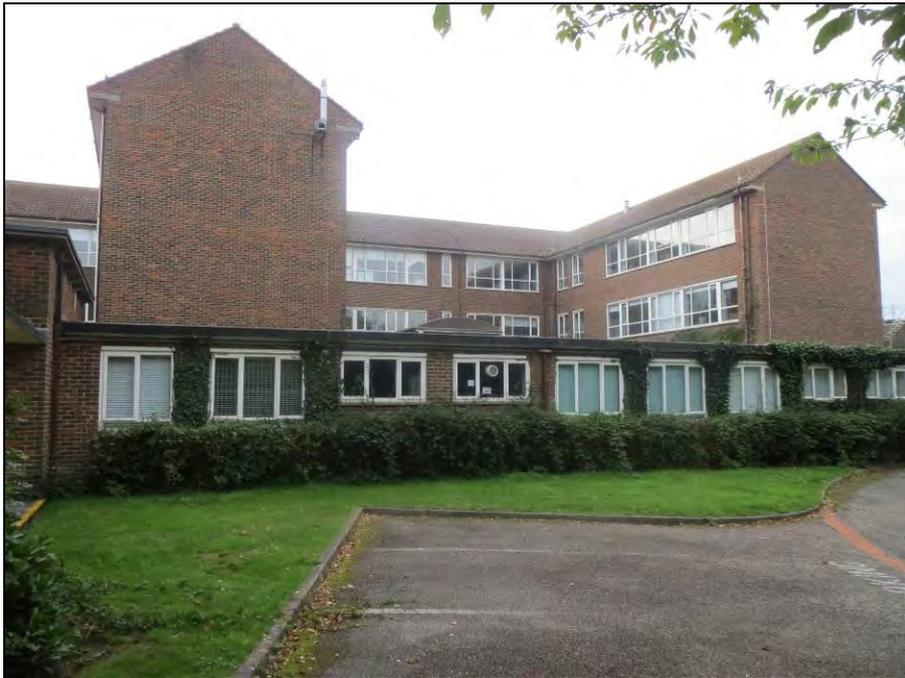
Plate 2.9 Central section of the north elevation, to the east of the main reception entrance, facing south (6959-0039)

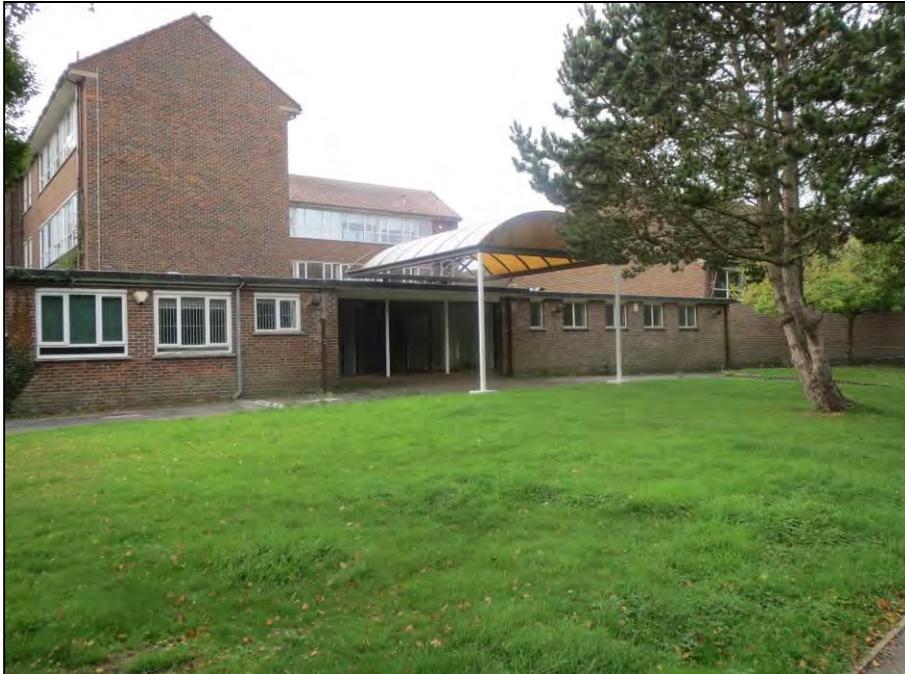
Plate 2.10 Main reception entrance with covered porch projecting north, located in the central section of the northern elevation, facing southwest (6959-0040)

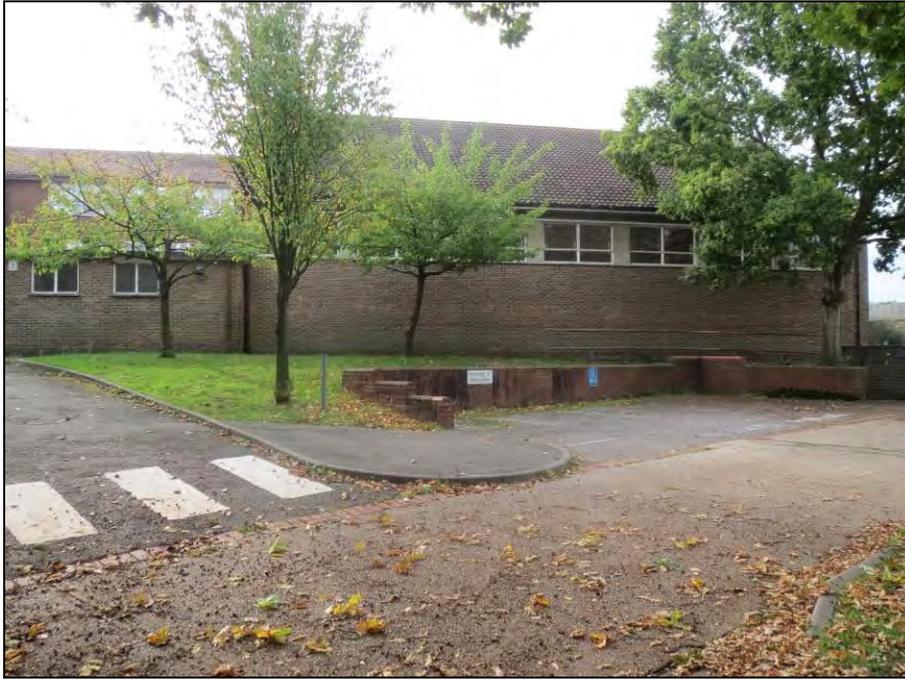
Plate 2.11 Central section of the northern elevation, situated to the west of the main reception entrance, facing southwest (6959-0041)

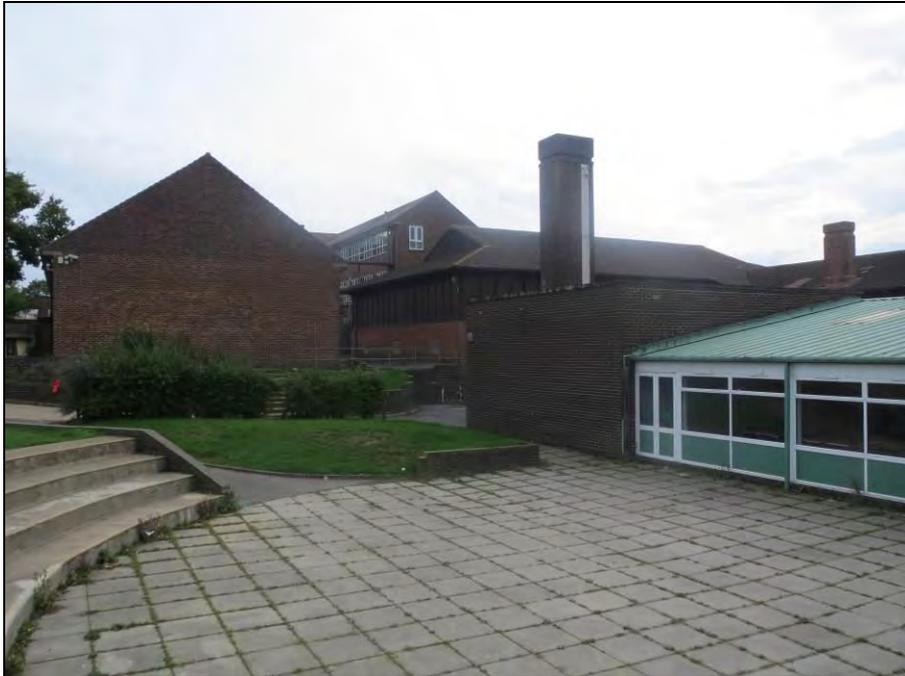
Plate 2.12 Western end of the northern elevation, facing east from a series of shallow semi-circular steps leading to a lower level forecourt (6959-0047)

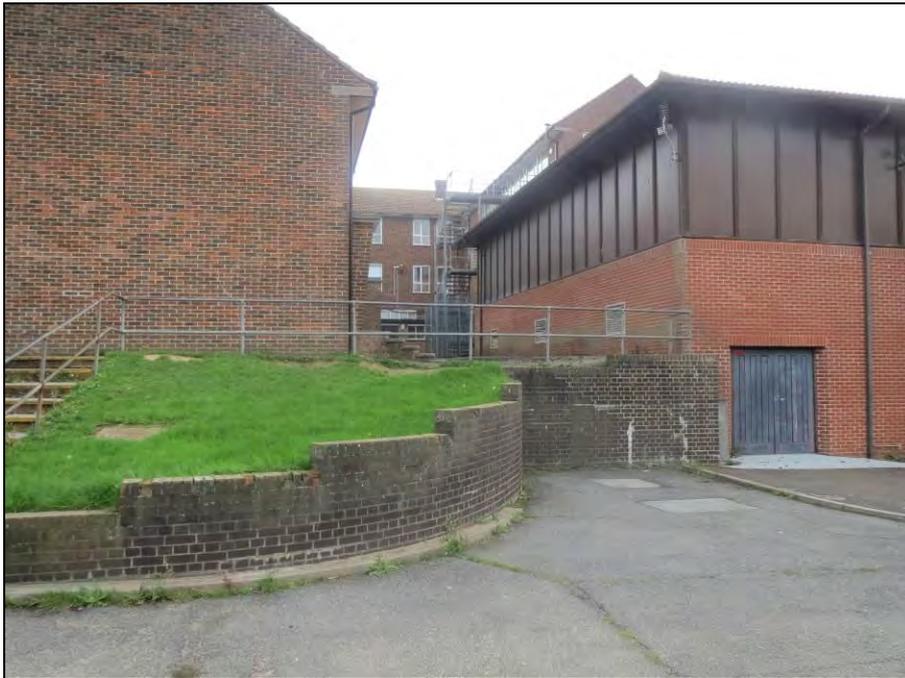
Plate 11 From within the 'L' shaped recess located to the western end of the northern elevation. Leading to a partially enclosed courtyard open at the west end, occupying an elevated position, facing east (6959-0043)

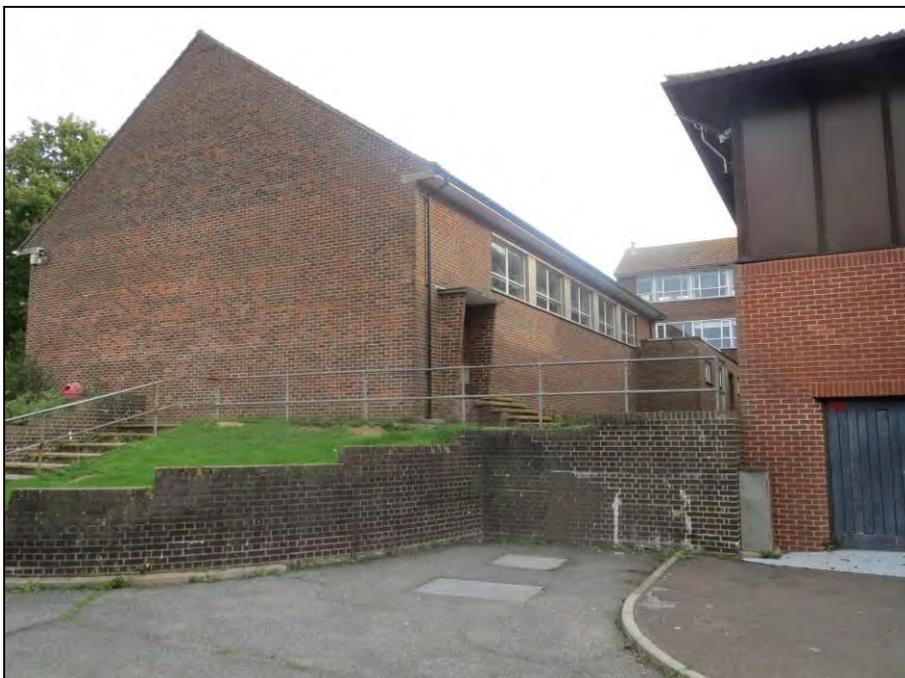
Plate 2.14 From within the 'L' shaped recess located to the western end of the northern elevation. Leading to a partially enclosed courtyard open at the west end, occupying an elevated position, facing northeast (6959-0045)

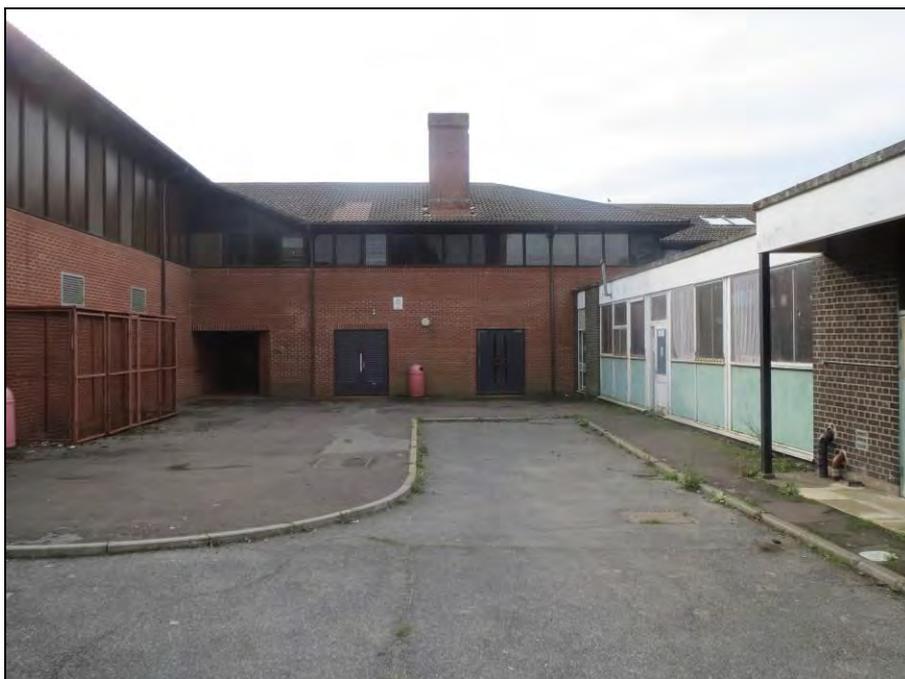
Plate 2.15 Taken from inside the partially enclosed 'L' shaped lower courtyard (open at the northern side), located to the western end of the northern elevation, facing south (6959-0044)

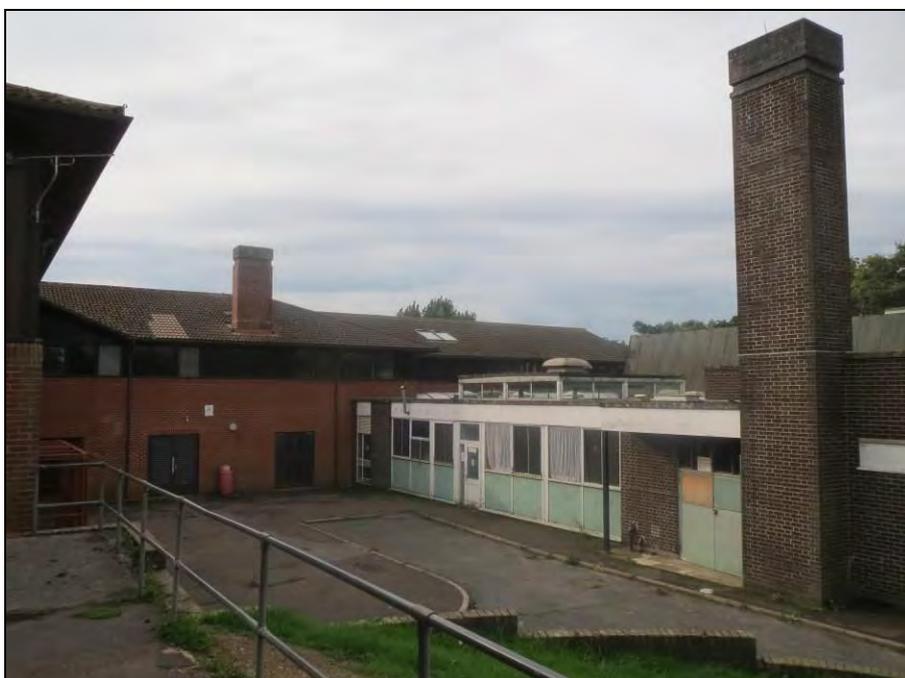
Plate 2.16 Taken from the elevated 'L' shaped courtyard recessed into the western end of the northern elevation, facing southwest towards the lower level courtyard (open at the north end) (6959-0046)

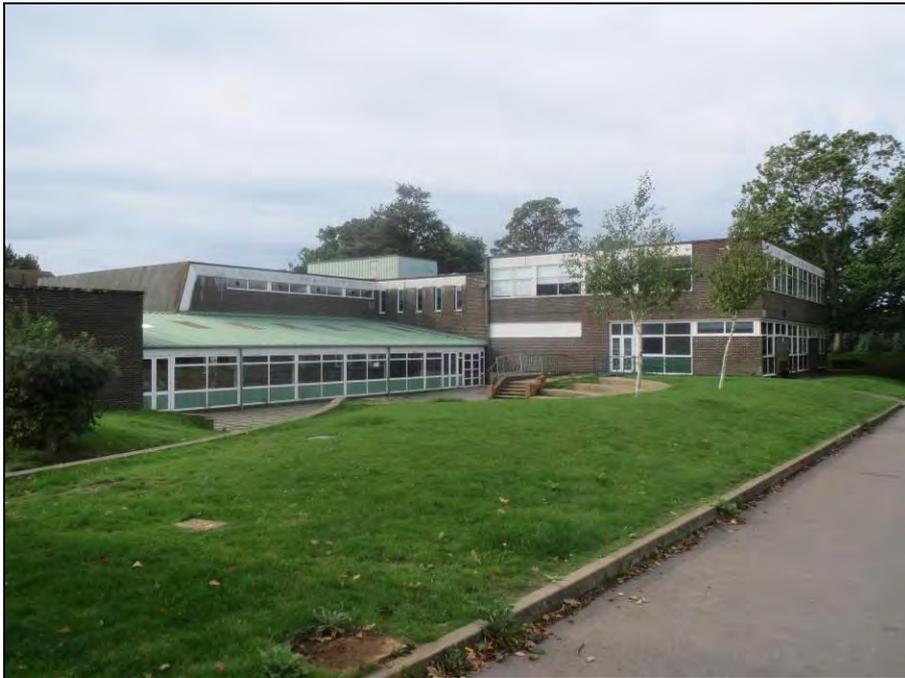
Plate 2.17 Western end of the northern elevation, situated to the south of a semi-circular low-level forecourt. The ground level section is constructed using prefabricated steel framed panelling, with large external windows and glass panelled doors, facing west (6959-0042)

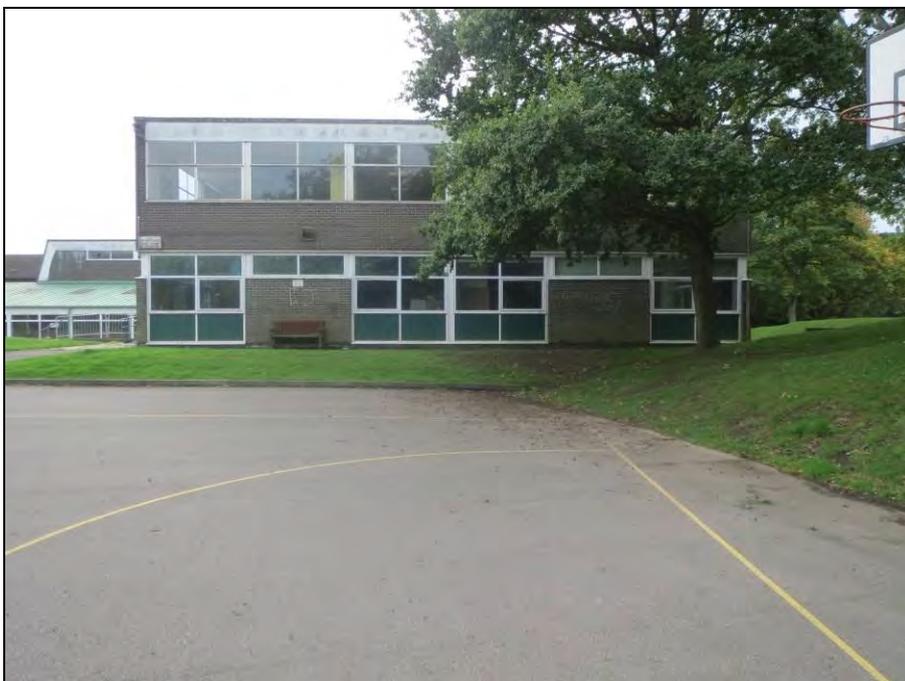
Plate 2.18 Extreme western end of the northern elevation, facing south (6959-0048)

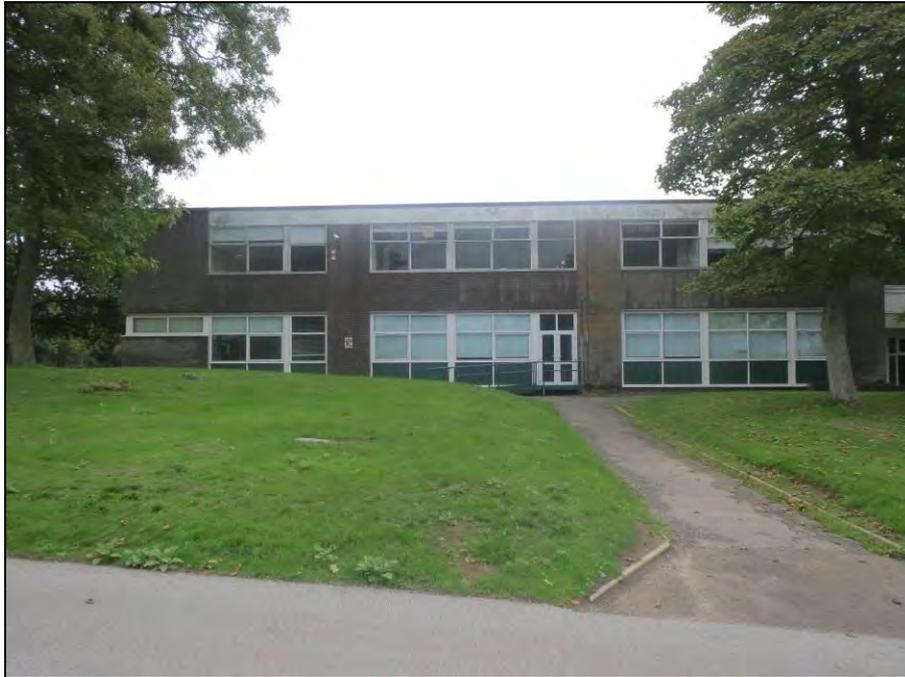
Plate 2.19 Northern end of the western elevation, occupying an elevated position at the top of an incline to the west, facing east (6959-0049)

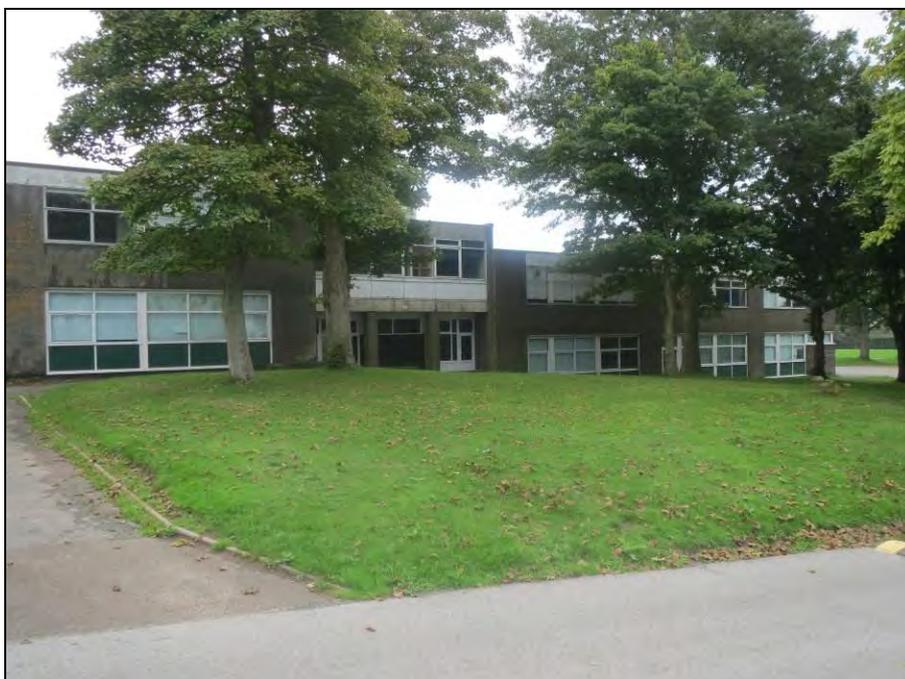
Plate 2.20 Southern end of the western elevation, each block occupies land at a lower ground level than the previous to accommodate for the change in ground height, facing southeast (6959-0050)

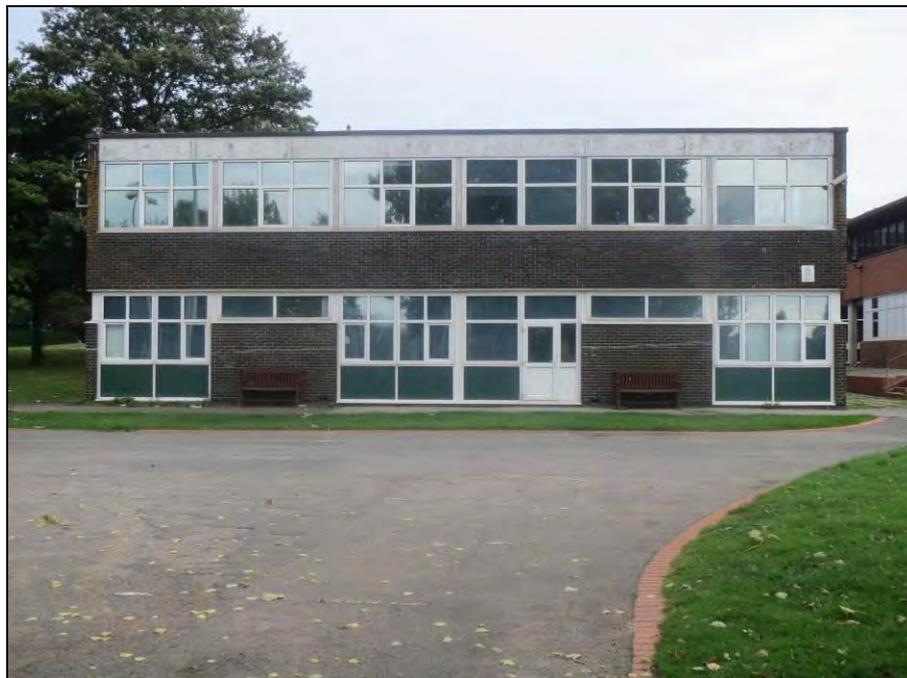
Plate 2.21 Extreme western end of the southern elevation. This block is situated at the lowest level of the western incline. This elevation optimises the use of external prefabricated wall panelling and continuous glass window panelling at both stories, facing north (6959-0051)

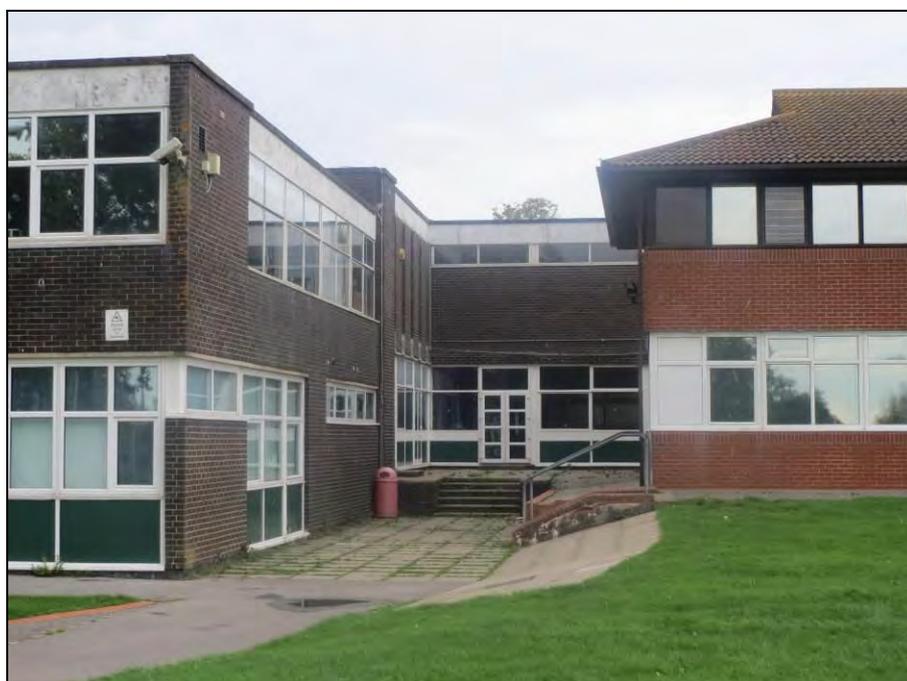
Plate 2.22 Recess (rectangular in plan) located to the western end of the southern elevation. Consisting of a partially enclosed courtyard (open at the southern end), facing north (6959-0052)

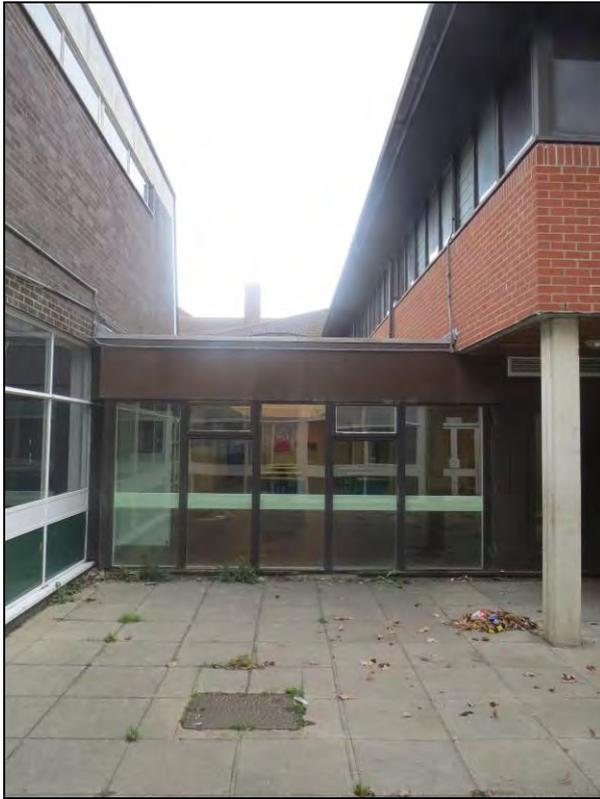
Plate 2.23 Recess (rectangular in plan) located to the western end of the southern elevation, facing towards the eastern wall enclosure within the courtyard (6959-0053)

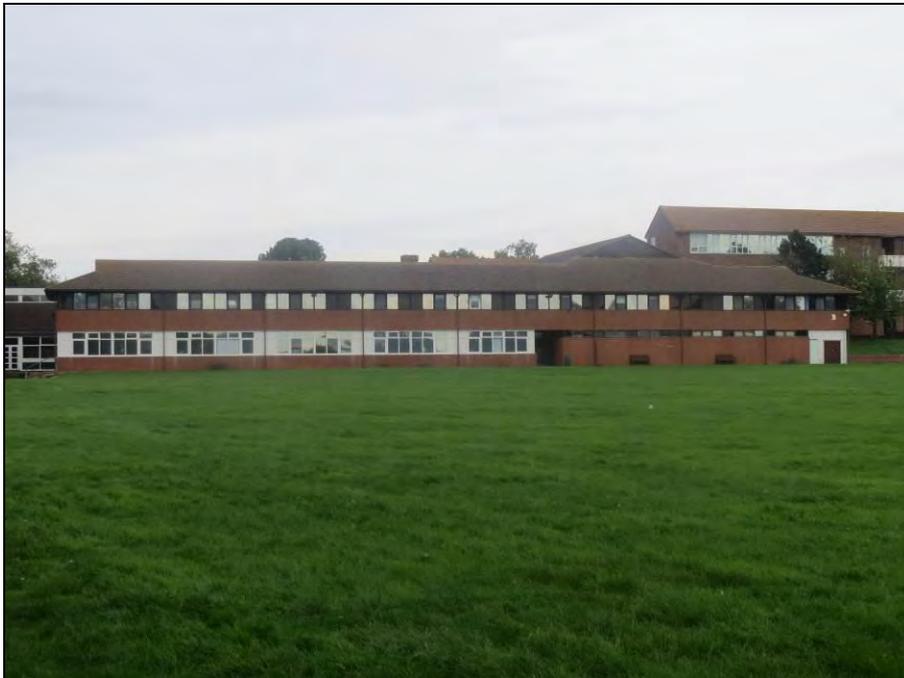
Plate 2.24 Central structure that forms part of the southern elevation, occupying a rectangular layout and built at the same ground level

as the far western end. A two-storey structure with pitched roof construction, facing north (6959-0055)

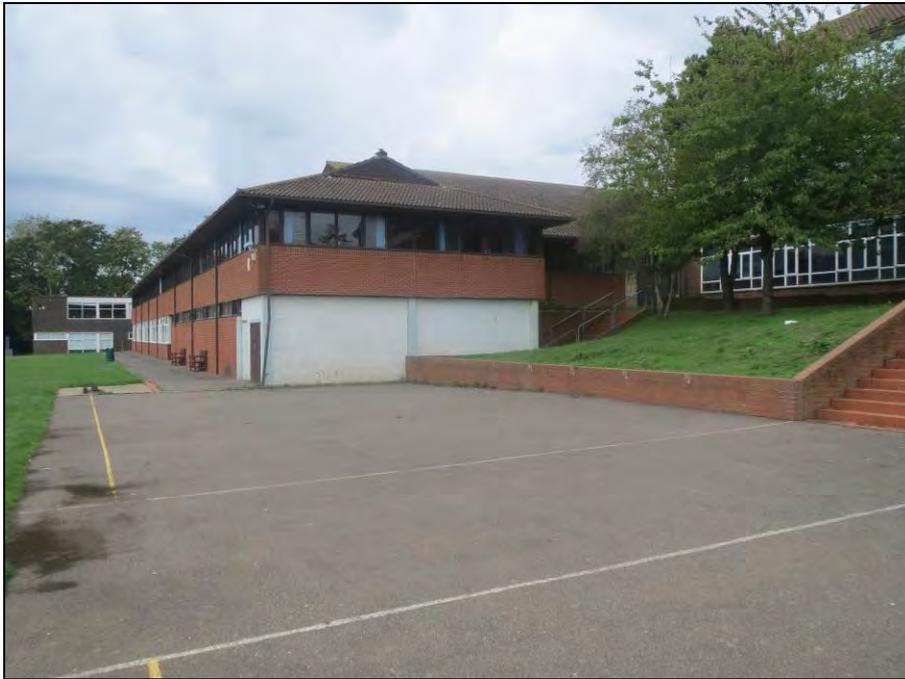
Plate 2.25 Eastern elevation of the central block which forms part of the southern elevation, facing west (6959-0056)
