The Grove School, St Leonards, East Sussex
Historic Environment Desk-Based Assessment
and Historic Buildings Record

Ellen Heppell
Contributions by Hannah Green & Guy Hopkinson

Project No. 6959
Report No. 2014304

September 2014

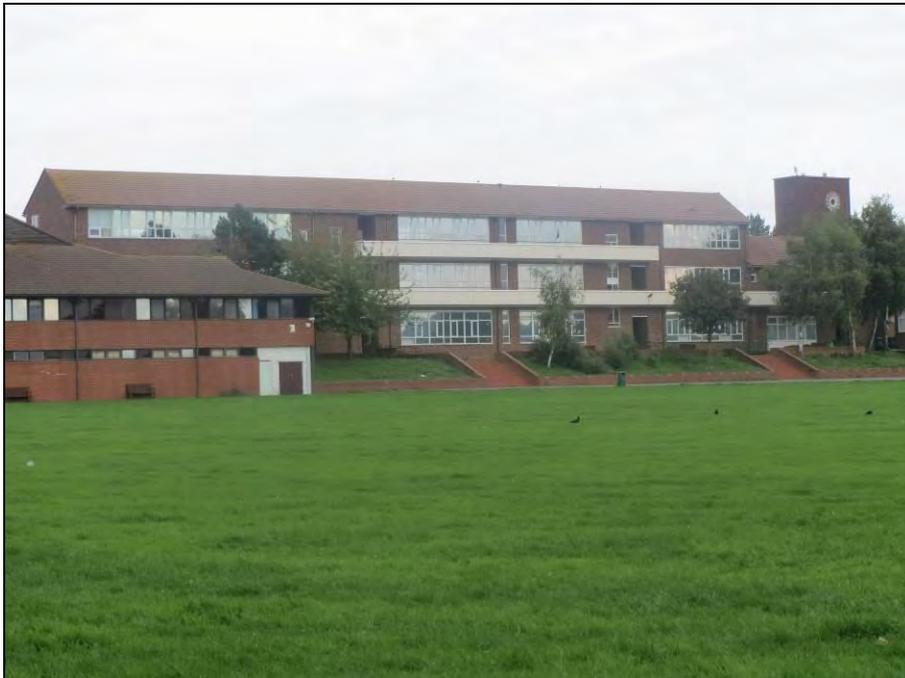
Plate 2.26 Eastern end of the southern elevation, a three-storey structure, consisting of a pitched roof and projecting balconies running continuously along the eastern end of the block at the second and

third floors. Occupying an elevated position in comparison to the central block constructed at a lower ground level, facing northeast
(6959-0054)

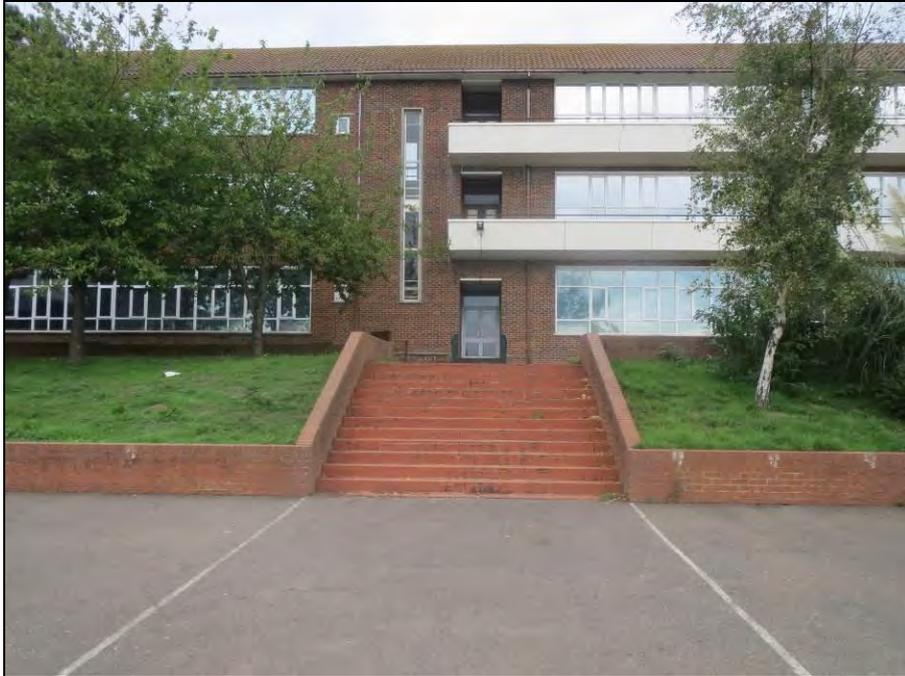
Plate 2.27 Entrance to the eastern end of the southern elevation, detail of access steps and the balcony, facing north (6959-0057)

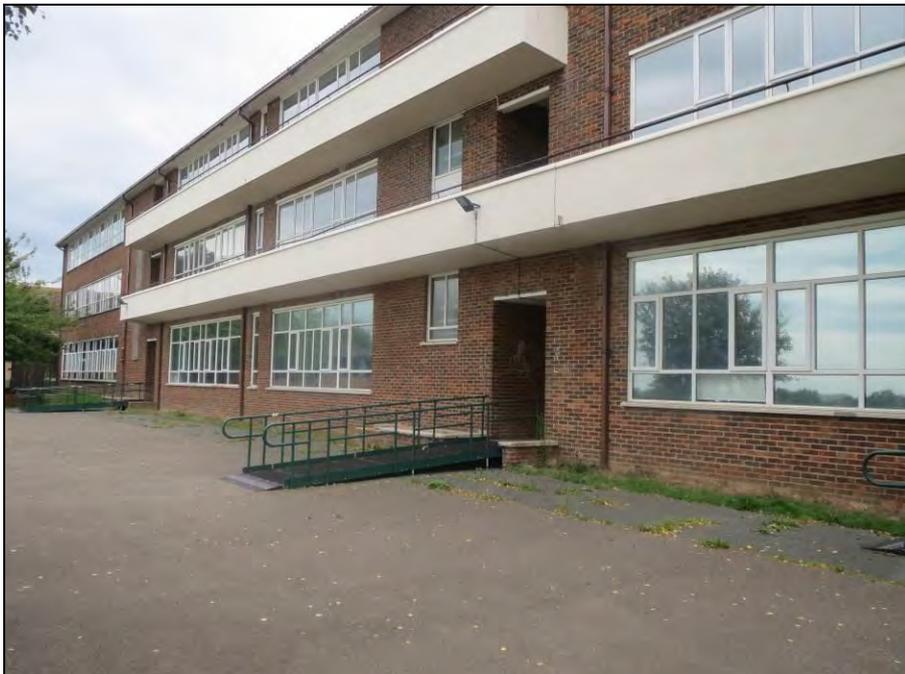
Plate 2.28 Eastern end of the southern elevation, taken from the elevated forecourt with detailing of the balcony construction, facing west towards the central block (6959-0061)

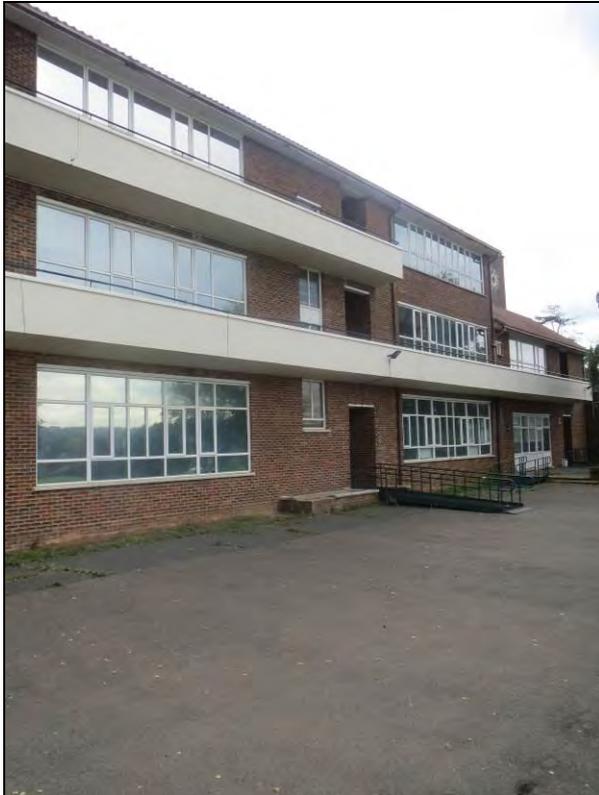
Plate 2.29 Eastern end of the southern elevation, taken from the elevated forecourt, facing northeast (6959-0062)

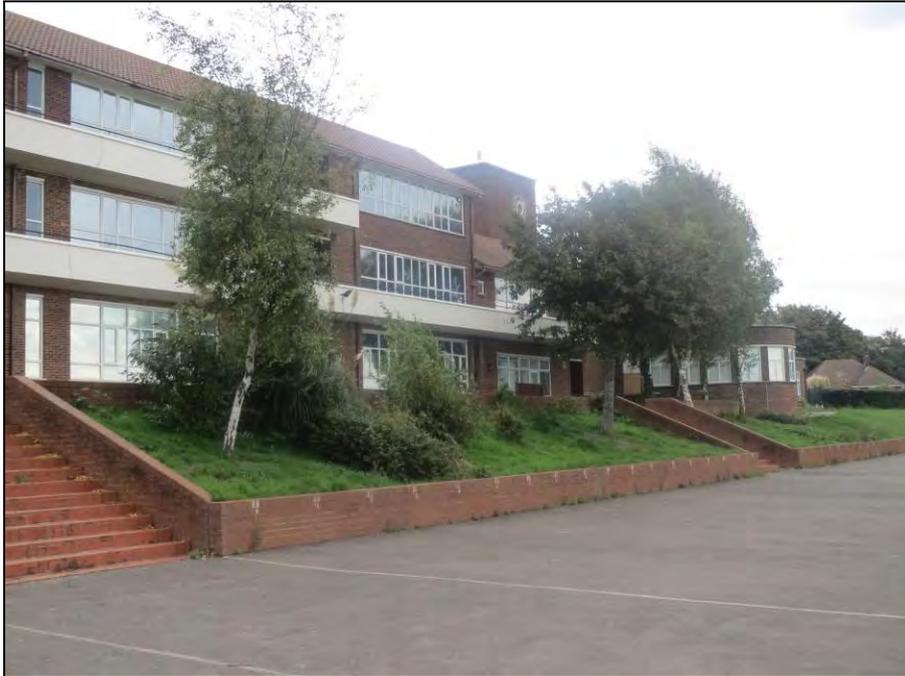
Plate 2.30 Eastern end of the southern elevation, detail of the projection (oblong shaped) with curved façade adjoining this block and the far eastern end of the southern elevation, facing northeast (6959-0063)

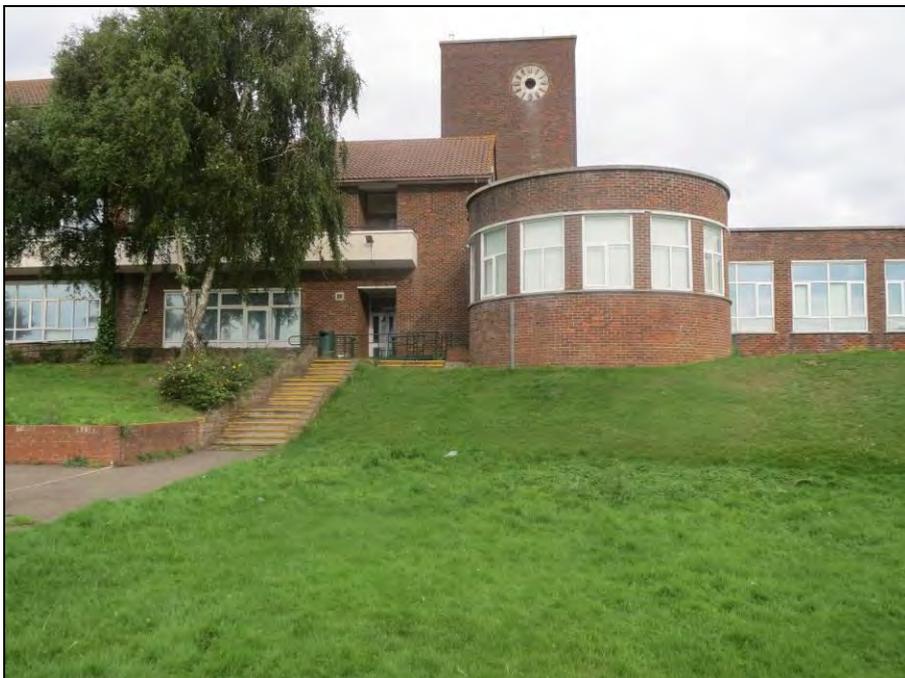
Plate 2.31 Eastern end of the southern elevation, projection with curved façade (foreground) with clock tower to the north (background), facing north (6959-0058)

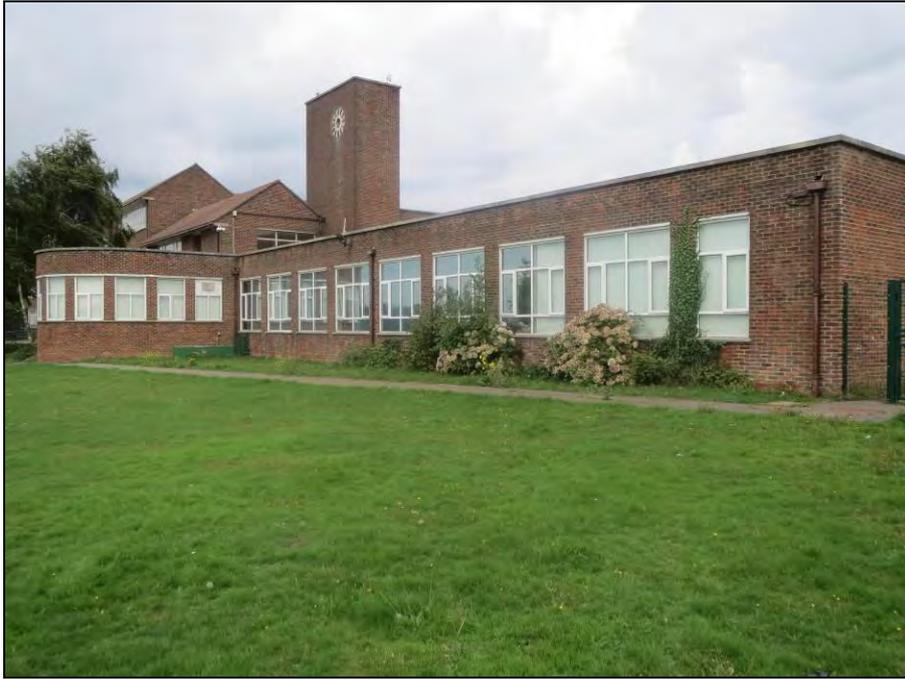
Plate 2.32 Extreme eastern end of the southern elevation, facing northwest towards the projection and clock tower (6959-0060)

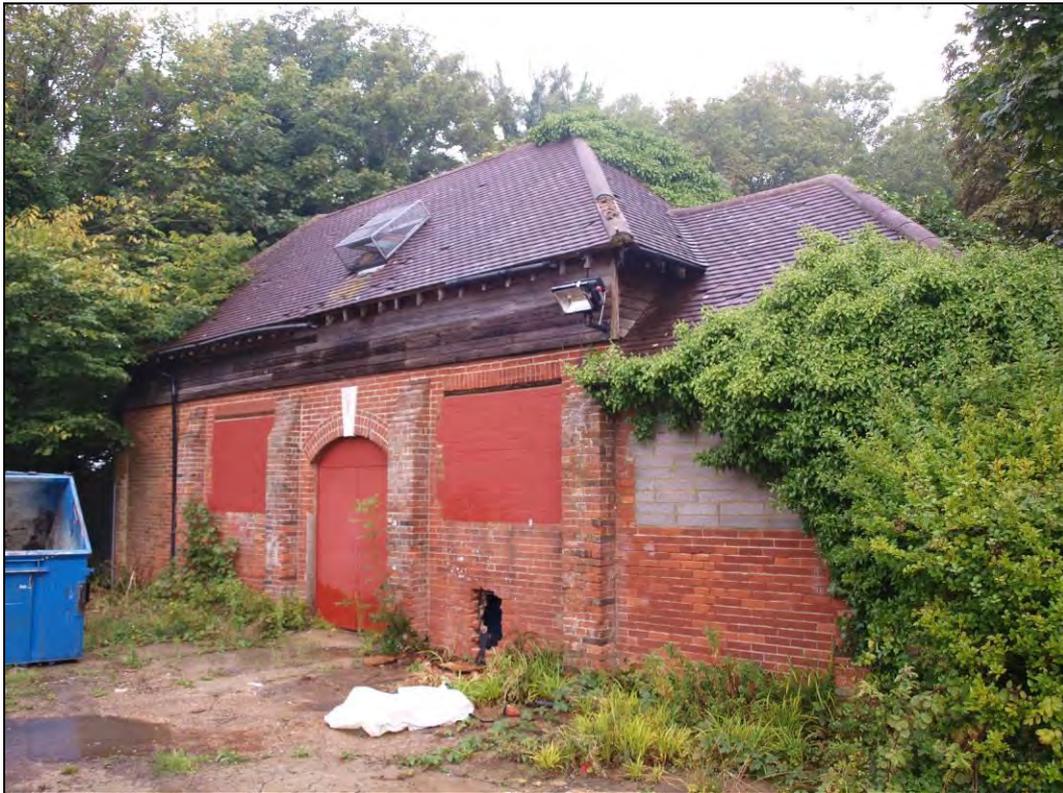
Plate 3.1 Stable, southern and eastern elevations, facing northwest (6959-0017)

The south elevation forms the main façade, divided into five bays by external buttresses which in the main protrude a brick's length (25cm), with stepped chamfers spanning the uppermost eight courses (Plate 3.1). The central bay houses a large double door with relieving arch above, the arch being formed by two courses of headers laid on end followed by a single course of headers laid on edge and with a central concrete keystone extending into the brickwork above (Plate). The current door is of painted metal, sealed shut at the time of survey. To either side, beyond the flanking buttresses, the adjacent bays hold large window openings which are now in-filled with breeze blocks. The sills to the windows are no longer extant, but the heads remain and are formed of rubbed soldier bricks giving a chamfered lower edge. The top of the window heads is in line with the chamfered buttress tops and keystone to the door arch. The westernmost bay wall has been partially rebuilt and no evidence survives of any opening it may have held (Plate). The easternmost bay (the south elevation of the outshut) also held a wide window aperture, again now blocked, and is buttressed at its eastern end. Between the eaves and first floor level the façade is weather-boarded.

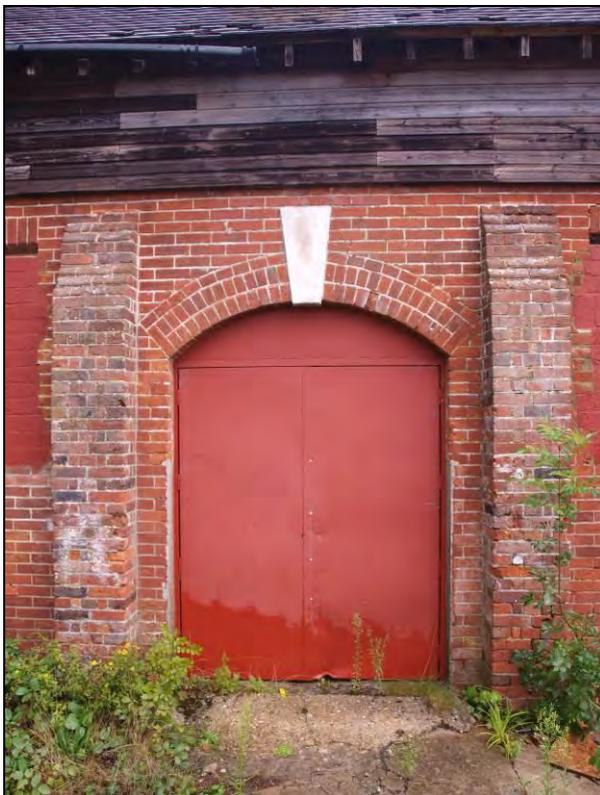
Plate 3.2 Stable, southern elevation, central entrance doorway, facing north (6959-0019)

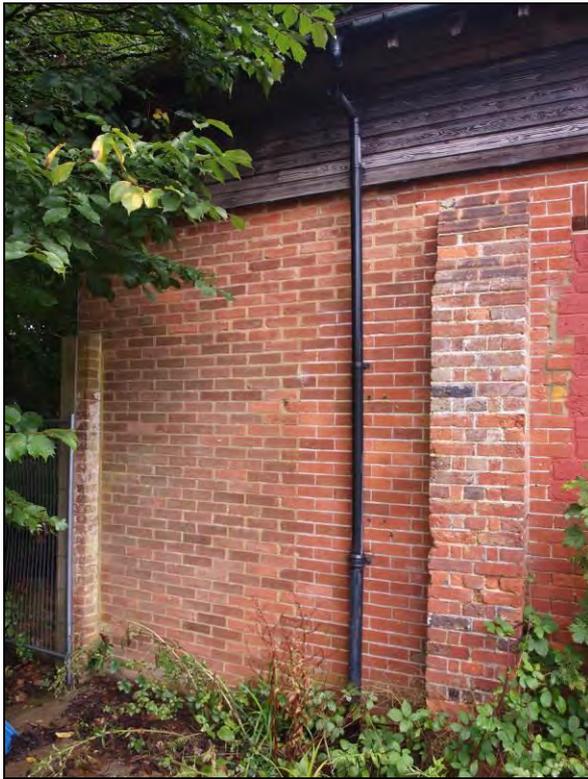
Plate 3.3 Stable, far western end of the southern elevation, facing northwest
(6959-0018)

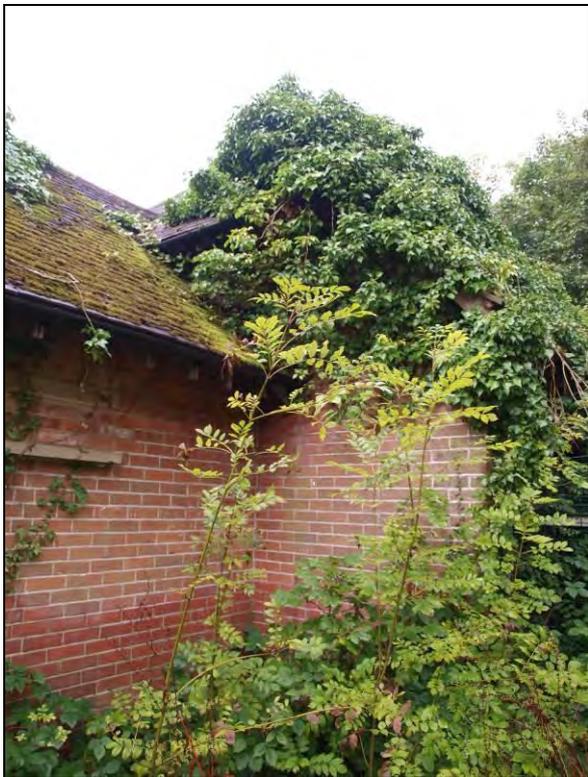
Plate 3.4 Stable, northern elevation of outshut, east elevation of main building, facing southwest (6959-0023)

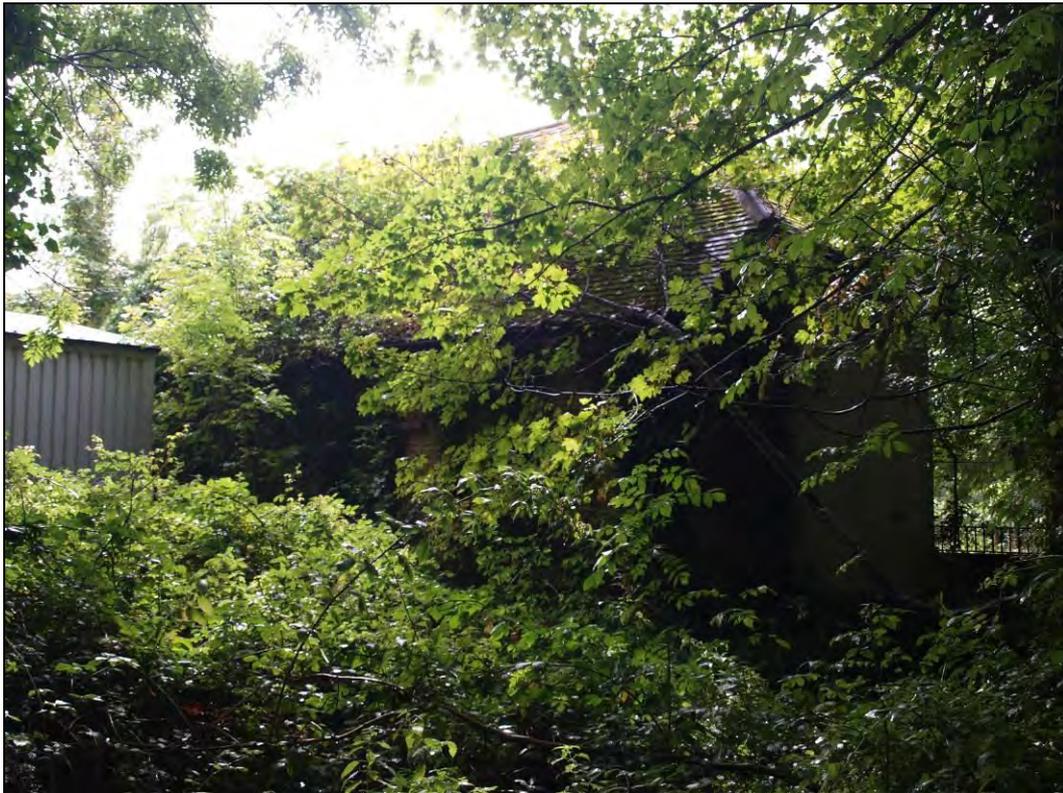
Plate 3.5 Stable, northern and western elevations, facing southeast (6959-0025)

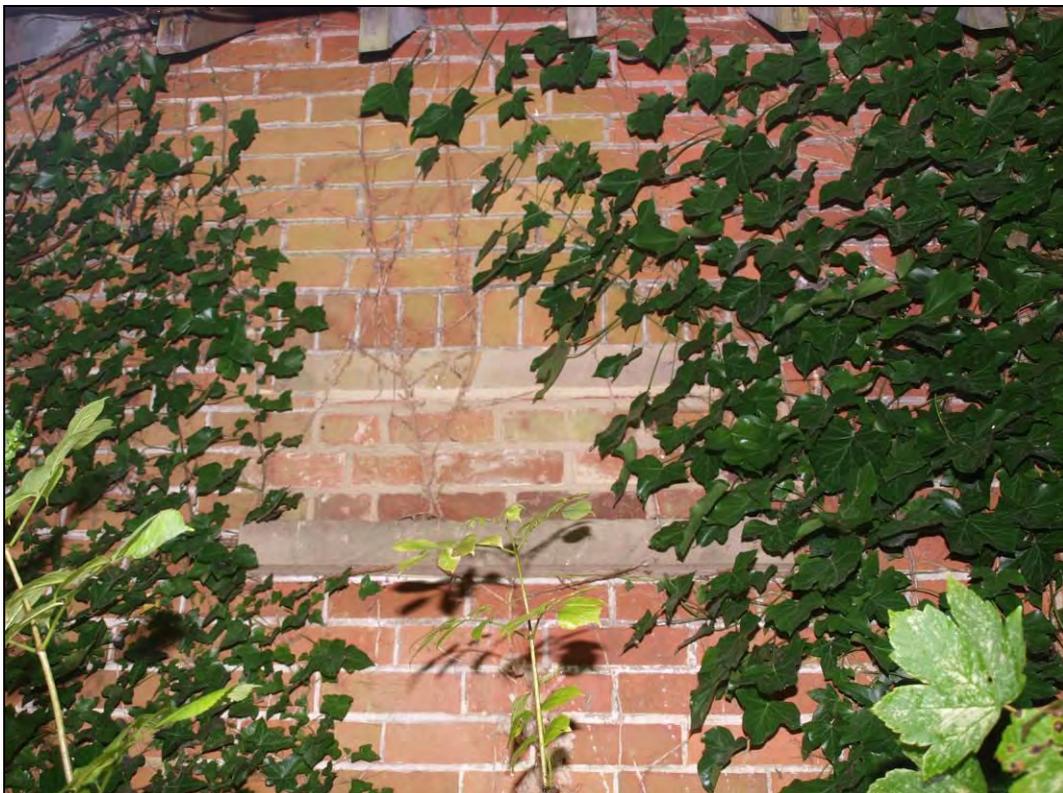
Plate 3.6 Stable, northern elevation, detail of blocked window, facing south (6959-0027)

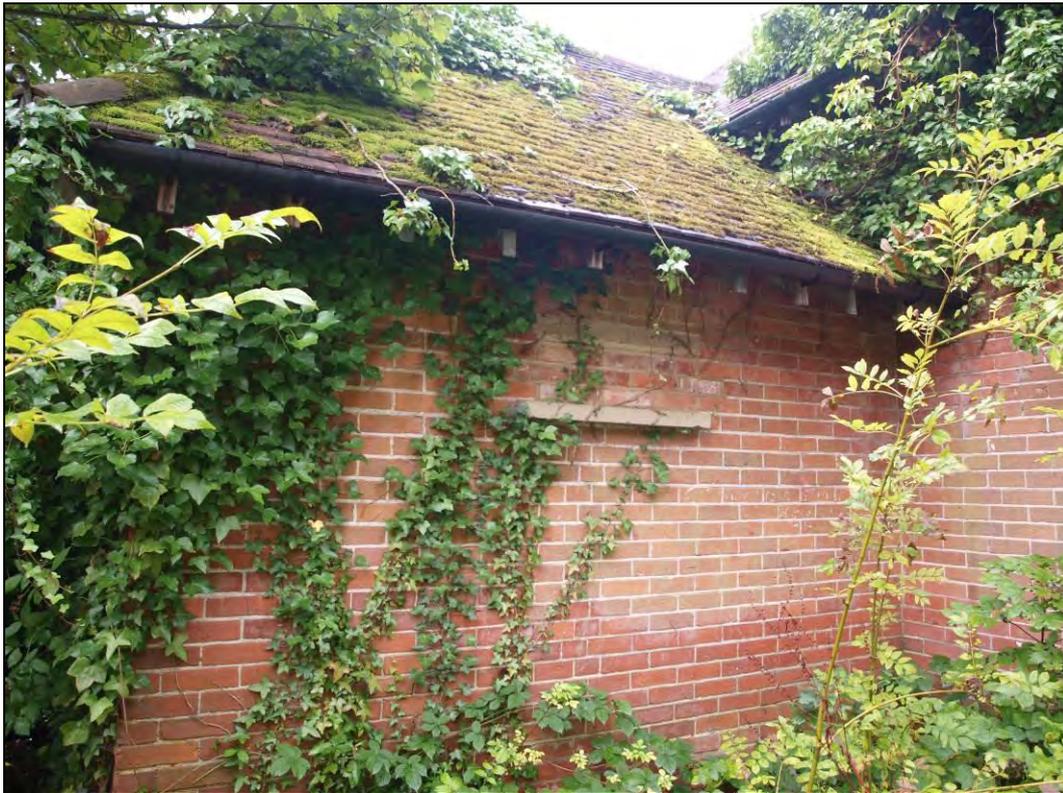
Plate 3.7 Stable, northern elevation of the far eastern projection, facing southwest (6959-0022)

main body of the building, holds a similar small window, though without the course of header bricks above the head (Plate 3.7).

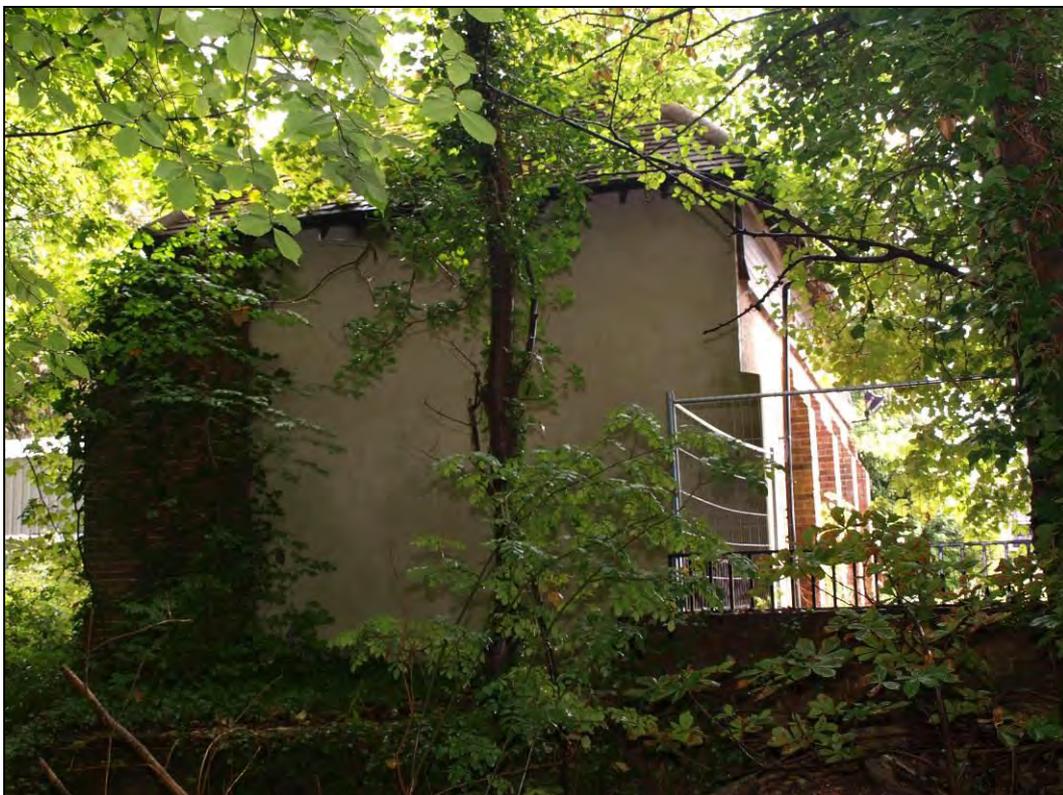
Plate 3.8 Stable, western elevation, facing east (6959-0024)

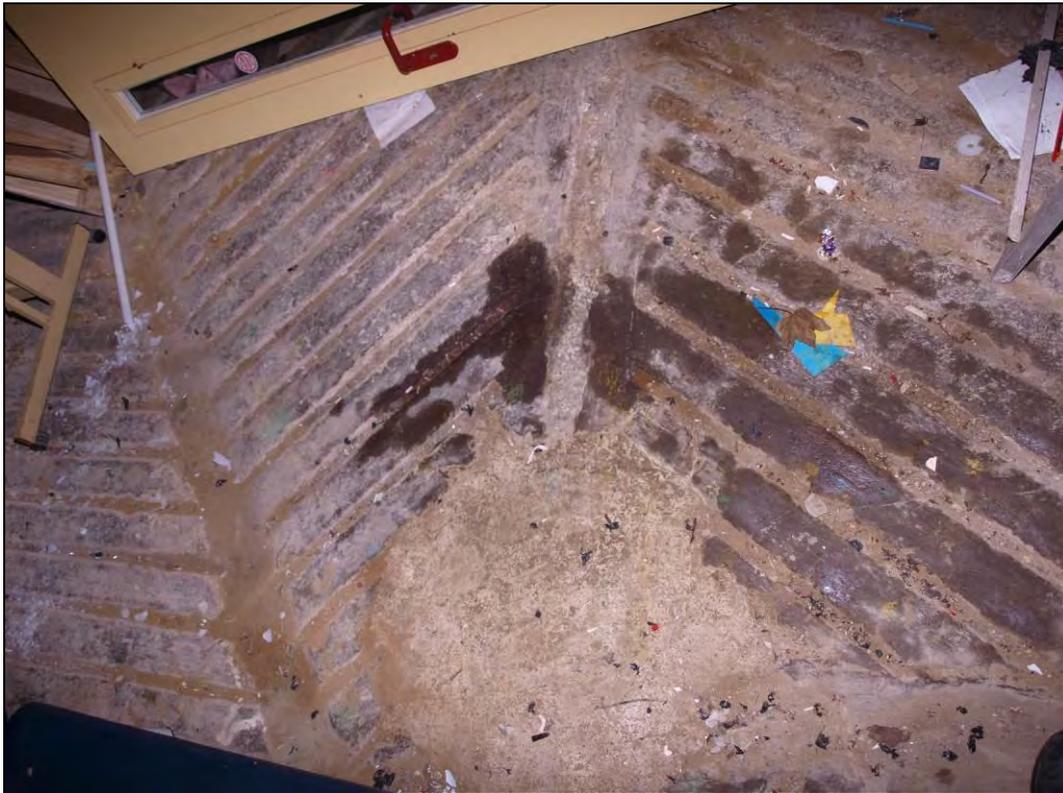
Plate 3.9 Stable, interior, detail of ground level flooring, facing north (6959-0003)

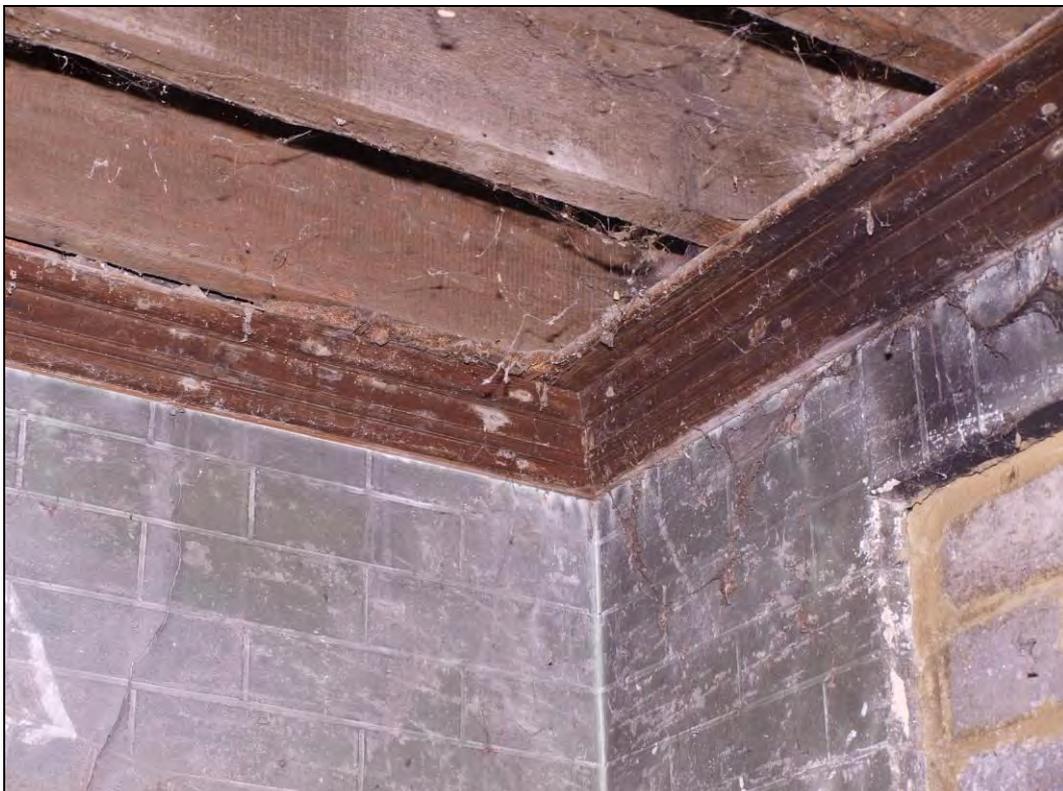
Plate 3.10 Stable, interior, ground floor, detail of ceiling cornice, facing southeast (6959-0011)

Documentary sources describe the stable complex as comprising paved stalls, loose boxes, a coach house, motor house and man's room, all arranged round a walled courtyard. Although now somewhat dilapidated and without its associated ancillary buildings, the stable would clearly have been quite well appointed (also suggested by the remaining internal detailing such as scored render and cornices).

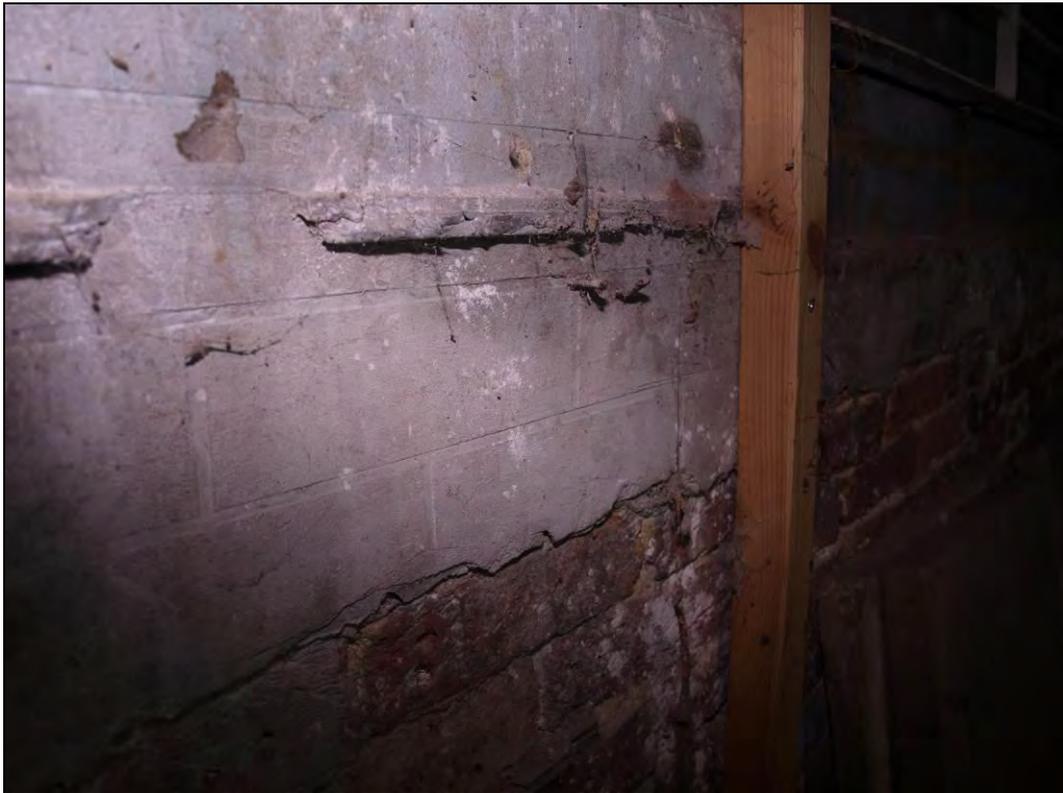
Plate 3.11 Stable, interior, ground floor, detail of rendered brickwork on the southern elevation, facing southwest (6959-0014)

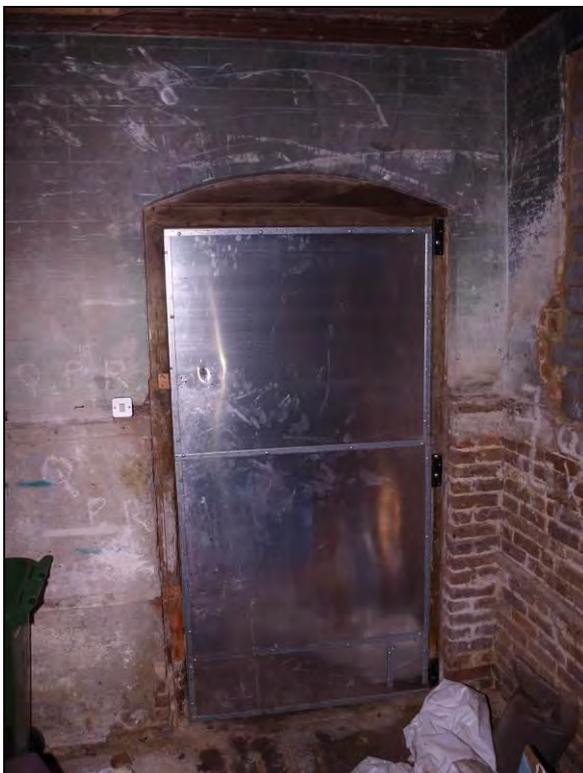
Plate 3.12 Stable, interior, ground floor, blocked doorway leading to the far eastern end of the structure, facing east (6959-0010)
