## Invasive Weed Control Limited

| Site | Queen Court Farm, ME13 8UA |
| Title | Post-works update – Japanese Knotweed Mitigation |

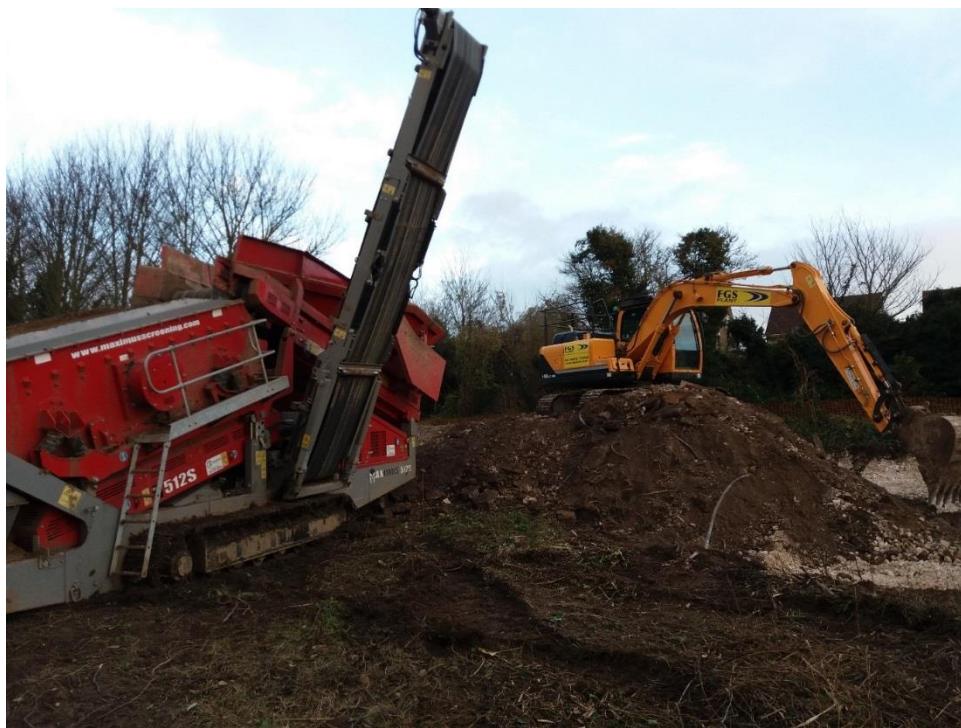
*Excavator and Maximus screener in the contaminated area.*

The works consisted of a complete excavation of two areas of knotweed and underground rhizome system, as identified in the initial survey and management plan. All material was processed through a Maximus aggregate screener to separate rhizomes, fine soils and larger debris.

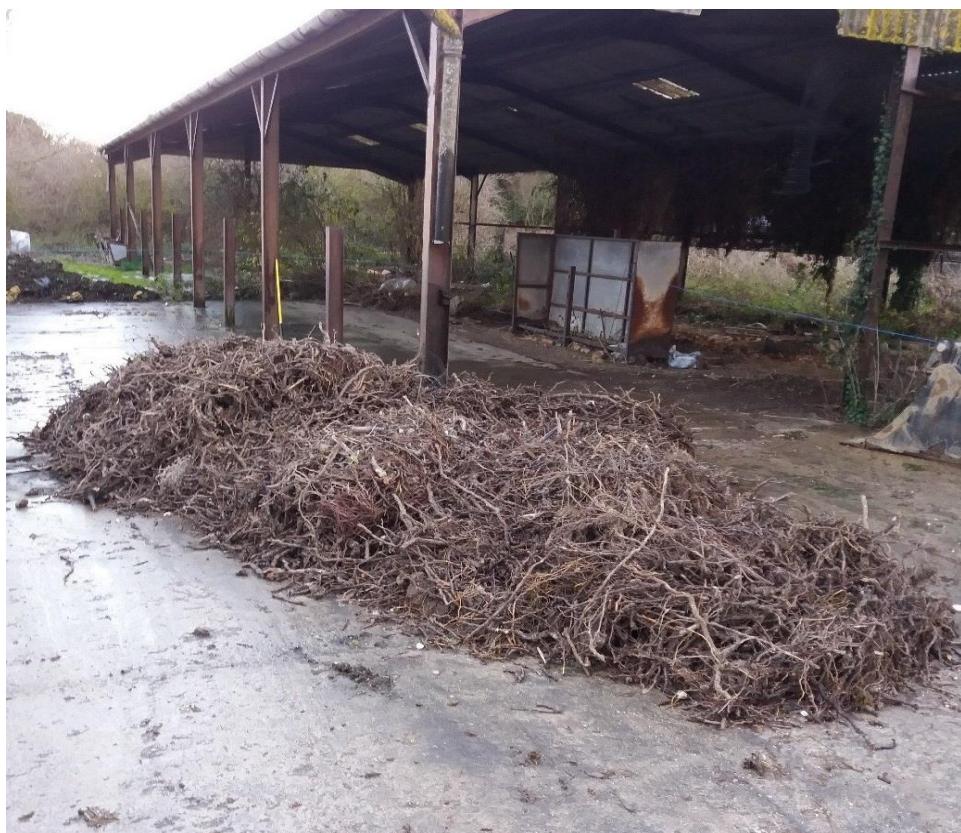
*Rhizomes ready for collection.*

A team of workers were stationed on the rhizomes belt to pick out all rhizome pieces. These rhizomes were temporarily stored on an area of hard standing, awaiting disposal to a licensed landfill facility.

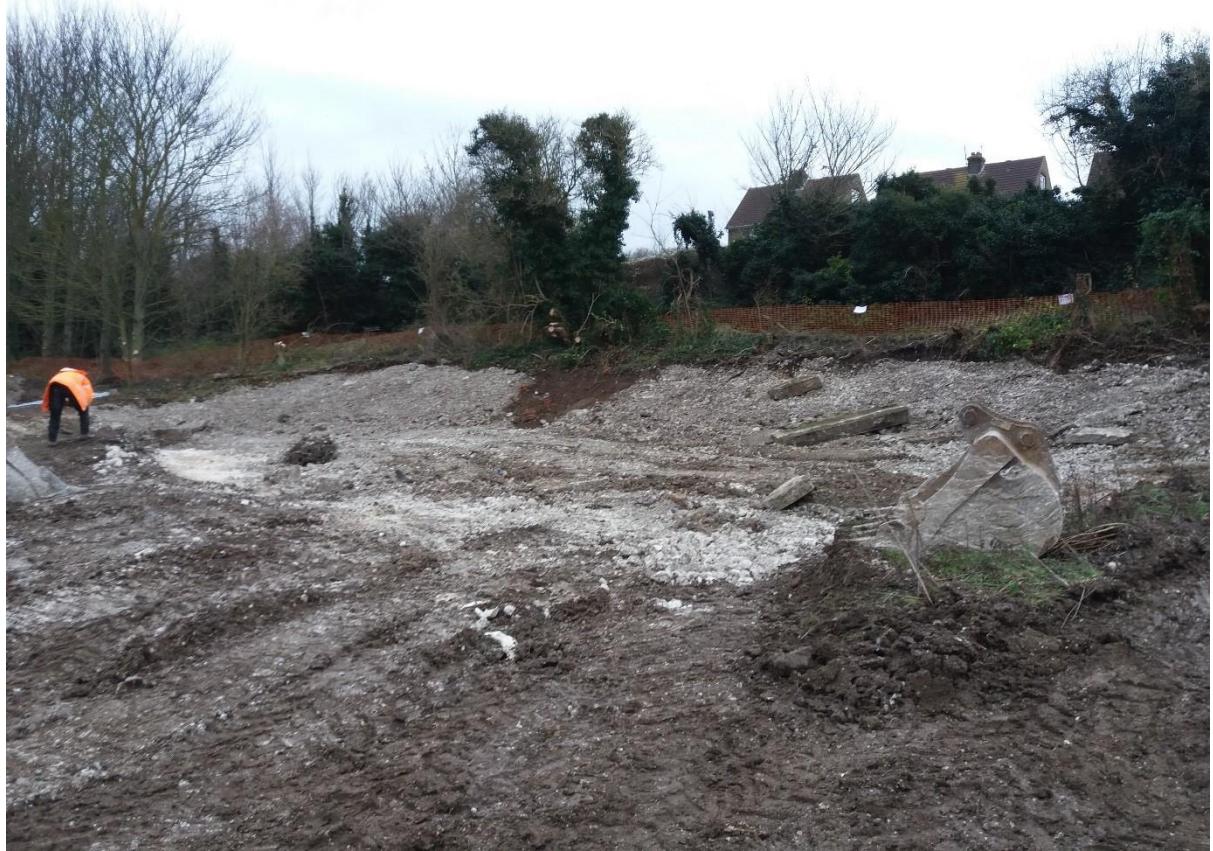
*The larger excavation area after back-fill and levelling*

Larger debris was collected and inspected for contamination. Clean loads were recycled back into the excavation area as backfill material.

The larger knotweed infestation was in an area that had previously been used for landfill. In some areas the rhizomes were chased out to a depth of approximately 5 metres and appeared to originate from within the landfill material, as opposed to growing down from the surface.

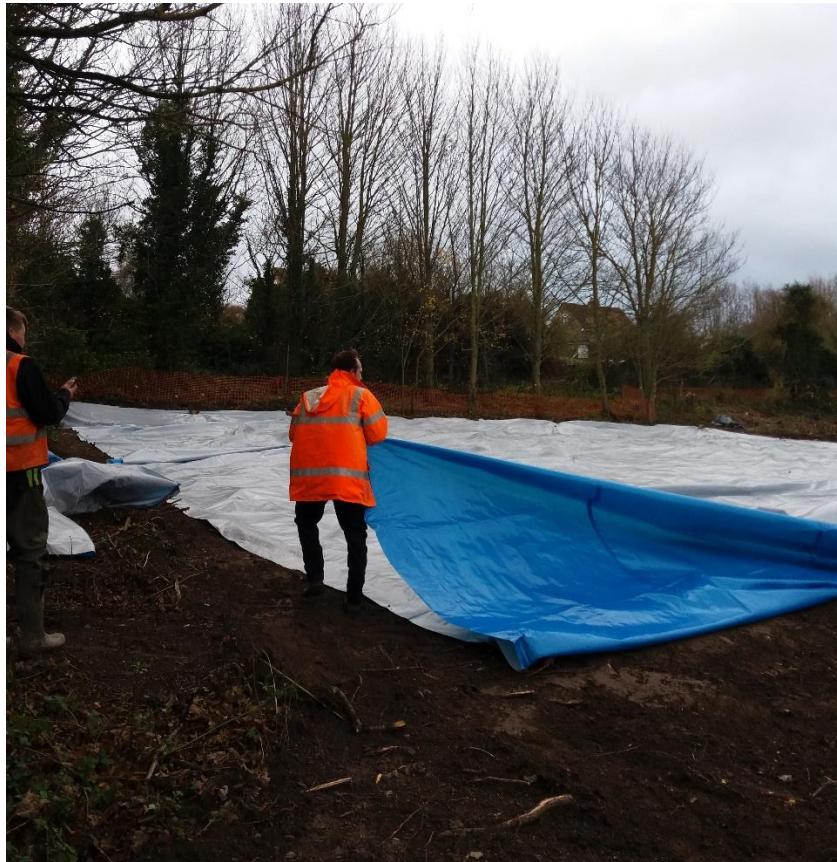
*Positioning the stockpile geotextile liner*

Before the excavation began a stockpile area was created and lined with an approved knotweed-resistant geotextile. The fine soils collected during the process were transferred to this area for future monitoring. The soil was distributed to ensure that the depth did not exceed one metre. This will allow any remaining rhizomes to produce growth which can be chemically treated, rather than becoming dormant in the soil.

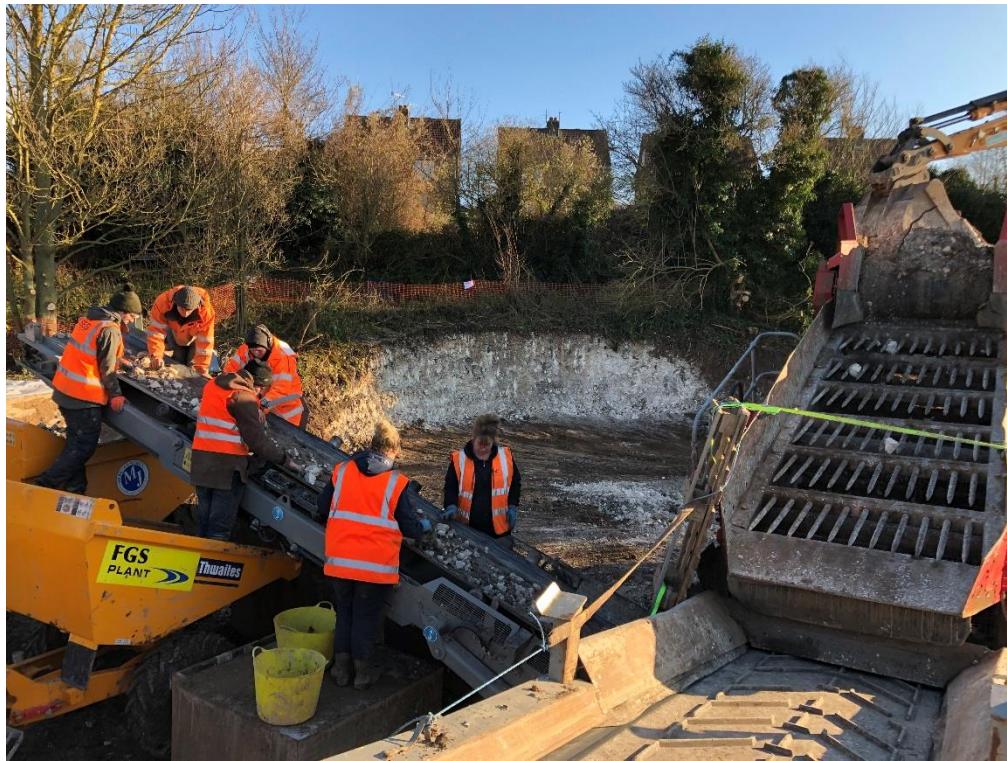
*Rhizome separation in progress*

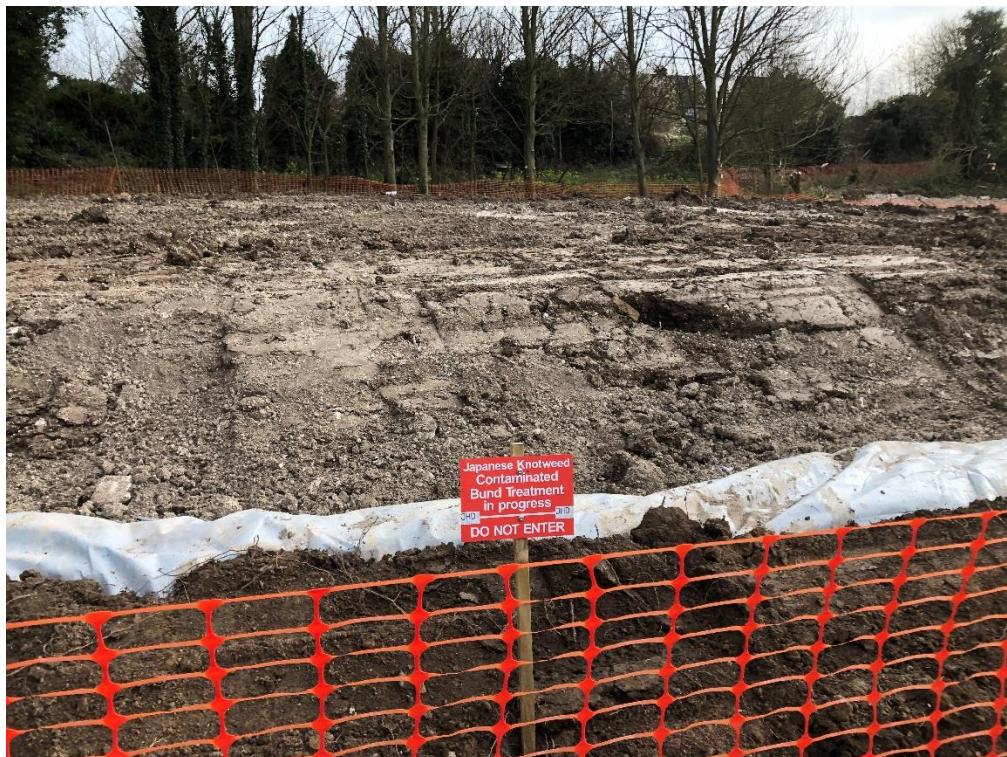
*Soil bund - fenced off with signage*

The excavation and stockpile areas will be subject to a monitoring program. Disturbance should be avoided in order to prevent causing accidental spread of contaminated material. If disturbance or works cannot be avoided IWC should be contacted to provide assistance on how to proceed without causing further spread.

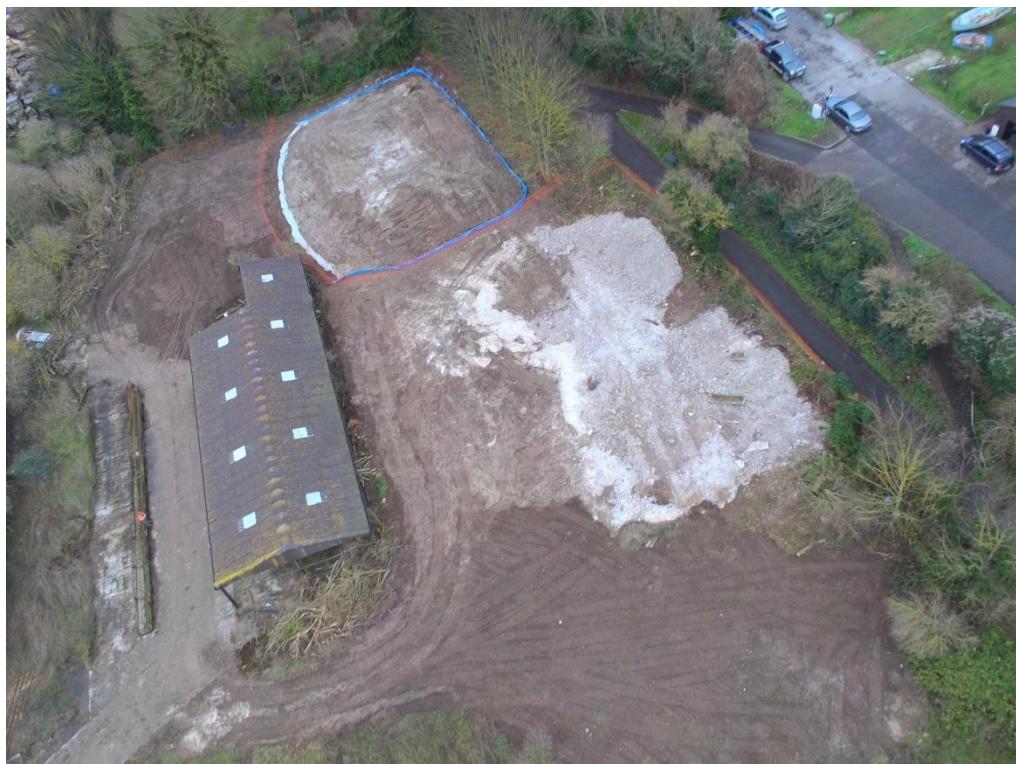
*Overhead view of the treatment area post-works*

IWC will undertake a twice-yearly monitoring and retreatment program for the works area (excavation and stockpile), applicable for up to five years or until two years without regrowth is achieved.
