Flood Risk Assessment

Land South of Kings Head PH, Lower Horsebridge, Hailsham BN27 4DH

Ref: 10273

Date: November 2019

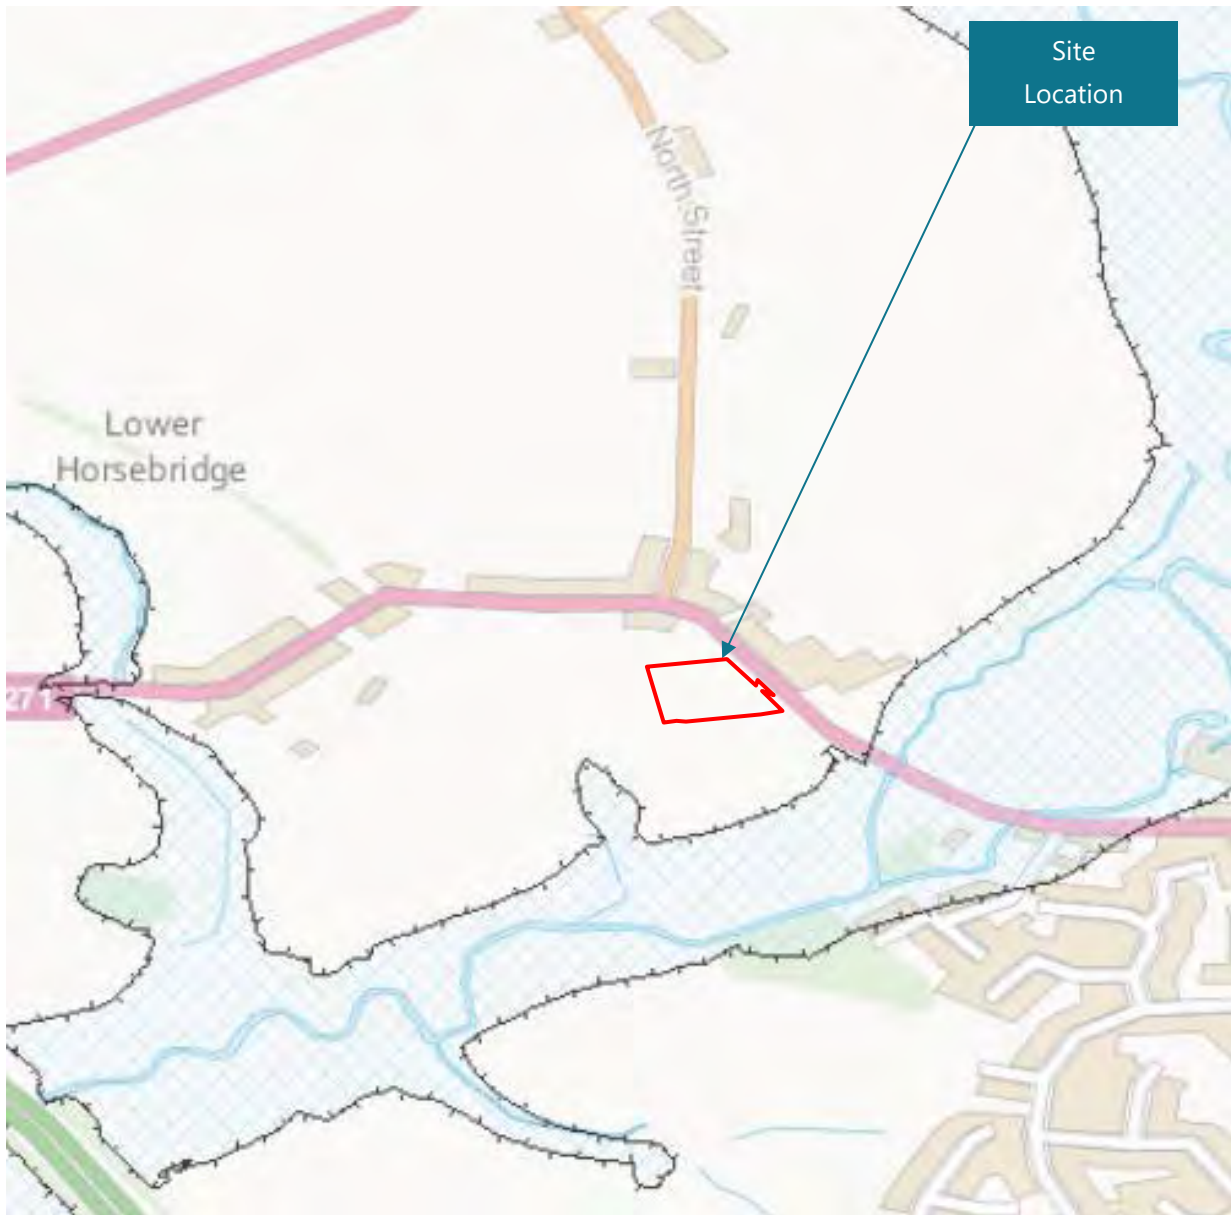
EA's Historic Flood Map

This site is removed from the nearest affected area

- 2.14 Historic records: the EA's online map in Appendix C shows that this site is removed from the nearest area of recorded flooding by the EA.
- 2.15 WDC's Strategic Flood Risk Assessment (SFRA) does not show any evidence of historical flood incidents on or near to the site.
