36897.L.001.R3.A.G.RJM

22nd March 2021

SUPPLEMENTARY GROUND INVESTIGATION & REMEDIATION REPORT FORMER RADNOR HOSPITAL, FOLKESTONE

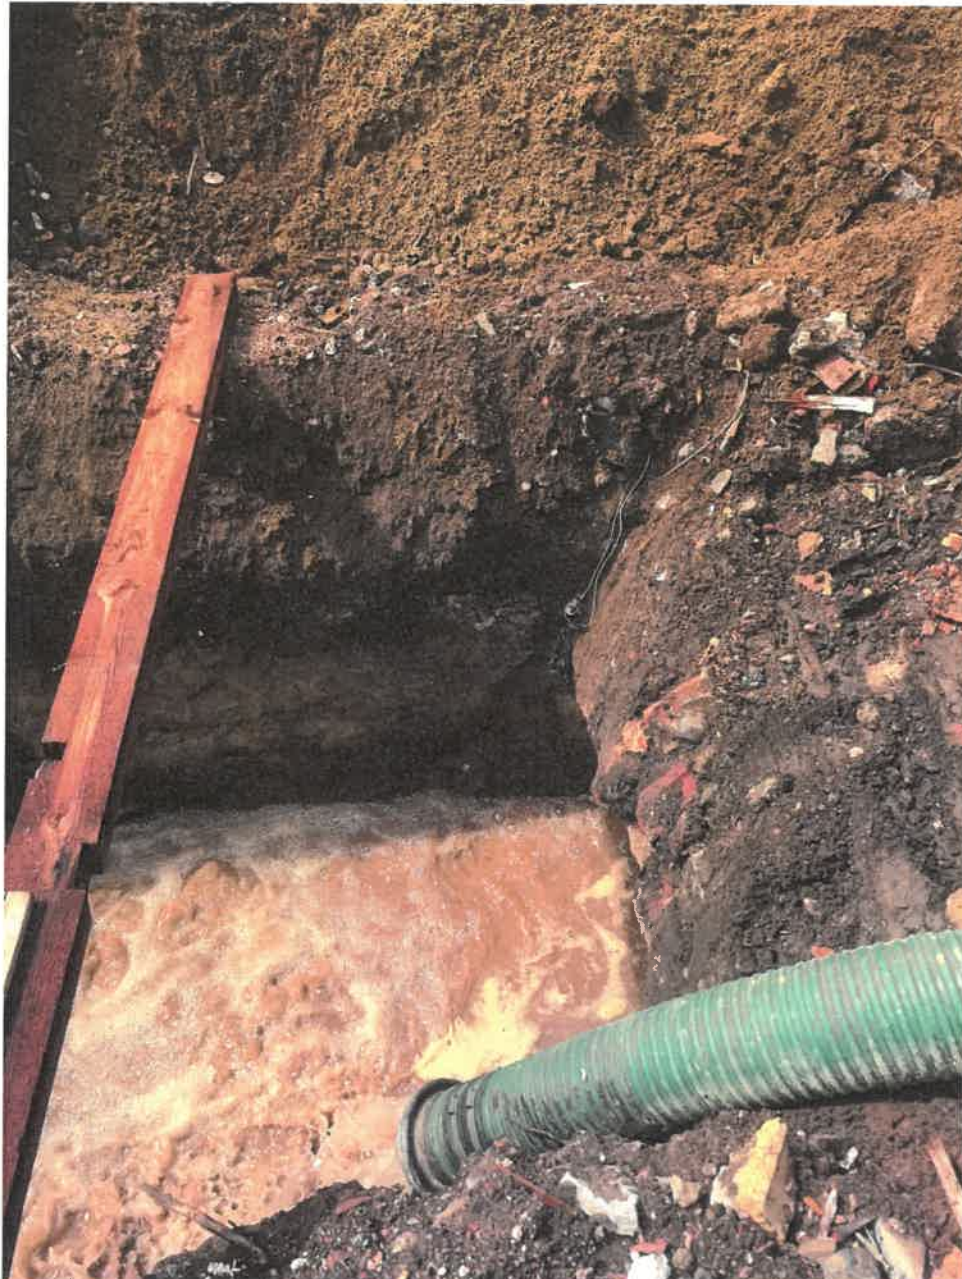
Trial Pit X1 – Soakage Test	
Depth	Description
Ground Level – 0.60m	MADE GROUND: Mix of topsoil and demolition rubble of crushed brick and concrete
0.60m – 0.80m	Dark greyish green clayey fine grained SAND (Folkestone Formation)
<u>Notes</u> Soakage test carried out and reported on separate sheet.

- X1 (GL- 0.60m) – The results indicate the soil would classify as **Non-hazardous** due to a slightly elevated concentration of Antimony.

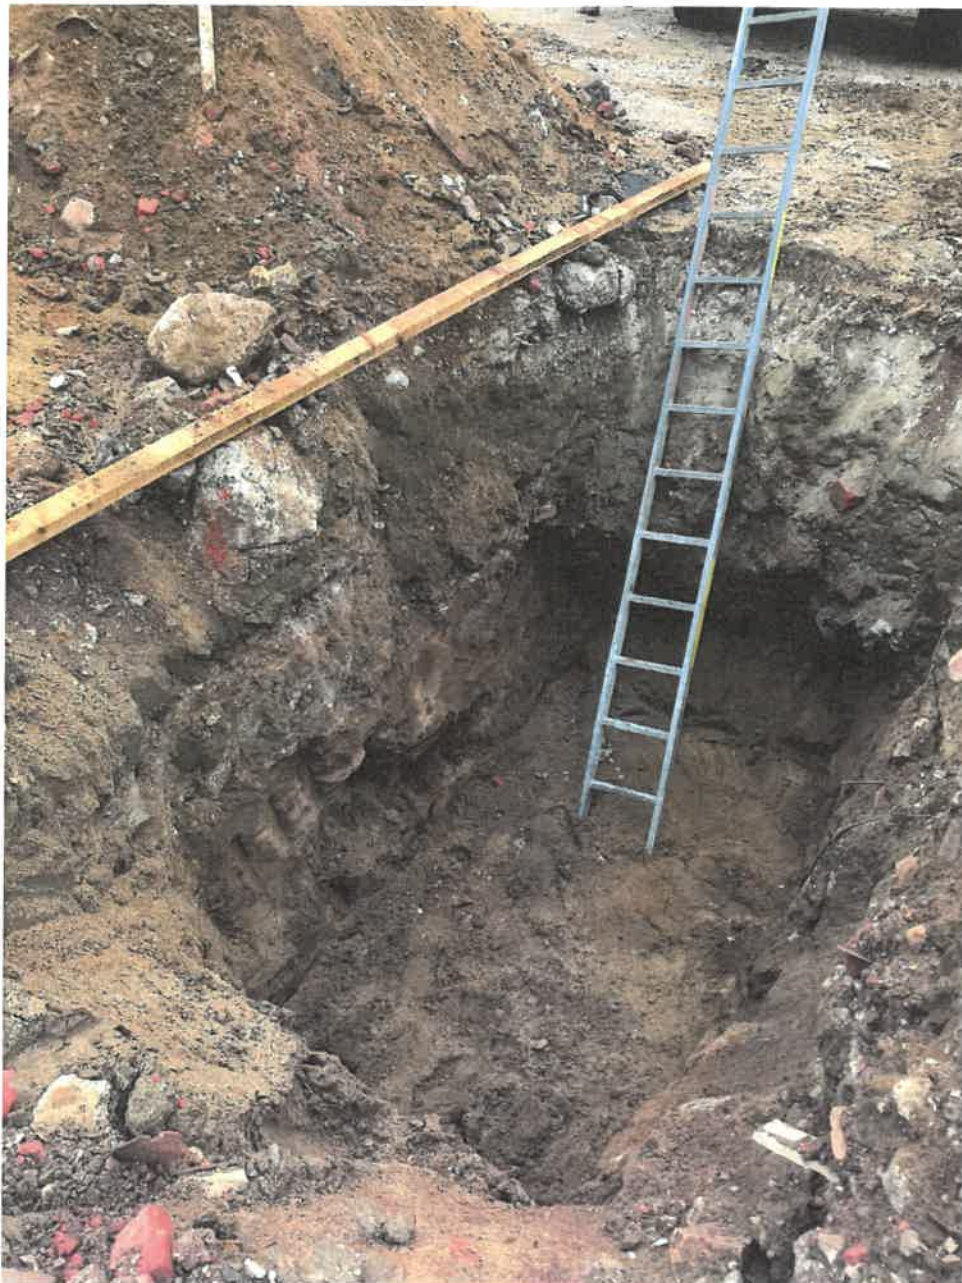
Trial Pit X2 – Soakage Test	
Depth	Description
Ground Level – 1.0m/1.2m	MADE GROUND: mix of fine to medium sand and crushed brick & concrete with occasional layers of sand.
1.0m/1.2m – 1.85m	Greyish green silty fine to medium SAND (Folkestone Formation)
<u>Notes</u> Soakage test carried out and reported on separate sheet.

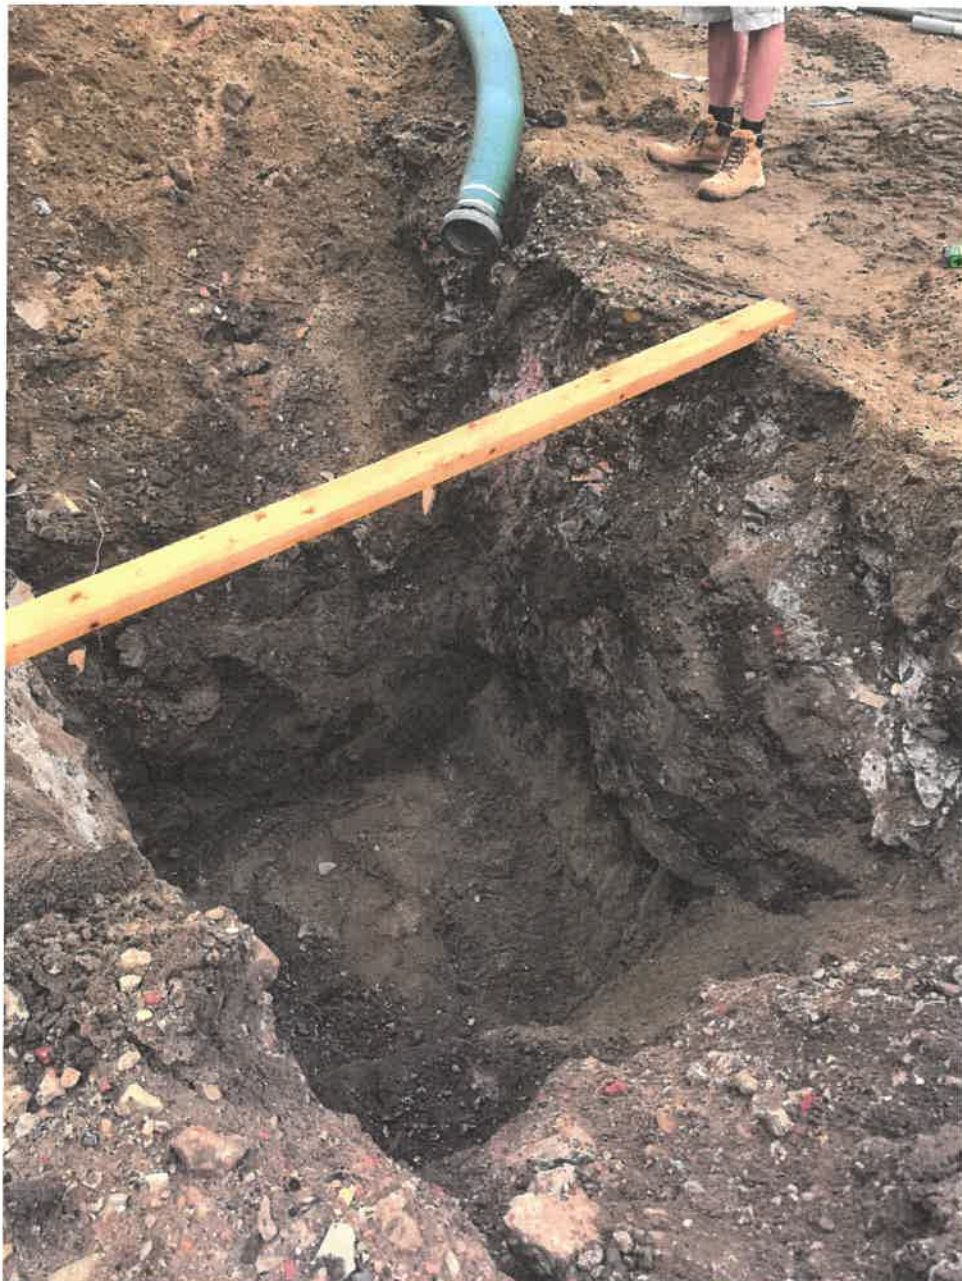
Trial Pit X3 – Soakage Test

Soakage test carried out and reported on separate sheet.

- X3 (GL- 0.60m) – Based on the results, this material classifies as **Non-hazardous** due to a slightly elevated concentration of Antimony above the inert waste threshold.

In addition, Amosite asbestos board debris was noted within the sample and therefore the sample was submitted for quantitative analysis which recorded a % by weight of 0.001%. Therefore, it is proposed that the Waste Classification for this material does not need to be changed to hazardous. However, we suggest that excavations in this area should be attended and observed by an asbestos awareness trained and appropriately insured person to identify any suspected asbestos containing materials (ACM's) as the work proceeds.

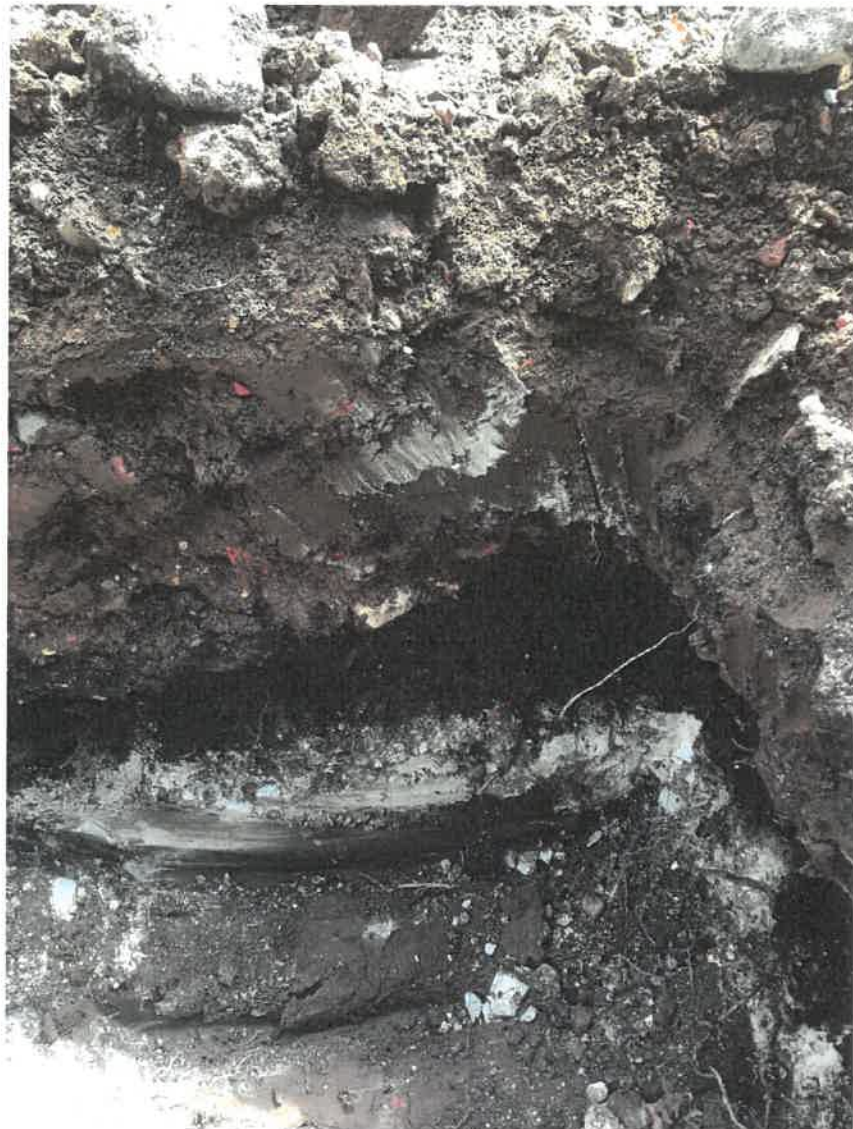
Trial Pit A1 – Located near Hydrock WS3 (proposed rear gardens)	
Depth	Description
Ground Level – 0.35m/0.40m	MADE GROUND: Brown fine sandy CLAY with occasional brick, flint, ash, concrete and roots
0.35m – 0.60m	MADE GROUND: Dark grey ASHPHALT – recovered as dark grey to black sand gravel and cobble size fragments
0.60m – 0.75m	MADE GROUND: Mostly chalk fill
0.75m – 1.00m	MADE GROUND: Dark greenish clayey fine to medium sand with rare fragments of brick and clay pottery
Notes	
Similar to WS3 borehole log but in trial pit it is easier to avoid cross contamination between layers

Site Area (Relevant Trial Pit)	Proposed Remediation including preliminary advice for disposal of excavated soils
Northwest Corner – townhouse rear gardens (Trial Pit TPA1)	<p>The extents of the asphalt and chalk layers found in TPA1 and WS3 in relation to the soft landscaped areas should be delineated in due course and removed from the footprint of the soft landscaping. We suggest they are selectively excavated and stockpiled or removed directly from site. The waste handler should be able to assign separate waste codes for asphalt and chalk.</p> <p>The layer of soil overlying the asphalt layer is uncontaminated but as it contains lumps of concrete, brick etc is not considered suitable for re-use as subsoil and we recommend it is excavated and stockpiled separately.</p> <p>Gardens should be supplied with a 600mm clean cover and we recommend this consist of 450mm clean subsoil overlain by 150mm clean topsoil. This can be placed directly onto the soils beneath the asphalt and chalk which were found to have no contamination</p>

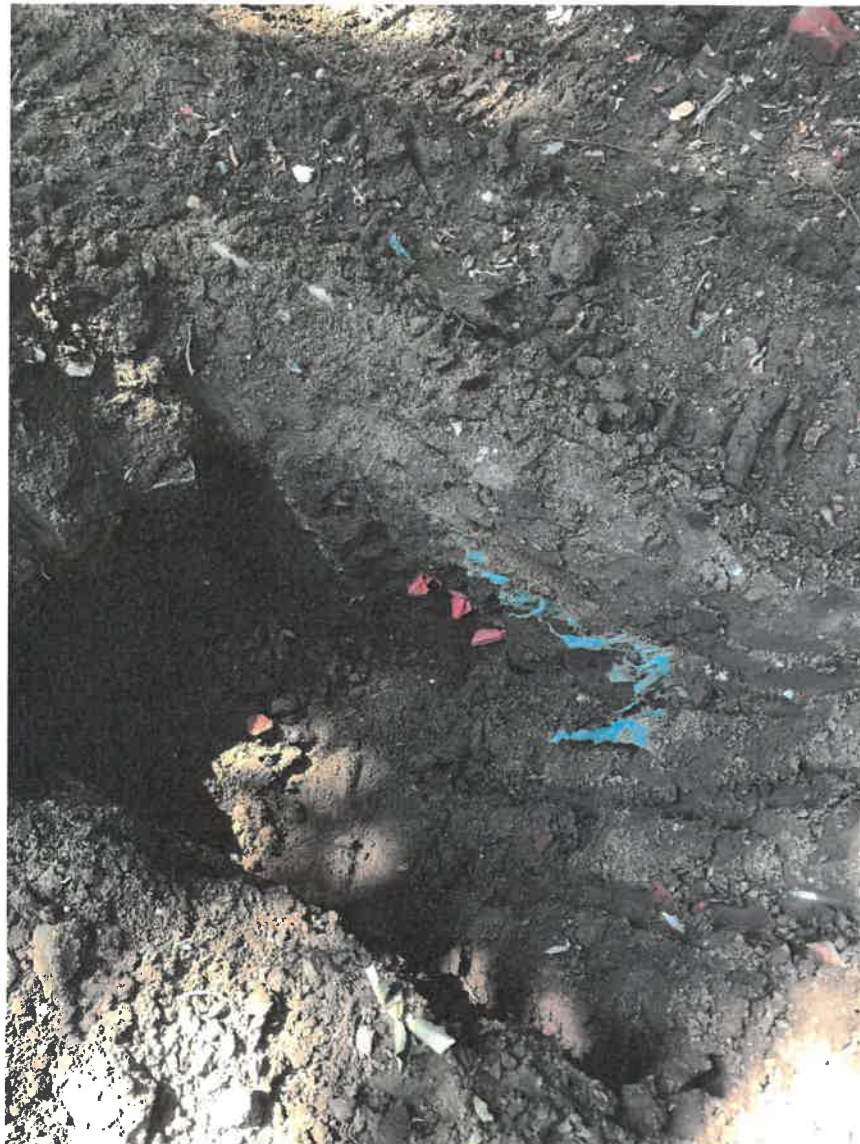
TPA2 was located in the same area of rear gardens as TPA1 and encountered made ground to full depth at 0.80m. TPA2 did not encounter the asphalt and chalk layers encountered in TPA1. A blue plastic membrane extended across the pit at 0.2m and a plastic bag was noted at 0.45m. At the base of the pit there seemed to be a layer of crushed concrete.

Trial Pit A2 (proposed rear gardens)	
Depth	Description
Ground Level – 0.80m	Generally dark brown and greenish brown mix of fine sand and silty fine sandy topsoil with occasional fragments of concrete, brick, tile, charcoal and asphalt. Note blue membrane at 0.20mbgl Note red orange plastic discontinuous in side of pit at 0.45m Note increasing fragments of concrete gravel at base of pit
Notes

<p>Northwest Corner – townhouse rear gardens <u>(Trial Pit TPA2)</u></p>	<p><i>Recommended remediation for TPA2 area:</i></p> <p>Both layers of soil down to 0.80m are uncontaminated but as they contain sheets of plastic and lumps of concrete, brick etc they are not considered suitable for re-use as subsoil and we recommend it is excavated and stockpiled separately.</p> <p>Remediation in the gardens can be the same as specified for the adjoining area around TPA1 and WS3</p> <p><i>Preliminary WAC Assessment (TPA2 area)</i></p> <p>A WAC test was undertaken on the upper layer (GL-0.60m) and the results indicate the sample is Inert and no elevated contamination was encountered. This material can be selectively excavated and stockpiled along with the uppermost layer from TPA1 taking care not to let it be contaminated with any asphalt layers encountered.</p>
<p>Gardens to rear of central terrace <u>(Trial Pit TPA3)</u></p>	<p>Based on the results of testing of the insitu Folkestone Formation underlying the temporary hardcore layer, and assuming the hardcore will be fully stripped prior to preparation of gardens, it is considered that no particular remediation is required other than providing suitable clean soils for the soft landscaping. Elsewhere, under buildings and hard landscaping, the hardcore layer could be left in place.</p> <p><i>Preliminary WAC Assessment (TPA3 and TPX2)</i></p> <p>A KH2 suite was undertaken on the hardcore layer.</p> <p>TPA3 (GL-0.60) – Based on the test certificate this classifies as Non-hazardous due to elevated concentrations of Antimony and Sulphate above the Inert waste threshold. (Note: Antimony is often associated with lead and is used in alloys, batteries and micro-electrics). These results should be taken into account when the hardcore layer is being stripped and we recommend that this area is selectively stripped and stockpiled and re-tested prior to disposal.</p>

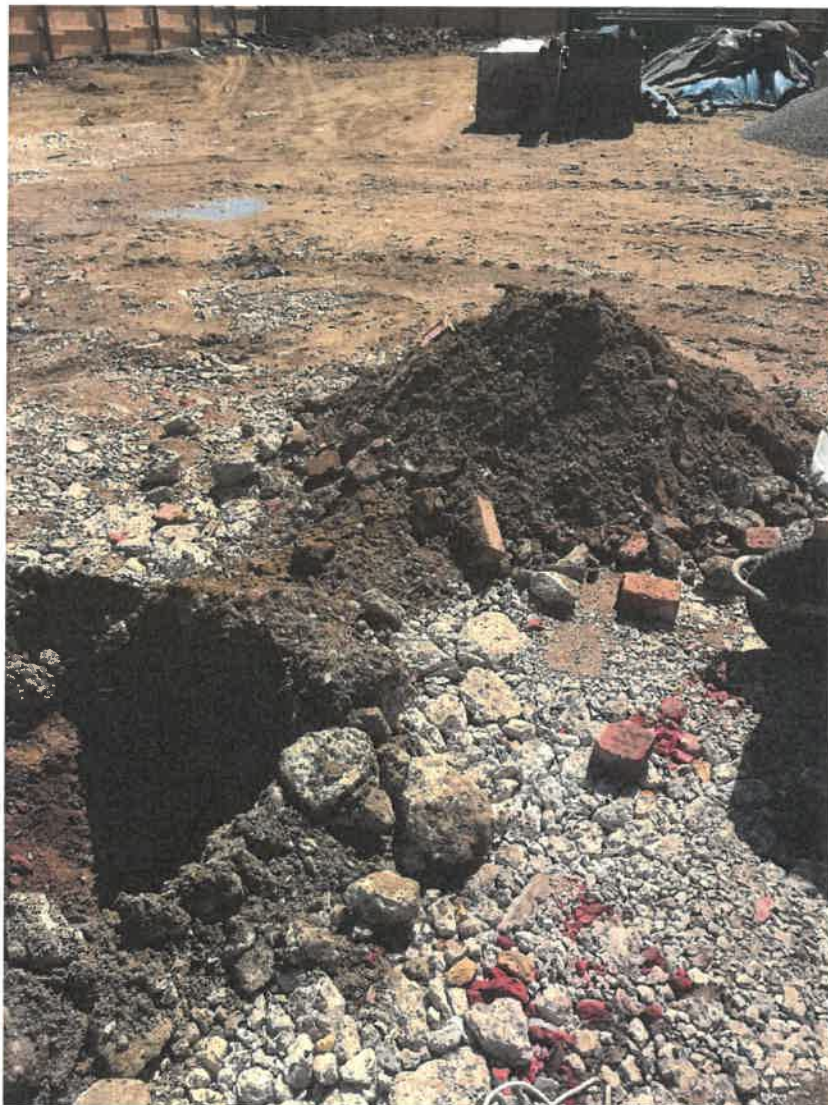
Trial Pit A3 (proposed rear gardens in centre of site)	
Depth	Description
Ground Level – 0.60m	MADE GROUND: Mix of greyish green fine to medium SAND and medium gravel to cobble of concrete and brick
0.60m – 0.80m	Greenish fine to medium SAND (Folkestone Formation)
Notes

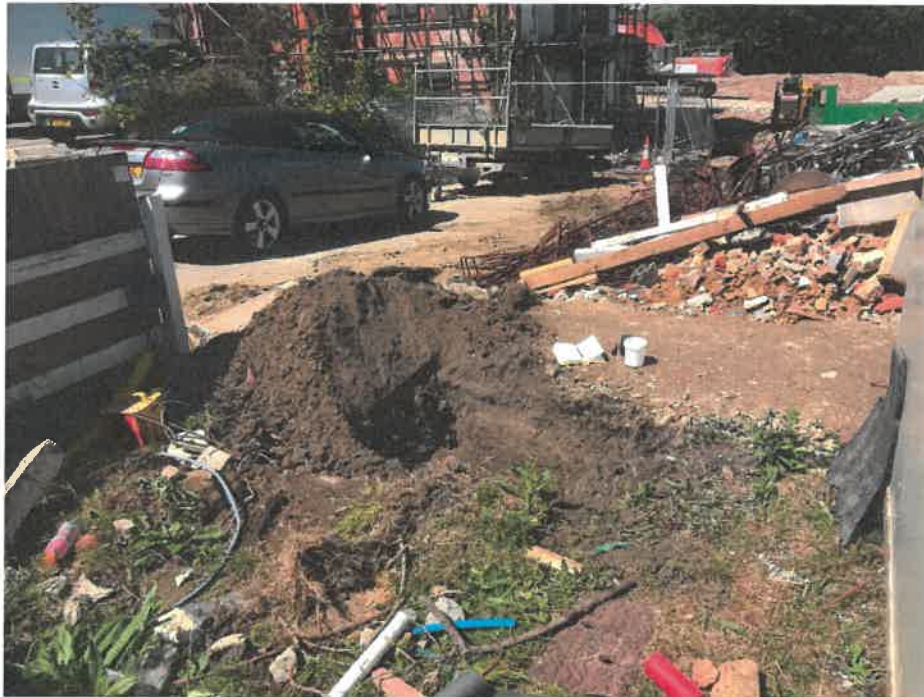
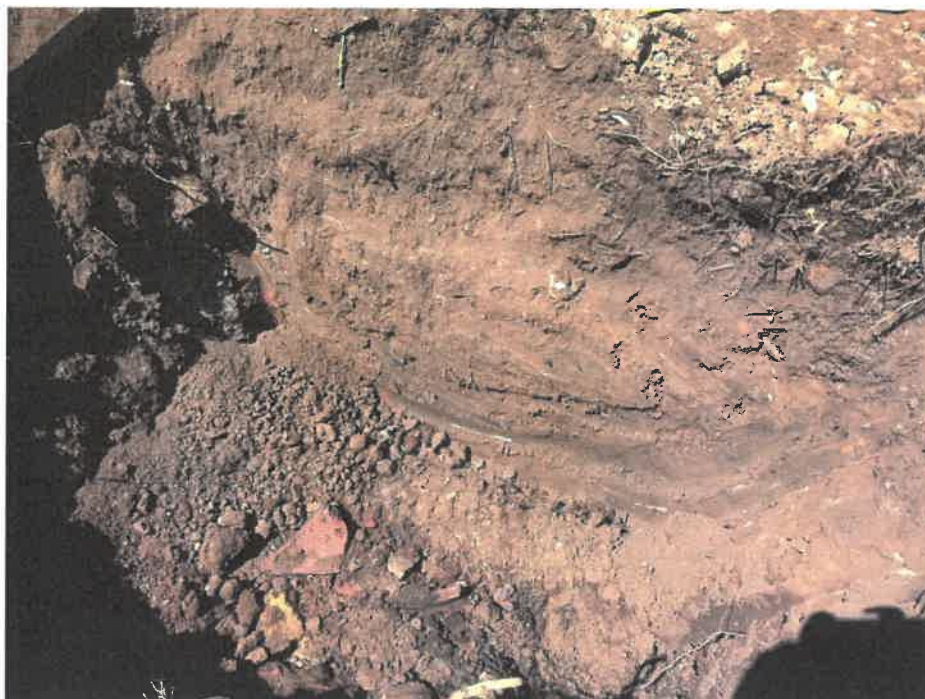
Trial Pit A4 – Located near Hydrock WS6 in grass verge

Depth	Description
Ground Level – 0.50m	Thin layer of brown turf over brown silty fine sandy TOPSOIL with rootlets and occasional coarse sand to fine gravel of brick, tile, ash and charcoal

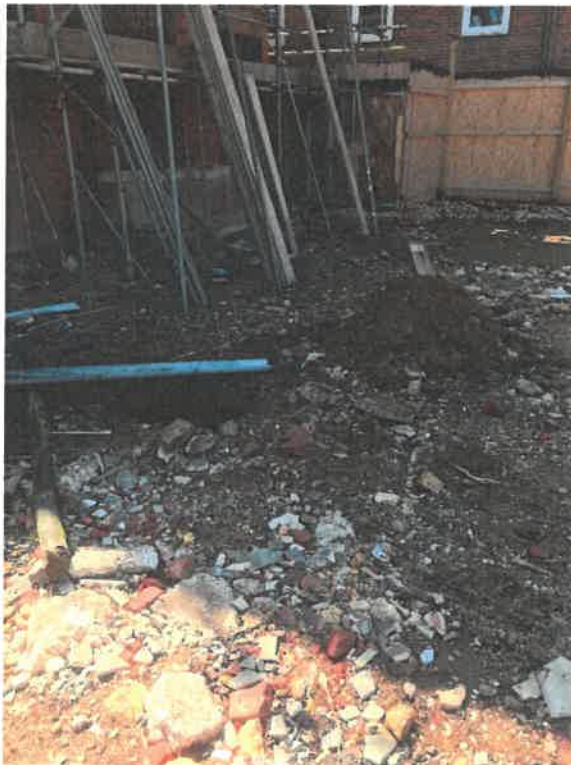
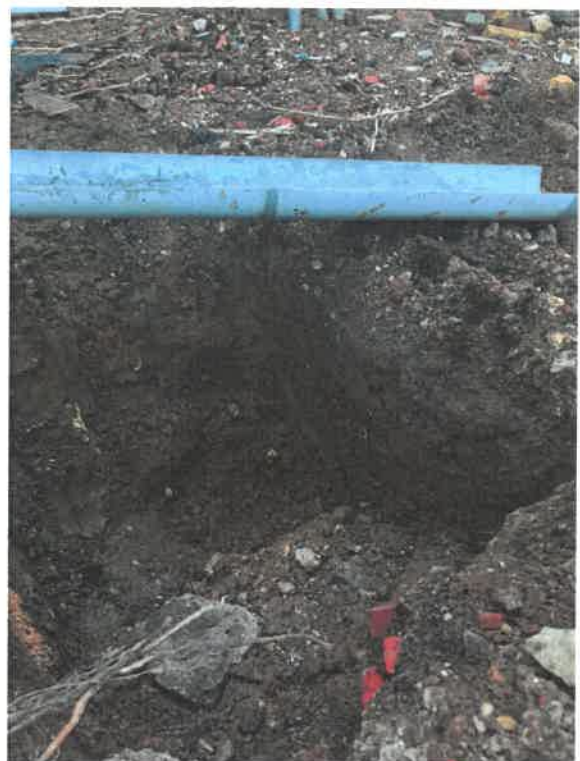
TPA5 was located near WS7 where Hydrock had found elevated PAH (200mg/kg Total PAH at 0.40mbgl).

Trial Pit A5 – Located near Hydrock WS7	
Depth	Description
Ground Level – 0.10m	MADE GROUND: Tracked-in hardcore
0.10m – 0.60m	MADE GROUND: Mid brown silty and fine sandy CLAY with occasional fragments of brick, concrete, occasional asphalt and ash/charcoal
Notes

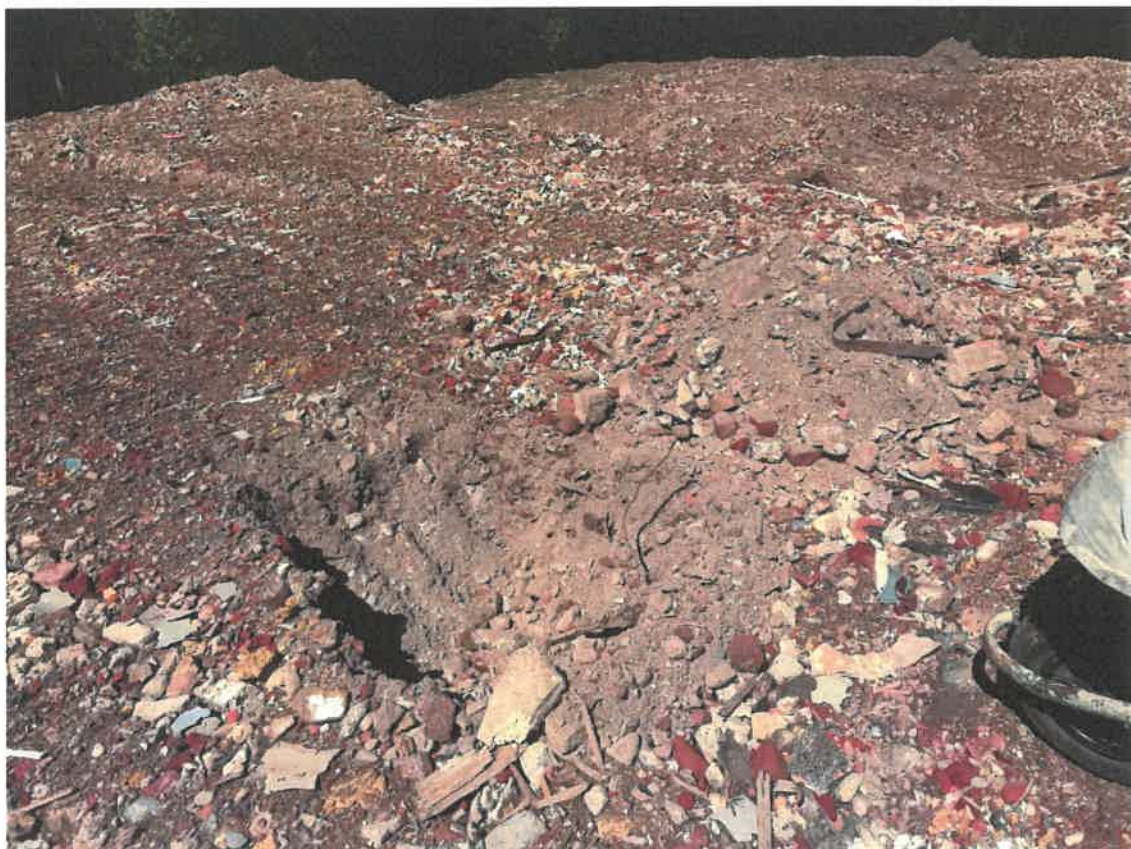
- Stockpile 1- Based on the results this material classifies as **Non-hazardous** due to elevated concentrations of Antimony and Sulphate above the inert waste threshold.

Stockpile 2 – Based on the results the material classifies as **Non-hazardous** due to elevated concentrations of Total Dissolved Solids (TDS), Antimony and Sulphate above the inert waste threshold.

Stockpile SP1
Description
MADE GROUND: Mix of crushed concrete, occasional brick fragment, and rare fragment of steel bar, metal and plastic
Notes

Stockpile SP2
Description
MADE GROUND: Mix of crushed brick, concrete and occasional tile fragment with random fragments of plastic, wood, steel, metal pipe and bitumen sheet recovered with matrix of fine crushed concrete
Notes

Stockpiles 1 (left) and 2 (right) viewed from Trial Pit X2

Stockpile 1 Phase 2 Demolition	<p>Based on the results this material classifies as Non-hazardous due to elevated concentrations of Antimony and Sulphate above the inert waste threshold.</p> <p>The contamination suite identified no BTEX. The heavy metals, TPH concentrations were below the <i>Residential with homegrown-produce</i> thresholds. A number of the PAH parameters (Benzo(a)pyrene, Benzo(b)Fluoranthene, Dibenz(a,h)anthracene) exceeded the <i>Residential with homegrown-produce</i> threshold. Therefore, the material could potentially pose a risk to future site users.</p> <p>In addition, Amosite asbestos board debris was noted within the sample and therefore the sample was submitted for quantitative analysis which recorded a % by weight of less than 0.001%. Therefore, it is proposed that the Waste Classification for this material does not need to be changed to hazardous.</p> <p>It is assumed this material will be removed from site in due course and the test results may be submitted to a waste handler to confirm their classification.</p>

Stockpile 3 Phase 2 Demolition	<p>Based on the results the material classifies as Non-hazardous due to elevated concentrations of Total Dissolved Solids (TDS), Antimony and Sulphate above the inert waste threshold.</p> <p>The contamination suite identified no BTEX. The heavy metals, TPH concentrations were below the <i>Residential with homegrown-produce</i> thresholds. A number of the PAH parameters (Benzo(a)pyrene, Benzo(b)Fluoranthene,</p>

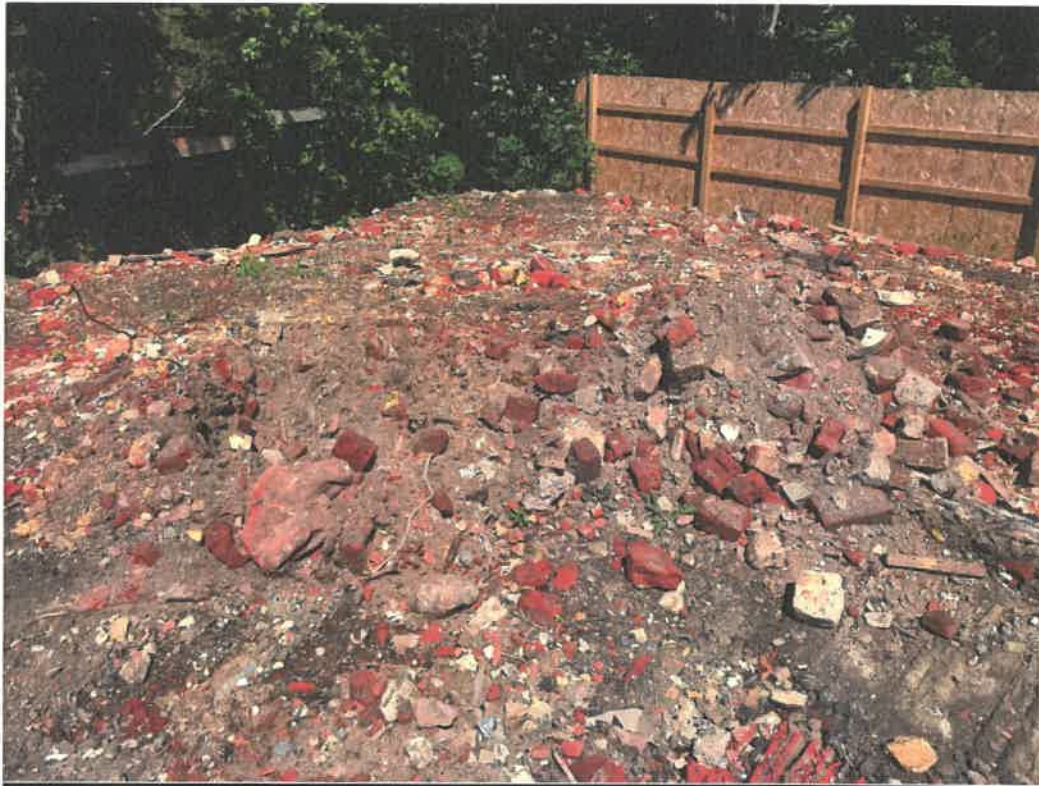
- Phase 1 Demolition 'Old' Stockpile – Based on the results the material classifies as **Non-hazardous** due to elevated concentrations of Total Dissolved Solids (TDS), Mineral oil and Sulphate above the inert waste threshold.

Old Stockpile
Description
MADE GROUND: Crushed brick with some fragments of crushed concrete, asphalt, wood, steel, tile, plastic, geotextile and bitumen sheeting.
Notes

Stockpile from Phase 1 Demolition	<p>Based on the results the material classifies as Non-hazardous due to elevated concentrations of Total Dissolved Solids (TDS), Mineral oil and Sulphate above the inert waste threshold.</p> <p>The contamination suite identified no BTEX. The heavy metals, were below the <i>Residential with homegrown-produce</i> thresholds. A number of the TPH parameters had recordable concentrations above their respective laboratory detection limit, but Mineral oil (C21-C35) recorded a concentration above the <i>Residential with homegrown-produce</i> threshold.</p> <p>A number of the PAH parameters (Benzo(a)pyrene, Benzo(b)Fluoranthene, Dibenz(a,h)anthracene) exceeded the <i>Residential with homegrown-produce</i> threshold. Therefore, the material could potentially pose a risk to future site users.</p> <p>It is assumed this material will be stripped and removed from site in due course and the test results may be submitted to a waste handler as required to assist with its disposal.</p>

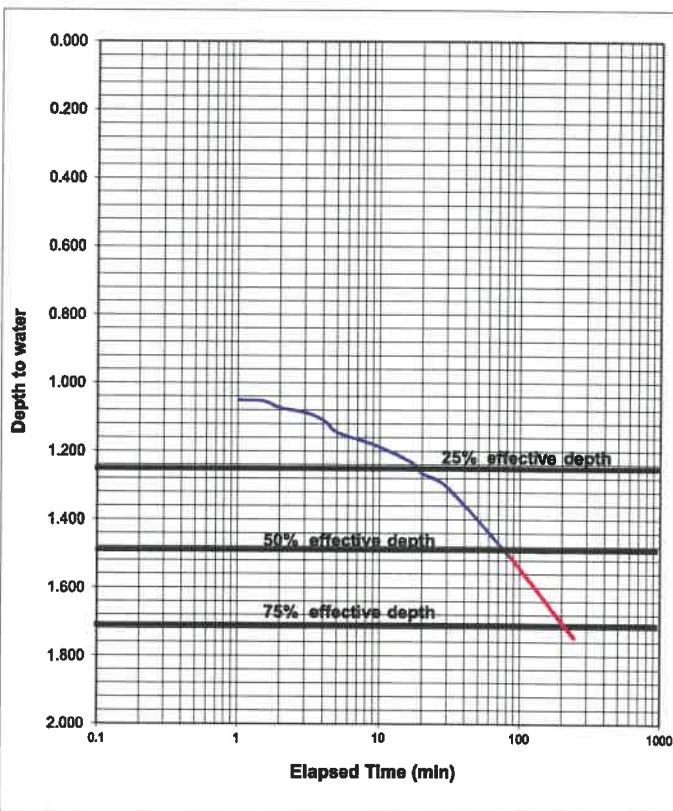
Time (mins)	Depth m
0	1.020
0.5	1.035
1	1.050
1.5	1.053
2	1.073
3	1.087
4	1.110
5	1.145
9	1.180
16.5	1.230
20	1.265
30	1.305
87	1.515

$V_{p75-25} = 1.07415 \text{ m}^3$ m^3

$a_{p50} = 5.1465 \text{ m}^2$ Infiltration factor

* Indicates that the full drainage was not achieved within the duration of the test. Consequently, the infiltration value has been calculated using the reduced depth test as outlined in BRE 365. Caution should be applied to the value obtained and where possible further long term testing carried out.
