Site Investigation Report

**Project Name:** Land of Bull Lane, Bethersden

**Location:** Ashford, TN26 3LA

**Project ID:** J16261

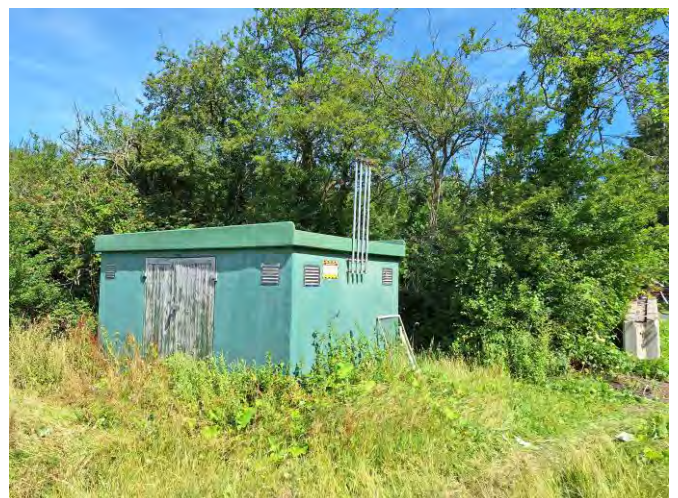
The only structure noted on site was a single-storey concrete structure within the north western area of the site, which is understood to be associated with the Medium Pressure gas pipe running across the site. The site is located within a predominately rural/residential area.

Gas installation in north east corner of site.

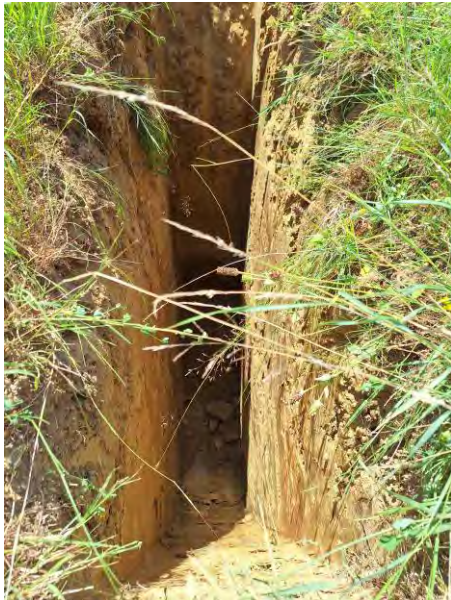
TP05

During the course of the intrusive investigation works, no visual or olfactory evidence of significant contamination was noted, however made ground was noted, in three of the trial pits (TP05, TP10 & TP11), such soils can potentially contain elevated concentrations of heavy metals, Polyaromatic Hydrocarbons (PAH's), asbestos etc. which can only be detected through laboratory analysis. The results of the laboratory analysis undertaken to date are discussed in Section E.

Made Ground/Topsoil was noted within all seventeen of the exploratory holes, to depths of 0.2/0.4m (bgl). The soils within fourteen of the trial pits were recorded as topsoil, whereas the soils within three of the trial pits (TP05, TP10 & TP11) were observed to include fragments of ceramic, flint and chalk and therefore, were recorded as made ground.
