## **Site Report & Management Plan**

Queen Court Farm, ME13 8UA

Shepherd Neame Ltd, The Faversham Brewery,  
17 Court Street, Faversham, Kent ME13 7AX

#### ***Herbicidal treatment with excavation & removal off site of the JK bund/stockpile.***

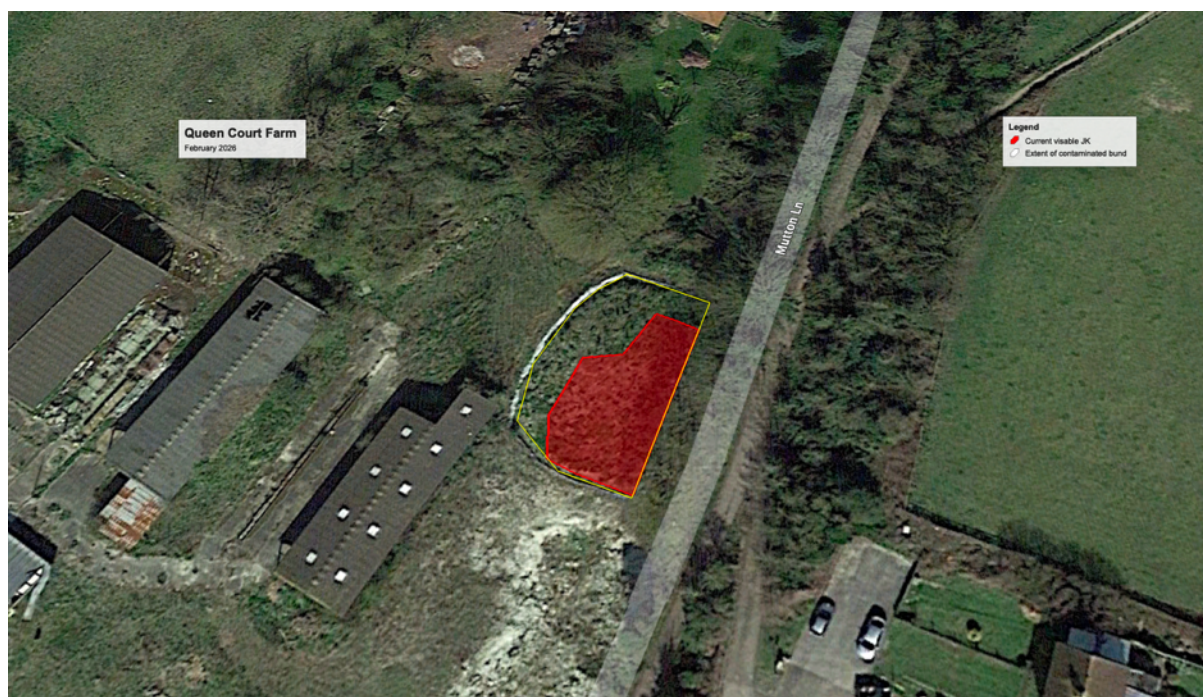
*February 2026 contaminated bund.*

**2.3** In December 2023 multiple small stands of JK were recorded on the lined bund. JHD has attended site marked each location and was treating accordingly. To enable this JHD conducted vegetation clearance on the bund. As the bund was lined the JK as unable to spread. The JK identified was immature and was particularly susceptible to herbicide treatments. JHD was instructed to monitor and treat any resulting JK on the bund and original two stand locations until 2028.

**2.5** On the 20/02/2026 JHD were instructed to attend site, survey the bund and subsequently produce fees for the complete removal of the stockpile. This was then instructed and works started on the 30/03/2026.

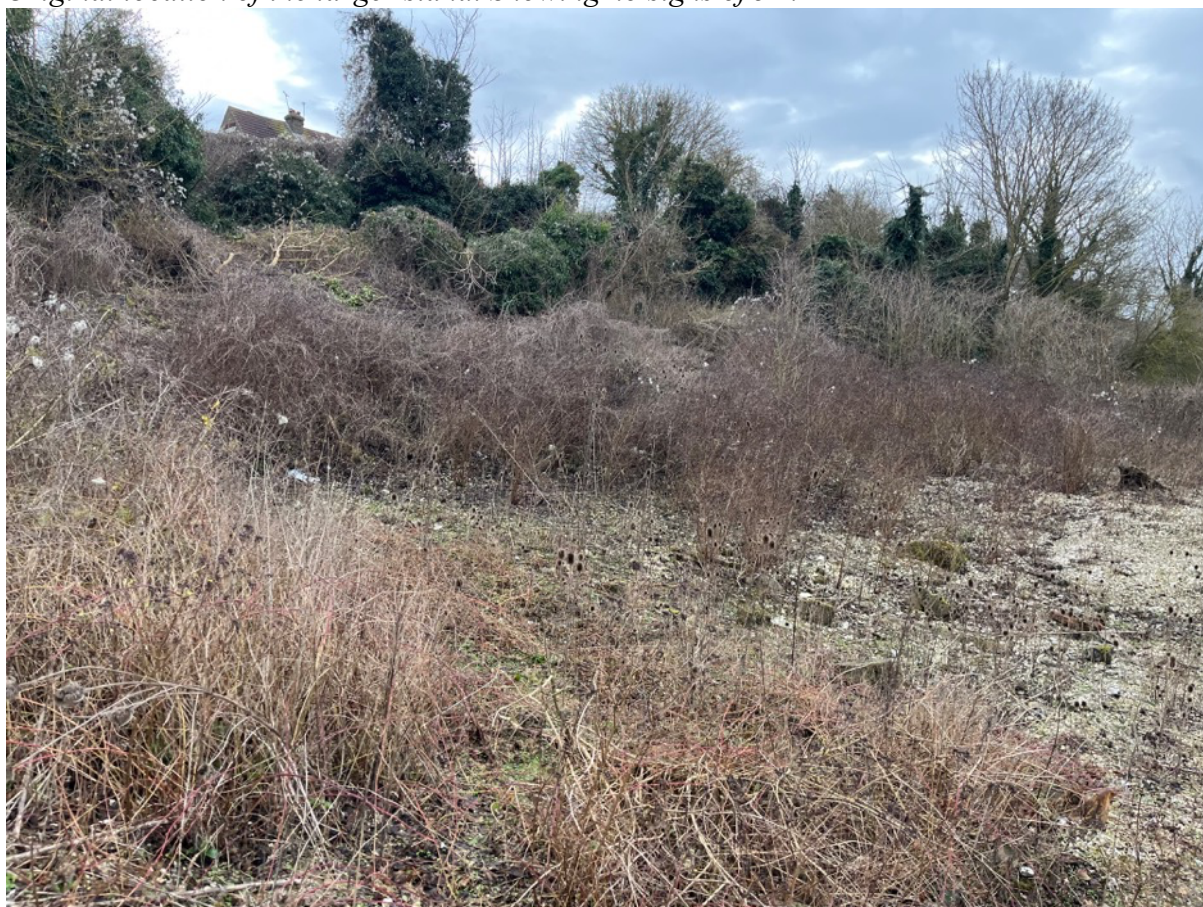
Demarked JK within the contained bund.

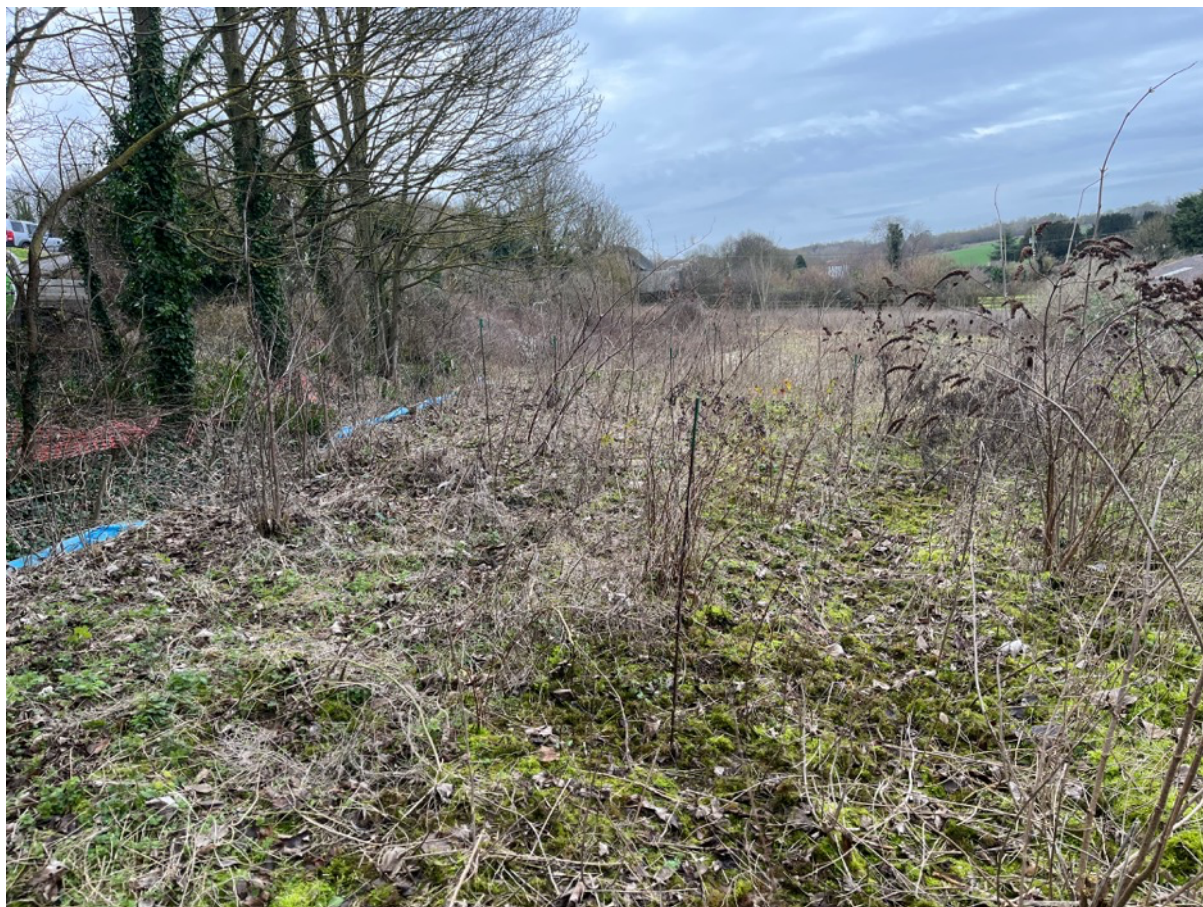
Bund undergoing vegetation clearance.

**3.2** The trees/scrub was removed following nesting bird inspections, they were felled in a manner to not disturb the JK contaminated soils.

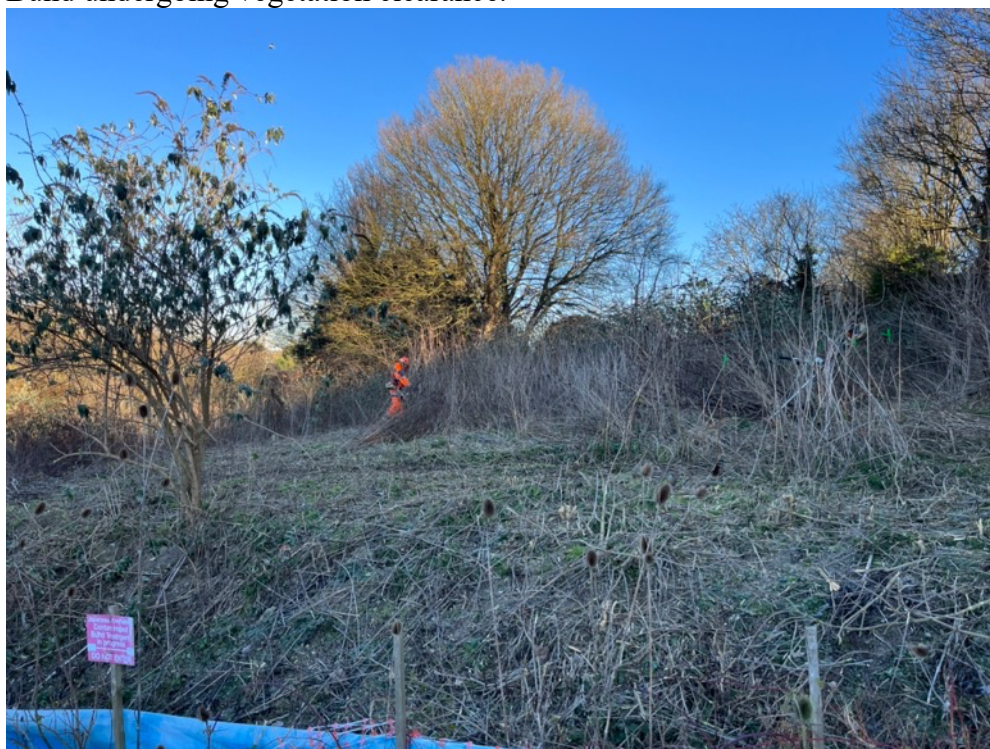
Bund post vegetation clearance.

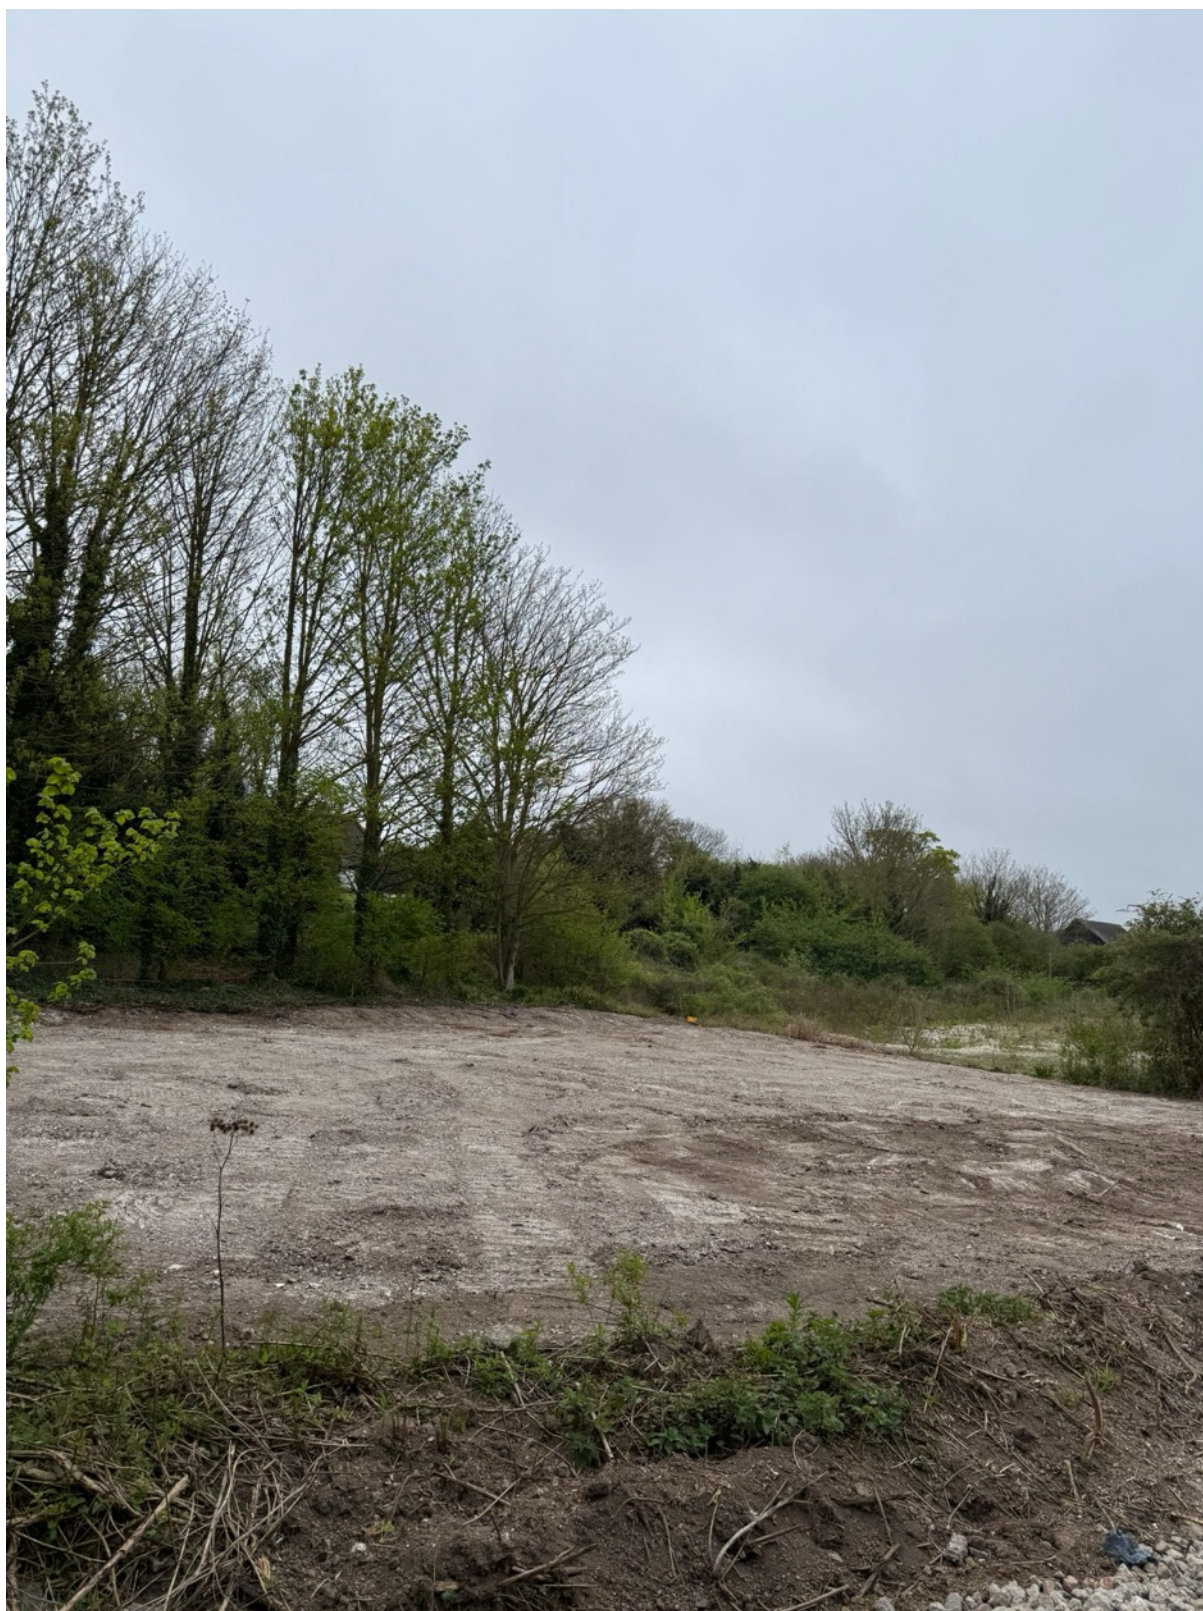
*Looking south at the cleared location on completion of works.*

**3.4** The JK stockpile was excavated fully and the membrane cleaned and disposed off to a licensed waste facility.

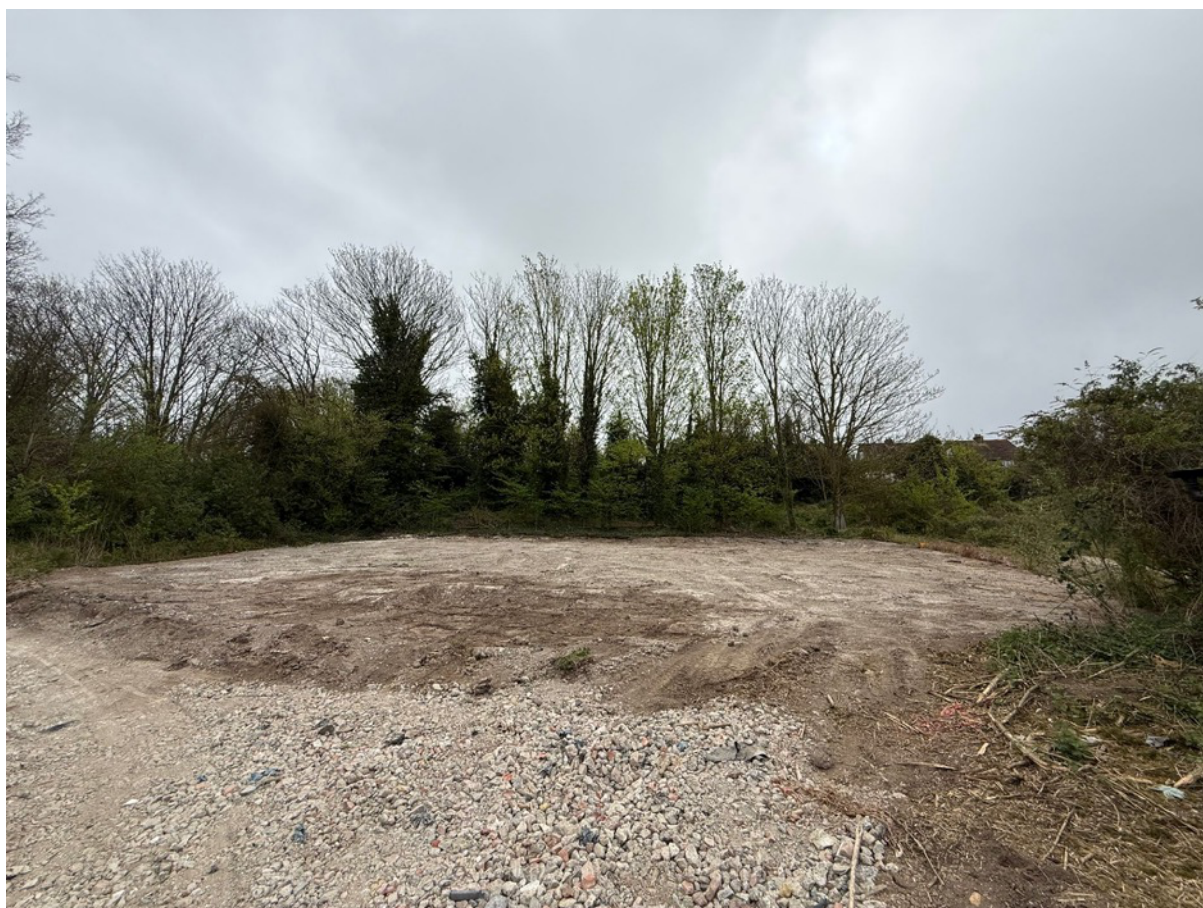
*Looking North East at the cleared location.*

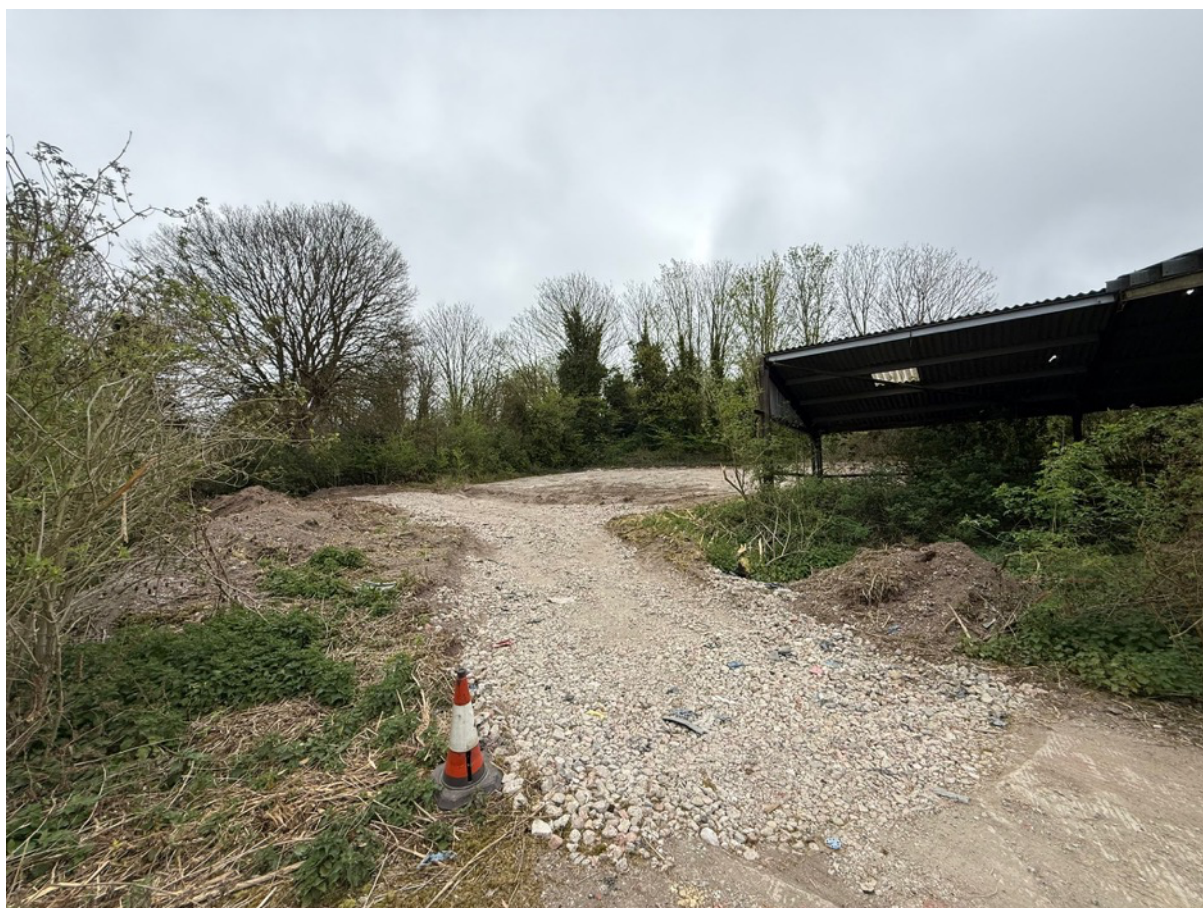
*Image shows track created for access and historic position of JK2 and the Bund.*

**3.3** A recycled aggregate track was installed to prevent any lorries becoming stuck and to help monitor any potential spillages whilst loading.
