Ecological Report

Extended Phase 1 Habitat Assessment Bat Scoping Assessment

Sittingbourne Adult Education Centre
College Road
Sittingbourne
Kent
ME10 1LF

171102-ED-01

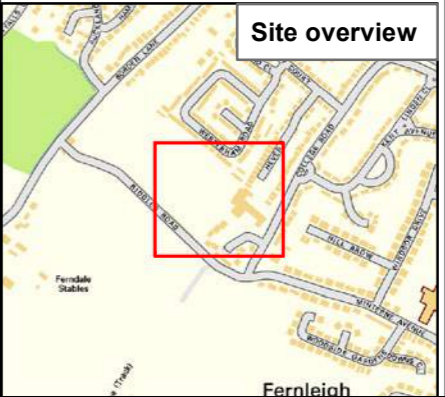
Project Name:		Sittingbourne AEC
Drawing title:		Phase 1 Plan
Drawing number:		171102-E-01
Client:		Gen2
Agent:		Tim Moya Associates
Date:	Drawn by:	
31/01/2018	BP	
Scale:		1:1,100

- TargetNote
- Tree
- Fence
- Boundary
- TreeGroup
- Building
- Scrub - dense/continuous
- Amenity grassland
- Introduced shrub
- Hardstanding

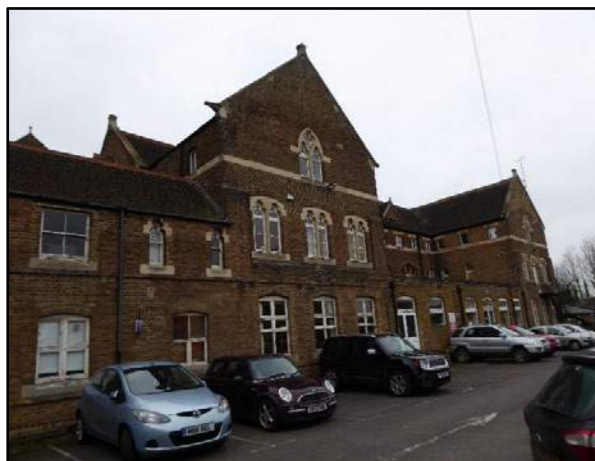
Photo 8 – Dormer structures offering potential bat roost features

A number of buildings and trees within the site were assessed as having features with potential for roosting bats, particularly the Main Building, due to its large size and clay-tiled roof.

6.17 Recommendation: In order to ascertain whether the buildings are used by roosting bats, in accordance with Bat Surveys for Professional Ecologists: Good Practice Guidelines (Collins, 2016), it is recommended that the buildings are subject to nocturnal emergence/re-entry (also known as dusk/dawn or presence/absence) surveys, as follows:

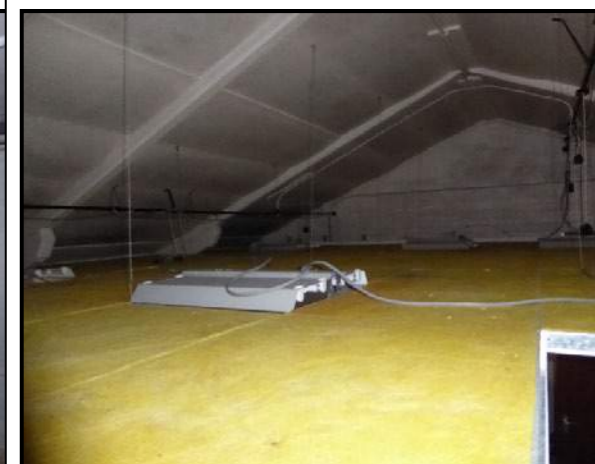
Photo 16 – Roof space of Outbuilding 2

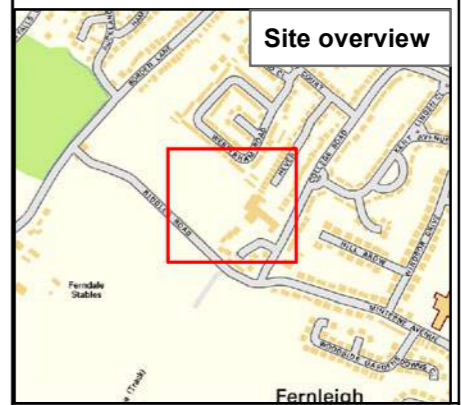
Project Name:		Sittingbourne AEC	
Drawing title:		Tree Bat Potential Plan	
Drawing number:		171102-E-02	
Client:		Gen2	
Agent:		Tim Moya Associates	
Date:	31/01/2018	Drawn by:	BP
Scale:	1:1,100

- Boundary
- Tree Group Bat Potential- L (Low)
- Tree Group Bat Potential - N (Negligible)
- Building
- ▨ Scrub - dense/continuous
- Amenity grassland
- ▨ Introduced shrub
- Hardstanding
- Tree Bat Potential
- H (High)
- M (Moderate)
- L (Low)
- N (Negligible)

- 5.7 There are a number of trees within the site boundary, ranging from those with no potential for roosting bats to those with a number of highly suitable features.
- 5.8 Tree dimensions, inspection notes and recommendations for each tree are listed in Appendix 5 of this report.
