DESK STUDY REPORT
for the land at
MEDWAY BRIDGE MARINA
MANOR LANE,
ROCHESTER, KENT,
on behalf of
KENT PLANNING LTD

GE9823\DSR\APR14 STATUS: FINAL	
Prepared by : JUSTYNA OAK BSc (Hons), FGS	Reviewed by : GLYN EVANS B.Sc. M.Sc. PGDip F.G.S. MEnvSc

FIGURE 1:	Site Location Plan
FIGURE 2:	Site Plan
FIGURE 3:	Aerial Photograph

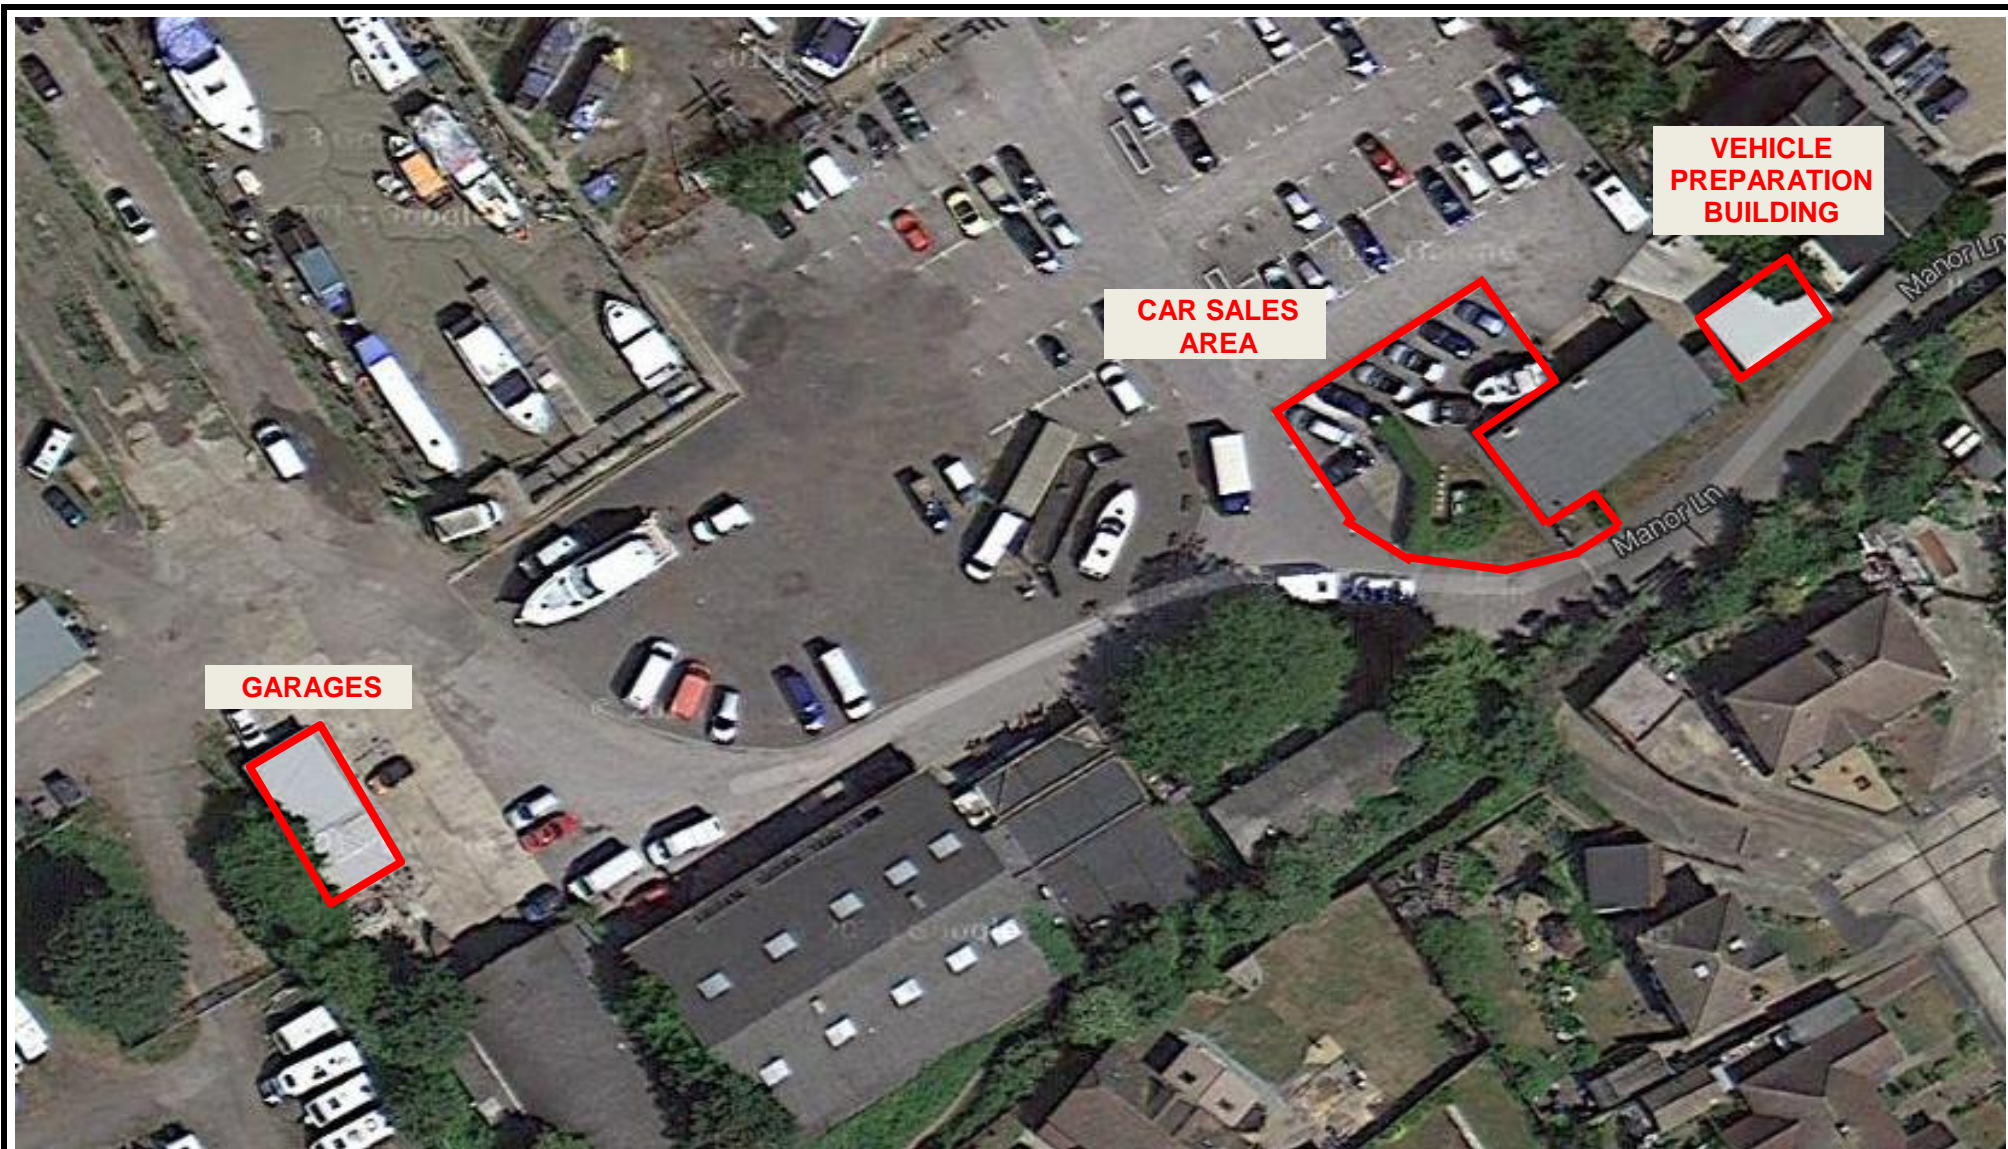
Project:	Medway Bridge Marina III			Title	Aerial Photograph	
Client:	Kent Planning Ltd			<div>

Geo-Environmental Services Limited was instructed by Kent Planning to undertake a Desk Study of the geotechnical and geo-environmental factors pertaining to land at Medway Bridge Marina, Rochester, Kent ('the site'). The site's location is presented in Figure 1 and an aerial photograph of the site is presented in Figure 3.
