MANAGEMENT ASBESTOS SURVEY REPORT

Conducted at: Foxbury Farm House & Foxbury Farm Cottage
Stone Street
Sevenoaks
Kent TN15 0LW

Date: 6th September 2018

Survey Reference: AS/05838-MS/MH

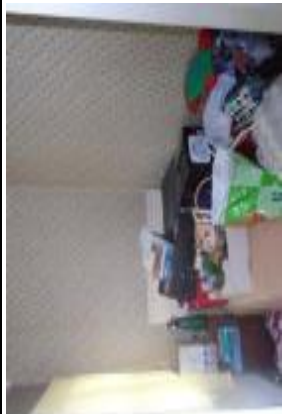
Floor level	Foxbury Farm House- First Floor						Floor	Wooden/Carpet	Walls	Solid
Area Ref/Location							Ceiling	Lath & Plaster	Boxing	Not Applicable
	1.04- Bedroom						Pipework	Un-Insulated	Doors	Wooden Panelled
Inc No.							Material Sampled	Considered Action Required (in accordance with CAR 2012)		
Sample No.							Approx Extent	No Action Required		
Product Type							Risk Score Total			
Damage							Category	No asbestos detected		
Surface Treatment							Likelihood of Disturbance			
Asbestos Type							Personnel Accessibility

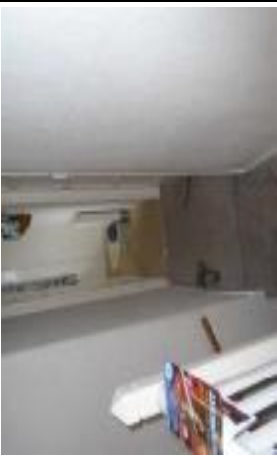
Floor level	Area Ref / Location	Area Description	Floor	Wooden/Carpet	Walls	Solid
	1.09- Landing		Ceiling	Lath & Plaster	Boxing	Not Applicable
			Pipework	Not Applicable	Doors	Not Applicable
Inc No.		Material Sampled			Considered Action Required (in accordance with CAR 2012)	
Sample No.		Approx Extent			No Action Required	
Product Type		Risk Score Total				
Damage		Category			Comments	
Surface Treatment		Likelihood of Disturbance				
Asbestos Type		Personnel Accessibility			No asbestos detected

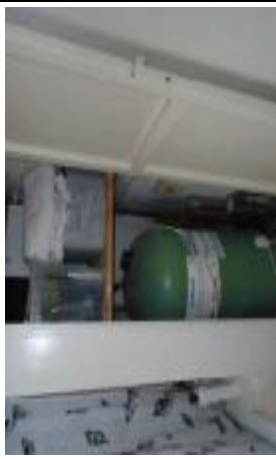
Floor level	Area Ref / Location	Area Description	Floor	Wooden	Walls	Solid
	1.11- Cylinder Cupboard		Ceiling	Lath & Plaster	Boxing	Not Applicable
			Pipework	Un-Insulated	Doors	Wooden Panelled
Inc No.		Material Sampled			Considered Action Required (in accordance with CAR 2012)	
Sample No.		Approx Extent			No Action Required	
Product Type		Risk Score Total				
Damage		Category			Comments	
Surface Treatment		Likelihood of Disturbance				
Asbestos Type		Personnel Accessibility			No asbestos detected

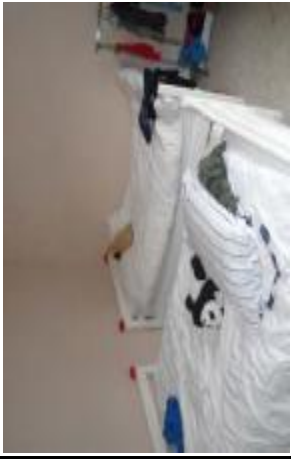
Floor level	Foxbury Farm Cottage- First Floor						
Area Ref/ Location	1.12- Bedroom						
Inc No.		Area Description	Floor	Wooden/Carpet	Walls	Solid
