Asbestos Management Survey
Sandbanks
1 Cacklebury Close, Hailsham, Wealden, BN27 3LU

A Management Survey has been carried out at Sandbanks, 1 Cacklebury Close, Hailsham, Wealden, BN27 3LU.

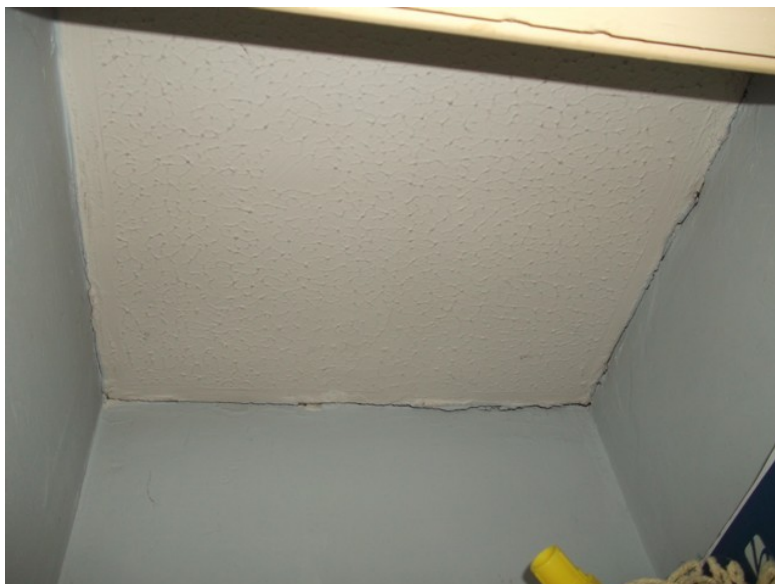
Sample No.	26462-REF 035	Product Type	Textured Coating	1
	Photo 55957-004.jpg	Condition	Good Condition	-
Building	Sandbanks	Surface Treatment	Sealed	-
Floor	First	Asbestos Type	Chrysotile	1
Room	073 - Store	Material Risk Assessment		2
Item	Textured Coating	Item Risk Classification	Very Low Risk	
Extent & Location	1sqm - Ceiling	Highest Risk Classification for Room	Very Low Risk

Main Recommendations: **Manage risk using appropriate controls and training.**
Inspect materials at least annually for further damage

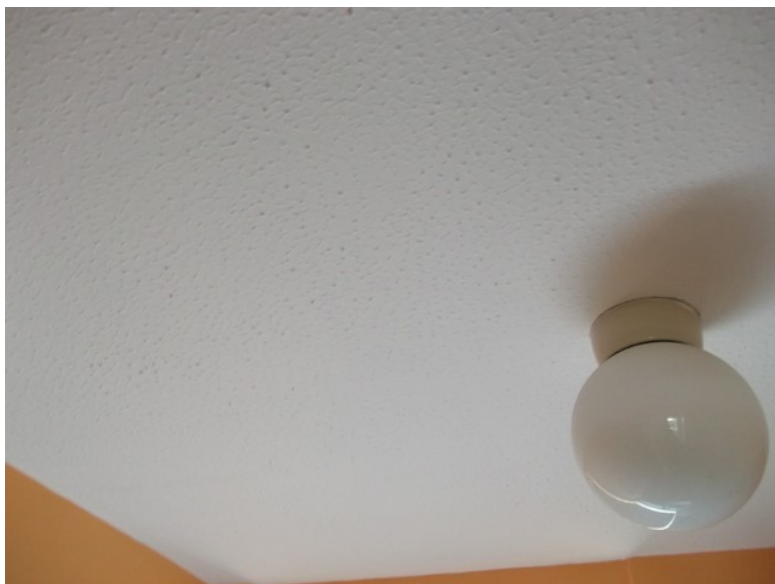
Sample No.	26462-035	Product Type	Textured Coating	1
	Photo 55957-005.jpg	Condition	Good Condition	-
Building	Sandbanks	Surface Treatment	Sealed	-
Floor	First	Asbestos Type	Chrysotile	1
Room	074 - Toilet	Material Risk Assessment		2
Item	Textured Coating	Item Risk Classification	Very Low Risk	
Extent & Location	5sqm - Ceiling	Highest Risk Classification for Room	Very Low Risk

Main Recommendations: **Manage risk using appropriate controls and training.**
Inspect materials at least annually for further damage

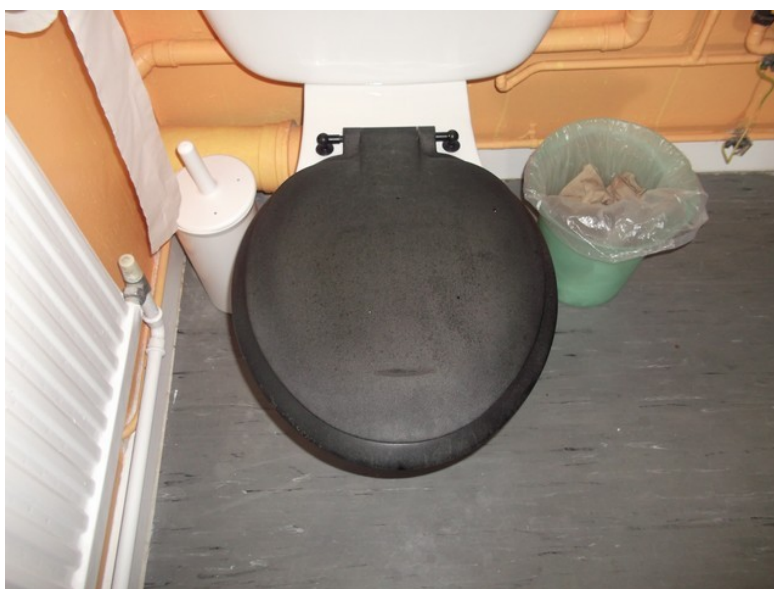
001	074	Toilet	Toilet Seat	Toilet	26462-VISUAL	4	Manage risk using appropriate controls and training. Inspect materials at least annually for further damage

Sample No.	26462-VISUAL	Product Type	Asbestos Reinforced Composite	1
	Photo 55957-006.jpg	Condition	Minor Damage	1
Building	Sandbanks	Surface Treatment	Sealed	-
Floor	First	Asbestos Type	Amosite, Presumed	2
Room	074 - Toilet	Material Risk Assessment		4
Item	Toilet Seat	Item Risk Classification	Very Low Risk	
Extent & Location	x1 - Toilet	Highest Risk Classification for Room	Very Low Risk

Main Recommendations: **Manage risk using appropriate controls and training.**
Inspect materials at least annually for further damage

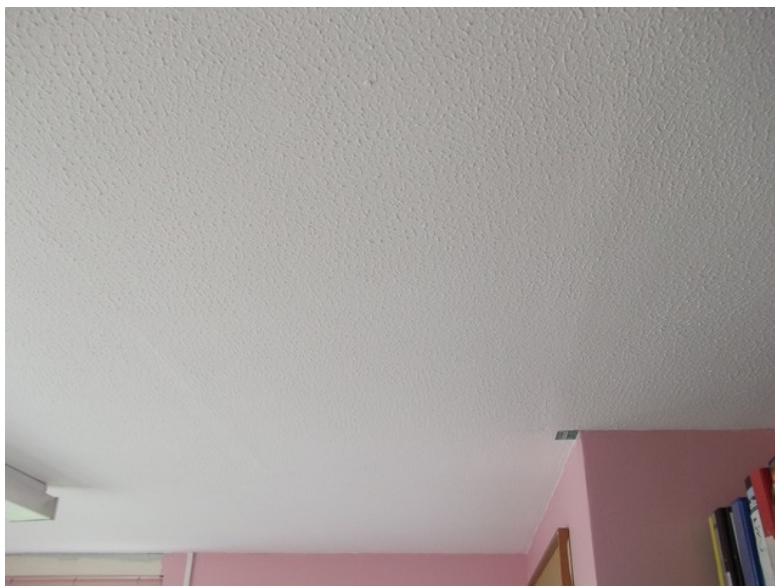
Floor / Level	Room Num	Room Name	Item Description	Location	Sample No	Material Assessment	Recommendation
	001	075	Office	Textured Coating	Ceiling	55957-REF 034	2	Manage risk using appropriate controls and training. Inspect materials at least annually for further damage
	001	076	Corridor	Textured Coating	Ceiling	26462-034	2	Manage risk using appropriate controls and training. Inspect materials at least annually for further damage
	001	078	Office	Textured Coating	Ceiling	26462-REF 034	2	Manage risk using appropriate controls and training. Inspect materials at least annually for further damage
	001	079	Photocopy Room	Textured Coating	Ceiling	26462-REF 034	2	Manage risk using appropriate controls and training. Inspect materials at least annually for further damage
	001	080	Store	Textured Coating	Ceiling	26462-REF 034	2	Manage risk using appropriate controls and training. Inspect materials at least annually for further damage

Sample No.	55957-REF 034	Product Type	Textured Coating	1
	Photo 55957-007.jpg	Condition	Good Condition	-
Building	Sandbanks	Surface Treatment	Sealed	-
Floor	First	Asbestos Type	Chrysotile	1
Room	075 - Office	Material Risk Assessment		2
Item	Textured Coating	Item Risk Classification	Very Low Risk	
Extent & Location	12sqm - Ceiling	Highest Risk Classification for Room	Very Low Risk

Main Recommendations: **Manage risk using appropriate controls and training.**
Inspect materials at least annually for further damage

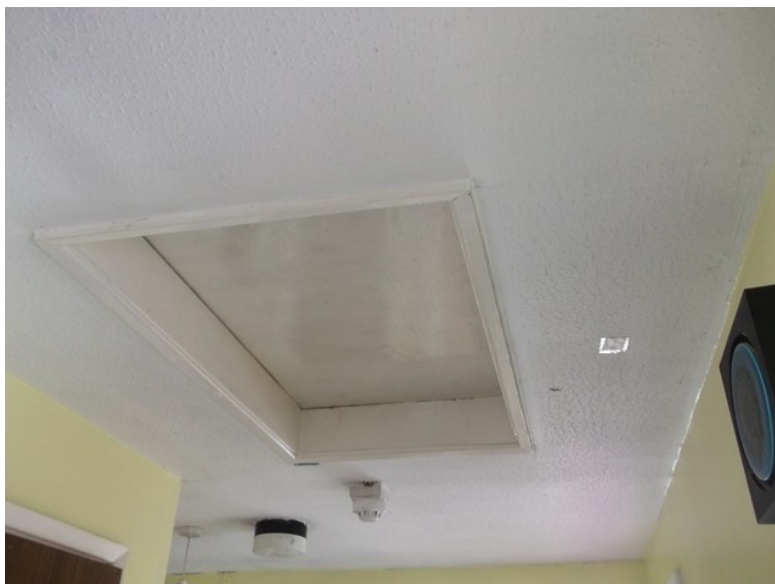
Sample No.	26462-034	Product Type	Textured Coating	1
	Photo 55957-008.jpg	Condition	Good Condition	-
Building	Sandbanks	Surface Treatment	Sealed	-
Floor	First	Asbestos Type	Chrysotile	1
Room	076 - Corridor	Material Risk Assessment		2
Item	Textured Coating	Item Risk Classification	Very Low Risk	
Extent & Location	10sqm - Ceiling	Highest Risk Classification for Room	Very Low Risk

Main Recommendations: **Manage risk using appropriate controls and training.**
Inspect materials at least annually for further damage

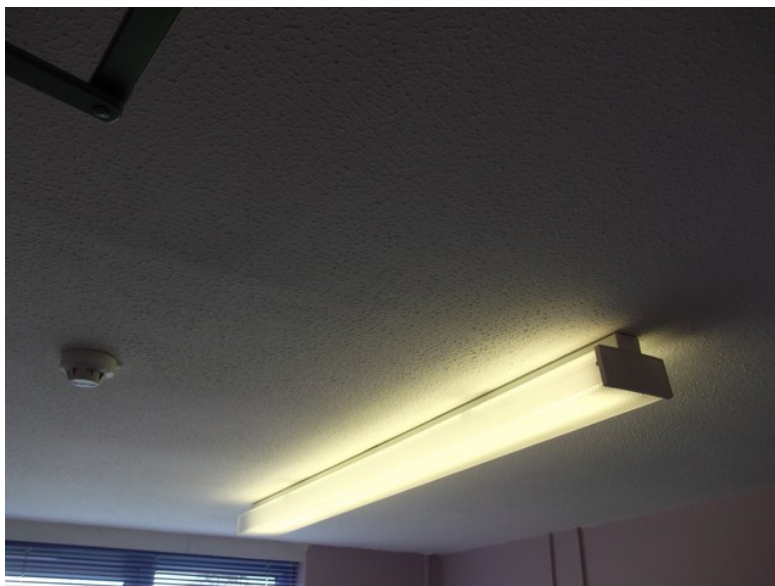
Sample No.	26462-REF 034	Product Type	Textured Coating	1
	Photo 55957-009.jpg	Condition	Good Condition	-
Building	Sandbanks	Surface Treatment	Sealed	-
Floor	First	Asbestos Type	Chrysotile	1
Room	078 - Office	Material Risk Assessment		2
Item	Textured Coating	Item Risk Classification	Very Low Risk	
Extent & Location	8sqm - Ceiling	Highest Risk Classification for Room	Very Low Risk

Main Recommendations: **Manage risk using appropriate controls and training.
Inspect materials at least annually for further damage**

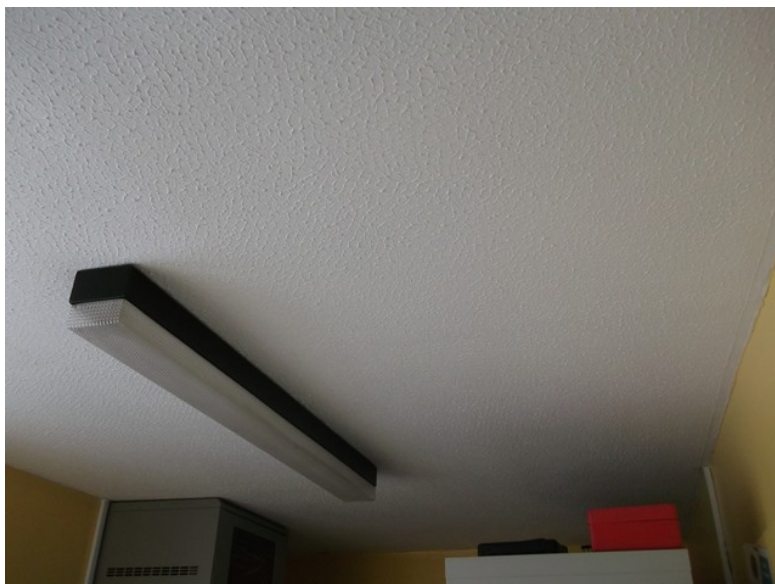
Sample No.	26462-REF 034	Product Type	Textured Coating	1
	Photo 55957-010.jpg	Condition	Good Condition	-
Building	Sandbanks	Surface Treatment	Sealed	-
Floor	First	Asbestos Type	Chrysotile	1
Room	079 - Photocopy Room	Material Risk Assessment		2
Item	Textured Coating	Item Risk Classification	Very Low Risk	
Extent & Location	8sqm - Ceiling	Highest Risk Classification for Room	Very Low Risk

Main Recommendations: **Manage risk using appropriate controls and training.**
Inspect materials at least annually for further damage

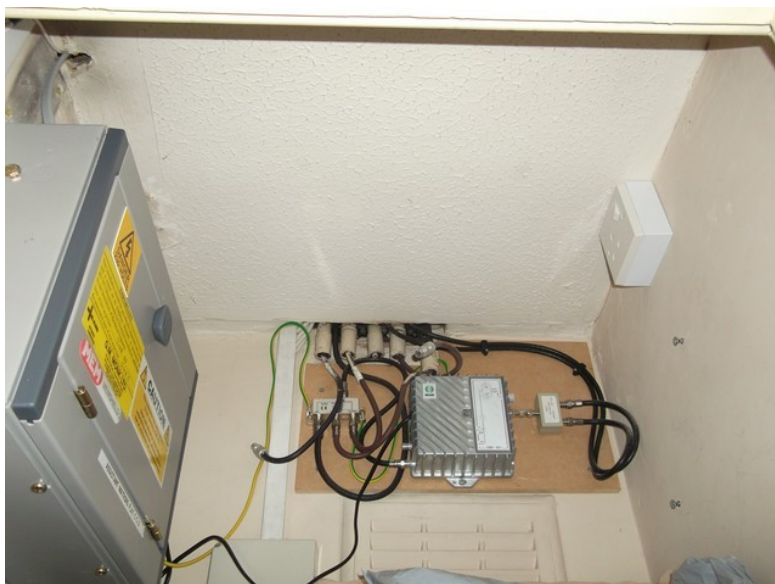
Sample No.	26462-REF 034	Product Type	Textured Coating	1
	Photo 55957-012.jpg	Condition	Good Condition	-
Building	Sandbanks	Surface Treatment	Sealed	-
Floor	First	Asbestos Type	Chrysotile	1
Room	080 - Store	Material Risk Assessment		2
Item	Textured Coating	Item Risk Classification	Very Low Risk	
Extent & Location	1sqm - Ceiling	Highest Risk Classification for Room	Very Low Risk

Main Recommendations: **Manage risk using appropriate controls and training.**
Inspect materials at least annually for further damage

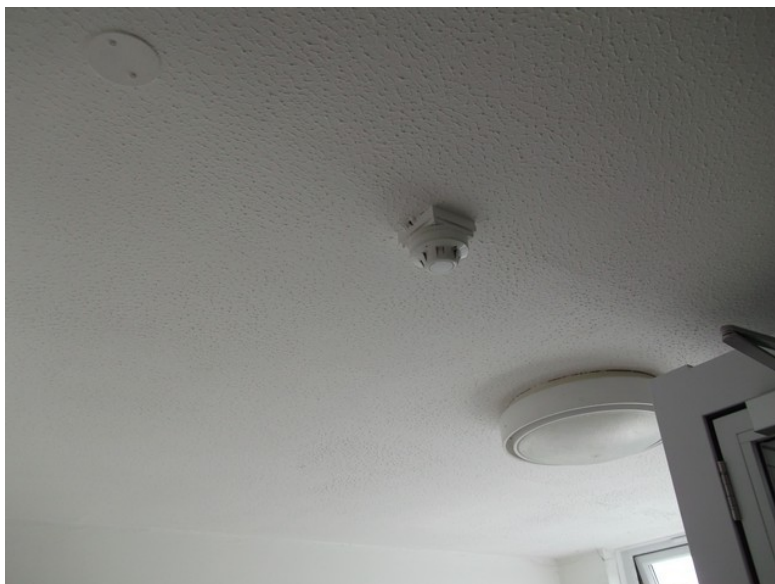
001 to 000	026	Stairwell	Textured Coating	Ceiling	55957-REF026	3	Manage risk using appropriate controls and training. Inspect materials at least annually for further damage

Sample No.	55957-REF026	Product Type	Textured Coating	1
	Photo 55957-034.jpg	Condition	Minor Damage	1
Building	Sandbanks	Surface Treatment	Sealed	-
Floor	First To Ground	Asbestos Type	Chrysotile	1
Room	026 - Stairwell	Material Risk Assessment		3
Item	Textured Coating	Item Risk Classification	Very Low Risk	
Extent & Location	10sqm - Ceiling	Highest Risk Classification for Room	Very Low Risk

Main Recommendations: **Manage risk using appropriate controls and training.
Inspect materials at least annually for further damage**

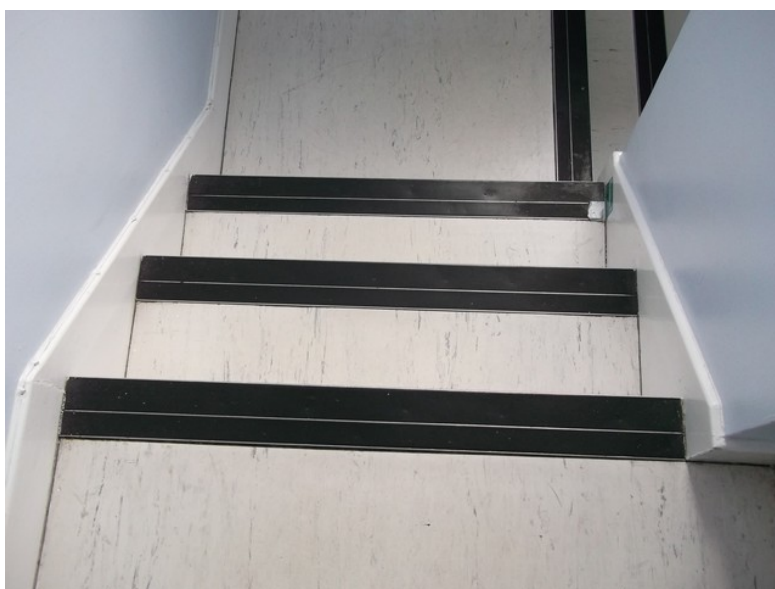
Floor / Level	Room Num	Room Name	Item Description	Location	Sample No	Material Assessment	Recommendation
	001 to 000	077	Stairwell	Black Nosing	Steps	55957-REF2646 2-037	3	Manage risk using appropriate controls and training. Inspect materials at least annually for further damage
	001 to 000	077	Stairwell	Textured Coating	Ceiling	55957-REF 26462-036	2	Manage risk using appropriate controls and training. Inspect materials at least annually for further damage

Sample No.	55957-REF26462-037	Product Type	Asbestos Reinforced Composite	1
	Photo 55957-014.jpg	Condition	Minor Damage	1
Building	Sandbanks	Surface Treatment	Sealed	-
Floor	First To Ground	Asbestos Type	Chrysotile	1
Room	077 - Stairwell	Material Risk Assessment		3
Item	Black Nosing	Item Risk Classification	Very Low Risk	
Extent & Location	15Lin.m - Steps	Highest Risk Classification for Room	Very Low Risk

Main Recommendations: **Manage risk using appropriate controls and training.**
Inspect materials at least annually for further damage

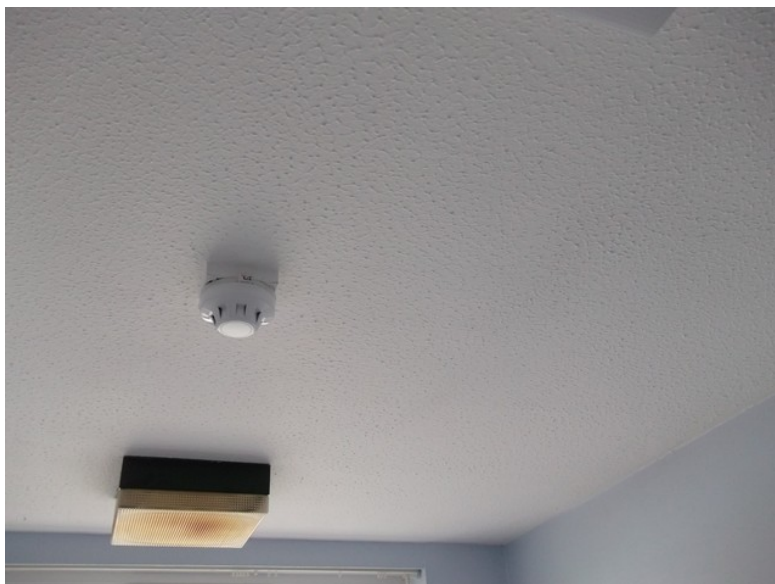
Sample No.	55957-REF 26462-036	Product Type	Textured Coating	1
	Photo 55957-013.jpg	Condition	Good Condition	-
Building	Sandbanks	Surface Treatment	Sealed	-
Floor	First To Ground	Asbestos Type	Chrysotile	1
Room	077 - Stairwell	Material Risk Assessment		2
Item	Textured Coating	Item Risk Classification	Very Low Risk	
Extent & Location	6sqm - Ceiling	Highest Risk Classification for Room	Very Low Risk

Main Recommendations: **Manage risk using appropriate controls and training.**
Inspect materials at least annually for further damage
