Appendix 2 - Bat Scoping Assessment (Trees)

Project Name:		Boughton Mount, Maidstone
Drawing title:		Tree Bat Potential Plan
Drawing number:		180337-E-03
Client:		Kent County Council
Agent:		Tim Moya Associates
Date:	17/10/2018	Drawn by:
		BP
Scale:		1:1,300

180337 - Boughton Mount 180337-ED-12

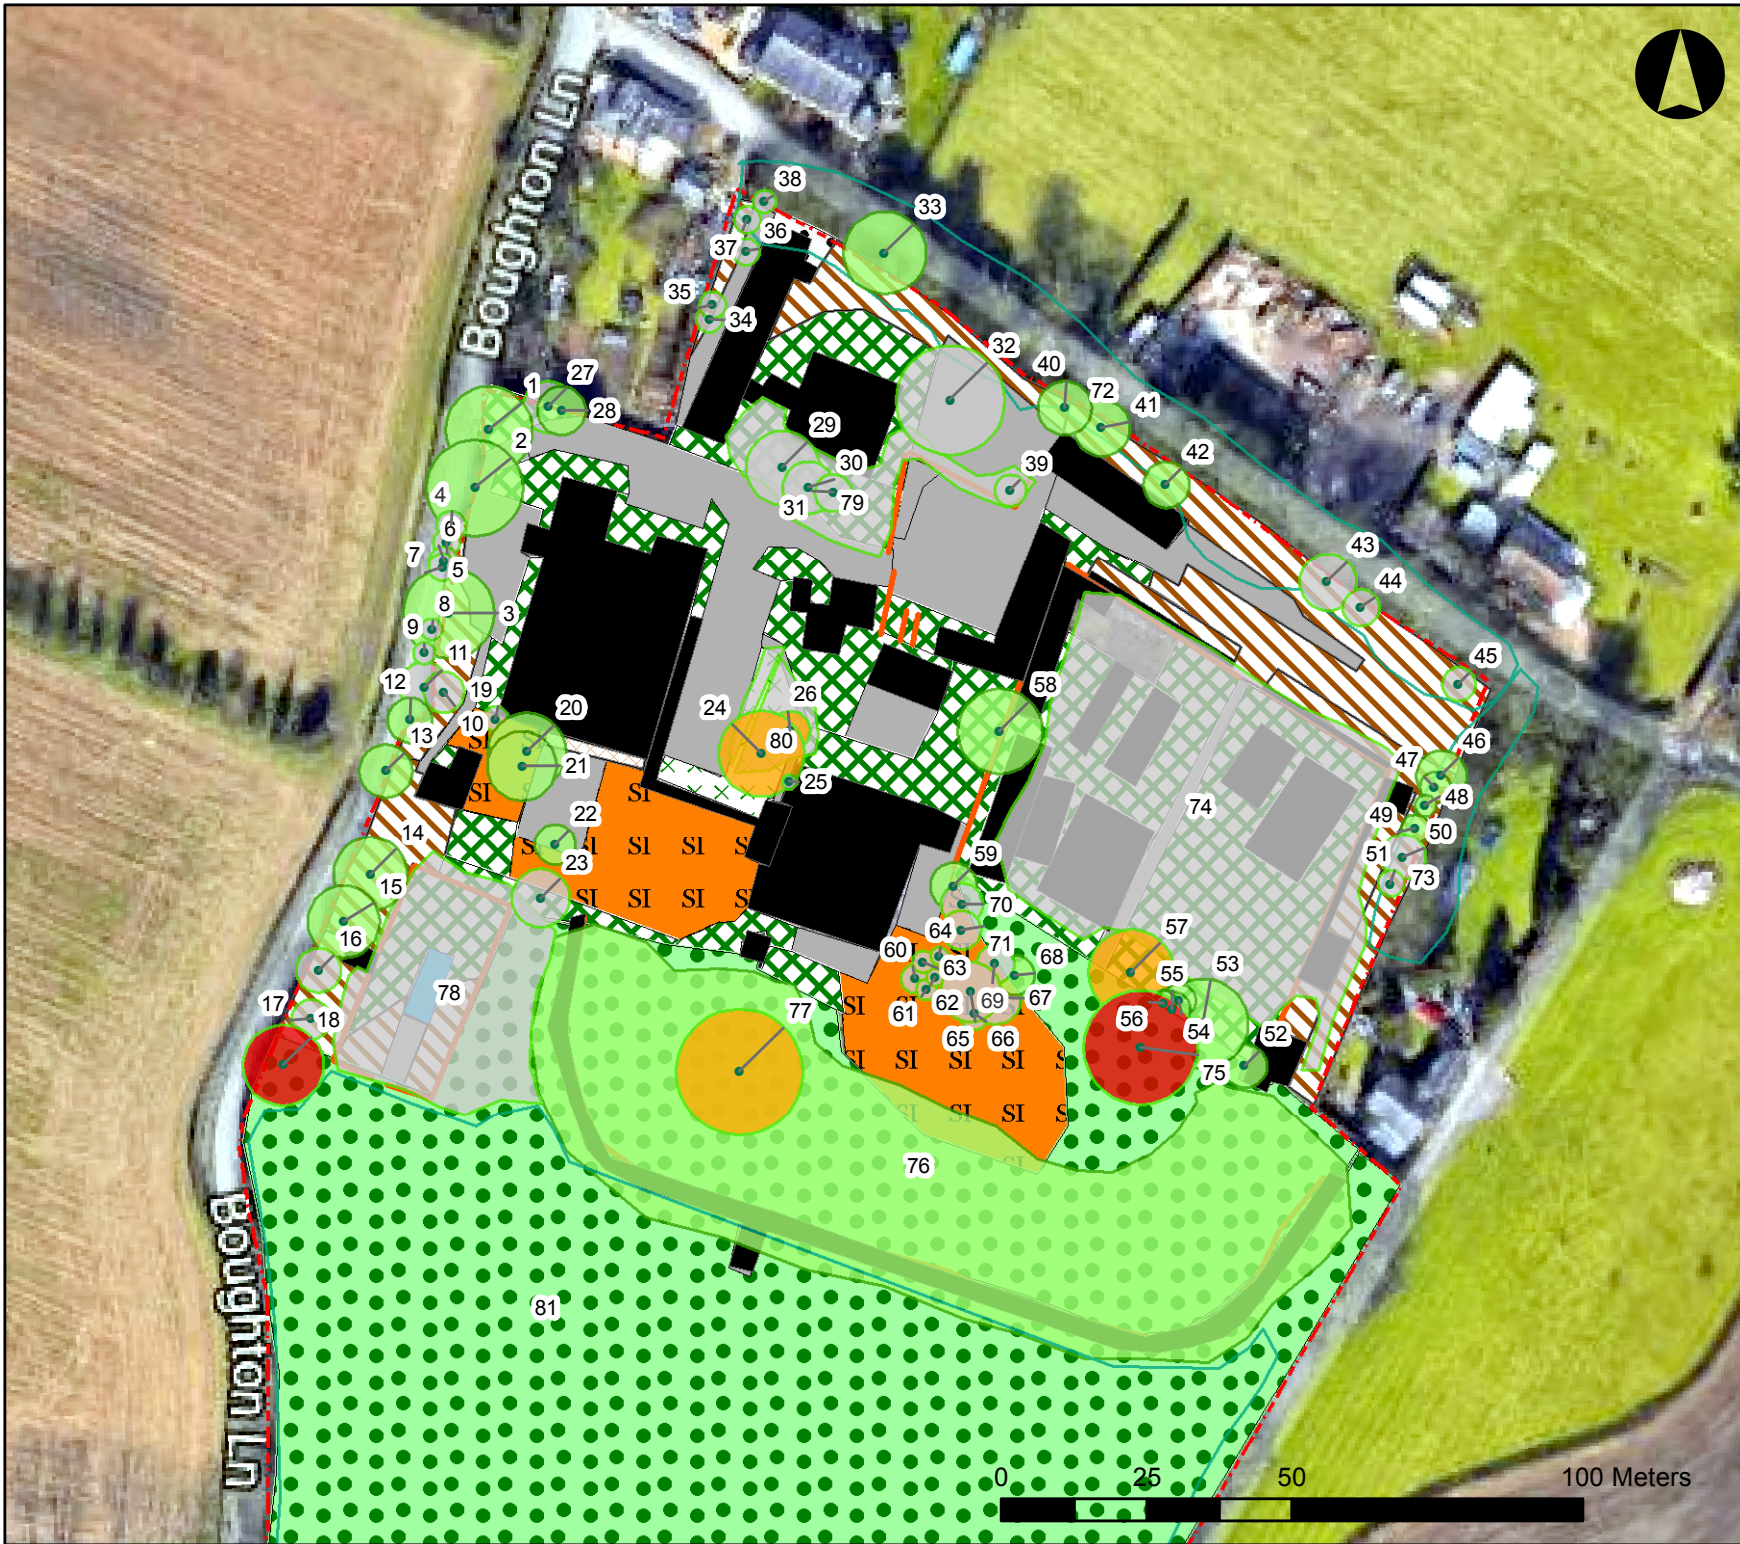
Tree No.	Species	Tree Height (m)	Age Class	BCT Category (explanation at end of schedule)	Notes	Ecological Recommendations
1	Quercus robur English Oak	18.0	Late Mature	Low	Not fully visible from the ground. Small bat roost features could exist out of sight. Not fully visible from the ground.	Climbed inspection if felling or pruning required. Climbed inspection to endoscope features. Results of this inspection may result in further surveys being recommended.
2	Cupressocyparis leylandii Leyland Cypress	18.0	Late Mature	Low	Not fully visible from the ground. Small bat roost features could exist out of sight. Not fully visible from the ground.	Climbed inspection if felling or pruning required. Climbed inspection to endoscope features. Results of this inspection may result in further surveys being recommended.
3	Quercus robur English Oak	18.0	Late Mature	Low	Not fully visible from the ground. Small bat roost features could exist out of sight. Not fully visible from the ground.	Climbed inspection if felling or pruning required. Climbed inspection to endoscope features. Results of this inspection may result in further surveys being recommended.

4	Chamaecyparis lawsoniana Lawson Cypress	12.0	Mature	Negligible	No notable features of bat roost potential.	No further bat recommendations
5	Chamaecyparis lawsoniana Lawson Cypress	10.0	Mature	Negligible	No notable features of bat roost potential.	No further bat recommendations

Tree No.	Species	Tree Height (m)	Age Class	BCT Category (explanation at end of schedule)	Notes	Ecological Recommendations
6	Chamaecyparis lawsoniana Lawson Cypress	10.0	Mature	Negligible	No notable features of bat roost potential.	No further bat recommendations
7	Fagus sylvatica Common Beech	8.0	Mature	Negligible	No notable features of bat roost potential.	No further bat recommendations
8	Chamaecyparis lawsoniana Lawson Cypress	9.0	Early Mature	Negligible	No notable features of bat roost potential.	No further bat recommendations
9	Chamaecyparis lawsoniana Lawson Cypress	16.0	Early Mature	Negligible	No notable features of bat roost potential.	No further bat recommendations
10	Ilex aquifolium Holly	10.0	Mature	Negligible	No notable features of bat roost potential.	No further bat recommendations
11	Taxus baccata Yew	9.0	Mature	Negligible	No notable features of bat roost potential.	No further bat recommendations

12	Acer pseudoplatanus Sycamore	11.0	Early Mature	Low	Not fully visible from the ground. Small bat roost features could exist out of sight. Not fully visible from the ground.	Climbed inspection if felling or pruning required. Climbed inspection to endoscope features. Results of this inspection may result in further surveys being recommended.
13	Acer pseudoplatanus Sycamore	11.0	Early Mature	Low	Not fully visible from the ground. Small bat roost features could exist out of sight. Not fully visible from the ground.	Climbed inspection if felling or pruning required. Climbed inspection to endoscope features. Results of this inspection may result in further surveys being recommended.
14	Quercus robur English Oak	18.0	Late Mature	Low	Not fully visible from the ground. Small bat roost features could exist out of sight. Not fully visible from the ground.	Climbed inspection if felling or pruning required. Climbed inspection to endoscope features. Results of this inspection may result in further surveys being recommended.

Tree No.	Species	Tree Height (m)	Age Class	BCT Category (explanation at end of schedule)	Notes	Ecological Recommendations
15	Quercus robur English Oak	18.0	Late Mature	Low	Not fully visible from the ground. Small bat roost features could exist out of sight. Not fully visible from the ground.	Climbed inspection if felling or pruning required. Climbed inspection to endoscope features. Results of this inspection may result in further surveys being recommended.
16	Quercus ilex Holm Oak	9.0	Early Mature	Negligible	No notable features of bat roost potential.	No further bat recommendations
17	Quercus ilex Holm Oak	9.0	Early Mature	Negligible	No notable features of bat roost potential.	No further bat recommendations
18	Carpinus betulus Hornbeam	14.0	Post Mature	High	Woodpecker holes and wounds throughout tree.	Climbed inspection if felling or pruning required. Climbed inspection to endoscope features. Results of this inspection may result in further surveys being recommended.

19	Picea abies Norway Spruce	7.0	Semi Mature	Negligible	No notable features of bat roost potential.	No further bat recommendations
20	Cupressus macrocarpa Monterey cypress	16.0	Late Mature	Low	No notable features of bat roost potential visible. Small features may be present out of site. Not fully visible from ground inspection.	Climbed inspection if felling or pruning required. Climbed inspection to endoscope features. Results of this inspection may result in further surveys being recommended.
21	Pinus nigra Black Pine	18.0	Late Mature	Low	No notable features of bat roost potential visible. Small features may be present out of site. Not fully visible from a ground inspection.	Climbed inspection if felling or pruning required. Climbed inspection to endoscope features. Results of this inspection may result in further surveys being recommended.

Tree No.	Species	Tree Height (m)	Age Class	BCT Category (explanation at end of schedule)	Notes	Ecological Recommendations
22	Chamaecyparis lawsoniana 'Aurea Lawson's Cypress cv.	12.0	Mature	Low	No fully visible from the ground. Small bat roost features may exist out of site.	Precautionary soft-fell if felling required. Climbing survey considered unsuitable, soft fell required if being pruned or felled.
23	Eucalyptus sp. Eucalyptus Tree	14.0	Early Mature	Negligible	No notable features of bat roost potential.	No further bat recommendations
24	Quercus robur English Oak	20.0	Late Mature	Moderate	Two notable holes half way up main stem (one in use by nesting starlings). Also various wounds and cavities in large branches of crown.	Climbed inspection if felling or pruning required. Climbed inspection to endoscope features. Results of this inspection may result in further surveys being recommended.
25	Chamaecyparis lawsoniana Lawson Cypress	8.0	Early Mature	Negligible	No notable features of bat roost potential.	No further bat recommendations

26	Acer pseudoplatanus Sycamore	5.0	Early Mature	Moderate	Rams horns present and flaking bark.	Climbed inspection if felling or pruning required. Climbed inspection to endoscope features. Results of this inspection may result in further surveys being recommended.
27	Laurus nobilis Bay/Bay Laurel/Poets Laurel	8.0	Early Mature	Negligible	No notable features of bat roost potential.	No further bat recommendations
28	Laurus nobilis Bay/Bay Laurel/Poets Laurel	8.0	Early Mature	Low	Small areas of flaking bark. Limited bat roost potential.	Precautionary soft-fell if felling required. Climbing survey considered unsuitable, soft fell required if being pruned or felled.

Tree No.	Species	Tree Height (m)	Age Class	BCT Category (explanation at end of schedule)	Notes	Ecological Recommendations
29	Acer pseudoplatanus Sycamore	14.0	Mature	Negligible	No notable features of bat roost potential.	No further bat recommendations
30	Cerasus avium Wild Cherry	12.0	Mature	Negligible	No notable features of bat roost potential.	No further bat recommendations
31	Cerasus avium Wild Cherry	10.0	Mature	Negligible	No notable features of bat roost potential.	No further bat recommendations
32	Cedrus atlantica 'Glauca' Blue Atlas Cedar	18.0	Mature	Negligible	No notable features of bat roost potential.	No further bat recommendations
33	Castanea sativa Sweet Chestnut	16.0	Late Mature	Low	Not fully visible from the ground. Small bat roost features could exist out of sight. Not fully visible from the ground.	Climbed inspection if felling or pruning required. Climbed inspection to endoscope features. Results of this inspection may result in further surveys being recommended.

34	Chamaecyparis lawsoniana 'Aurea' Lawson's Cypress cv.	14.0	Mature	Negligible	No notable features of bat roost potential.	No further bat recommendations
35	Laurus nobilis Bay/Bay Laurel/Poets Laurel	6.0	Early Mature	Negligible	No notable features of bat roost potential.	No further bat recommendations
36	Acer pseudoplatanus Sycamore	6.0	Early Mature	Negligible	No notable features of bat roost potential.	No further bat recommendations

Tree No.	Species	Tree Height (m)	Age Class	BCT Category (explanation at end of schedule)	Notes	Ecological Recommendations
37	Acer pseudoplatanus Sycamore	6.0	Early Mature	Negligible	No notable features of bat roost potential.	No further bat recommendations
38	Acer pseudoplatanus Sycamore	6.0	Early Mature	Negligible	No notable features of bat roost potential.	No further bat recommendations
39	Salix caprea Goat Willow/Great Sallow	6.0	Semi Mature	Negligible	No notable features of bat roost potential.	No further bat recommendations
40	Acer pseudoplatanus Sycamore	14.0	Early Mature	Low	Covered in ivy, not fully visible for inspection.	Climbed inspection if felling or pruning required. Climbed inspection to endoscope features. Results of this inspection may result in further surveys being recommended.
41	Acer pseudoplatanus Sycamore	14.0	Early Mature	Low	Covered in ivy, not fully visible for inspection.	Climbed inspection if felling or pruning required. Climbed inspection to endoscope features. Results of this inspection may result in further surveys being recommended.
