Appendix 3 - Target Notes and Locations

Project Name:		Boughton Mount, Maidstone
Drawing title:		Target Note Plan
Drawing number:		180337-E-03
Client:		Kent County Council
Agent:		Tim Moya Associates
Date:	02/07/2018	Drawn by:
		BP
Scale:		1:900

Appendix 4 – Bat Scoping Assessment (Buildings)

Project Name:
Boughton Mount, Maidstone

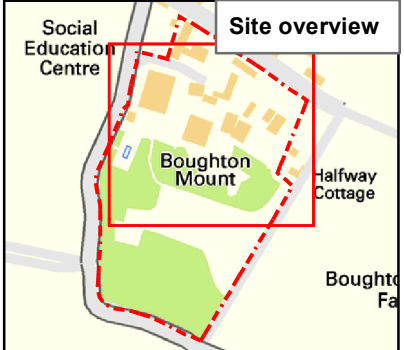
Object ID	Type	Notes and findings
1	Invasive plant species	Snowberry.
2	Miscellaneous target note	Large oak tree with fungus at base.
3	Miscellaneous target note	Canvas canopies and seating area.
4	Mammal evidence	Large mammal burrow. Current evidence of use by fox (hairs).
5	Habitat description	Historic stone Ha-Ha 2.2 m tall. Includes numerous crevices between stones, suitable for roosting bats and other small mammals. Harts tongue fern and male fern growing from cracks.
6	Miscellaneous target note	Historic stone bridge leading over Ha-Ha. Underside would provide poential for hibernating bats but no crevices are present.
7	Miscellaneous target note	Historic fountain (dry).
8	Habitat description	Tussocky grass - Optimal reptile habitat.
9	Potential Bat Roost Feature (PRF)	Hanging tiles (partly smashed off). Potential for use by roosting bats.
10	Potential Bat Roost Feature (PRF)	Hanging tiles (partly smashed off). Potential for use by roosting bats.

11	Potential Bat Roost Feature (PRF)	Access hole to void beneath building. Grill has been removed.
12	Potential Bat Roost Feature (PRF)	Hanging tiles (partly smashed off). Potential for use by roosting bats.
13	Potential Bat Roost Feature (PRF)	Hanging tiles (partly smashed off). Potential for use by roosting bats.
14	Miscellaneous target note	Dense ivy obscuring gable end of building.
15	Potential Bat Roost Feature (PRF)	Hanging tiles. Potential for use by roosting bats.

Object ID	Type	Notes and findings
16	Habitat description	Tussocky grass - Optimal reptile habitat.
17	Miscellaneous target note	Raised planter.
18	Miscellaneous target note	Raised planter.
19	Miscellaneous target note	Raised planter.
20	Potential Bat Roost Feature (PRF)	Historic folly building, extremely overgrown. Missing bricks offer potential bat access into inside of building which offers excellent bat roosting habitat, particularly for hibernation.
21	Mammal evidence	Large mammal burrow. Currently considered most likely used by fox.
22	Bird nest	Evidence of birds nesting within roof of covered walkway.
23	Bat access point	Boiler room viewed internally. No evidence of bats. Hole in internal wall could provide access into cavity.
24	Habitat description	Large pile of brash and wood covered with nettles.
25	Potential Bat Roost Feature (PRF)	Old chimney (rest of structure collapsed) - potential for use by roosting bats entering fireplace or top of chimney.

26	Miscellaneous target note	Broken asbestos sheeting partly buried.
27	Potential Bat Roost Feature (PRF)	15 cm x 12 cm hole into cavity wall.
28	Potential Bat Roost Feature (PRF)	Approx 6m tall wall - brick on one side and stone on the other. Generally intact but where cavities exist, offers roosting potential for bats.
29	Potential Bat Roost Feature (PRF)	Approx 6m tall wall - brick on one side and stone on the other. Generally intact but where cavities exist, offers roosting potential for bats.
30	Potential Bat Roost Feature (PRF)	Notable gap in end of large brick and stone wall behind in-built wooden beam.

Object ID	Type	Notes and findings
31	Potential Bat Roost Feature (PRF)	Approx 6m tall wall - brick on one side and stone on the other. Generally intact but where cavities exist, offers roosting potential for bats.
32	Potential Bat Roost Feature (PRF)	Notable gaps into gable end wall alongside beams and pipes.
33	Potential Bat Roost Feature (PRF)	Notable gap into soffit.
34	Bird nest	Starlings nesting in tower.
35	Bat access point	7x7 cm hole through wall.
36	Mammal evidence	Mammal 'couch' (above ground resting place) - most likely fox.
37	Potential Bat Roost Feature (PRF)	Hanging tiles (intact). Potential for use by roosting bats.
38	Habitat description	Large pile of logs and brash.
39	Habitat description	Large pile of brash and wood covered with nettles.
40	Potential Bat Roost Feature (PRF)	External basement access to building.

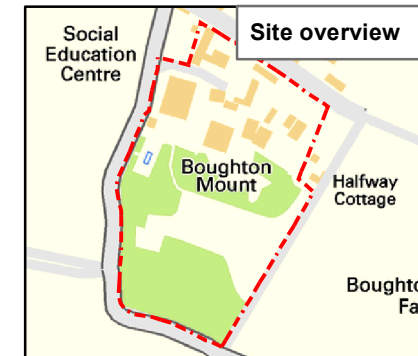
Drawing title:
Buildings Plan

Object ID REF	Storeys	Use of Building	Roof type Condition	Materials	Cellars	Chimneys	Roof void present	Bats evidence	Bat roost potential	Hibernation pot.	Internal Inspection	Potential bat access points Potential bat roost features	Recommendations	Ecological notes	Survey date
1 Dilapidated pond building	1	None	Pitched Poor	Roof external: Slate (largely missing) Roof internal: Wooden board (largely missing) Wall: Brick	N	0	N	N	N	N	Yes			Roof structure largely absent. Open to elements.	01/05/2018
2 Dilapidated swimming pool	1	None	Pitched Poor	Roof external: Fibreglass sheet Roof internal: None Wall: Fibreglass sheet (largely smashed)	N	0	N	N	N	N	Yes			Open structure due to dilapidation.	01/05/2018
3 Large flat-roofed building 2	1	None	Flat Medium	Roof external: Unknown Roof internal: Unknown Wall: Brick	Y		N	N	M	L	No	Cladding - hanging tiles. Cladding - wooden. Eaves - gaps under fascia boards Cladding - hanging tiles. Cladding - wooden. Eaves - gaps under fascia boards			08/05/2018

4 Lodge	2	Previously residential	Pitched Medium	Roof external: Cement tiles Roof internal: Unknown Wall: Brick	N	1	Y		M	L	No	Cladding - wooden. Eaves - gaps behind soffit boxes. Eaves - gaps under fascia boards. Tiles - missing. Window - broken/missing windows Cladding - wooden. Eaves - gaps behind soffit boxes. Roof void. Tiles - gaps under ridge tiles			01/05/2018
5 Folly	1	None	Flat Good	Roof external: Stone Roof internal: Stone Wall: Stone	N	0	N		H	H	No	Wall materials - gaps in brickwork/masonry Rooms - cavities within internal rooms. Underground features. Wall materials - gaps in brickwork/masonry		Historic folly building totally enveloped by vegetation. View through hole in wall shows internal cave-like structure with excellent suitability for roosting bats, particularly during hibernation.	01/05/2018

Object ID REF	Storeys	Use of Building	Roof type Condition	Materials	Cellars	Chimneys	Roof void present	Bats evidence	Bat roost potential	Hibernation pot.	Internal Inspection	Potential bat access points Potential bat roost features	Recommendations	Ecological notes	Survey date
6 Covered Way	1	Covered walkway (not enclosed)	Flat Poor	Roof external: Bitumen felt Roof internal: Wooden board Wall: No walls.	N	0	N	N	L	N	Yes	Roof materials - flat roof Roof materials - cavity under flat roof		Covered walkway roof has 10 cm gap between upper and lower layers of wooden board.	01/05/2018
7 Ruins	1	None	null	Roof external: No roof Roof internal: No roof Wall: Brick - largely collapsed	N	1	N	N	L	L	Limited	Wall materials - gaps in brickwork/masonry Wall materials - gaps in brickwork/masonry		Chimney and few remaining walls may include some crevices for roosting bats, although largely collapsed.	08/05/2018

8 Two-storey small building	2	None	Pitched Poor	Roof external: Slate tiles Roof internal: Bitumen roof felt Wall: Stone and brick	N		N	N	M	M	Limited	Door - broken/missing. Tiles - missing. Wall materials - cavity wall accessible. Wall materials - gaps in brickwork/masonry. Window - broken/missing windows Building foundations. Roof materials - gaps between bitumen felt and roof tiles. Rooms - cavities within internal rooms. Wall materials - cavity wall accessible. Wall materials - gaps in brickwork/masonry		Upper floor not safe to inspect fully - floor collapsing. Potential basement or underground features.	08/05/2018
9 Greenhouse 1	1	Ex-greenhouse	Pitched Poor	Roof external: Glass (largely broken) Roof internal: N/A Wall: Glass (largely broken)	N	0	N	N	N	N	Limited			Derelict greenhouse completely full of brambles.	08/05/2018
10 Greenhouse 2	1	Ex-greenhouse	Pitched Poor	Roof external: Glass (largely broken) Roof internal: N/A Wall: Glass (largely broken)	N	0	N	N	N	N	Limited			Derelict greenhouse completely full of brambles.	08/05/2018

Object ID REF	Storeys	Use of Building	Roof type Condition	Materials	Cellars	Chimneys	Roof void present	Bats evidence	Bat roost potential	Hibernation pot.	Internal Inspection	Potential bat access points Potential bat roost features	Recommendations	Ecological notes	Survey date
11 Large building with tower	2	None	Pitched Medium	Roof external: Slate tiles Roof internal: Not visible Wall: Stone		0	Y	N	H	H	No	Eaves - gaps behind soffit boxes. Gable end - gap. Structures through walls - beams. Structures through walls - pipe. Tiles - gaps between. Wall materials - gaps in brickwork/masonry. Window - broken/missing windows Brickwork - gaps in brickwork. Cavity Wall. Eaves - gaps behind soffit boxes. Roof void. Rooms - cavities within internal rooms. Tiles - gaps under roof tiles. Wall materials - cavity wall accessible. Wall materials - gaps in brickwork/masonry		Large castle-style turret/tower present. Numerous opportunities for roosting bats. Nesting birds also very likely.	08/05/2018

12 Garages	1	None	Pitched Good	Roof external: Corrugated asbestos Roof internal: Unknown Wall: Brick	N	0		N	L	L	No	Eaves - gaps under roof eaves. Gable end - gap. Wall materials - gaps in brickwork/masonry Rooms - cavities within internal rooms. Tiles - gaps under roof tiles. Wall materials - gaps in brickwork/masonry			08/05/2018
13 Greenhouse 3	1	Ex-greenhouse	Pitched Poor	Roof external: Glass (largely broken) Roof internal: N/A Wall: Glass (largely broken)	N	0	N	N	N	N	Limited			Derelict greenhouse completely full of brambles.	08/05/2018
14 Greenhouse 4	1	Ex-greenhouse	Pitched Poor	Roof external: Glass (largely broken) Roof internal: N/A Wall: Glass (largely broken)	N	0	N	N	N	N	Limited			Derelict greenhouse completely full of brambles.	08/05/2018
15 Greenhouse 5	1	Ex-greenhouse	Pitched Poor	Roof external: Glass (largely broken) Roof internal: N/A Wall: Glass (largely broken)	N	0	N	N	N	N	Limited			Derelict greenhouse completely full of brambles.	08/05/2018
