VISUAL STRUCTURAL SURVEY

WATER TOWER
BUILDING/OUT
HOUSE AND GARDEN
WALL

BOUGHTON MOUNT

PROJECT REF: 316289

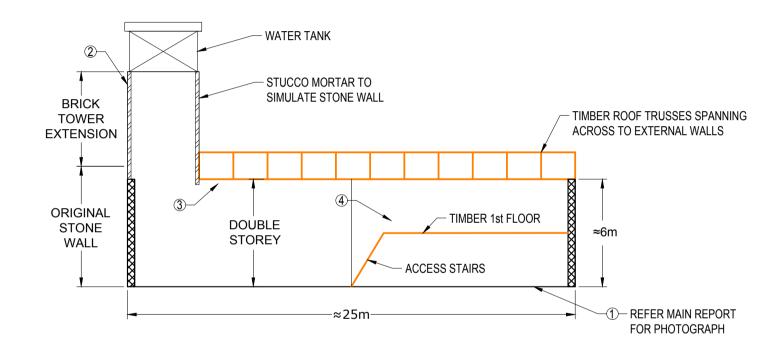
TYPICAL CROSS SECTION THROUGH WATER TOWER BUILDING

The original building consisted of a two storey stone wall structure, which supports a series of timber trusses and rafters that in turn, support a slate tilled roof. Internally, the stone wall has been finished with a lime mortar.

Historically a section of the roof was, removed and a brick tower constructed from the original eaves level to support a metal water tank. The brick tower has been finished with a stucco mortar to simulate the original stone walls below.

The original building adjacent to the Tower is double storey and the roof trusses are exposed.
