Arboricultural Report

**Assessment of tree constraints for
feasibility purposes**

Boughton Mount
Maidstone
ME17 4NB

180337-FD-02

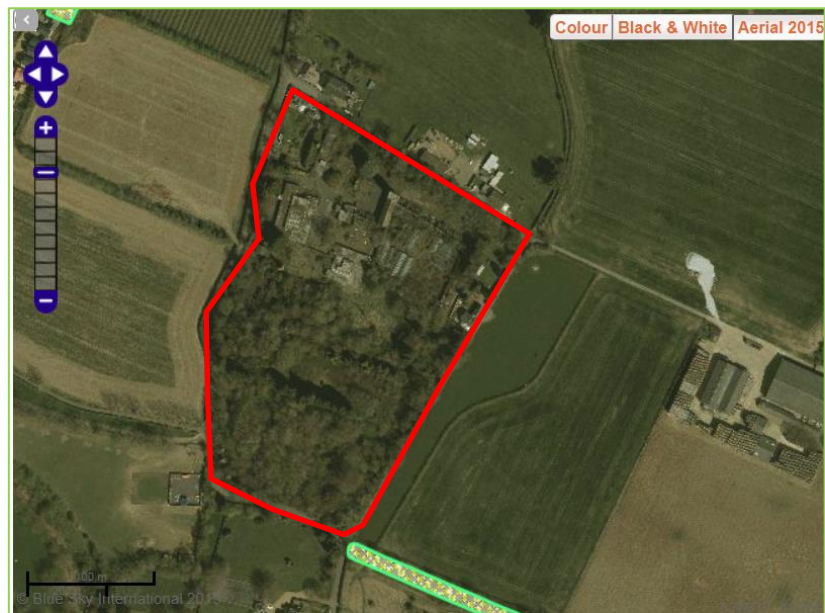
- 2.9 The Maidstone District Council online mapping indicates that the site is not within a conservation area and there are currently no tree preservation orders, but does indicate TPO's within an adjacent site. I was informed by a member of the forest school that the tree officer had recently emplaced an area TPO for the entire site and therefore further enquiry will be required at the client's discretion.

Image 1: screenshot from the council website showing no TPO's on the site.

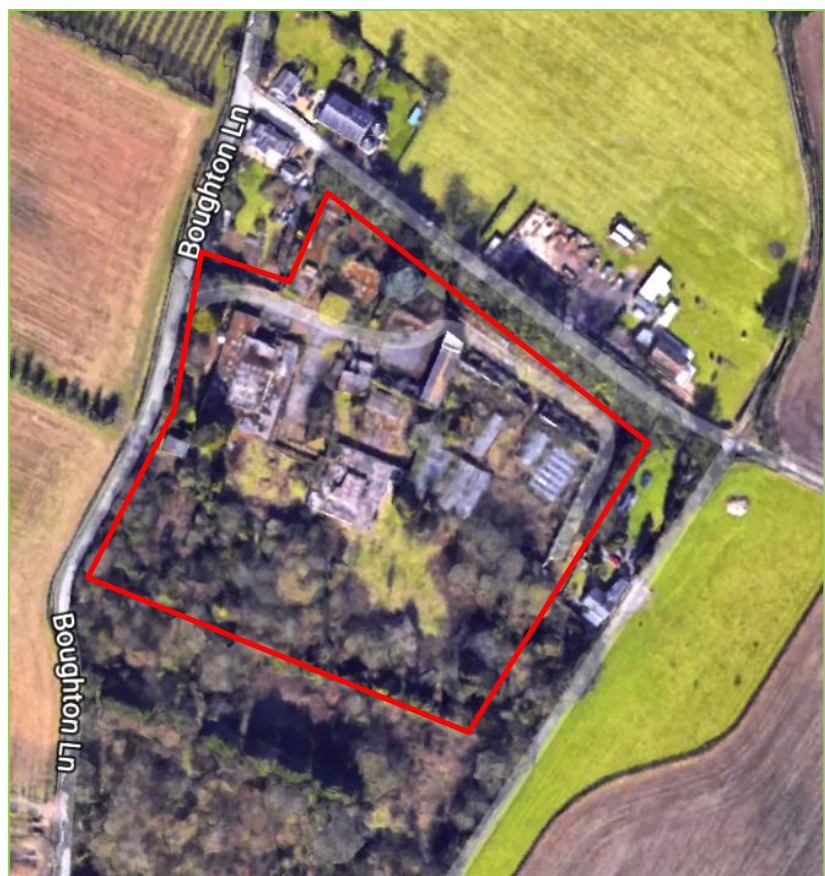
Image 2: area under consideration for potential development
