# **Hutton + Rostron Environmental Investigations Limited**

## **The Pest House: Penetrating damp and retained moisture investigation**

**Site note 1 for 27 November 2018, job no. 148.73**

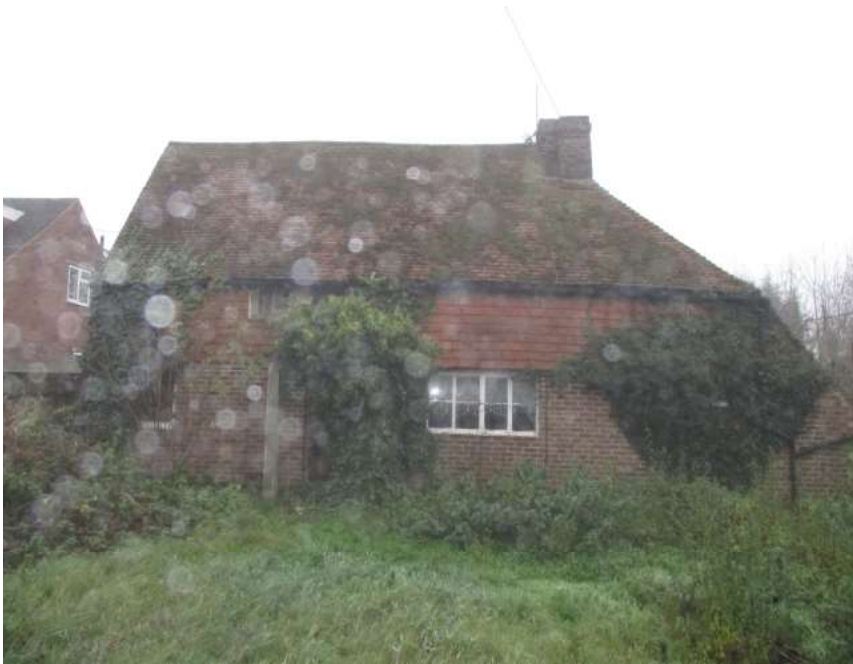
**Fig 1 :**

Exterior, north elevation; showing a general view of the elevation

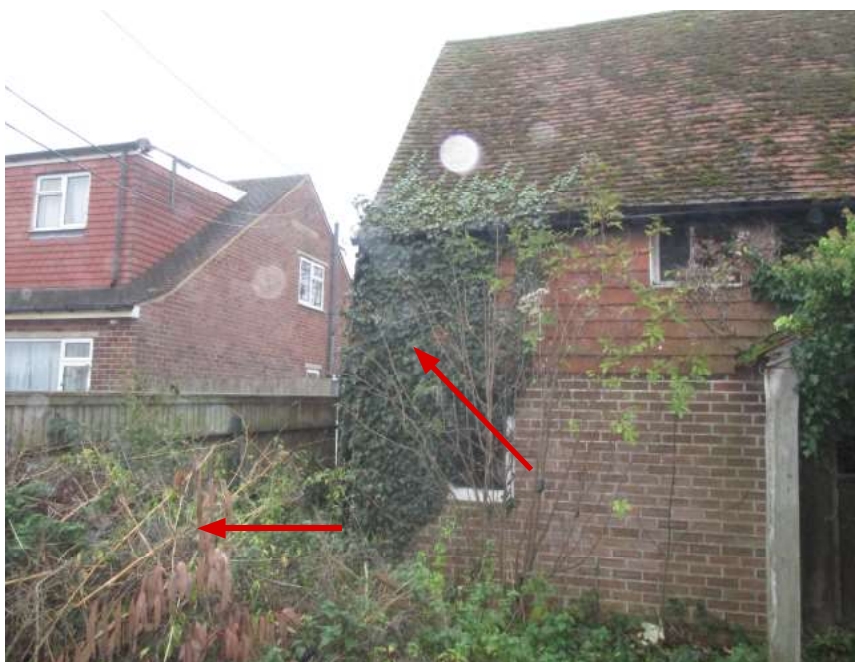
**Fig 4 :**

Exterior, north elevation; showing a view of extensive plant growth emanating from defective roof drainage systems above. The guttering appeared to be deformed and the downpipe appeared to be undersized for purpose, and was vulnerable to blockage due to blockage due to plant growth and moss growth above

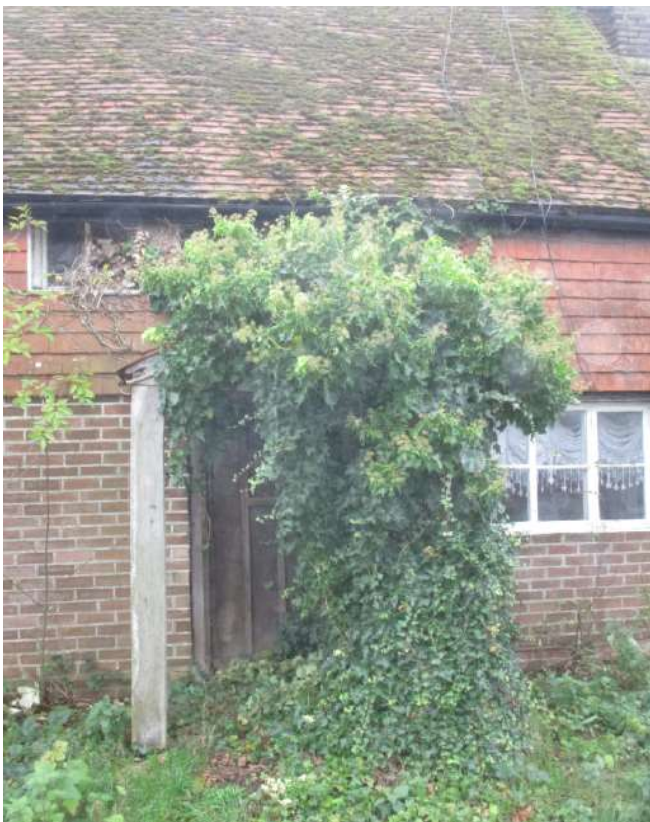
**Fig 6 :**

Exterior, north elevation; showing a view of plant growth around the entrance porch. This was caused by defective roof drainage systems above encouraging water to drain onto the unmade ground beneath

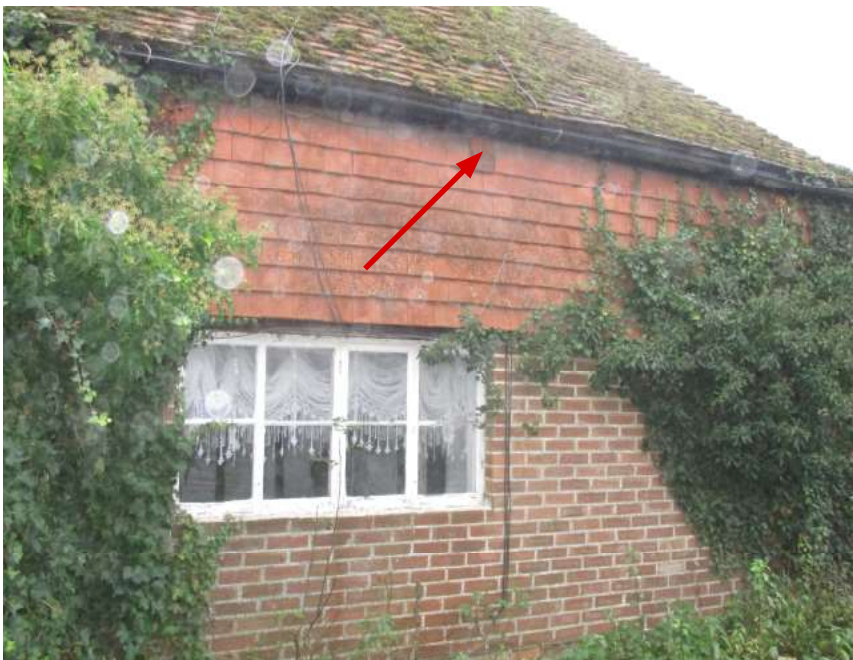
**Fig 8 :**

Exterior, north elevation; showing a view of the wall construction to the north elevation. The ground floor level appeared to be of modern brickwork with the first-floor level being covered in clay tiles. A number of these tiles were loose which may be allowing wind driven rain into the structure

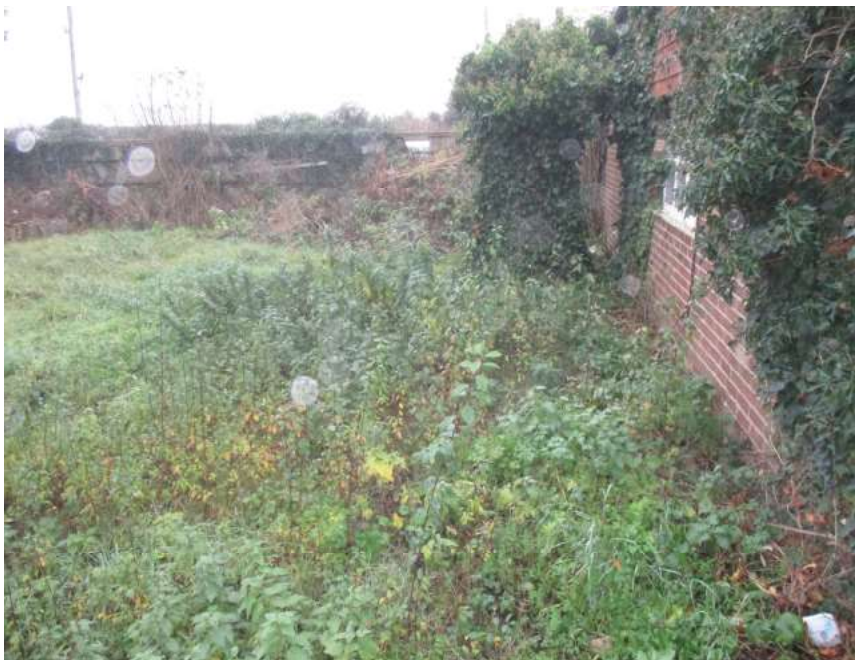
**Fig 14 :**

Exterior, north elevation; showing a general view along the front of the north elevation showing heavy plant growth indicating chronically damp conditions

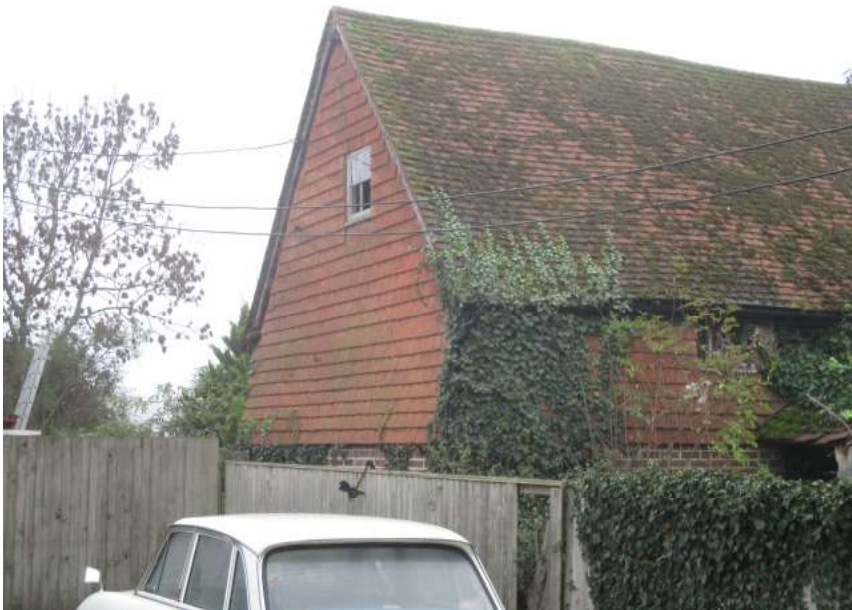
**Fig 15 :**

Exterior, east elevation; showing a general view of the elevation

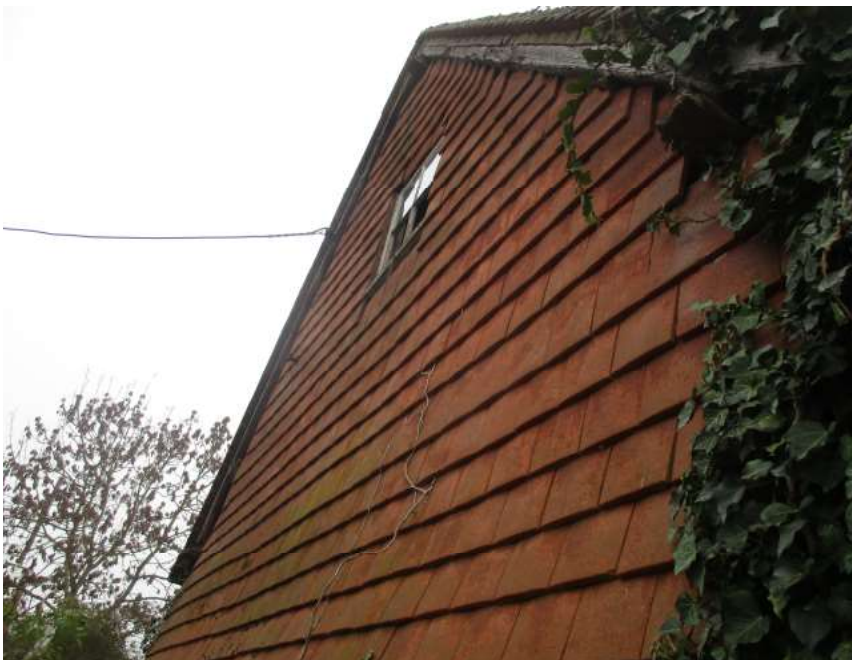
**Fig 16 :**

Exterior, east elevation; showing a view of vertical tiles to the first-floor level. These appeared to be in fair condition. However, detailing around the edges of the gable had not been weatherproofed, which may be allowing wind driven rain into the structure

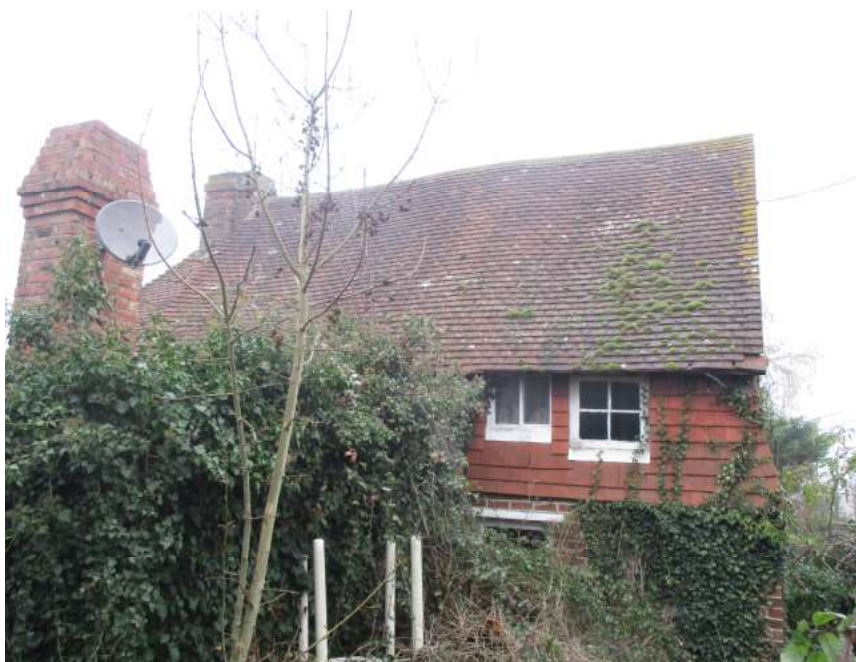
**Fig 20 :**

Exterior, south elevation; showing a general view of the east end of the elevation

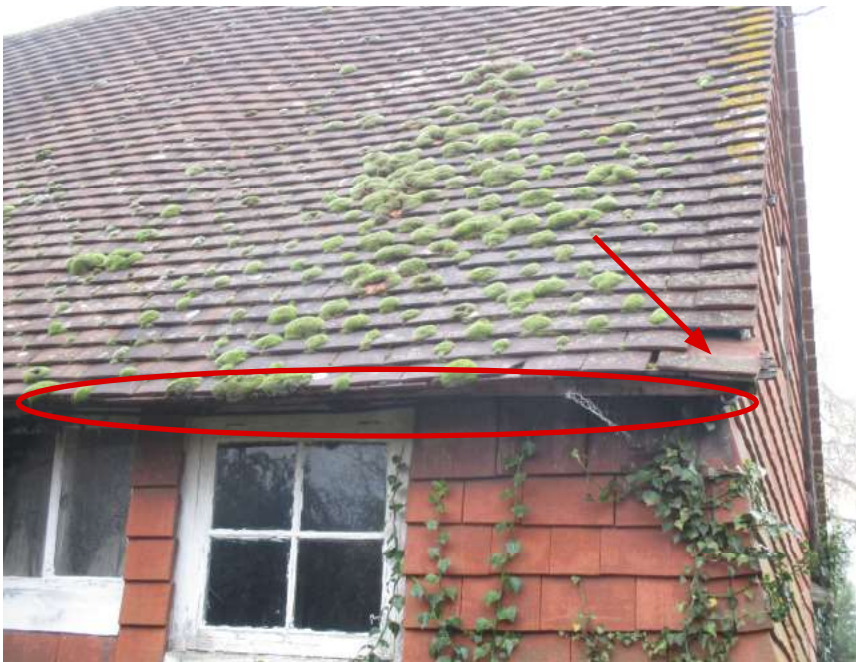
**Fig 22 :**

Exterior, south elevation; showing a view of defective roof tiles at the bottom east corner of the pitch. This would be providing a path for wind driven rain into the structure. Note also that there were no roof drainage systems in this area meaning any rainwater from the roof was being directed onto the ground beneath

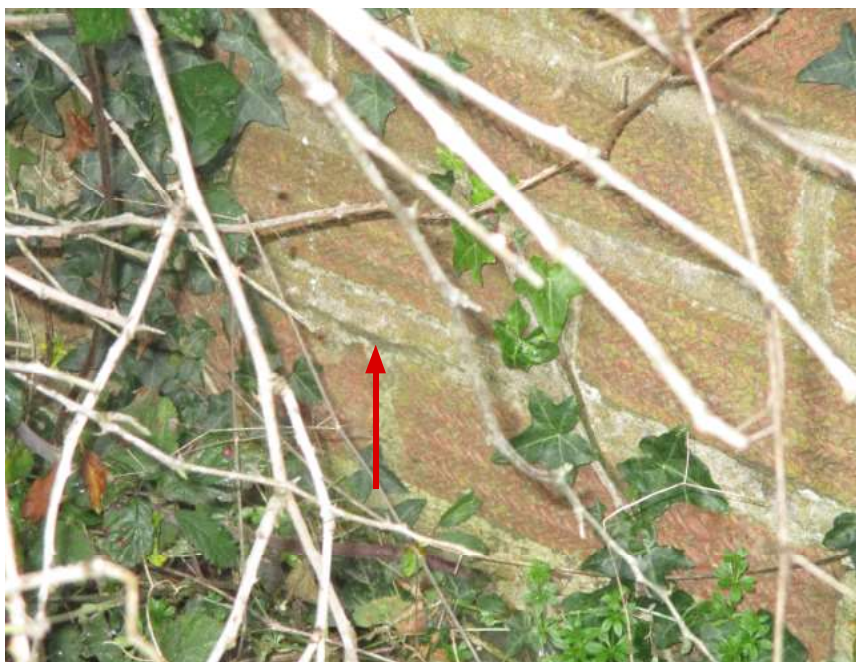
**Fig 24 :**

Exterior, south elevation; showing a view of the dpc which had extended around to the south elevation. This was approximately 1 no. brick course above the level of the ground, although ground levels appeared to be rising and they may be bridged in places

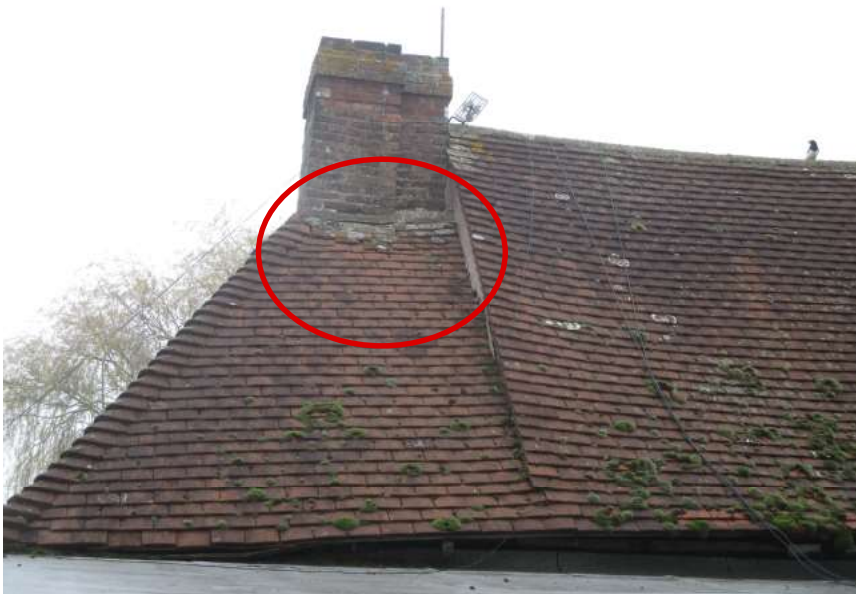
**Fig 26 :**

Exterior, south elevation; showing a view of the join between the original structure and more modern extension to the west. The join to the roofs was in poor condition with open joints to the mortar, likely to be allowing damp penetration into the structure

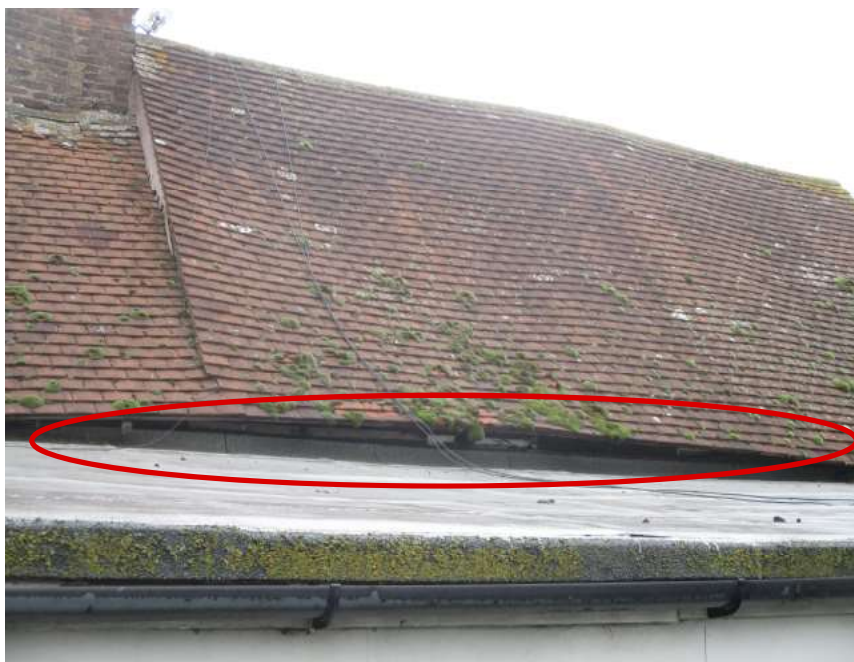
**Fig 28 :**

Exterior, south elevation; showing a view along the eaves of the main structure. There was no guttering system to this roof which drained water directly onto the flat roof structure of the ground floor extension

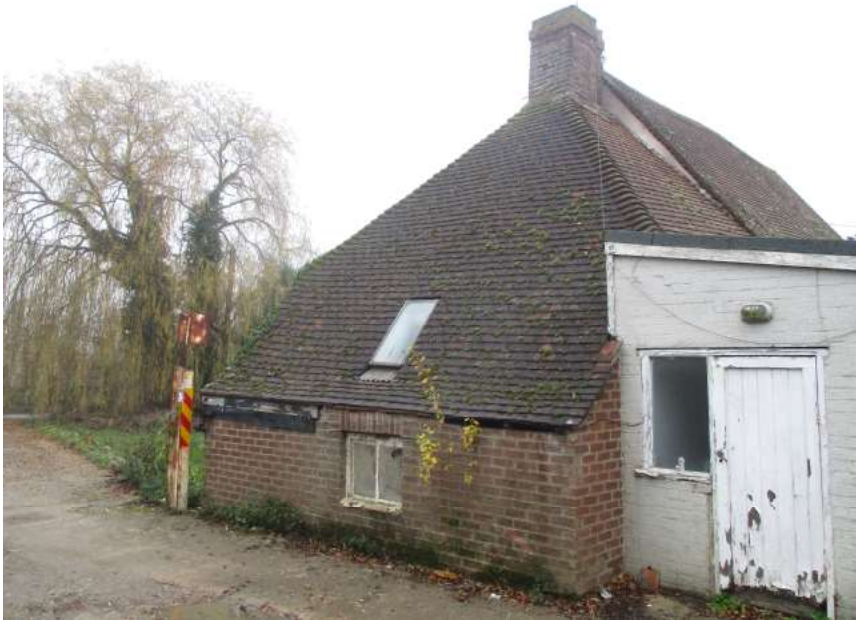
**Fig 29 :**

Exterior, west elevation; showing a general view of the west elevation to the main structure

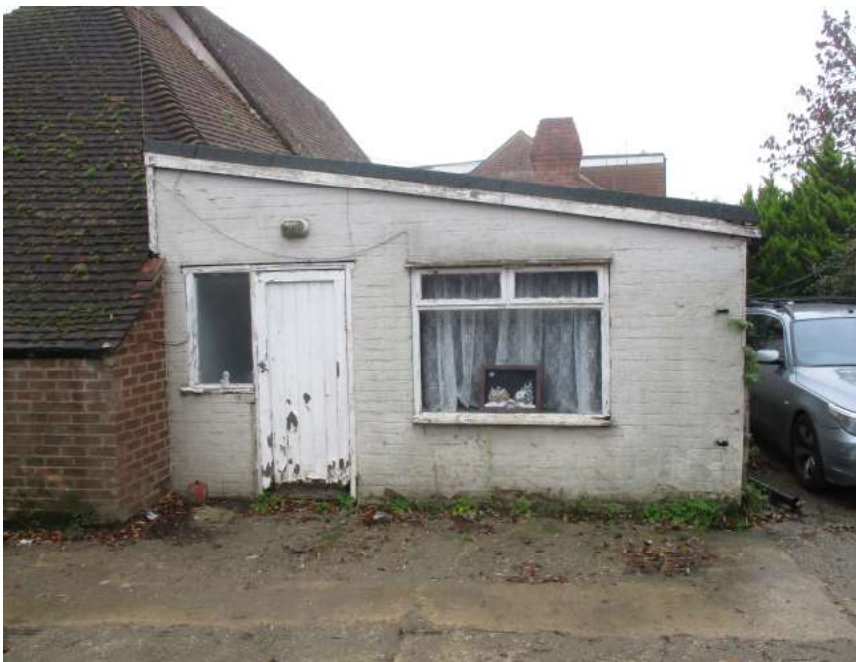
**Fig 30 :**

Exterior, west elevation; showing a general view of the west elevation to the ground floor extension

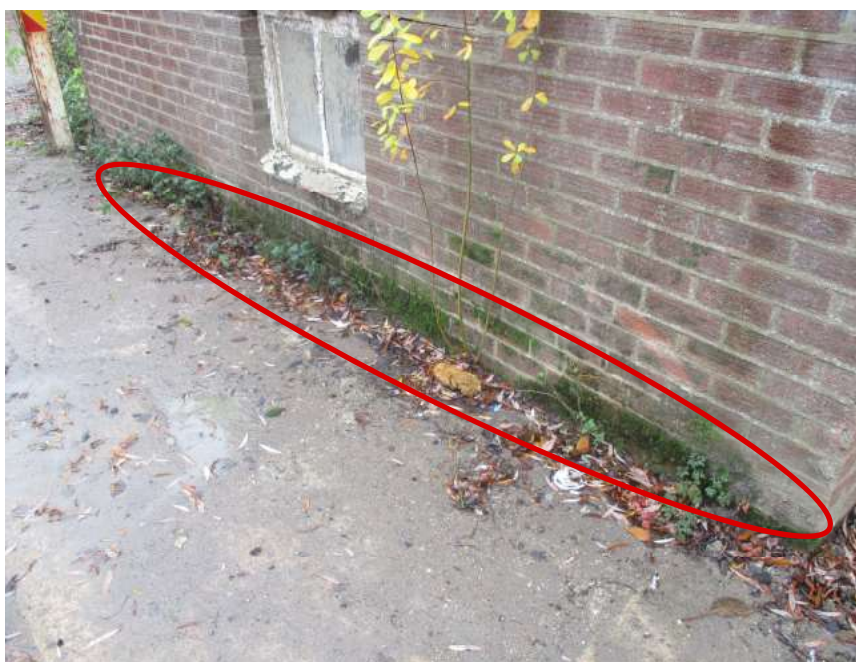
**Fig 32 :**

Exterior, west elevation; showing a view of plant and algae growth along the base of the wall indicating chronically damp conditions. This was unsurprising due to the lack of roof drainage systems above

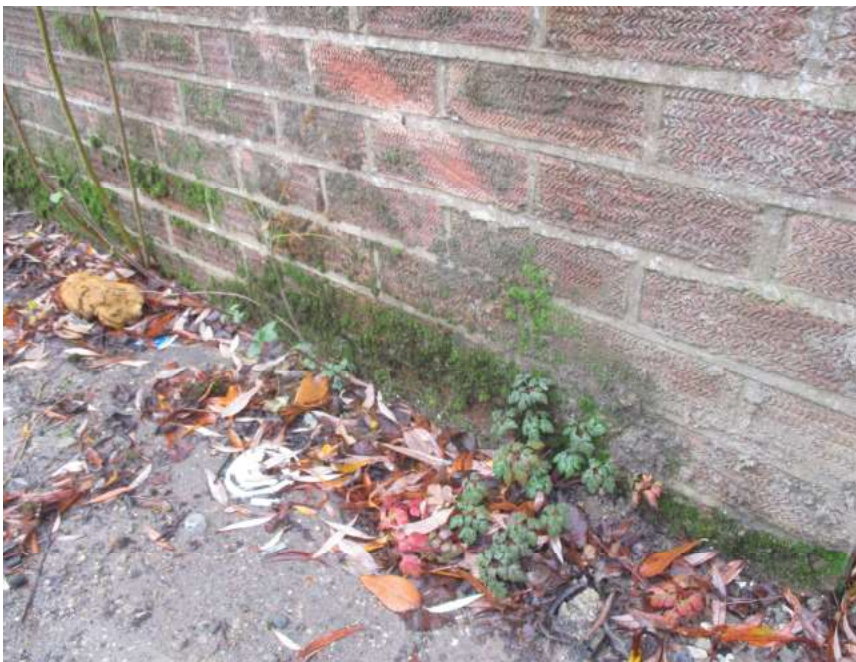
**Fig 34 :**

Exterior, west elevation; showing a close-up view of the base of the wall. The dpc seen to the other 3 no. elevations was not visible to this elevation. However, there may be one installed but had been covered by ground levels at the exterior

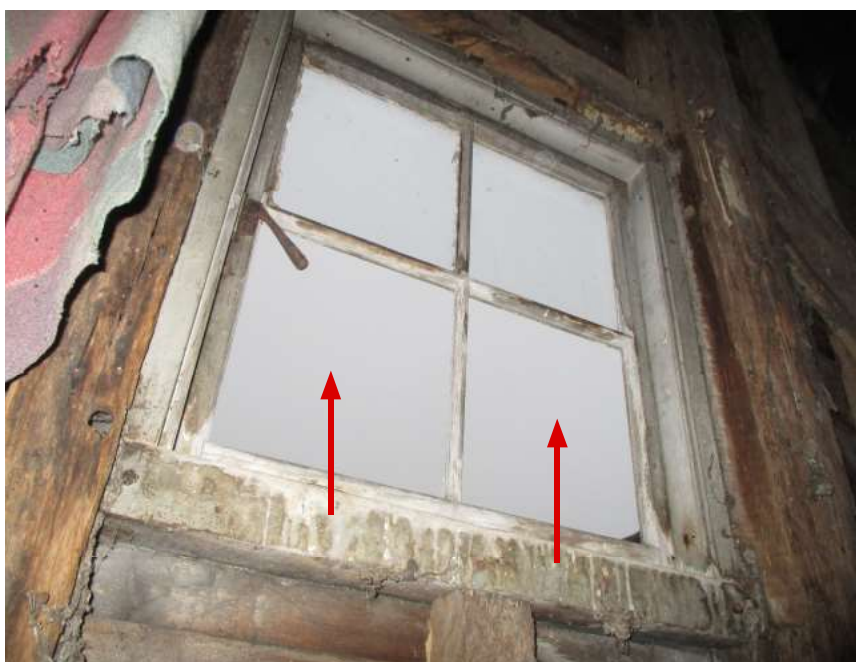
**Fig 36 :**

Interior, roof; showing a view of a window service the roof structure. Glazing was broken in this area which would be allowing wind driven rain into the structure; although it would also be allowing ventilation which would encourage drying of any damp structures and reduce the risk of condensation during periods of inoccupancy

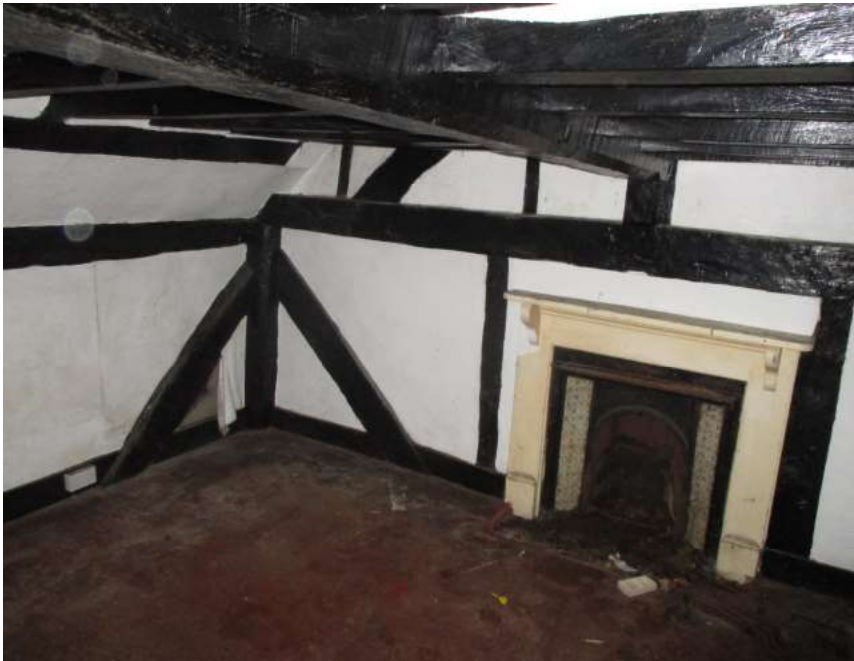
**Fig 37 :**

Interior, first floor; showing a general view of the master bedroom. The walls were constructed from a timber frame with infill panels. The panels were not in contact with solid material and could therefore not be sampled for masonry sample analysis

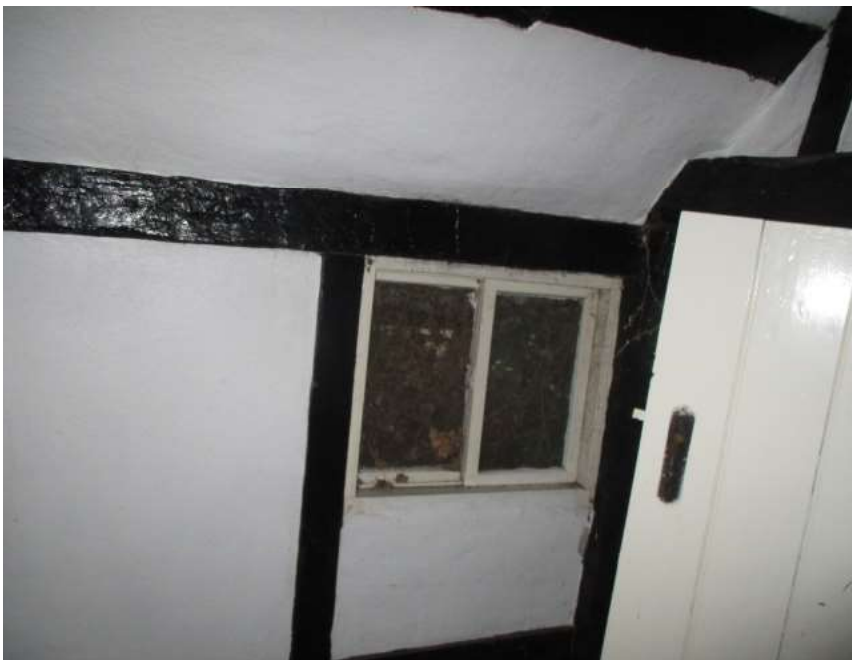
**Fig 40 :**

Interior, first floor; showing a view of the single window serving the bedroom. The view from the window was generally obscured by plant growth. This suggested damp conditions at the base of the walls encouraging plant growth to flourish

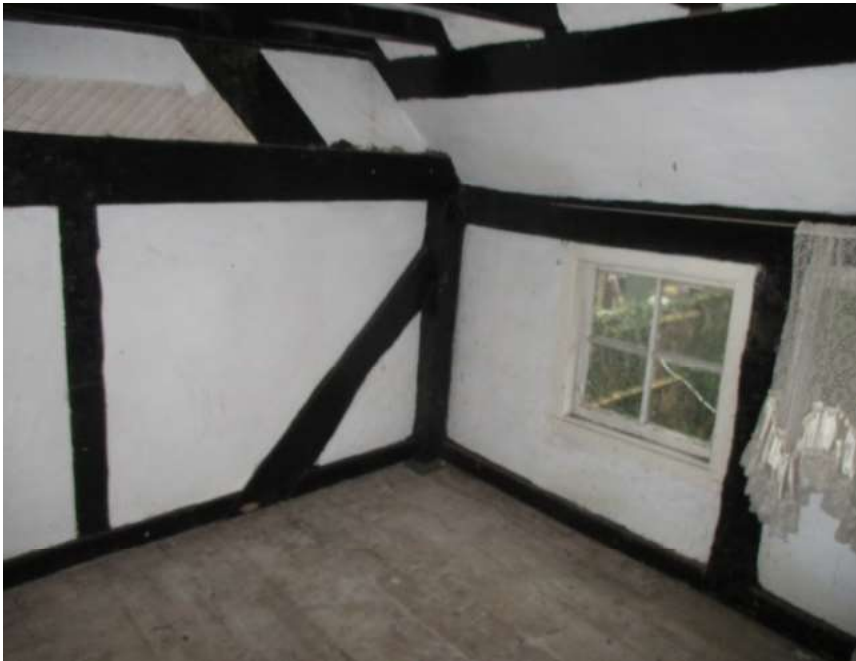
**Fig 41 :**

Interior, first floor; showing a general view of bedroom no. 3. This was generally free from signs of damp penetration and was constructed in a similar way described previously

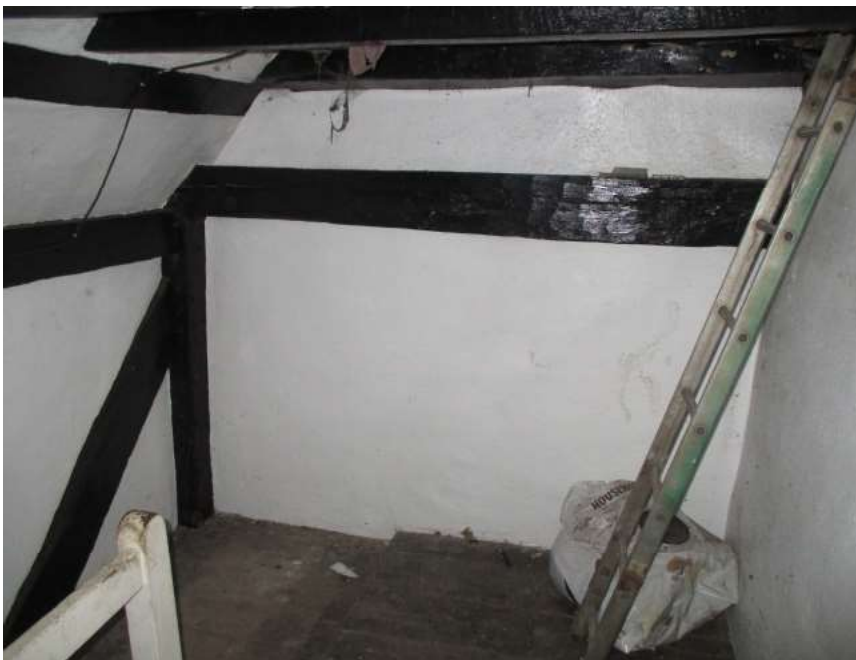
**Fig 42 :**

Interior, first floor; showing a general view of the landing area. This was free from signs of significant damp penetration. However, the window with broken glazing described previously was above this area which may have been allowing water ingress in the past, as well as ongoing

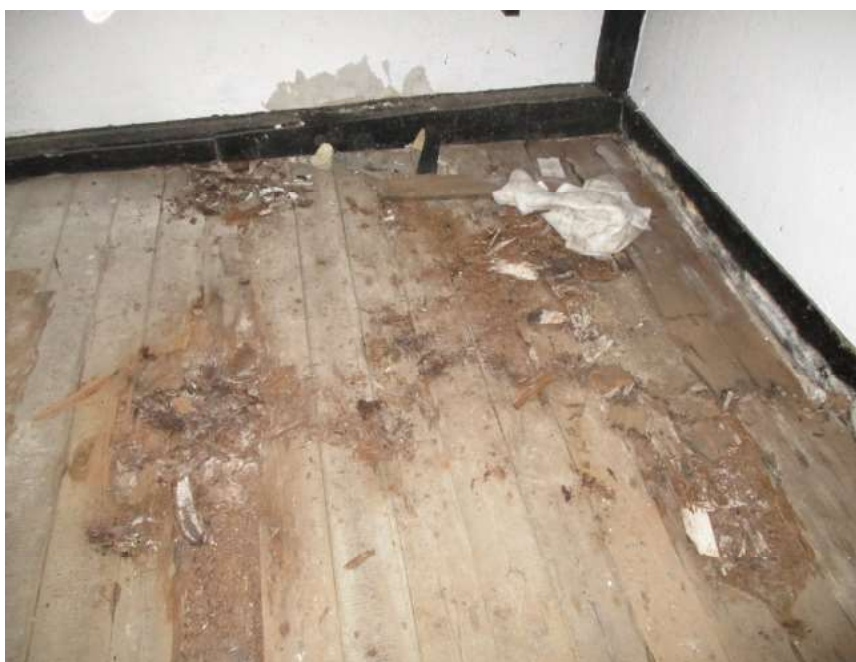
**Fig 44 :**

Interior, ground floor; showing a view of timber decay to the floor structure described previously

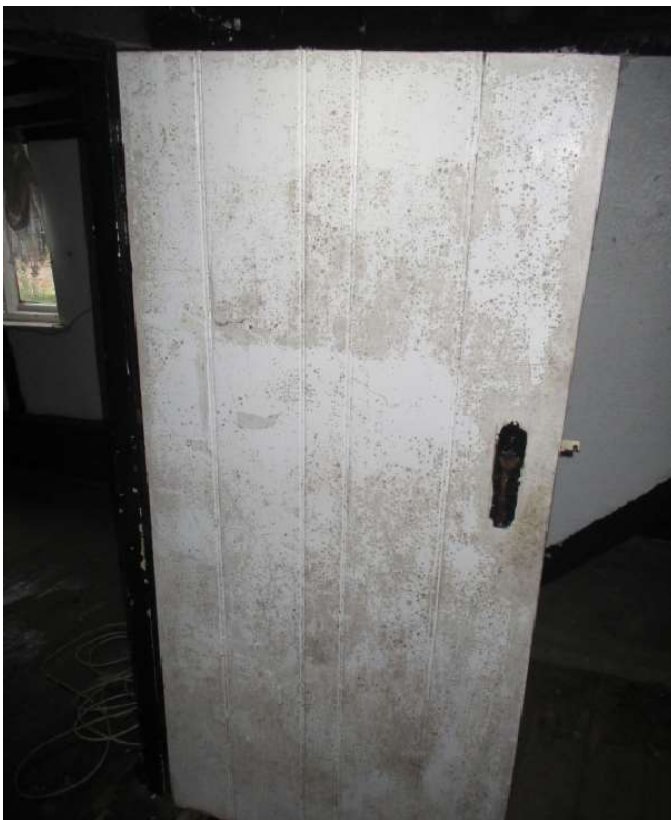
**Fig 46 :**

Interior, ground floor; showing a view of mould growth to the door of bedroom no 2

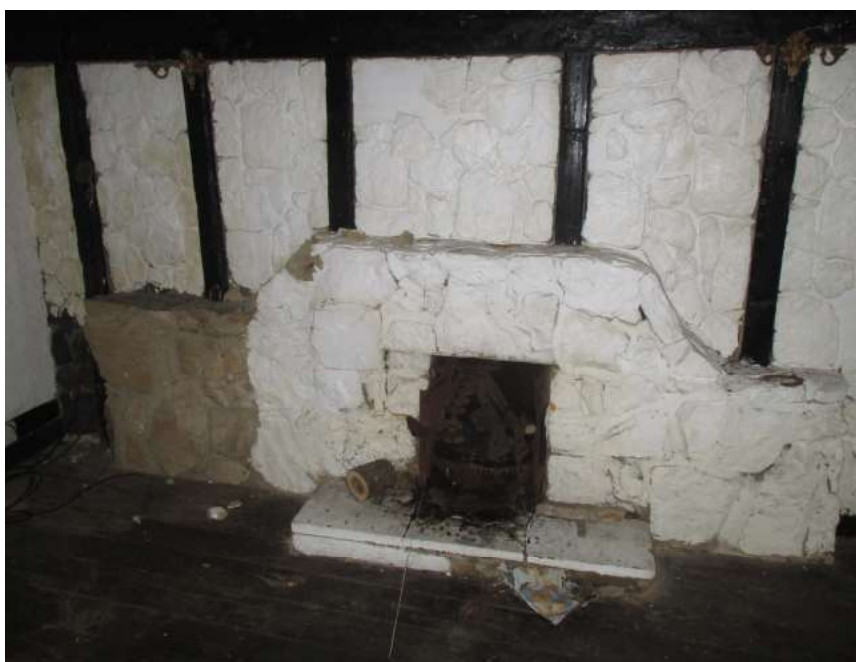
**Fig 48 :**

Interior, ground floor; showing a view of a fireplace serving the lounge. As with the fireplace described on the first floor, debris had fallen from within the flue indicating blockages above

All chimneys not in use should be capped so as to minimise water ingress but so as to allow maximum ventilation of the flues. Flues should be cleared and cleaned to remove blockages. Fireplaces and chimney breasts should be opened or vented to allow through-ventilation of the flues. This prevents moisture build-up in the flues and helps interior ventilation by the stack effect

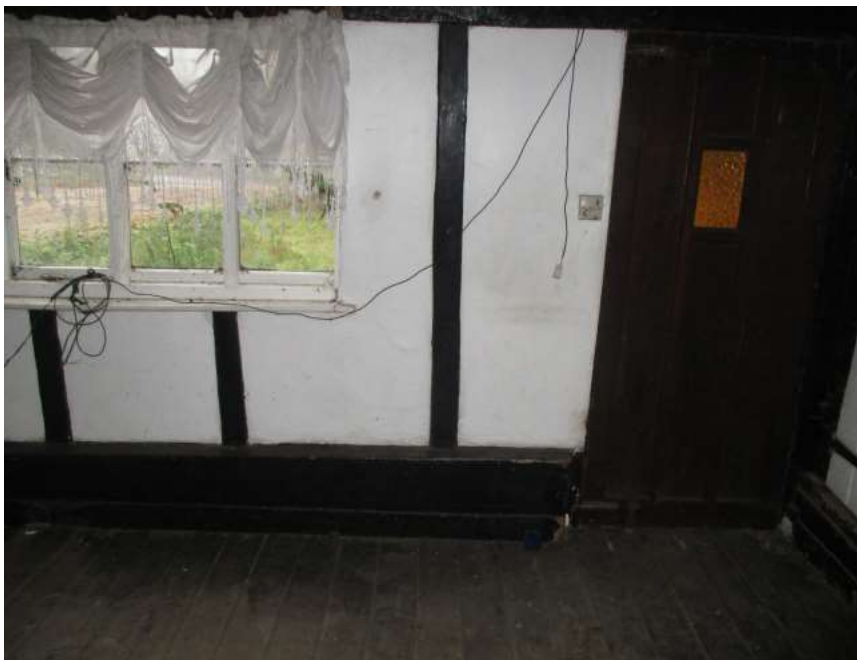
**Fig 49 :**

Interior, ground floor; showing a general view of the north end of the lounge. Generally, there was no signs of significant damp penetration around the edges of the door

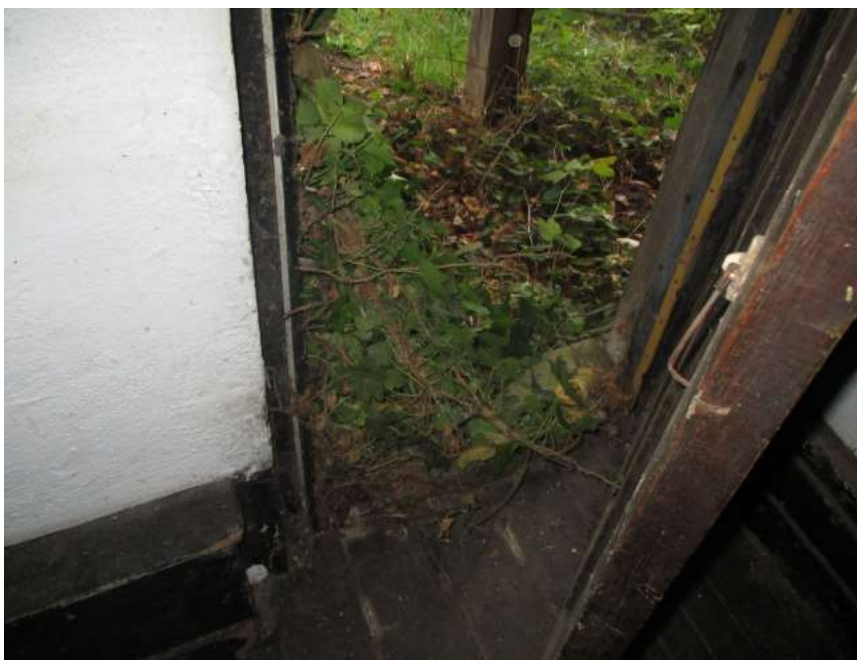
**Fig 50 :**

Interior, ground floor; showing a view over the threshold of the front door. The external ground levels were close to that of the internal floor, leaving any timbers to the ground floor vulnerable to damp penetration and possible decay

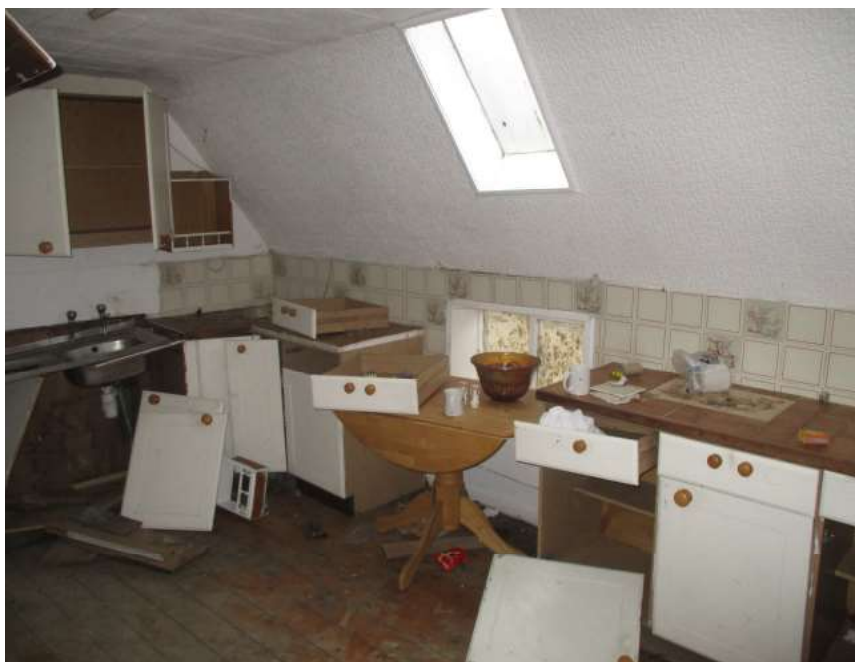
**Fig 51 :**

Interior, ground floor; showing a general view of the kitchen area. The walls were dry lined which prevented the extraction of masonry samples. However, generally the room appeared to be free from evidence of significant damp penetration at the time of the survey

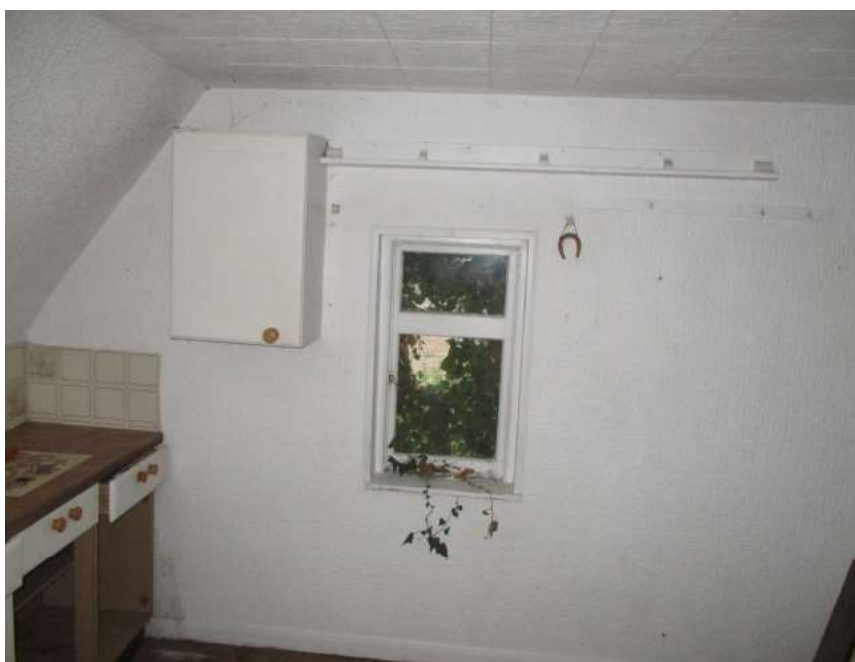
**Fig 52 :**

Interior, ground floor; showing a view of the north wall to the kitchen. There was significant plant growth at the exterior of the property which can be seen growing through the window opening. This indicated moisture reservoirs at the exterior, which may be affecting the timber floor to the kitchen

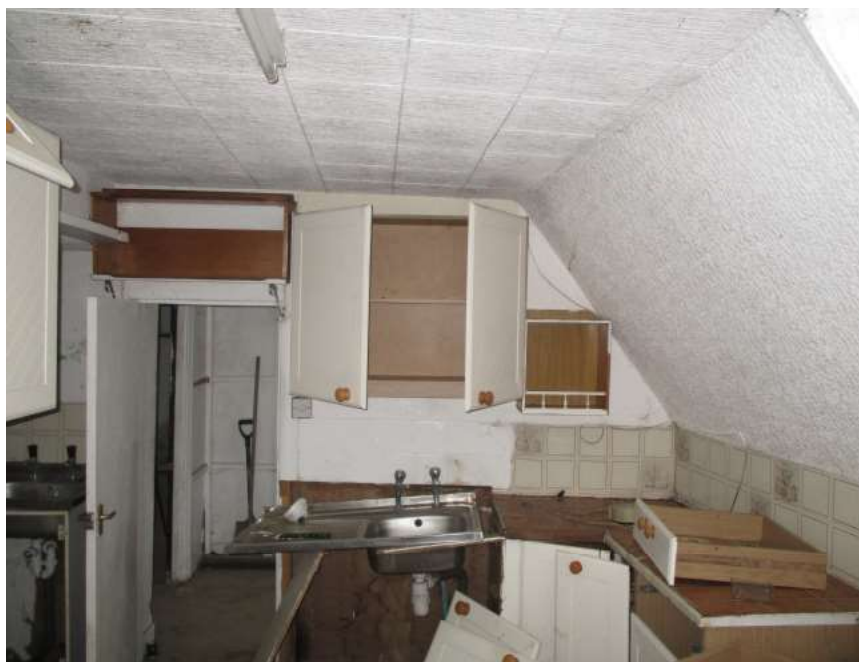
**Fig 53 :**

Interior, ground floor; showing a view of the south wall to the kitchen. Generally, this area was free from any signs of significant damp penetration

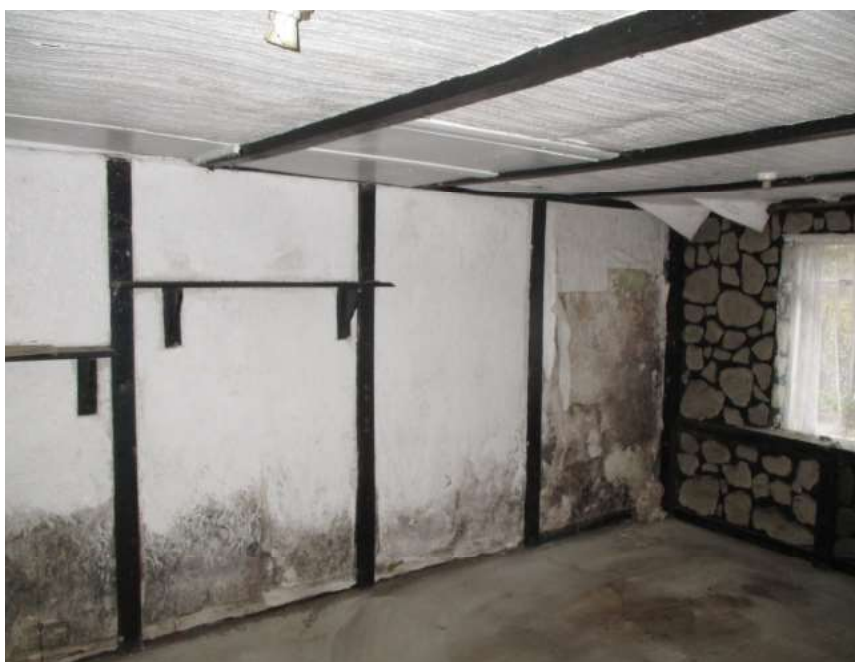
**Fig 56 :**

Interior, ground floor; showing a view of significant damp penetration and mould growth to the base of the wall within the area to be demolished

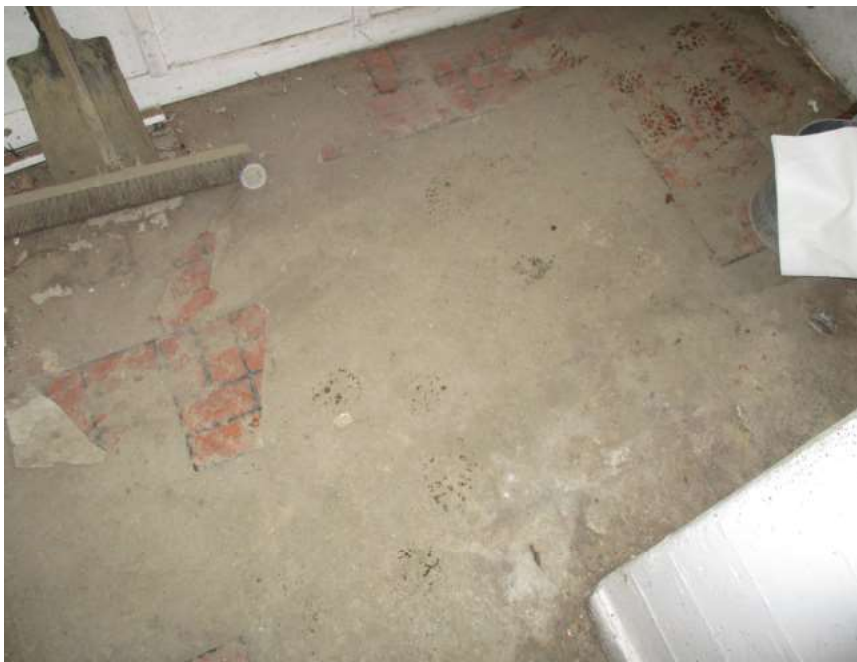
**Fig 57 :**

Interior, ground floor; showing a view of the solid floor structure to the structure due for demolition

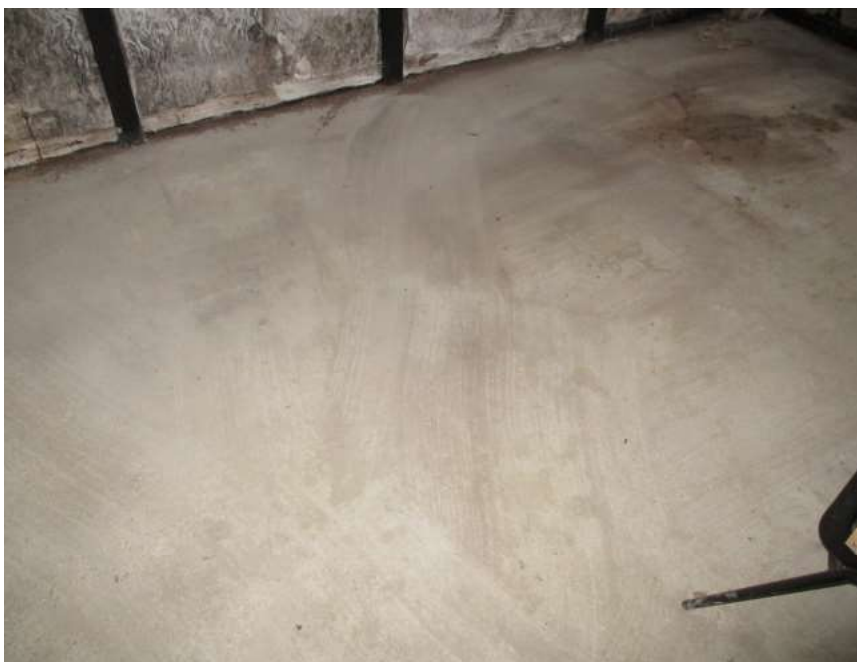
**Fig 58 :**

Interior, ground floor; showing a view of the solid floor structure to the structure due for demolition

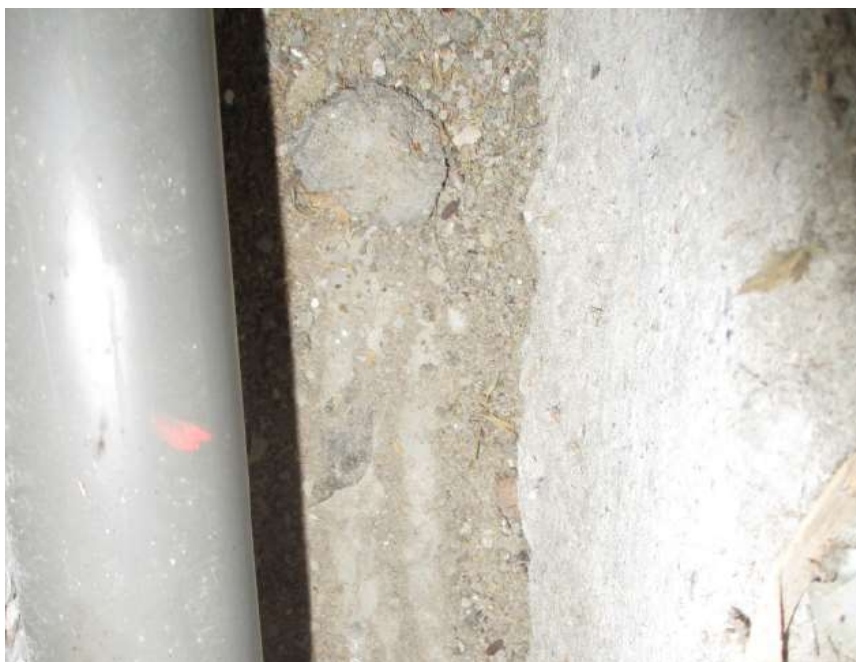
**Fig 59 :**

Interior, ground floor; showing a close-up view of the solid floor structure to the structure due for demolition

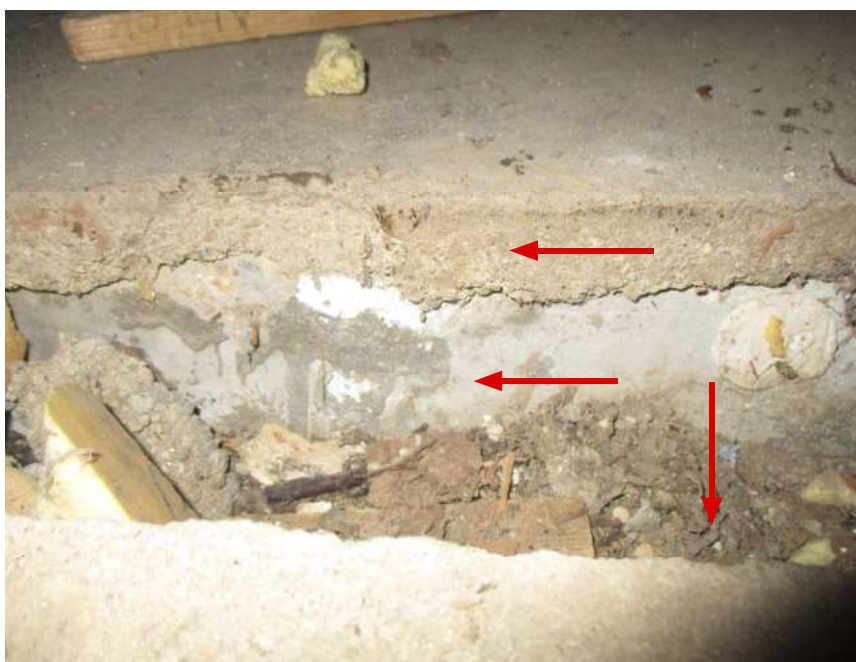
**Fig 60 :**

Interior, ground floor; showing a close-up view of the solid floor structure to the structure due for demolition. The floor make-up appeared to be of at least three layers of concrete. However, access was limited so detailed inspection was not possible
