The Pest House
Photographs
27 November 2018
Not to scale

The Pest House, Roof Truss and Ceiling Joist Plans
TIMBER CONDITION INVESTIGATION
27 November 2018

Hutton + Rostron Environmental Investigations Ltd
Netley House, Gomshall, Surrey, GU5 9QA Tel: 01483 203221 Fax: 01483 202911
148-73 Site Note 3 -Not to scale- © Copyright Hutton+Rostron 2018

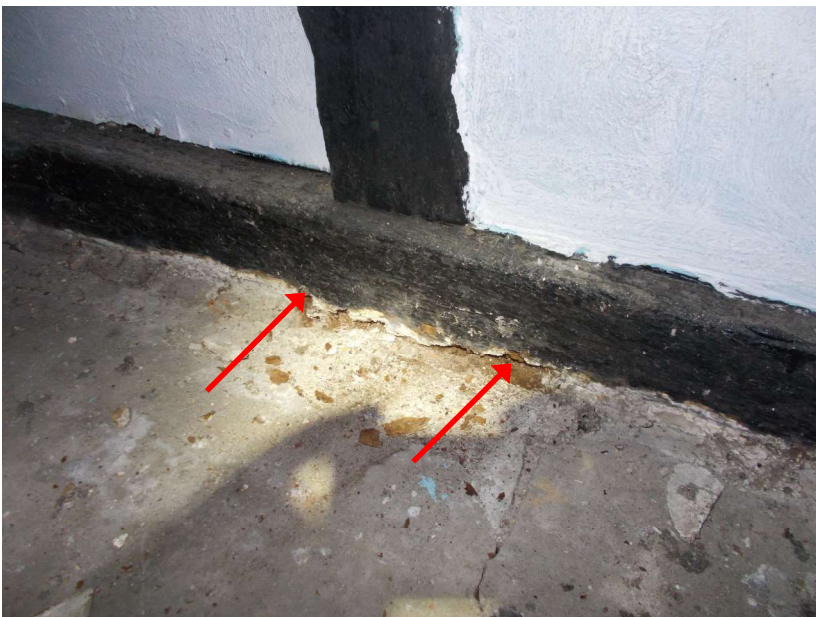
Fig 29:

Bedroom 2; showing the north-east corner and the decay to the timber sole plate where in contact with the concrete slab

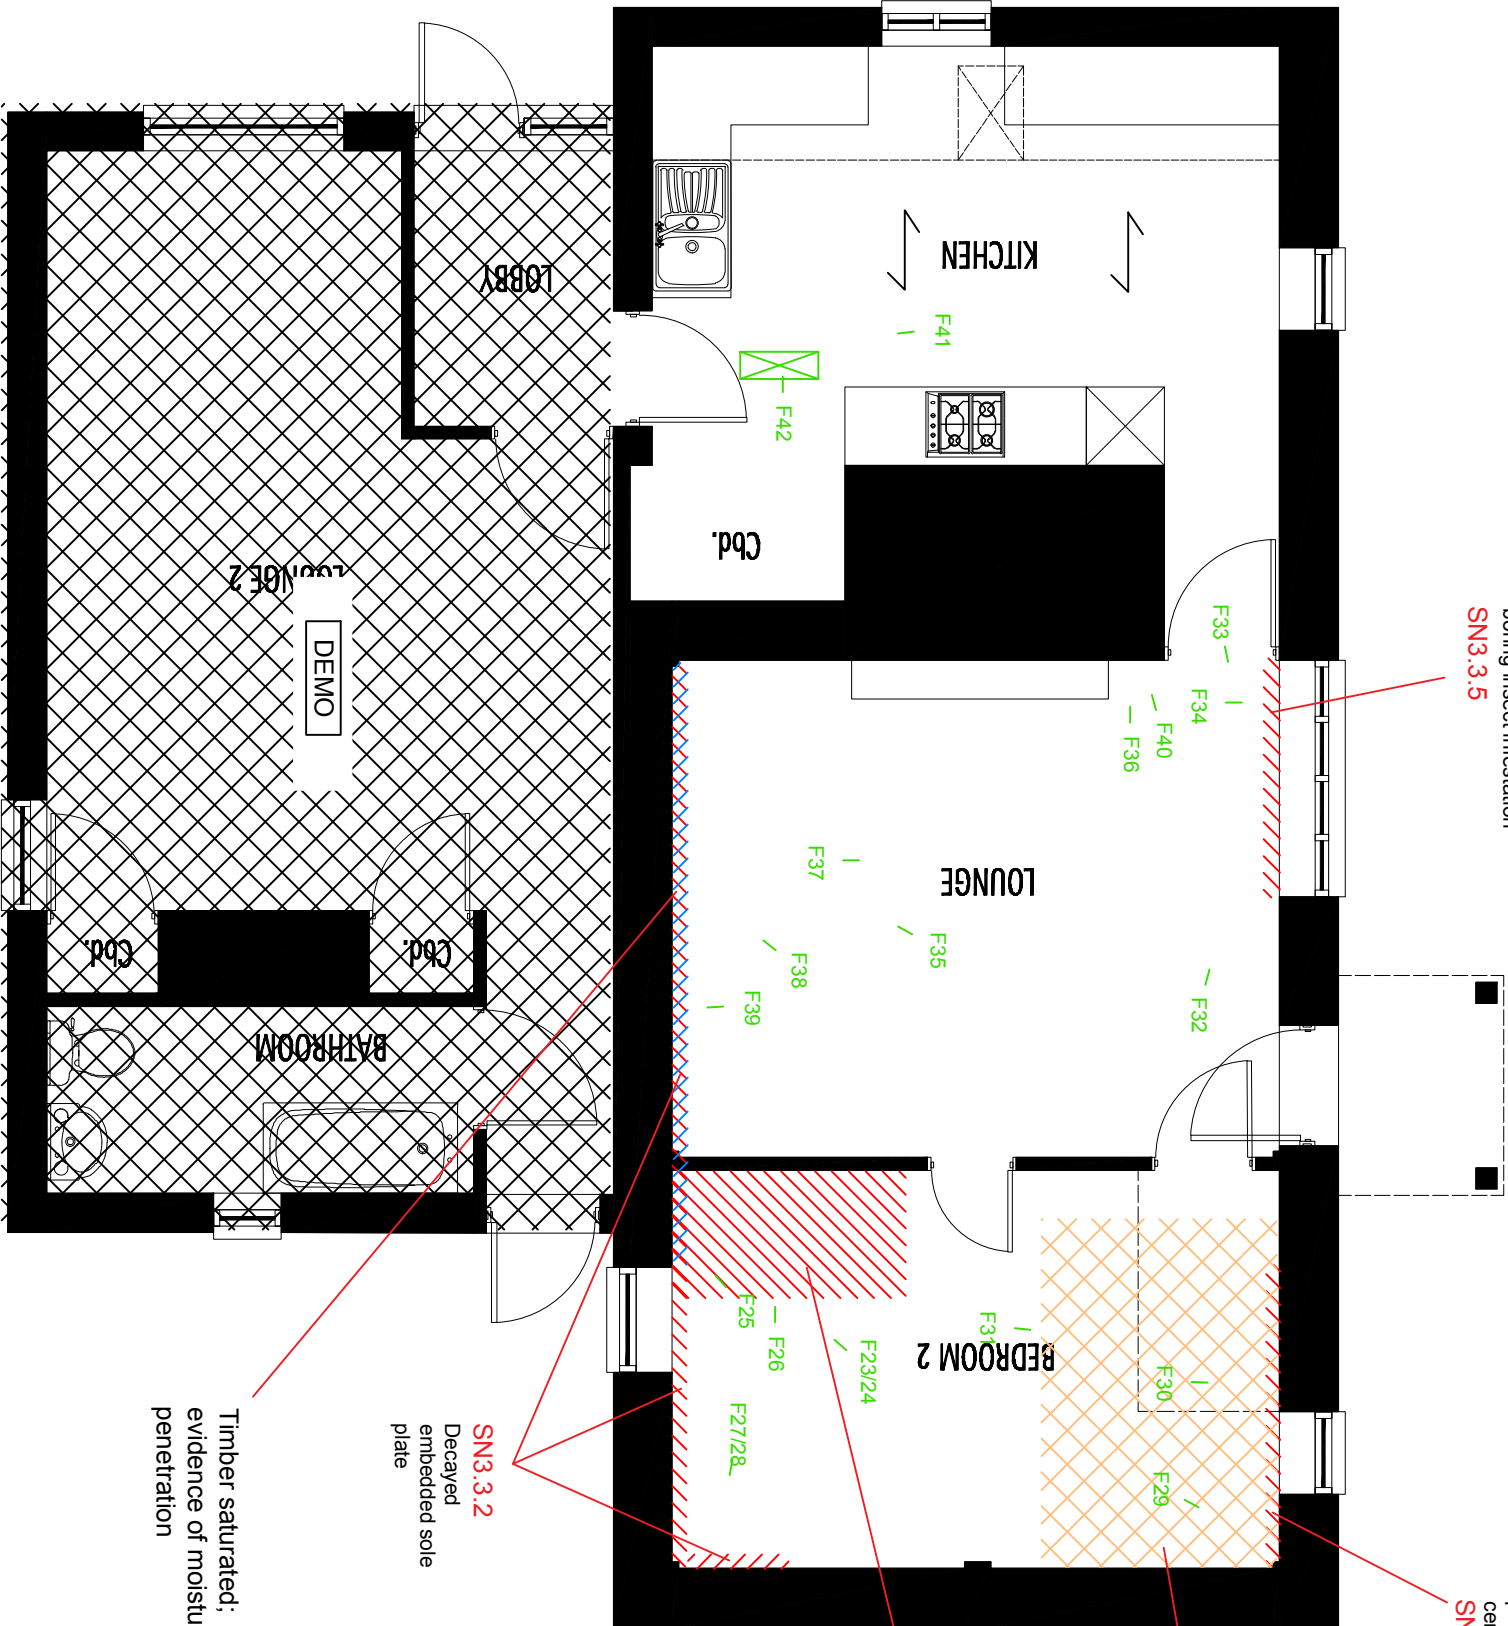
The Pest House, Ground Floor
TIMBER CONDITION INVESTIGATION
27 November 2018

Decayed sole plate with evidence of inactive wood boring insect infestation
SN3.3.5

Decayed embedded sole plate in cementitious slab
SN3.3.4

SN3.3.3
Decayed floor structure

SN3.3.2
Decayed embedded sole plate

Timber saturated: evidence of moisture penetration
