The Pest House: Timber lintel investigation

Site note 2 for 27 November 2018, job no. 148.73

148.73 THE PEST HOUSE – SITE NOTE 2

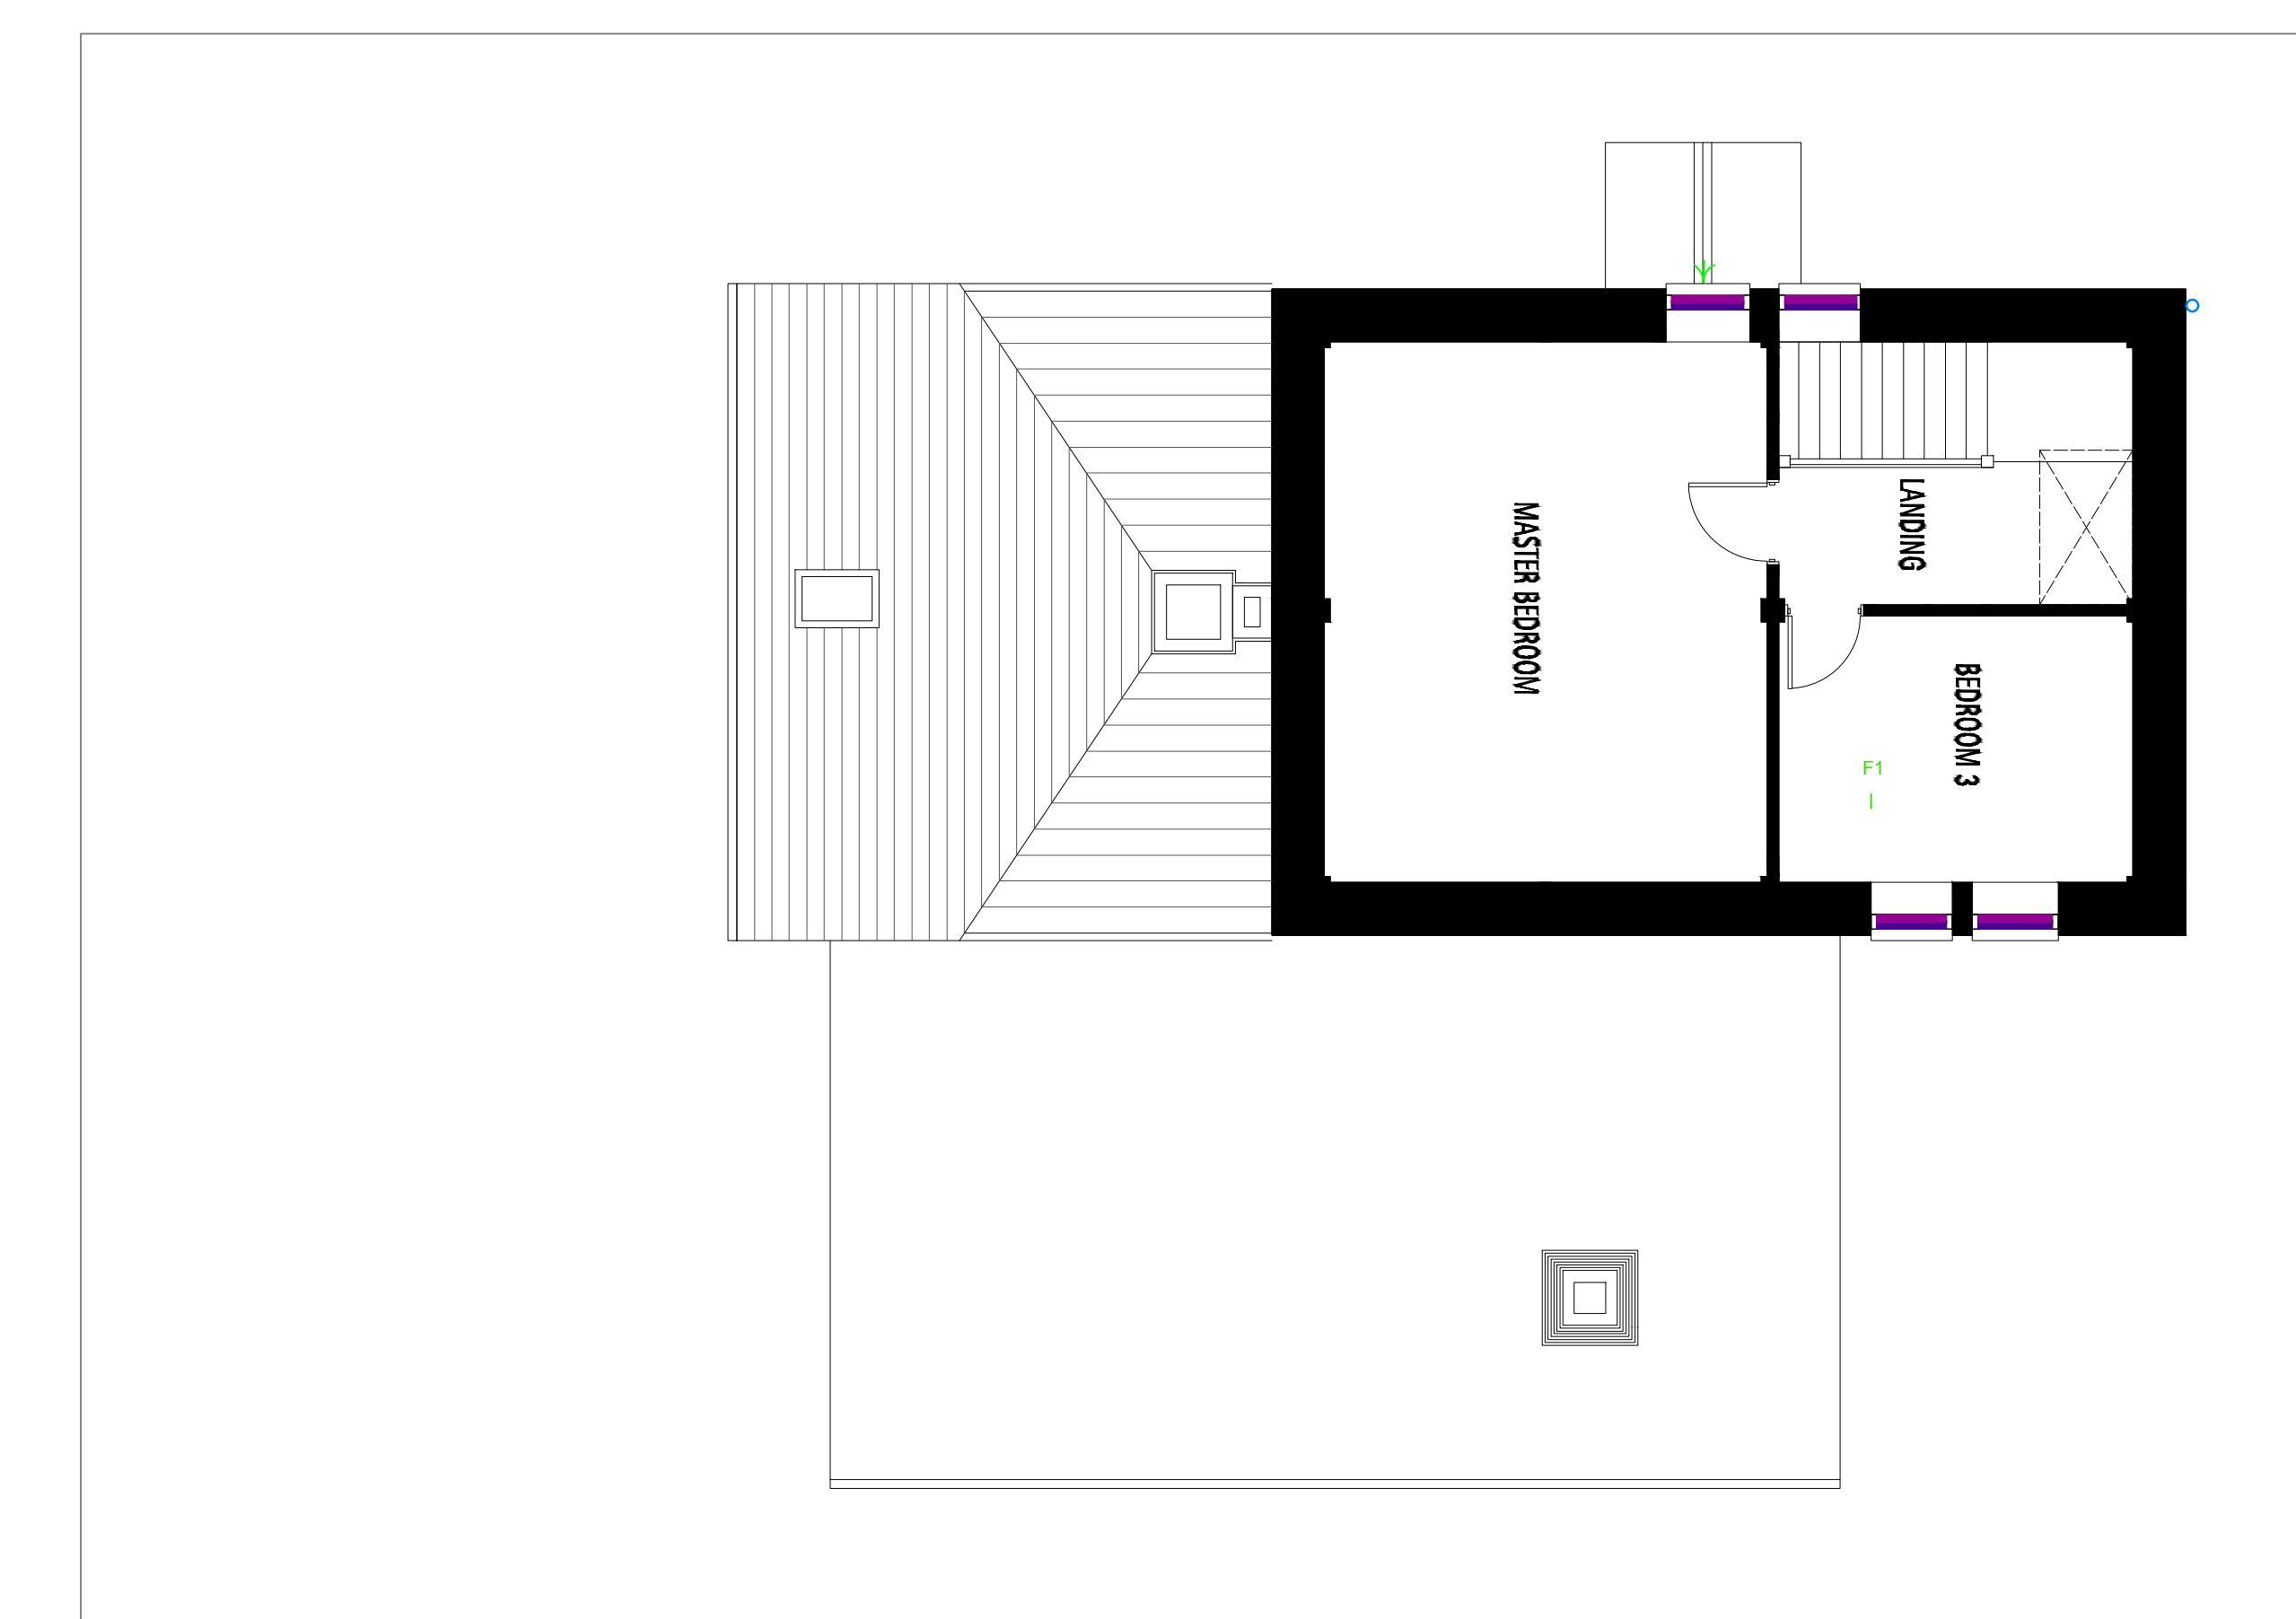
The Pest House, First Floor Timber lintel investigation 27 November 2018

All three "independent" lintels were found to be decayed or partially decayed as shown in the Schedule at Attachment A and on the plans at Attachment B. For further details on condition and recommendations please see Schedule at Attachment A
