East Sussex County Council

Sandbanks 1 Cacklebury Close, Hailsham,
East Sussex, BN27 3LF

WYG Asbestos Management Survey Report

15 Apr 2020

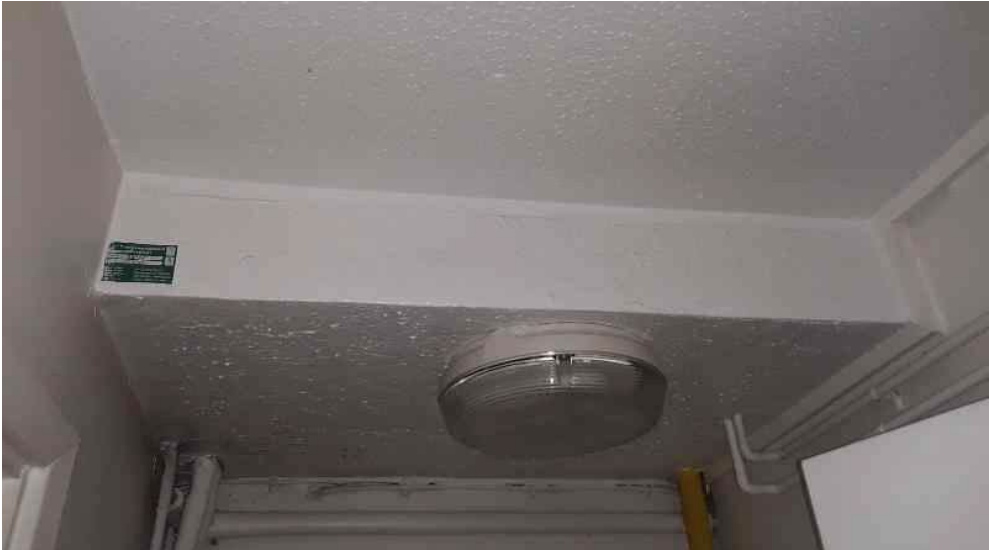
Inspection Number	2	Reference Number:	As Sample EC002540
Inspection / Sample	Visually similar to	Inspection Cross Reference / Visual I.D.	As Sample

Building	Main Building
Floor Level	Ground Floor
Area / Room	0.05 W.C Lobby
Feature	Textured coating to plasterboard ceiling
Product Type	Textured Coating
Extent Amount	2 m ²

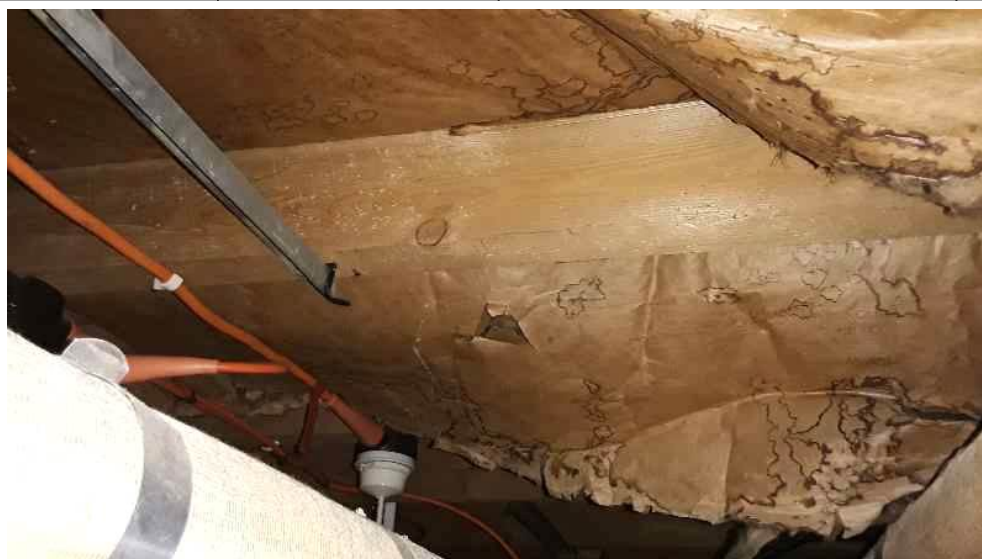
Inspection Number	4	Reference Number:	EC002529
Inspection / Sample	Sample taken	Inspection Cross Reference / Visual I.D.	N.A.D.I.S

Building	Main Building
Floor Level	Ground Floor
Area / Room	O.C02 Circulation
Feature	Bitumen backed paper lining to MMMF loft insulation within ceiling void
Product Type	Well Bound Material
Extent Amount	15 m ²

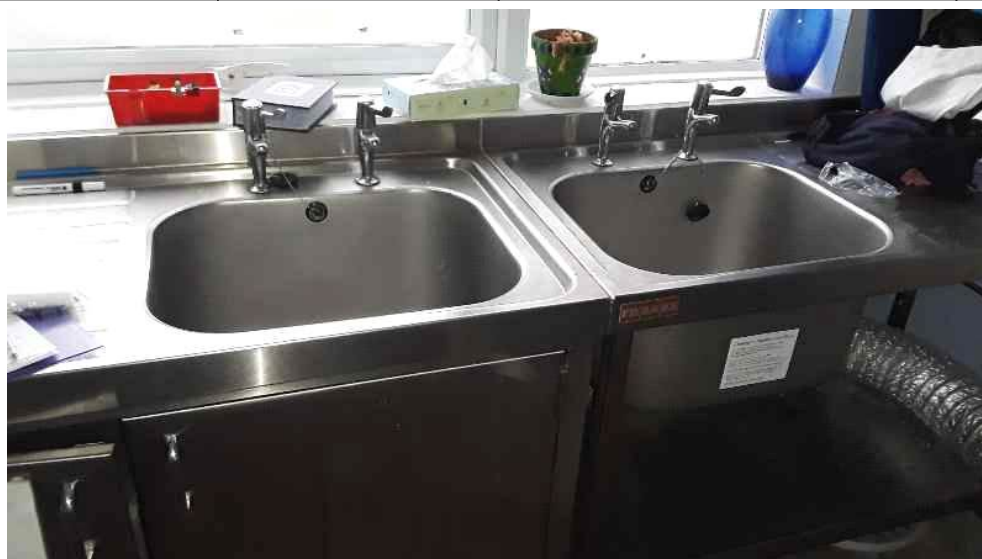
Inspection Number	5	Reference Number:	EC002530
Inspection / Sample	Sample taken	Inspection Cross Reference / Visual I.D.	N.A.D.I.S

Building	Main Building
Floor Level	Ground Floor
Area / Room	0.07 Laundry
Feature	Acoustic pads to sink unit
Product Type	Well Bound Material
Extent Amount	2 no.

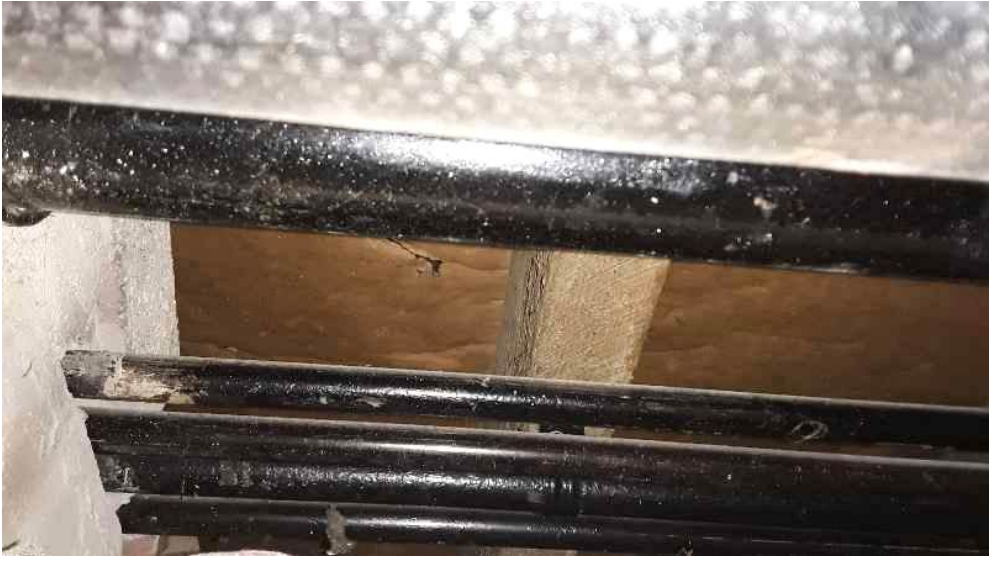
Inspection Number	6	Reference Number:	As Sample EC002529
Inspection / Sample	Visually similar to	Inspection Cross Reference / Visual I.D.	As Sample

Building	Main Building
Floor Level	Ground Floor
Area / Room	0.08 Store
Feature	Bitumen backed paper lining to MMMF loft insulation within ceiling void
Product Type	Well Bound Material
Extent Amount	4 m ²

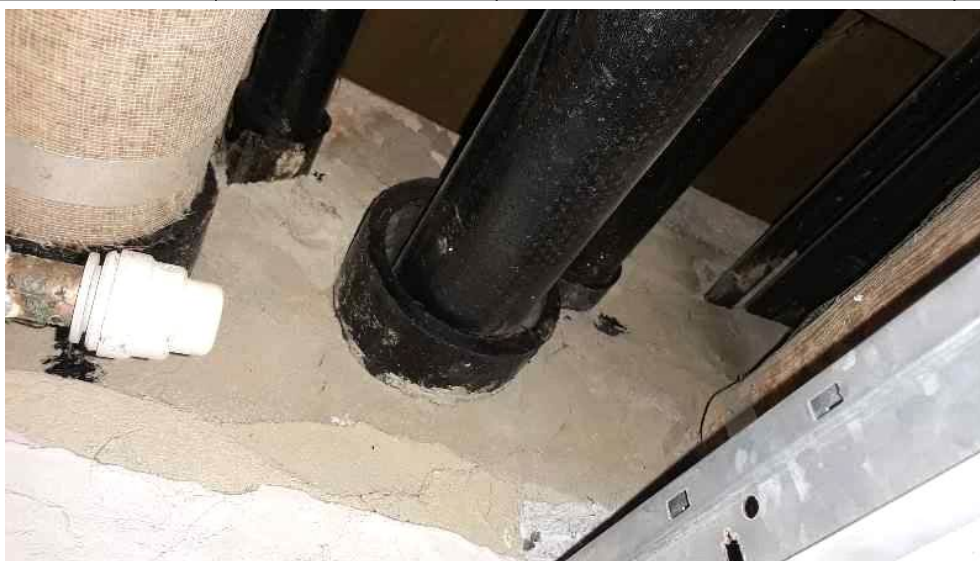
Inspection Number	7	Reference Number:	EC002531
Inspection / Sample	Sample taken	Inspection Cross Reference / Visual I.D.	N.A.D.I.S

Building	Main Building
Floor Level	Ground Floor
Area / Room	0.08 Store
Feature	Bitumen sleeves to pipework
Product Type	Well Bound Material
Extent Amount	1.5 lm

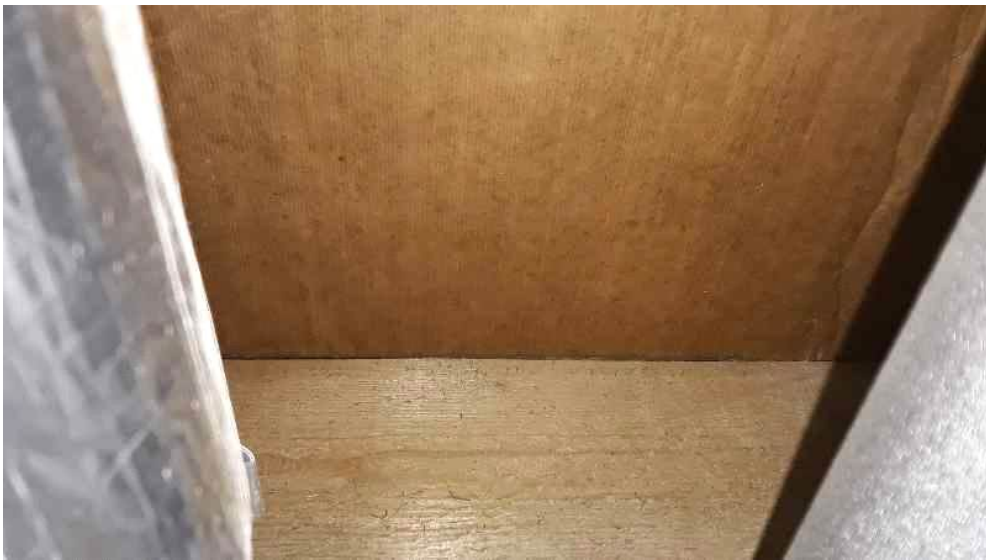
Inspection Number	9	Reference Number:	As Sample EC002529
Inspection / Sample	Visually similar to	Inspection Cross Reference / Visual I.D.	As Sample

Building	Main Building
Floor Level	Ground Floor
Area / Room	0.C04 Lobby
Feature	Bitumen backed paper lining to MMMF loft insulation within ceiling void
Product Type	Well Bound Material
Extent Amount	6 m ²

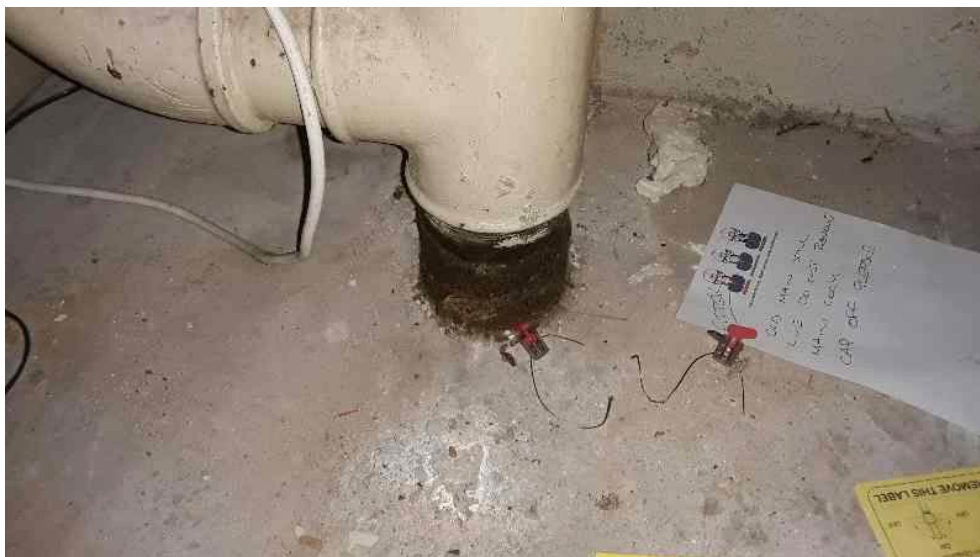
Inspection Number	10	Reference Number:	EC002533
Inspection / Sample	Sample taken	Inspection Cross Reference / Visual I.D.	N.A.D.I.S

Building	Main Building
Floor Level	Ground Floor
Area / Room	0.10 Gas Meter Room
Feature	Bitumen coated textile wrap to base of gas pipework
Product Type	Textiles
Extent Amount	1 lm

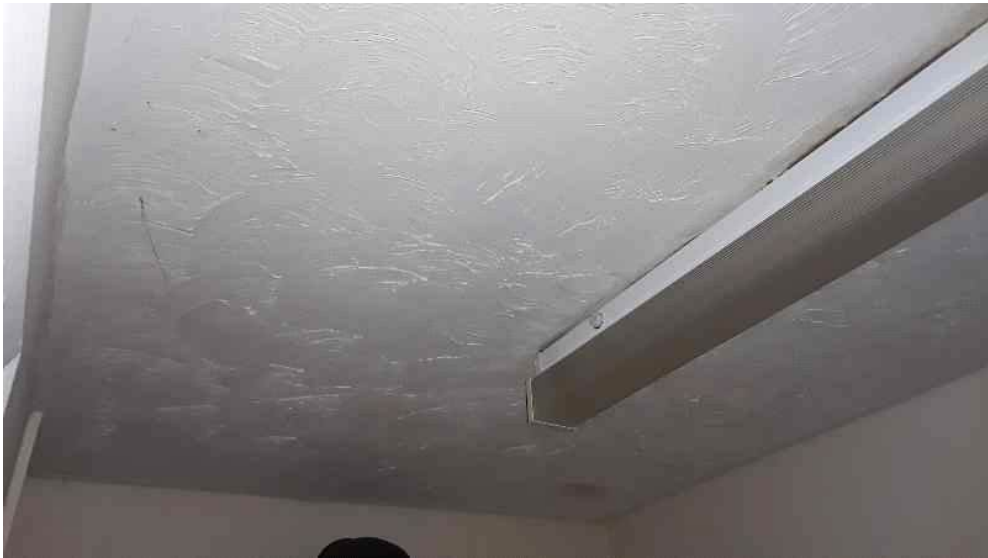
Inspection Number	11	Reference Number:	EC002534
Inspection / Sample	Sample taken	Inspection Cross Reference / Visual I.D.	N.A.D.I.S

Building	Main Building
Floor Level	Ground Floor
Area / Room	0.12 Kitchenette
Feature	Textured coating to plasterboard ceiling
Product Type	Textured Coating
Extent Amount	6 m ²

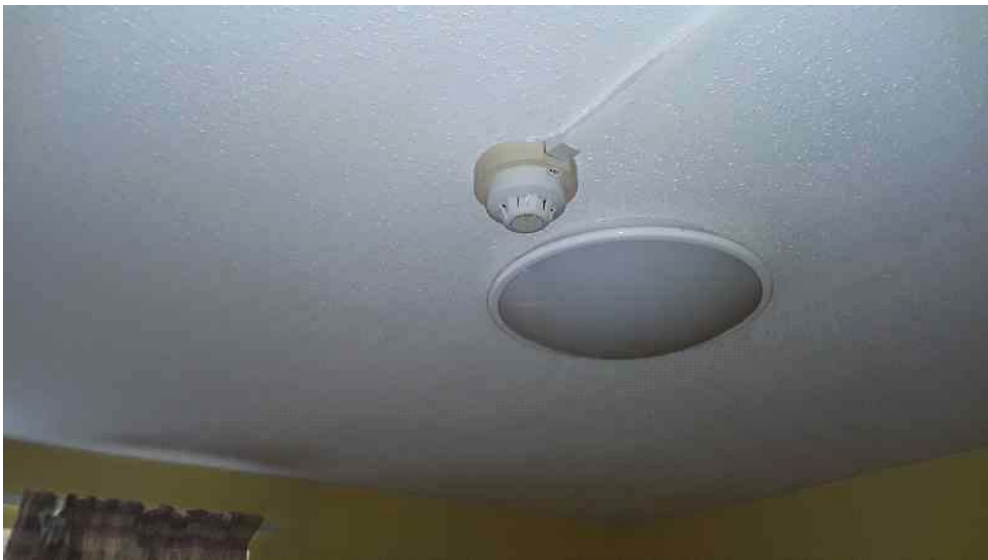
Inspection Number	13	Reference Number:	EC002535
Inspection / Sample	Sample taken	Inspection Cross Reference / Visual I.D.	N.A.D.I.S

Building	Main Building
Floor Level	Ground Floor
Area / Room	0.14 Bedroom 9
Feature	Textured coating to plasterboard ceiling
Product Type	Textured Coating
Extent Amount	9 m2

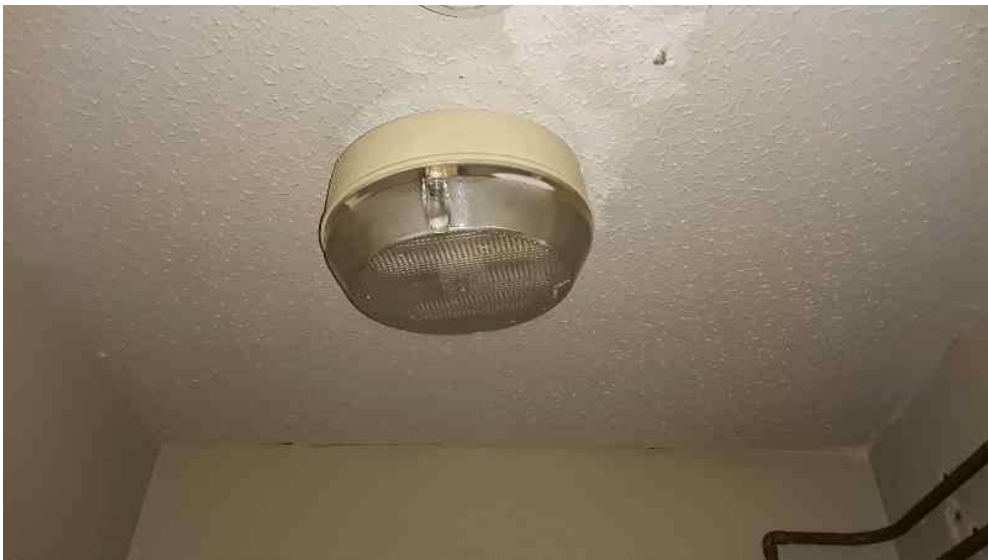
Inspection Number	14	Reference Number:	As Sample EC002540
Inspection / Sample	Visually similar to	Inspection Cross Reference / Visual I.D.	As Sample

Building	Main Building
Floor Level	Ground Floor
Area / Room	0.15 Airing Cupboard
Feature	Textured coating to plasterboard ceiling
Product Type	Textured Coating
Extent Amount	1 m ²

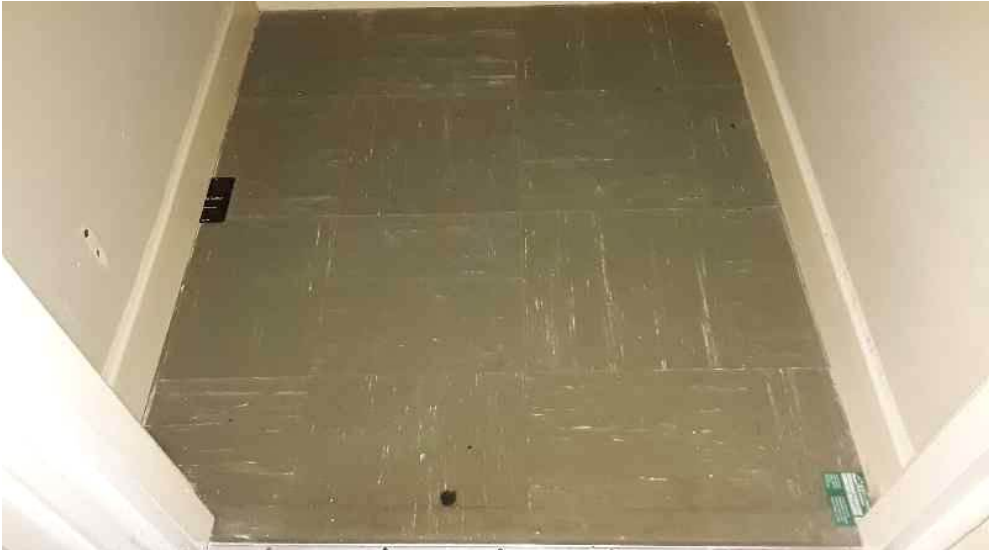
Inspection Number	15	Reference Number:	EC002536
Inspection / Sample	Sample taken	Inspection Cross Reference / Visual I.D.	Asbestos Identified

Building	Main Building
Floor Level	Ground Floor
Area / Room	0.15 Airing Cupboard
Feature	Green thermoplastic floor tiles and bitumen adhesive
Product Type	Well Bound Material
Extent Amount	1 m ²

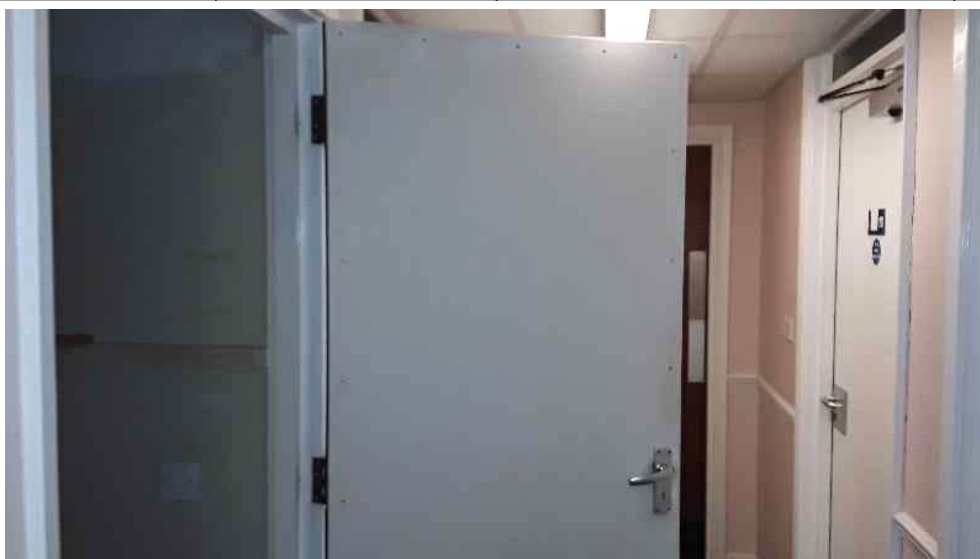
Inspection Number	16	Reference Number:	EC002537
Inspection / Sample	Sample taken	Inspection Cross Reference / Visual I.D.	N.A.D.I.S

Building	Main Building
Floor Level	Ground Floor
Area / Room	0.15 Airing Cupboard
Feature	Insulating board panel to rear of door
Product Type	Insulating Board
Extent Amount	2 m2

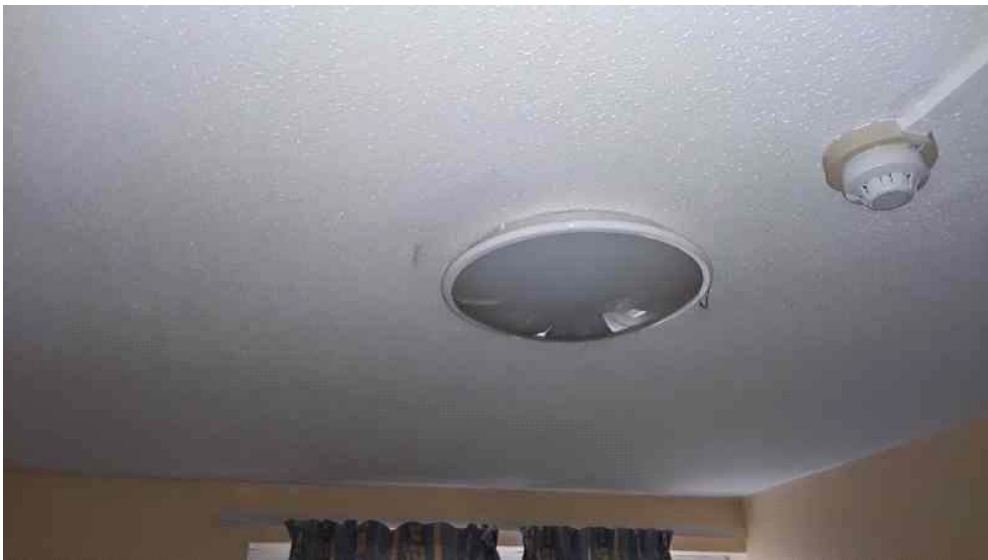
Inspection Number	18	Reference Number:	As Sample EC002540
Inspection / Sample	Visually similar to	Inspection Cross Reference / Visual I.D.	As Sample

Building	Main Building
Floor Level	Ground Floor
Area / Room	0.18 Bedroom 10
Feature	Textured coating to plasterboard ceiling
Product Type	Textured Coating
Extent Amount	9 m2

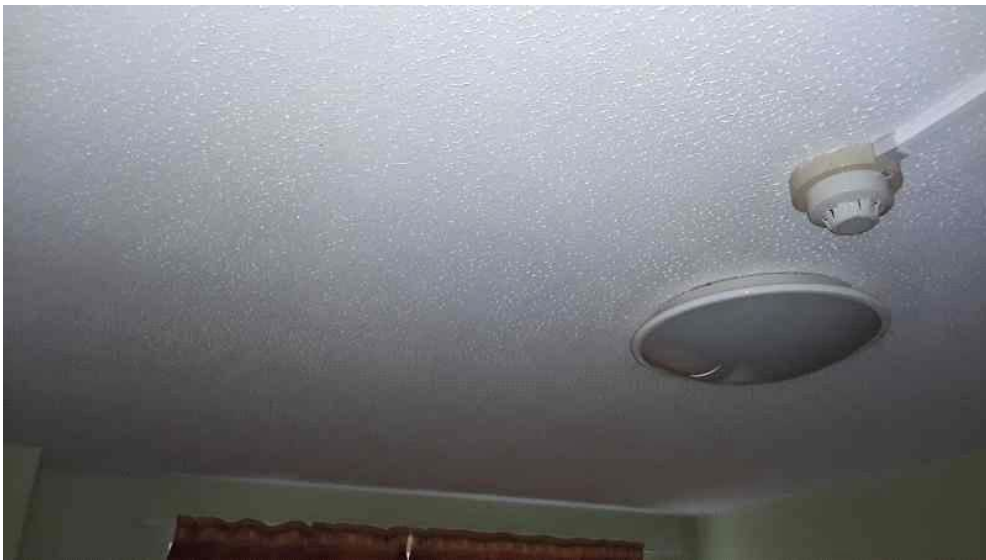
Inspection Number	19	Reference Number:	As Sample EC002540
Inspection / Sample	Visually similar to	Inspection Cross Reference / Visual I.D.	As Sample

Building	Main Building
Floor Level	Ground Floor
Area / Room	0.19 Bedroom 11
Feature	Textured coating to plasterboard ceiling
Product Type	Textured Coating
Extent Amount	9 m2

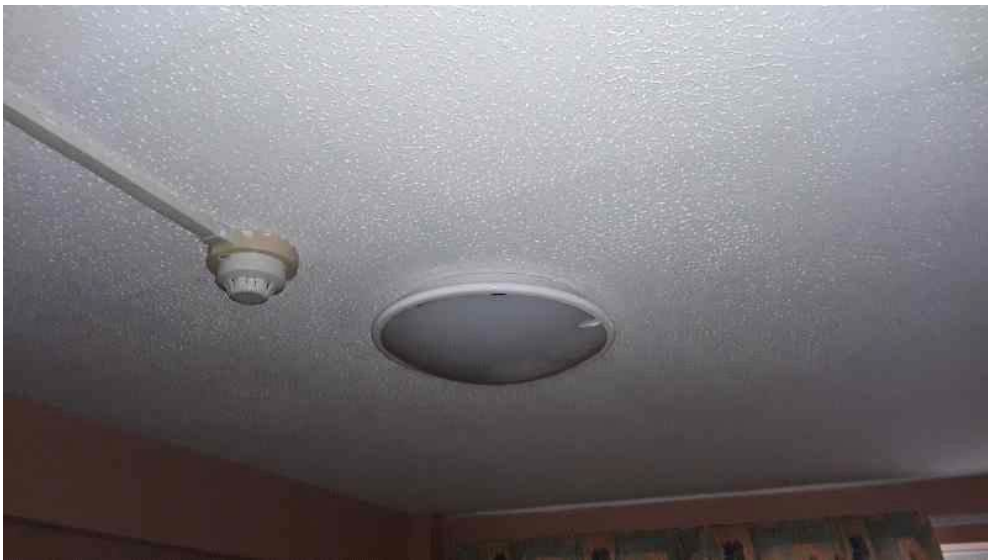
Inspection Number	20	Reference Number:	As Sample EC002540
Inspection / Sample	Visually similar to	Inspection Cross Reference / Visual I.D.	As Sample

Building	Main Building
Floor Level	Ground Floor
Area / Room	0.20 Bedroom 12
Feature	Textured coating to plasterboard ceiling
Product Type	Textured Coating
Extent Amount	9 m2

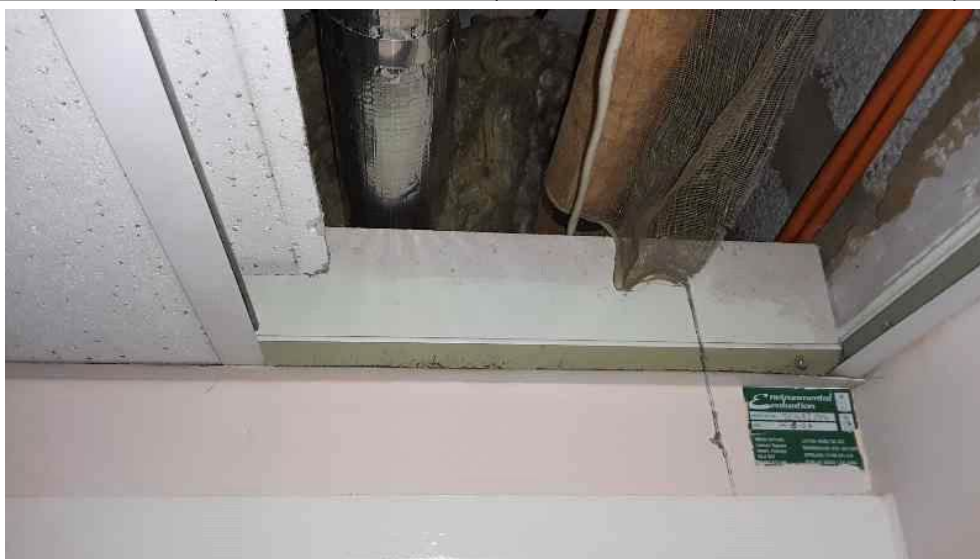
Inspection Number	21	Reference Number:	EC002538
Inspection / Sample	Sample taken	Inspection Cross Reference / Visual I.D.	N.A.D.I.S

Building	Main Building
Floor Level	Ground Floor
Area / Room	0.C07 Circulation
Feature	Insulating board surrounds to internal door
Product Type	Insulating Board
Extent Amount	2 m ²

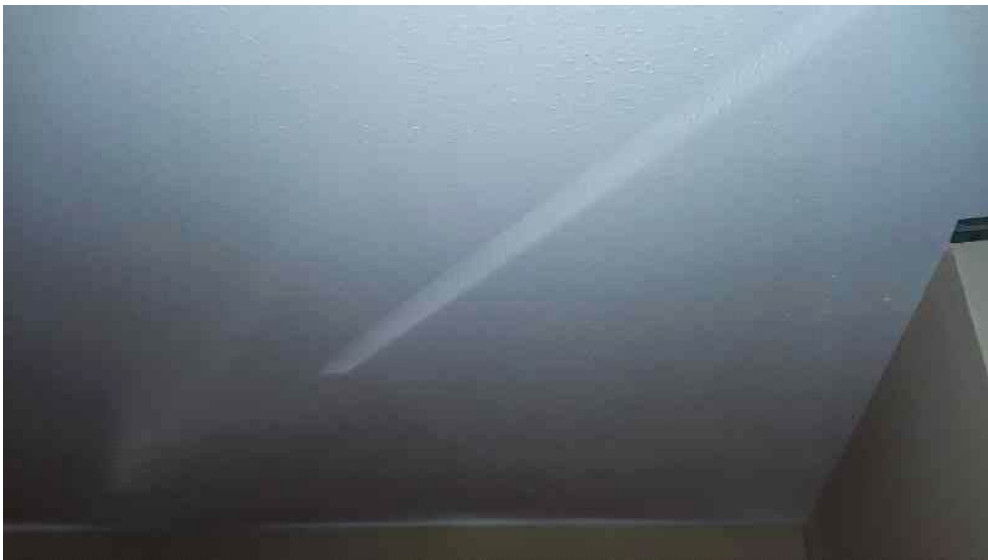
Inspection Number	22	Reference Number:	EC002539
Inspection / Sample	Sample taken	Inspection Cross Reference / Visual I.D.	N.A.D.I.S

Building	Main Building
Floor Level	Ground Floor
Area / Room	0.22 Bedroom 8
Feature	Textured coating to plasterboard ceiling
Product Type	Textured Coating
Extent Amount	12 m ²

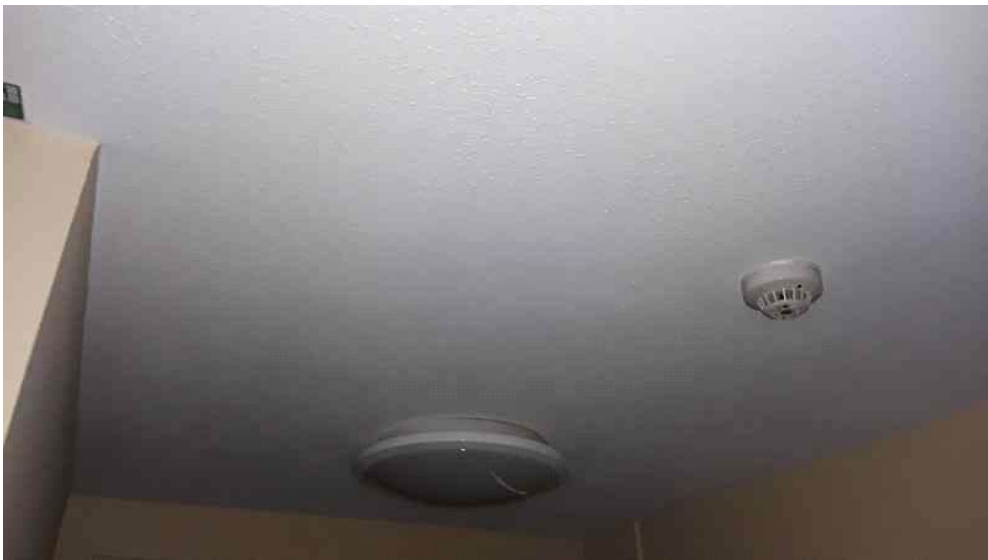
Inspection Number	23	Reference Number:	As Sample EC002540
Inspection / Sample	Visually similar to	Inspection Cross Reference / Visual I.D.	As Sample

Building	Main Building
Floor Level	Ground Floor
Area / Room	0.22A Bedroom 8 Kitchenette
Feature	Textured coating to plasterboard ceiling
Product Type	Textured Coating
Extent Amount	5 m ²

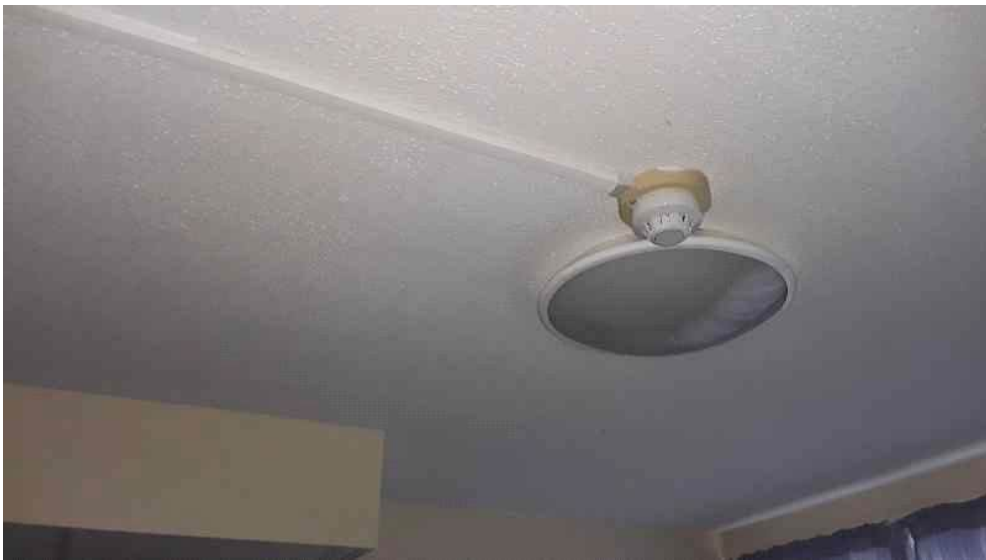
Inspection Number	24	Reference Number:	As Sample EC002540
Inspection / Sample	Visually similar to	Inspection Cross Reference / Visual I.D.	As Sample

Area	Inspection Number	Feature	Material Type – (Friability)	Asbestos Fibre	Material Assessment Score	Priority Assessment Score	Risk Assessment Score	Sample Number	Recommendations
Main Building, Ground Floor, Bedroom 7 (0.23)	24	Textured coating to plasterboard ceiling (as sample EC002540)	Textured Coating (Low)	(1) Chrysotile	3	7	10	EC002540	Manage
Main Building, Ground Floor, Store (0.27)	25	Textured coating to plasterboard ceiling (as sample EC002540)	Textured Coating (Low)	(1) Chrysotile	3	5	8	EC002540	Manage
Main Building, Ground Floor, Store (0.27)	26	Green thermoplastic floor tiles and bitumen adhesive (as sample EC002536)	Well Bound Material (Low)	(1) Chrysotile	2	4	6	EC002536	Manage
Main Building, Ground Floor, Bedroom 4 (0.28)	28	Textured coating to plasterboard ceiling (as sample EC002540)	Textured Coating (Low)	(1) Chrysotile	3	7	10	EC002540	Manage
Main Building, Ground Floor, Bedroom 5 (0.29)	29	Textured coating to plasterboard ceiling (as sample EC002540)	Textured Coating (Low)	(1) Chrysotile	3	7	10	EC002540	Manage

Building	Main Building
Floor Level	Ground Floor
Area / Room	0.23 Bedroom 7
Feature	Textured coating to plasterboard ceiling
Product Type	Textured Coating
Extent Amount	12 m ²

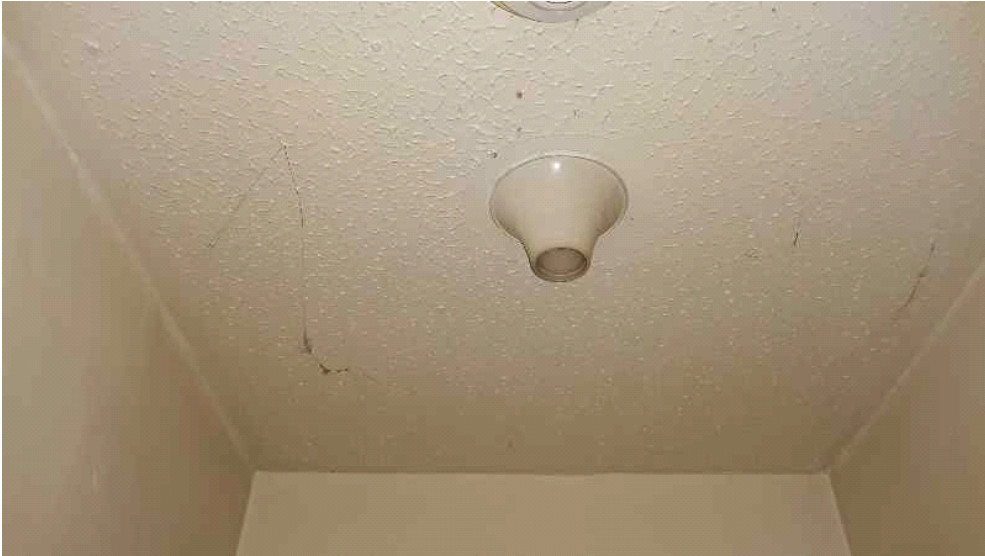
Inspection Number	25	Reference Number:	As Sample EC002540
Inspection / Sample	Visually similar to	Inspection Cross Reference / Visual I.D.	As Sample

Building	Main Building
Floor Level	Ground Floor
Area / Room	0.27 Store
Feature	Textured coating to plasterboard ceiling
Product Type	Textured Coating
Extent Amount	1 m ²

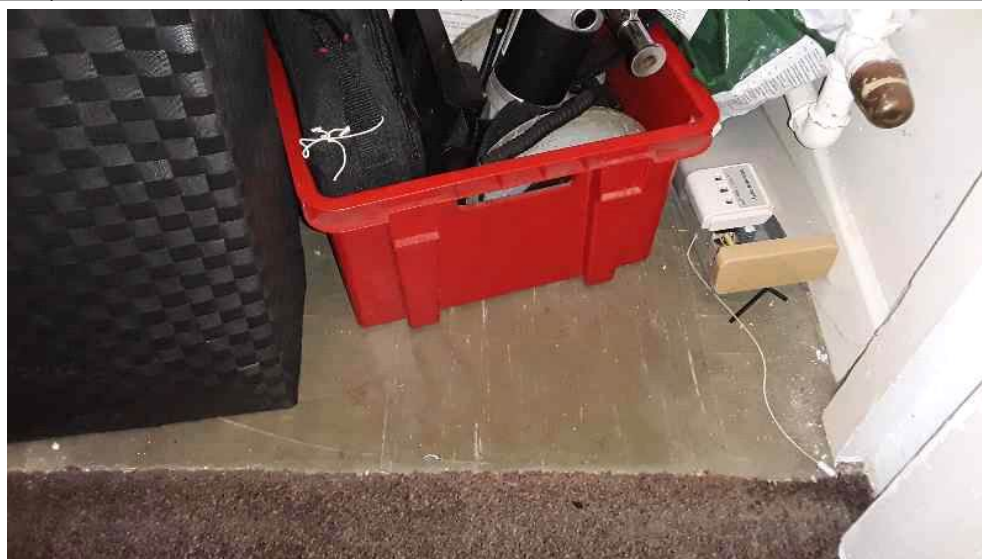
Inspection Number	26	Reference Number:	As Sample EC002536
Inspection / Sample	Visually similar to	Inspection Cross Reference / Visual I.D.	As Sample

Building	Main Building
Floor Level	Ground Floor
Area / Room	0.27 Store
Feature	Green thermoplastic floor tiles and bitumen adhesive
Product Type	Well Bound Material
Extent Amount	1 m ²

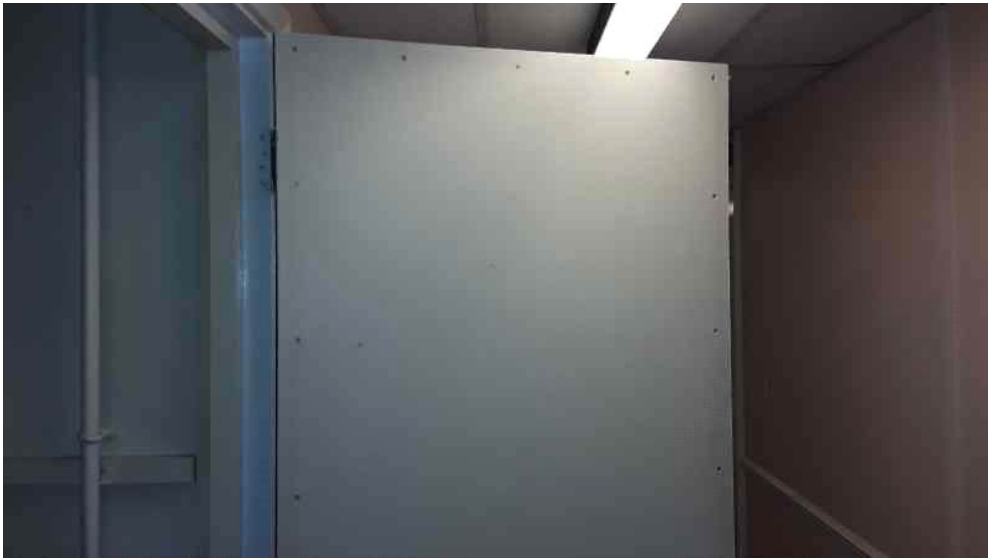
Inspection Number	27	Reference Number:	As Sample EC002537
Inspection / Sample	Visually similar to	Inspection Cross Reference / Visual I.D.	As Sample

Building	Main Building
Floor Level	Ground Floor
Area / Room	0.27 Store
Feature	Insulating board panel to rear of door
Product Type	Insulating Board
Extent Amount	2 m2

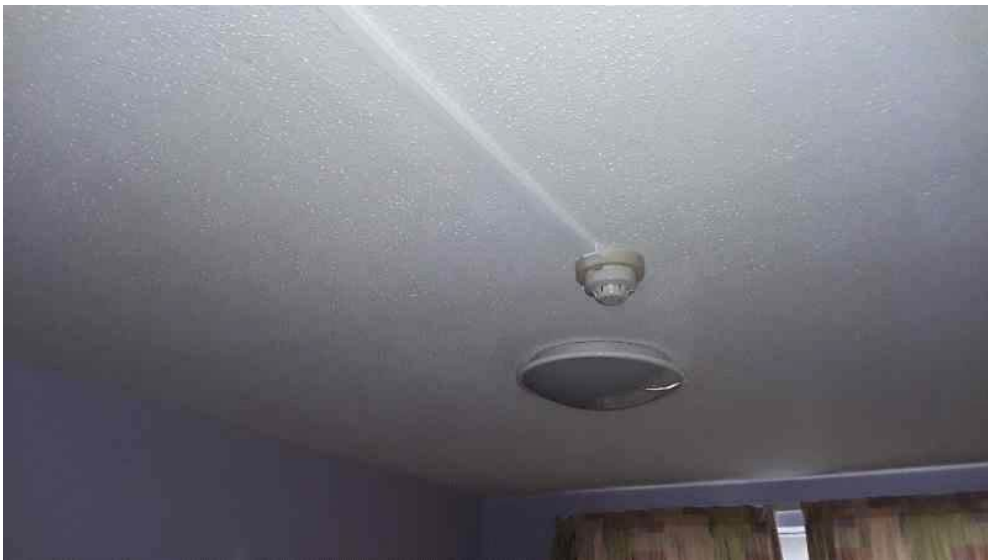
Inspection Number	28	Reference Number:	As Sample EC002540
Inspection / Sample	Visually similar to	Inspection Cross Reference / Visual I.D.	As Sample

Building	Main Building
Floor Level	Ground Floor
Area / Room	0.28 Bedroom 4
Feature	Textured coating to plasterboard ceiling
Product Type	Textured Coating
Extent Amount	9 m ²

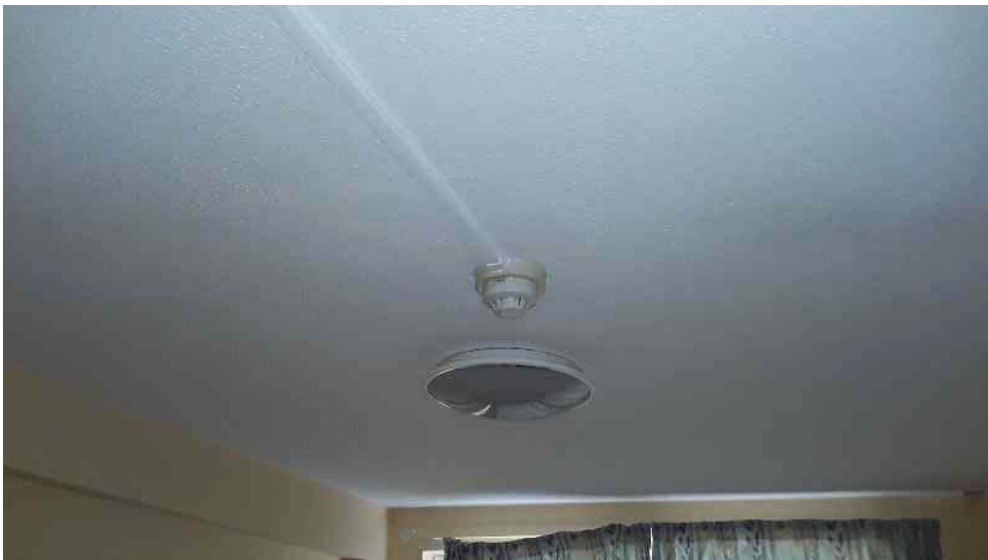
Inspection Number	29	Reference Number:	As Sample EC002540
Inspection / Sample	Visually similar to	Inspection Cross Reference / Visual I.D.	As Sample

Building	Main Building
Floor Level	Ground Floor
Area / Room	0.29 Bedroom 5
Feature	Textured coating to plasterboard ceiling
Product Type	Textured Coating
Extent Amount	9 m ²

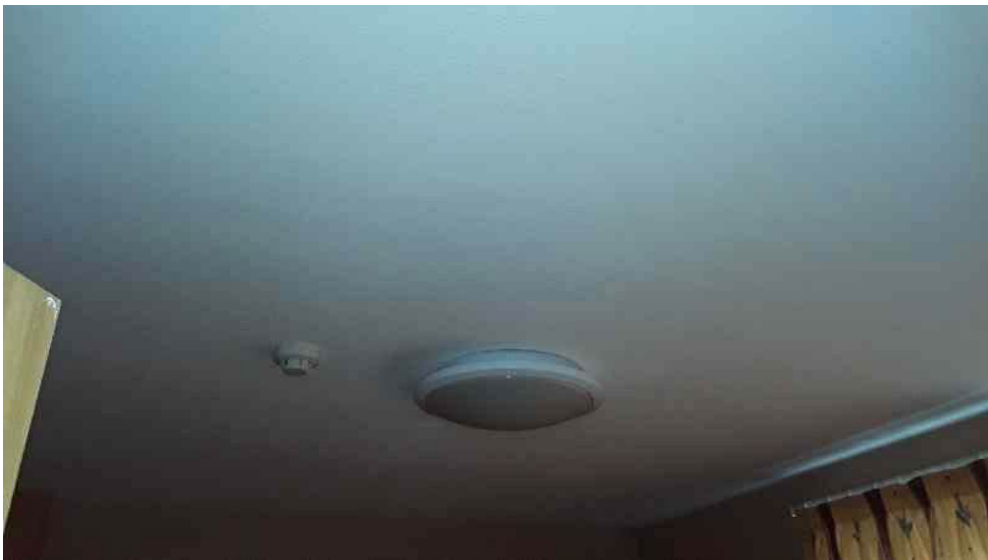
Inspection Number	30	Reference Number:	As Sample EC002540
Inspection / Sample	Visually similar to	Inspection Cross Reference / Visual I.D.	As Sample

Building	Main Building
Floor Level	Ground Floor
Area / Room	0.30 Bedroom 6
Feature	Textured coating to plasterboard ceiling
Product Type	Textured Coating
Extent Amount	9 m2

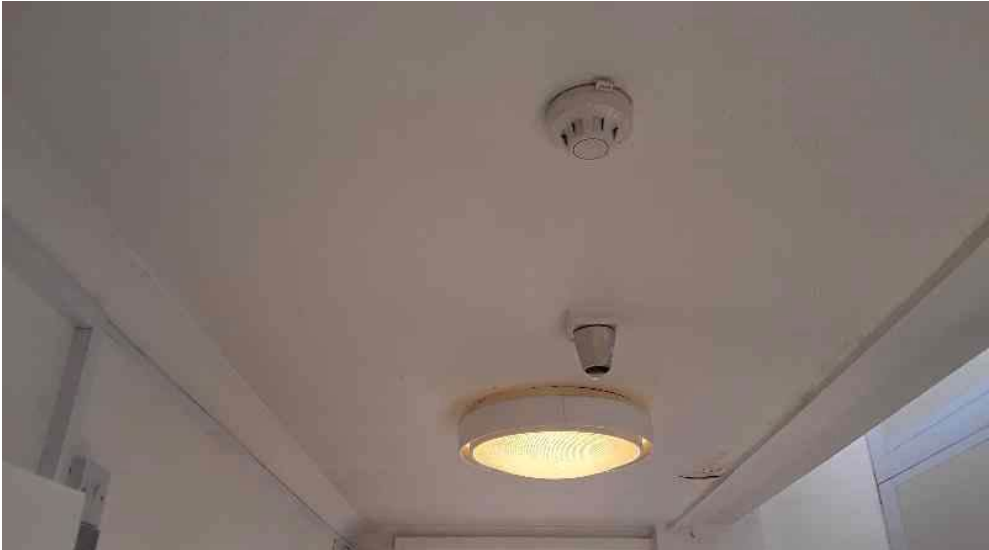
Inspection Number	32	Reference Number:	EC002541
Inspection / Sample	Sample taken	Inspection Cross Reference / Visual I.D.	Asbestos Identified

Area	Inspection Number	Feature	Material Type – (Friability)	Asbestos Fibre	Material Assessment Score	Priority Assessment Score	Risk Assessment Score	Sample Number	Recommendations
Main Building, Ground Floor, Stairwell (0.S01)	32	Textured coating to plasterboard ceiling	Textured Coating (Low)	(1) Chrysotile	5	5	10	EC002541	Repair or Remove
Main Building, Ground Floor, Stairwell (0.S02)	42	Composite nosings to stairs	Reinforced Composite (Low)	(1) Chrysotile	2	4	6	EC002591	Manage
Main Building, 1st Floor, Landing (1.01)	58	Textured coating to plasterboard ceiling	Textured Coating (Low)	(1) Chrysotile	3	5	8	EC002596	Manage
Main Building, 1st Floor, Store 1 (1.02)	61	Textured coating to plasterboard ceiling (as sample EC002596)	Textured Coating (Low)	(1) Chrysotile	3	5	8	EC002596	Manage
Main Building, 1st Floor, Store 1 (1.02)	62	Grey thermoplastic floor tiles & bitumen adhesive	Well Bound Material (Low)	(1) Chrysotile	2	4	6	EC002597	Manage

Building	Main Building
Floor Level	Ground Floor
Area / Room	0.S01 Stairwell
Feature	Textured coating to plasterboard ceiling
Product Type	Textured Coating
Extent Amount	3 m2

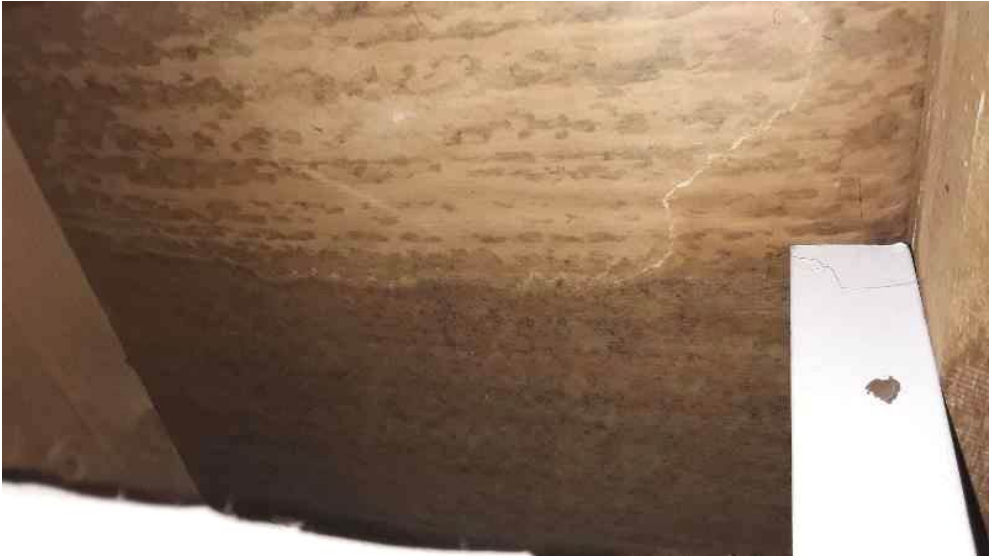
Inspection Number	33	Reference Number:	As Sample EC002529
Inspection / Sample	Visually similar to	Inspection Cross Reference / Visual I.D.	As Sample

Building	Main Building
Floor Level	Ground Floor
Area / Room	0.C09 Circulation
Feature	Bitumen backed paper lining to MMMF loft insulation within ceiling void
Product Type	Well Bound Material
Extent Amount	15 m ²

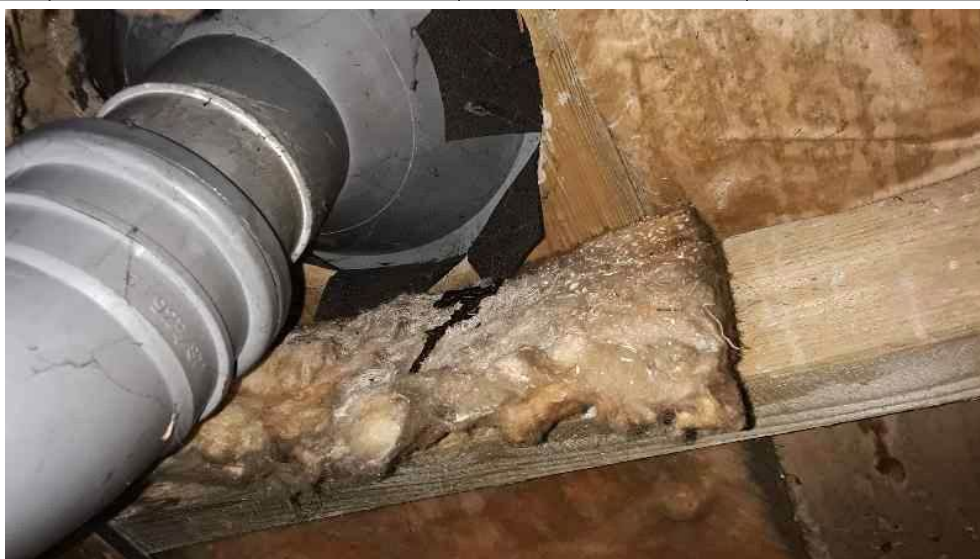
Inspection Number	34	Reference Number:	As Sample EC002532
Inspection / Sample	Visually similar to	Inspection Cross Reference / Visual I.D.	As Sample

Notes	Item presumed present throughout building
-------	---

Building	Main Building
Floor Level	Ground Floor
Area / Room	0.C09 Circulation
Feature	Bitumen debris to timbers within ceiling void
Product Type	Well Bound Material
Extent Amount	Small amounts

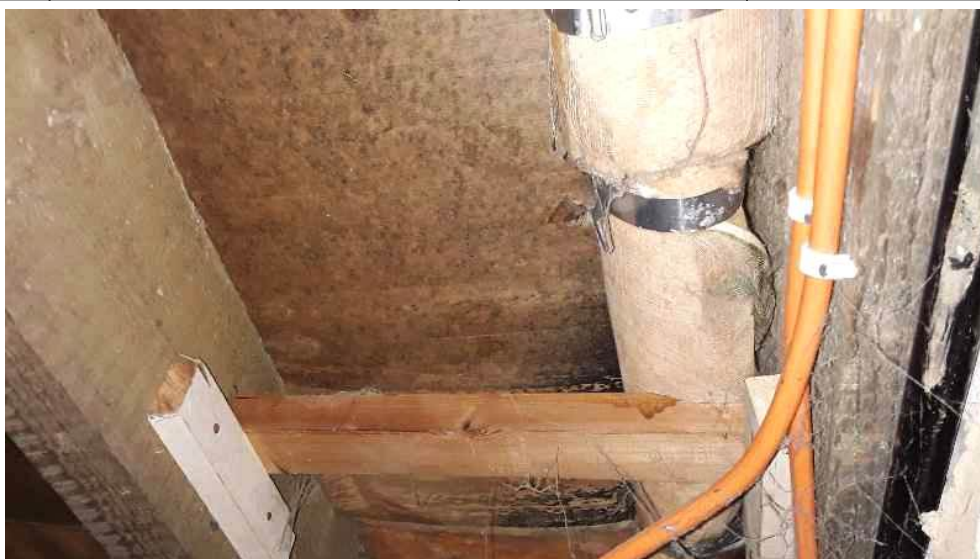
Inspection Number	35	Reference Number:	As Sample EC002529
Inspection / Sample	Visually similar to	Inspection Cross Reference / Visual I.D.	As Sample

Building	Main Building
Floor Level	Ground Floor
Area / Room	0.31 Bathroom
Feature	Bitumen backed paper lining to MMMF loft insulation within ceiling void
Product Type	Well Bound Material
Extent Amount	12 m ²

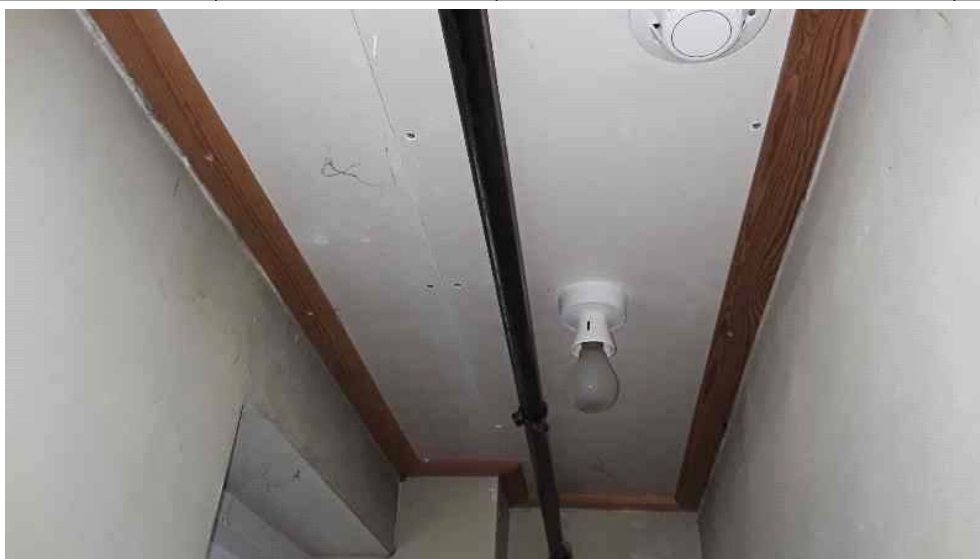
Inspection Number	39	Reference Number:	EC002590
Inspection / Sample	Sample taken	Inspection Cross Reference / Visual I.D.	N.A.D.I.S

Building	Main Building
Floor Level	Ground Floor
Area / Room	0.34 Void
Feature	Insulating board ceiling
Product Type	Insulating Board
Extent Amount	1 m ²

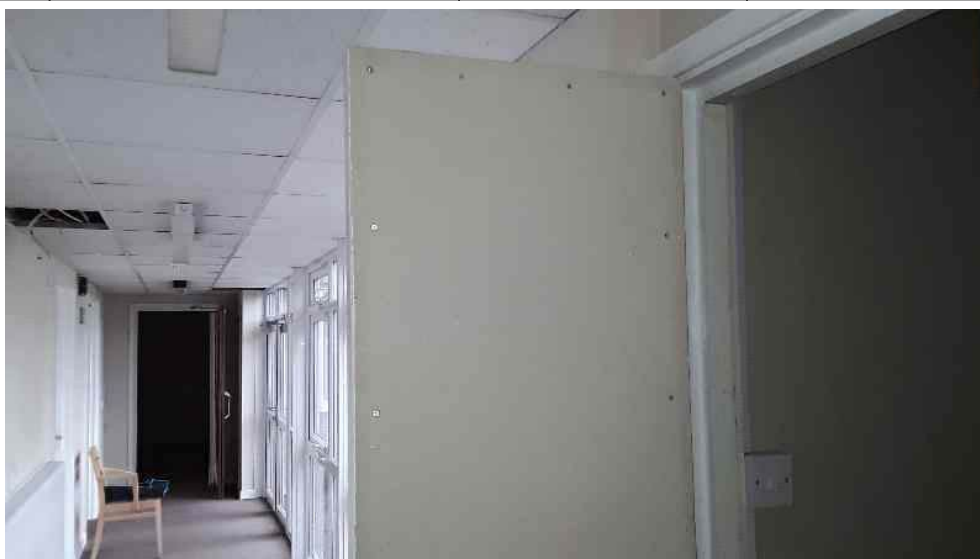
Inspection Number	40	Reference Number:	As Sample EC002537
Inspection / Sample	Visually similar to	Inspection Cross Reference / Visual I.D.	As Sample

Building	Main Building
Floor Level	Ground Floor
Area / Room	0.34 Void
Feature	Insulating board panel to rear of door
Product Type	Insulating Board
Extent Amount	2 m ²

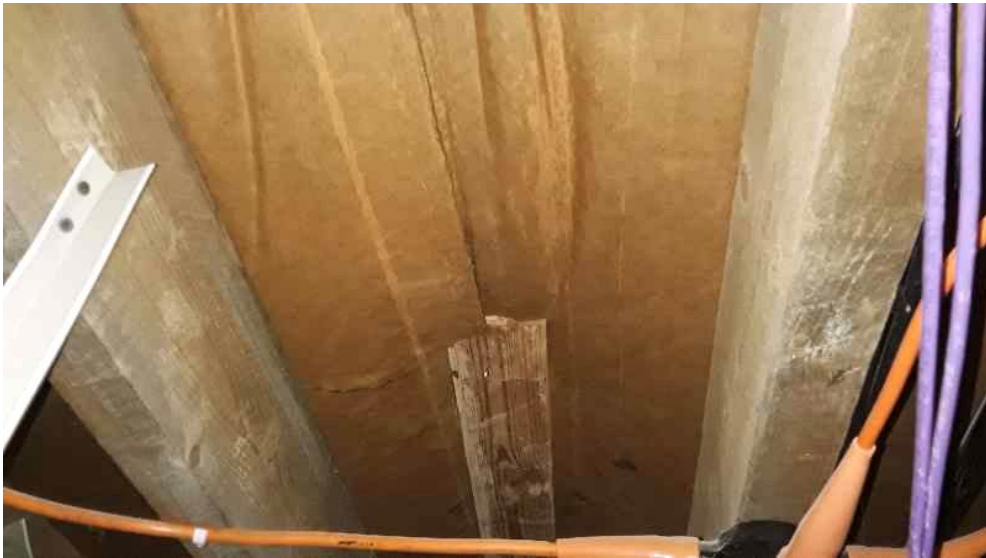
Inspection Number	41	Reference Number:	As Sample EC002529
Inspection / Sample	Visually similar to	Inspection Cross Reference / Visual I.D.	As Sample

Building	Main Building
Floor Level	Ground Floor
Area / Room	0.35 Entrance Lobby
Feature	Bitumen backed paper lining to MMMF loft insulation within ceiling void
Product Type	Well Bound Material
Extent Amount	6 m ²

Product Score	Low Fibre Release - Asbestos reinforced composites (plastics, resins, mastics, roofing felts, vinyl floor tiles, semi-rigid paints or decorative finishes, asbestos cement, etc.)	0
Extent of Damage	Low damage - a few scratches or surface marks; broken edges on boards, tiles etc.	0
Surface Treatment	Reinforced plastics, resins, vinyl tiles, well bound materials, bitumen adhesives, damp proof course	0
Asbestos Type	No Asbestos Detected	0

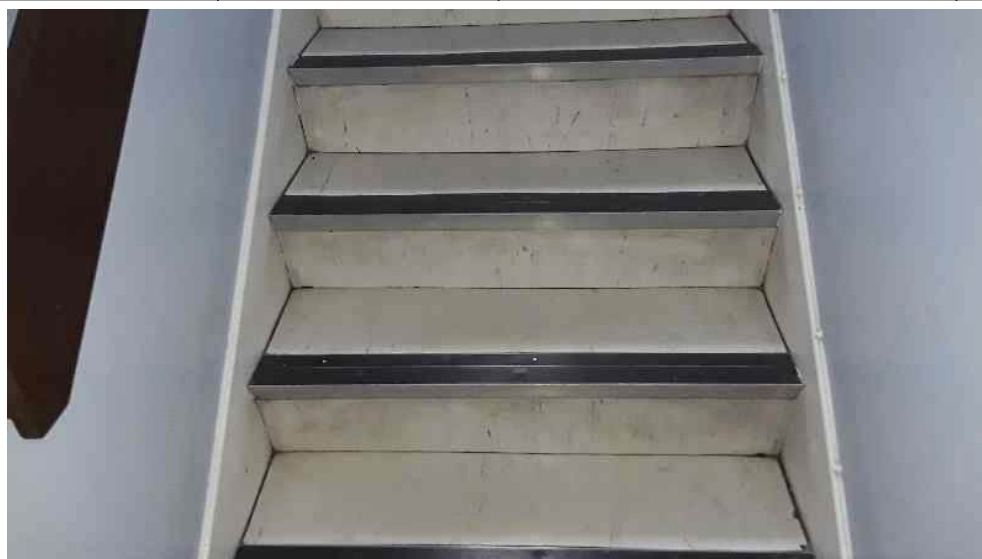
Inspection Number	43	Reference Number:	EC002592
Inspection / Sample	Sample taken	Inspection Cross Reference / Visual I.D.	N.A.D.I.S

Building	Main Building
Floor Level	Ground Floor
Area / Room	0.S02 Stairwell
Feature	Cream laminate flooring to stairs
Product Type	Reinforced Composite
Extent Amount	8 m ²

Product Score	Low Fibre Release - Asbestos reinforced composites (plastics, resins, mastics, roofing felts, vinyl floor tiles, semi-rigid paints or decorative finishes, asbestos cement, etc.)	0
Extent of Damage	Low damage - a few scratches or surface marks; broken edges on boards, tiles etc.	0
Surface Treatment	Reinforced plastics, resins, vinyl tiles, well bound materials, bitumen adhesives, damp proof course	0
Asbestos Type	No Asbestos Detected	0

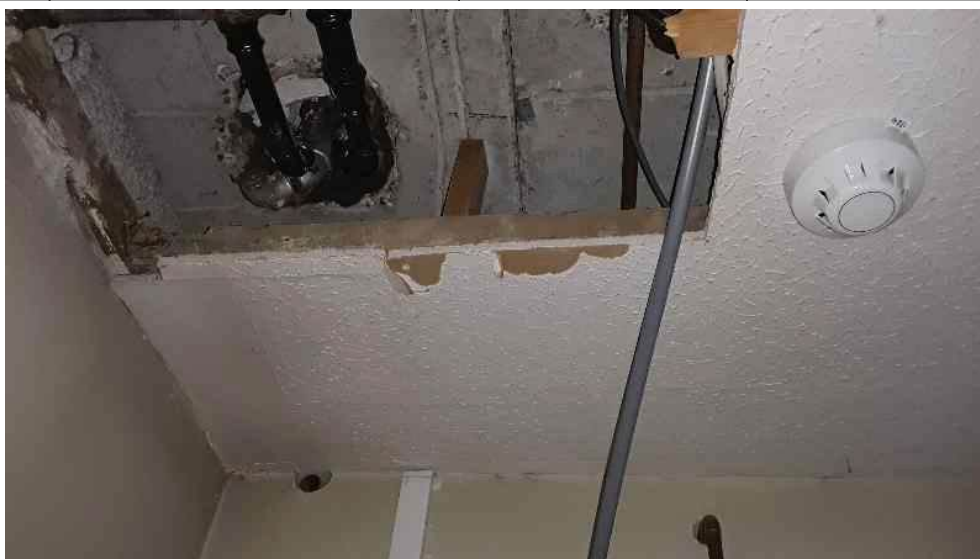
Inspection Number	45	Reference Number:	As Sample EC002593
Inspection / Sample	Visually similar to	Inspection Cross Reference / Visual I.D.	As Sample

Building	Main Building
Floor Level	Ground Floor
Area / Room	0.37 Store
Feature	Textured coating to plasterboard ceiling
Product Type	Textured Coating
Extent Amount	1 m2

Product Score	Low Fibre Release - Asbestos reinforced composites (plastics, resins, mastics, roofing felts, vinyl floor tiles, semi-rigid paints or decorative finishes, asbestos cement, etc.)	1
Extent of Damage	Medium damage - significant breakage of materials or several small areas where material has been damaged revealing loose asbestos fibres	2
Surface Treatment	Enclosed sprays and lagging, Sealed AIB, asbestos cement, textured coating, gasket	1
Asbestos Type	Chrysotile	1

Recommendation	Repair or Remove
----------------	------------------
